ENVIRONMENTAL MANAGEMENT PLAN

The Proposed Utilisation of Borrow Pits Road: DR08025 (OR Tambo District Municipality)

Department of Roads and Public Works Province of the Eastern Cape

Report Number 2011-R541

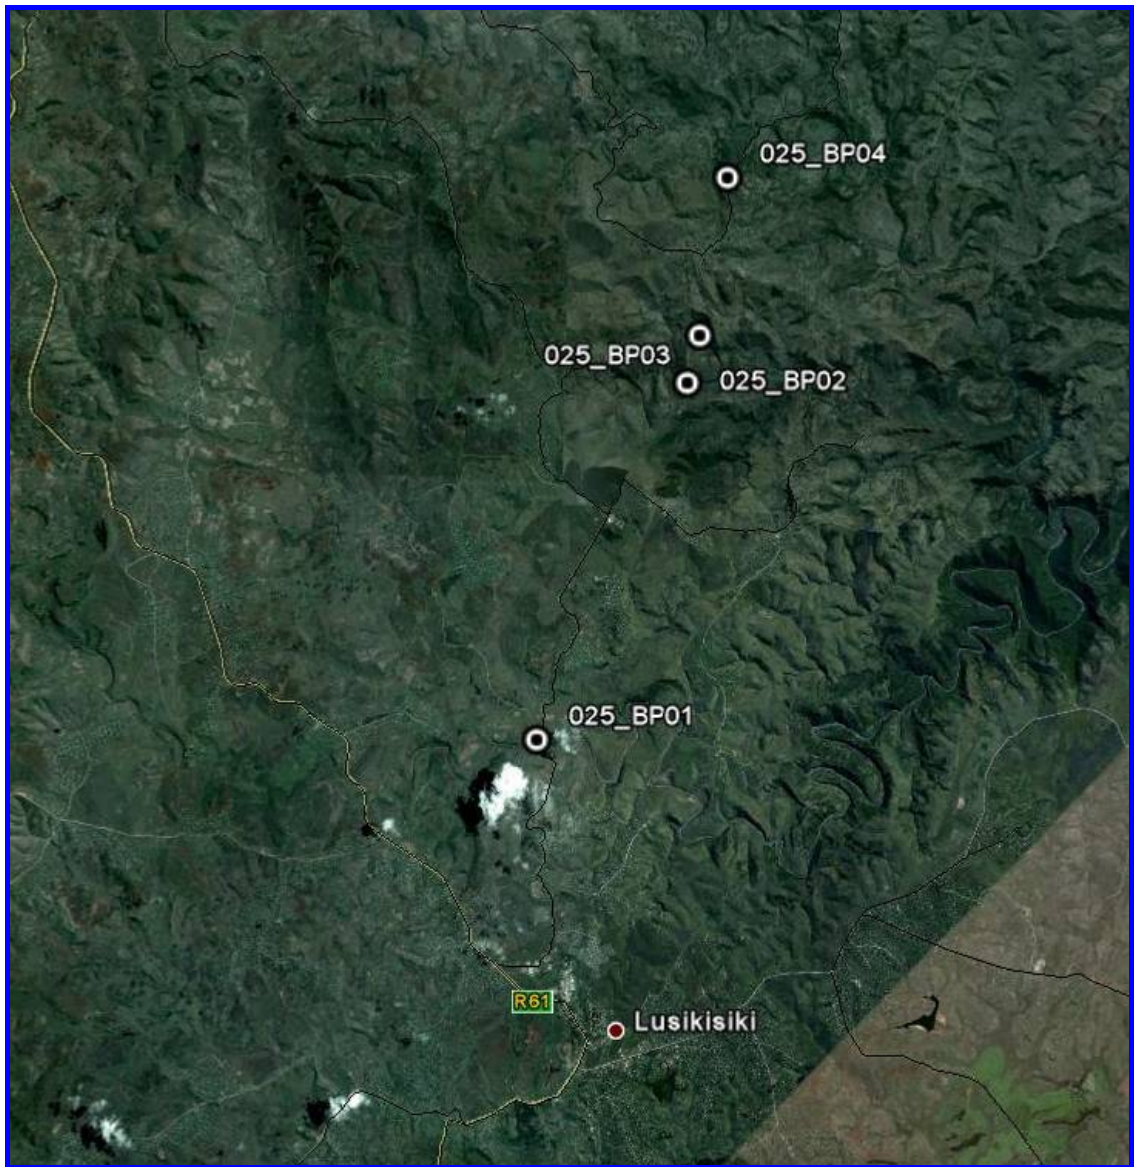
It is proposed here to utilise four (4) borrow pits identified along the DR08025, for the routine maintenance/re-gravelling of this district road (Table above). The nearest formal town is Lusikisiki. The borrow pits are located adjacent to the DR08025.

Figure 2: Aerial Image - Road DR08025 & associated BP's.

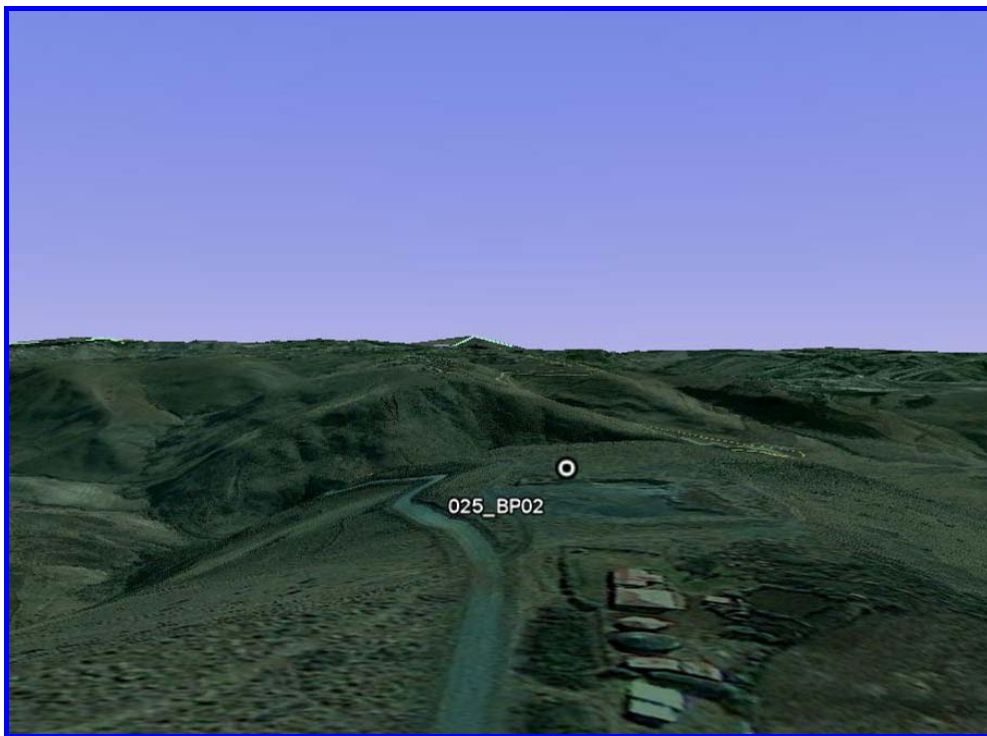
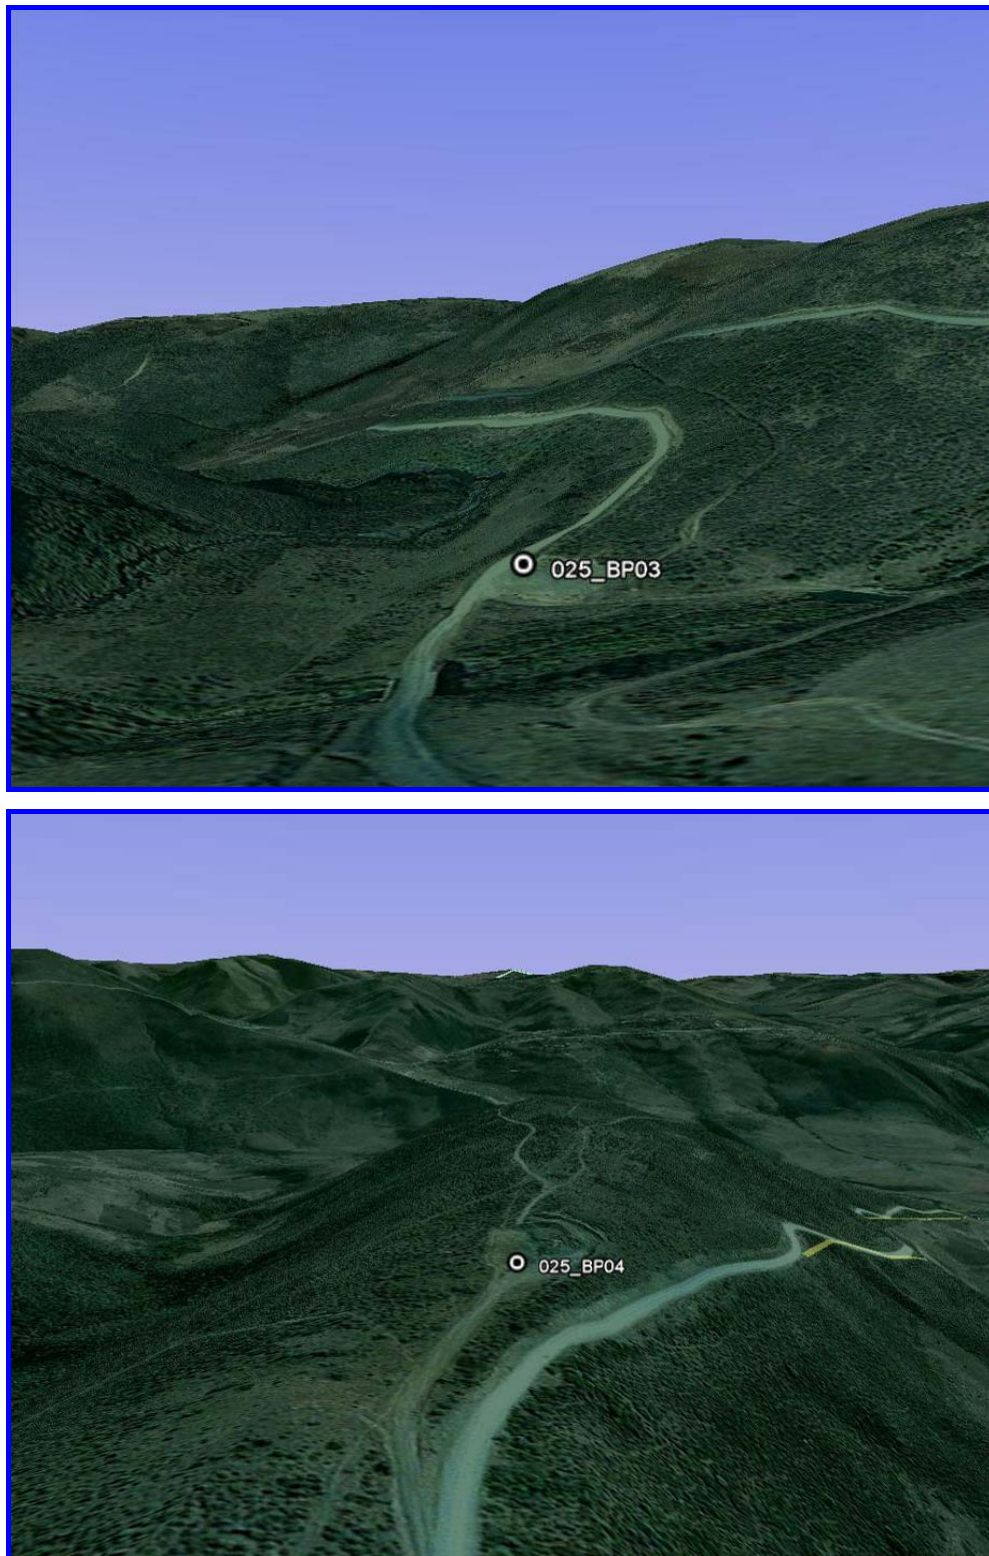
Figure 15: Terrain view indicating the position of the borrow pits in the landscape.

The topography may be impacted upon by the excavation of the existing borrow pits which in turn could have an effect on the storm water runoff and drainage of the immediate surrounding area. Areas of concentrated storm water runoff could be subject to increased erosion if not mitigated against appropriately by means of erosion control techniques and/or structures dissipating the velocity and flow of storm water runoff. The non-perennial drainage lines are referred to as such due to the fact that they are dry for the majority of the year, and some instance only flow during periods of high rainfall.

As the borrow pits are existing and have been utilised previously, the topography has been altered by the excavation of material from the hill slopes and hill tops.
