# ENVIRONMENTAL MANAGEMENT PLAN

## The Proposed Utilisation of Borrow Pits Road: DR08151 (OR Tambo District Municipality)

Department of Roads and Public Works  
Province of the Eastern Cape

Report Number 2011-R550

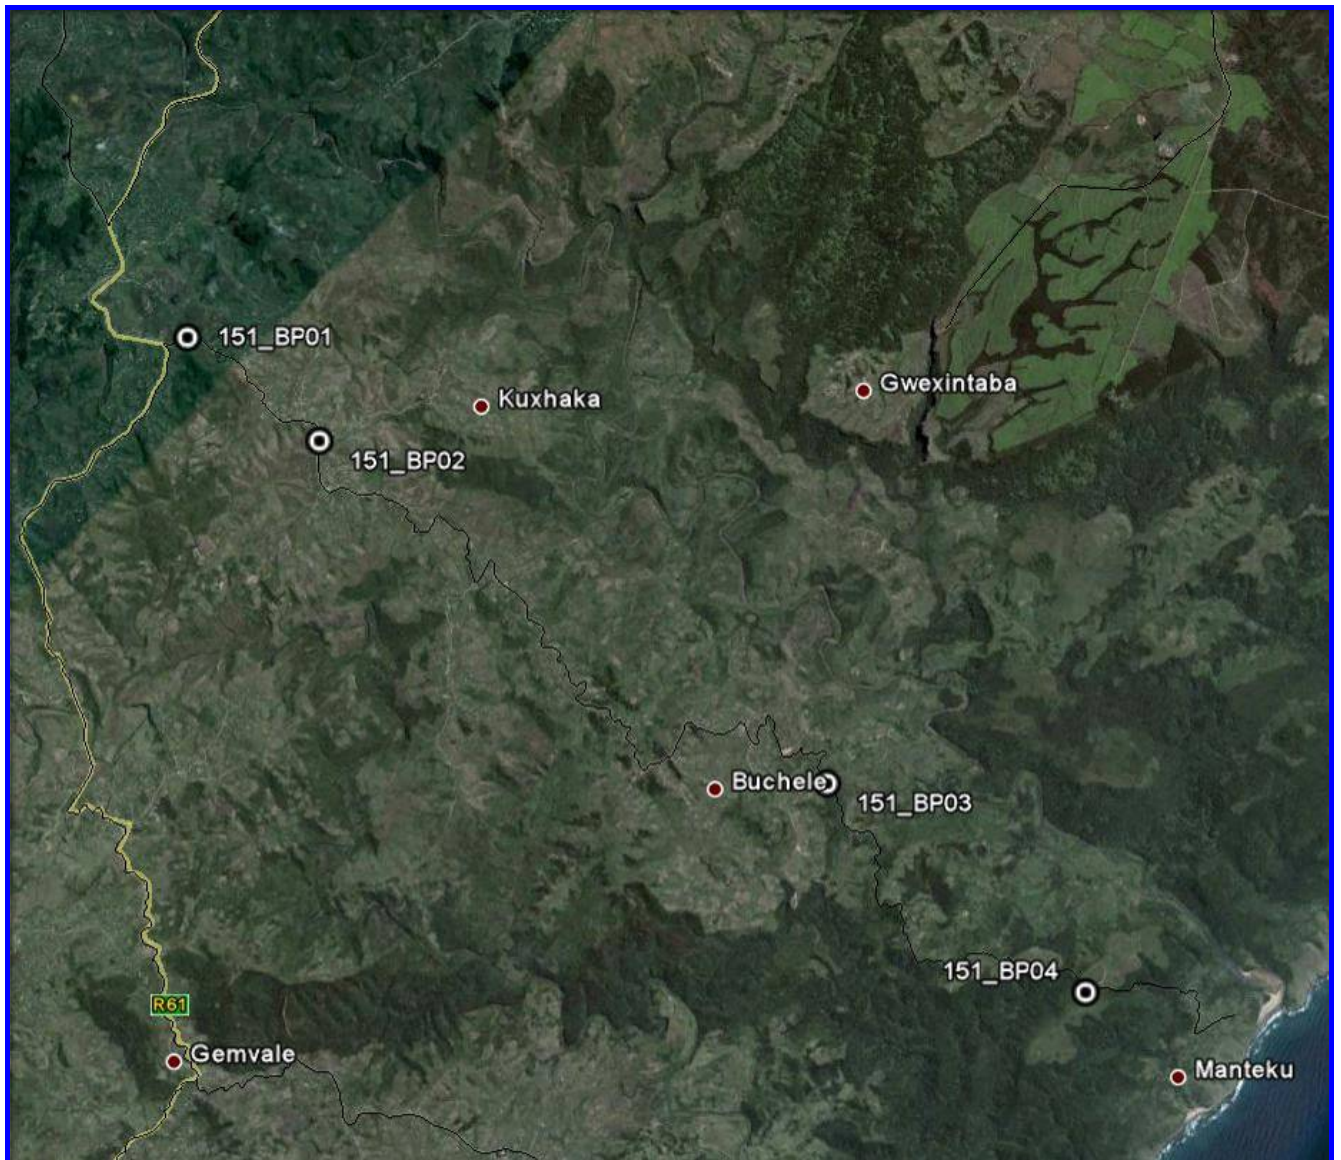
Figure 2: Aerial Image - Road DR08151 & associated BP's.

It is proposed here to utilise four (4) borrow pits identified along the DR08151, for the routine maintenance/re-gravelling of this district road (Table above). The nearest formal town is Lusikisiki. The borrow pits are located adjacent to the DR08151.

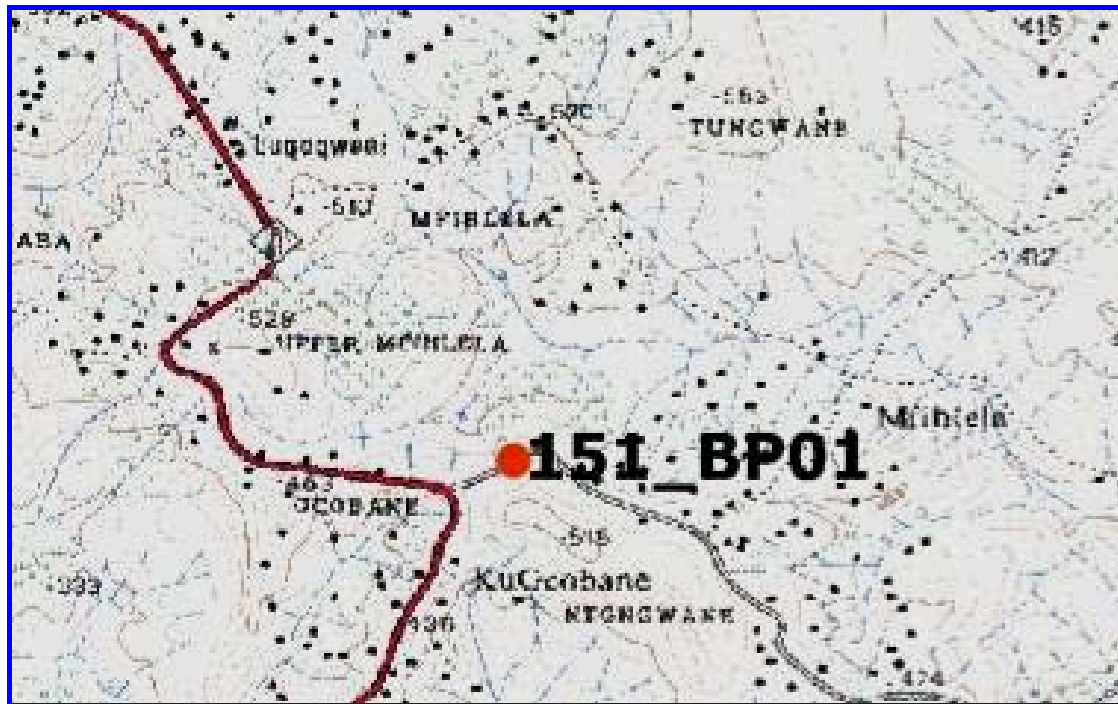
Figure 3: Topographical Location of 151\_BP01 - 1:50 000 map

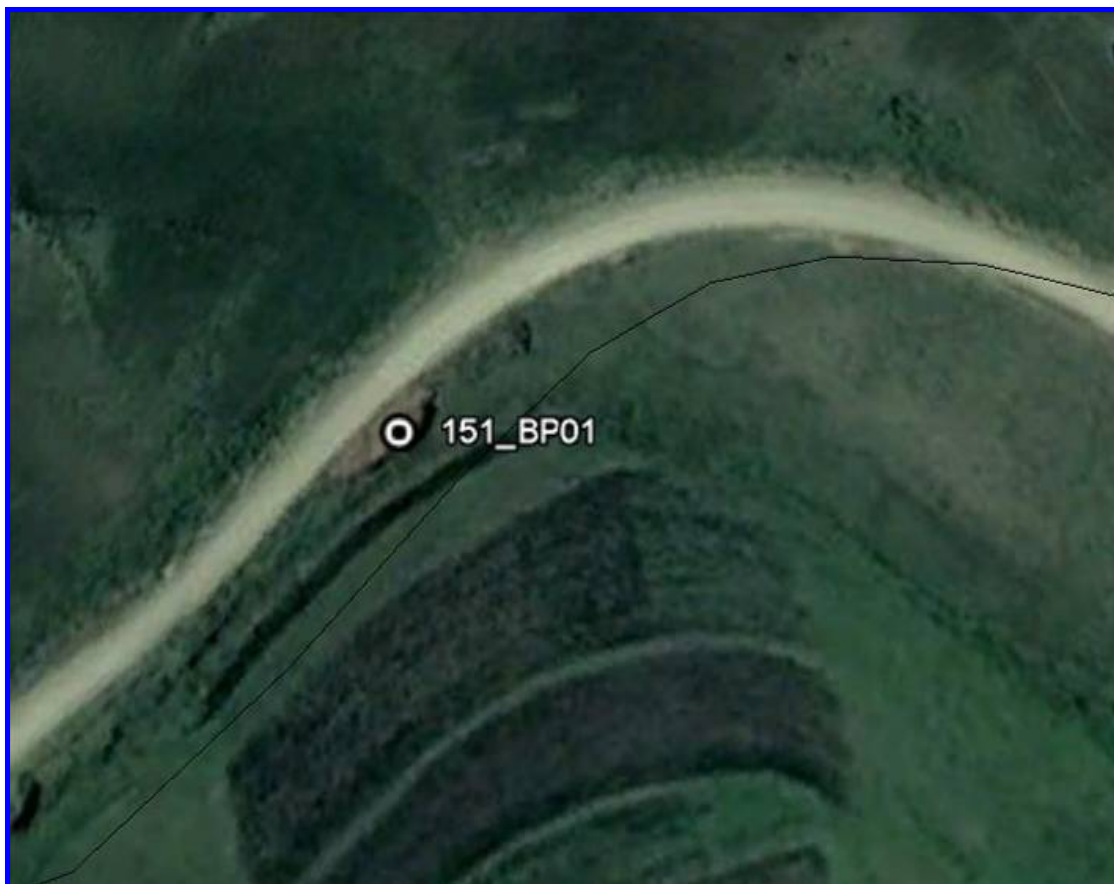
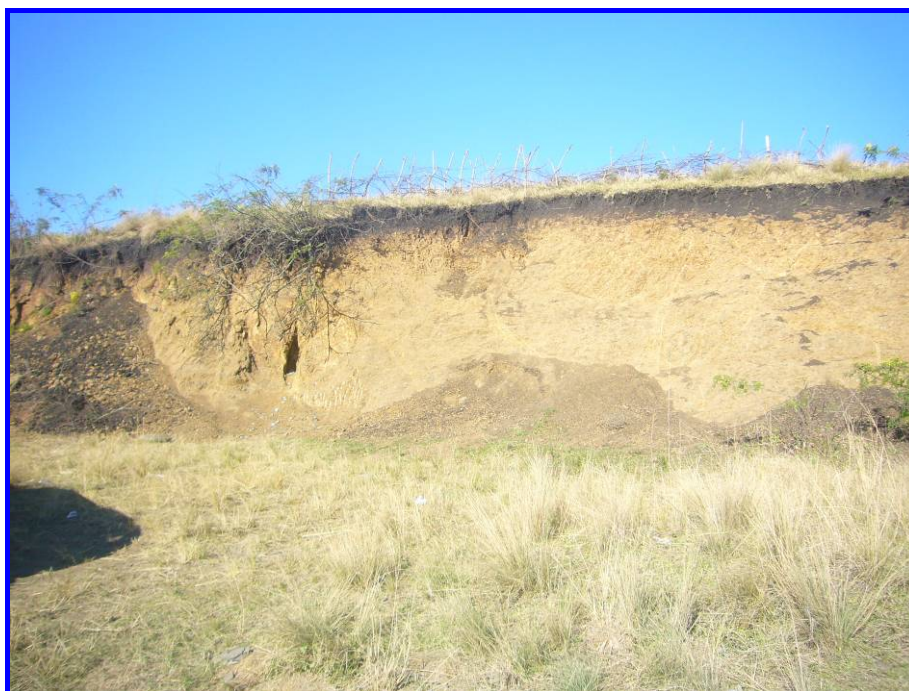
Figure 4: 151\_BP01

151\_BP01 is an existing borrow pit which has been used in the past. It is located on the side of a north facing hillslope. The site is accessed directly from the DR08151. The nearest village is Mfihlela, with the nearest settlement located approximately 140 m from the borrow pit. The borrow pit is located adjacent to active agricultural lands which are currently utilized. The borrow pit has been demarcated by a rural fence indicating the use of agricultural fields adjacent to the existing boundary of the borrow pit. The extension of the existing borrow pit would only be able to occur in a southerly direction away from the road and would thus encroach into the agricultural land being utilized. It is therefore recommended that this borrow pit not be investigated any further for use due to the controversy it would create with the community in terms of removing their agricultural land.

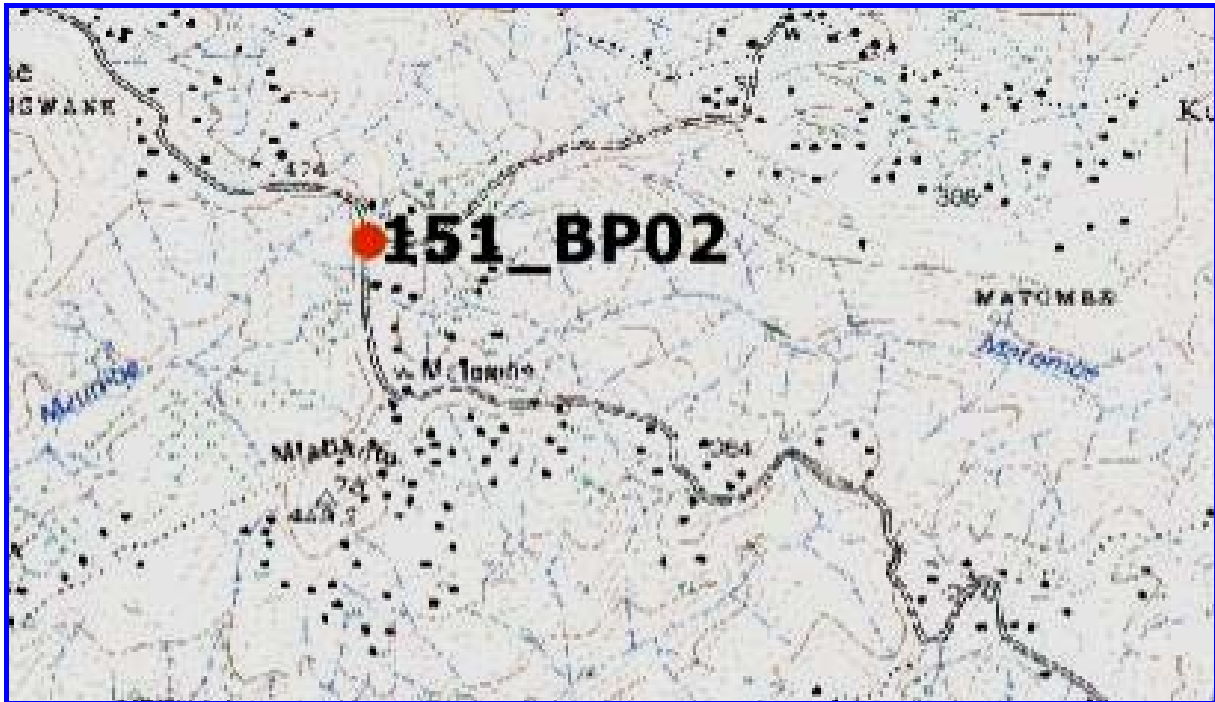
Figure 5: Topographical Location of 151\_BP02 - 1:50 000 map

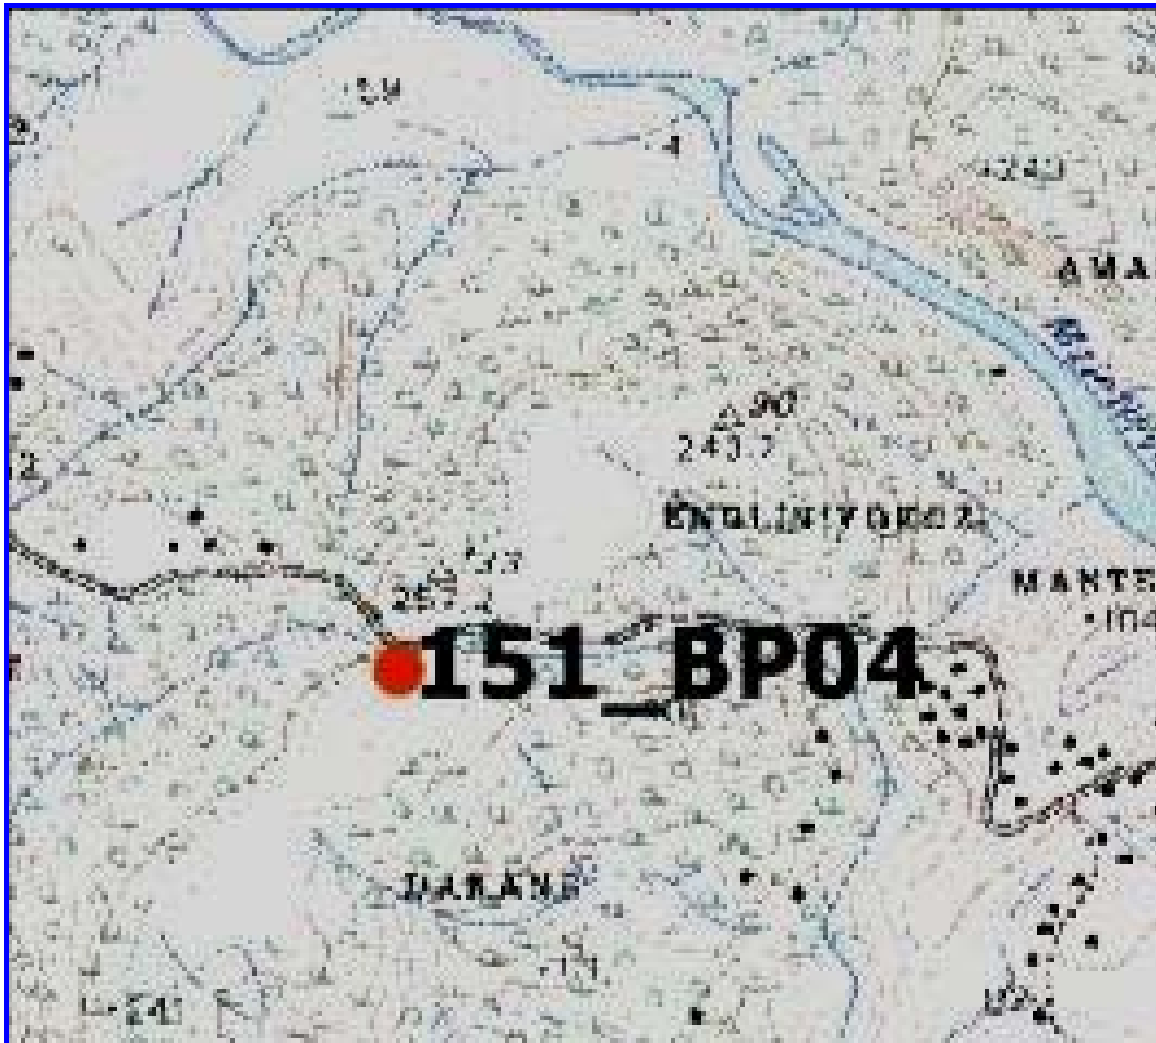
Figure 9: Topographical Location of 151\_BP04 - 1:50 000 map

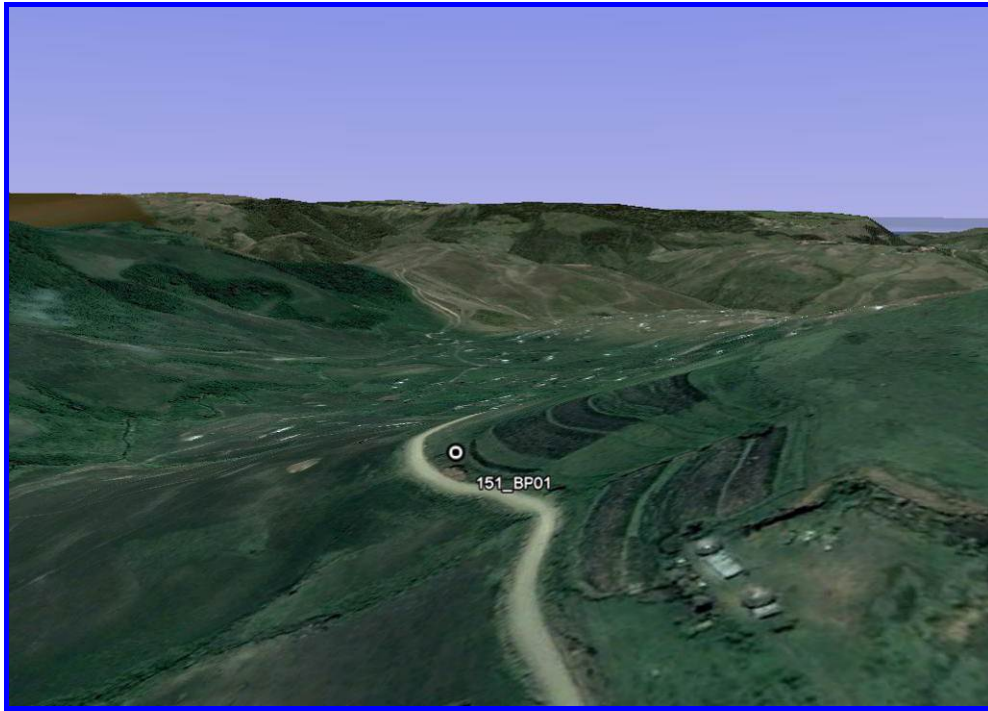
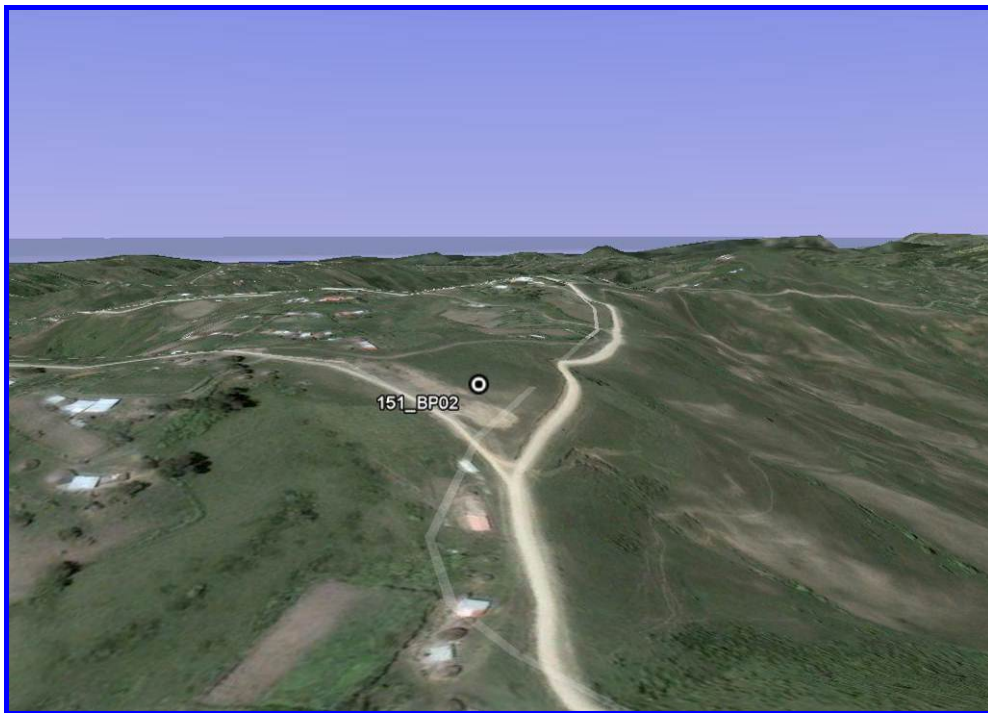
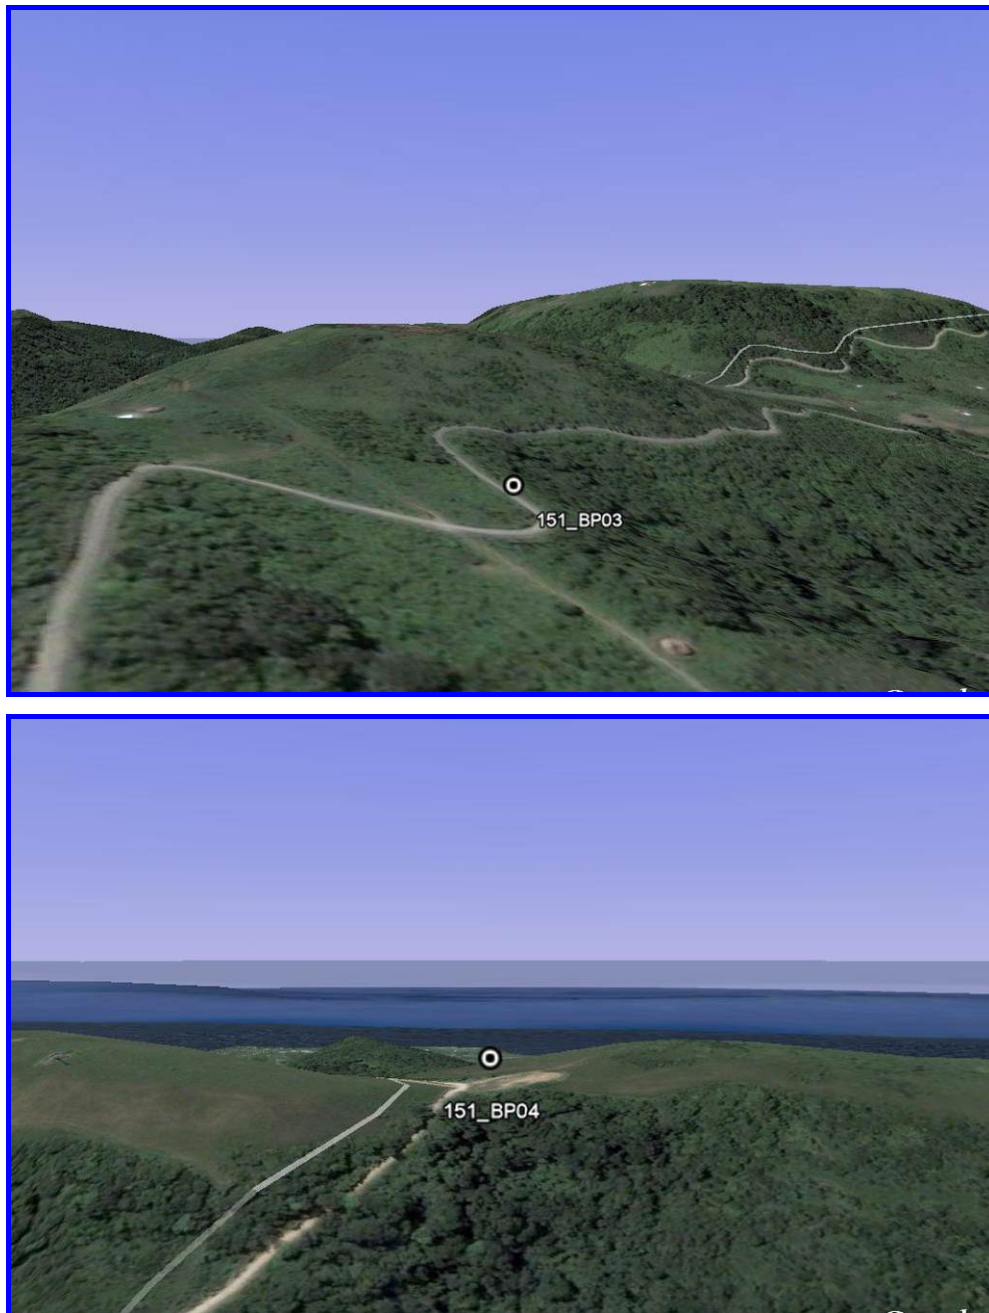
**Figure 15: Terrain view indicating the position of the borrow pits in the landscape.**

The topography may be impacted upon by the excavation of the existing borrow pits which in turn could have an effect on the storm water runoff and drainage of the immediate surrounding area. Areas of concentrated storm water runoff could be subject to increased erosion if not mitigated against appropriately by means of erosion control techniques and/or structures dissipating the velocity and flow of storm water runoff. The non-perennial drainage lines are referred to as such due to the fact that they are dry for the majority of the year, and some instance only flow during periods of high rainfall.
