ENVIRONMENTAL MANAGEMENT PLAN

The Proposed Utilisation of Borrow Pits Road: DR08174 (OR Tambo District Municipality)

Department of Roads and Public Works Province of the Eastern Cape

Report Number 2011-R551

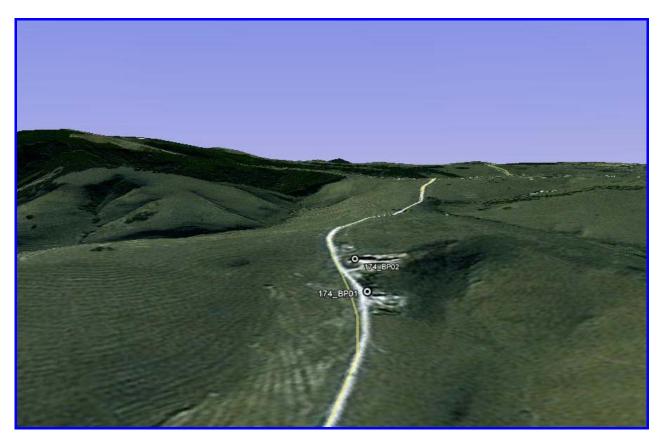
Figure 11: Terrain view indicating the position of the borrow pits in the landscape.
