# **ENVIRONMENTAL MANAGEMENT PLAN**

The Proposed Utilisation of Borrow Pits Road: DR08308 (OR Tambo District Municipality)

Department of Roads and Public Works Province of the Eastern Cape

Report Number 2011-R553

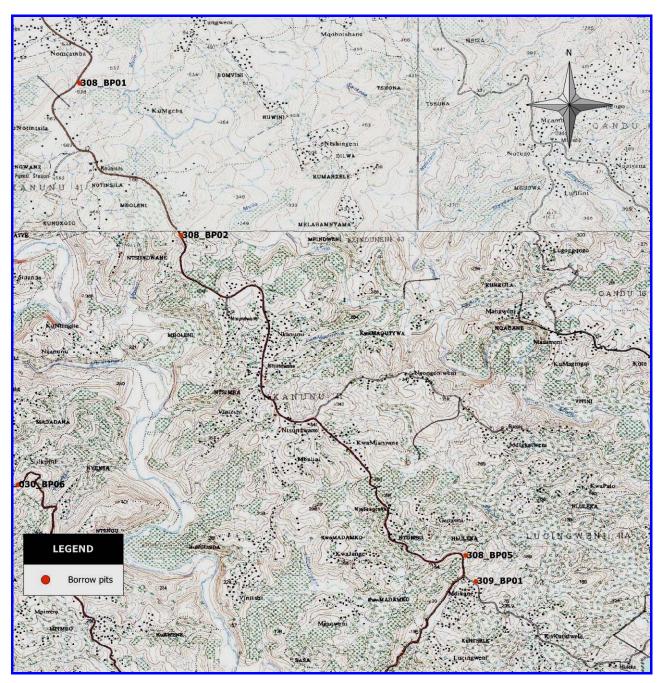
Figure 1: The location of the borrow pits (1: 50 000 map).

Road #	Borrow pit #	Latitude	Longitude
DR08308	308_BP01	31°43'16.0" S	29°10'57.2" E
DR08308	308_BP02	31°45'04.4" S	29°12'09.8" E
DR08308	308_BP05	31°48'52.6" S	29°15'33.1" E
