ENVIRONMENTAL MANAGEMENT PLAN

The Proposed Utilisation of Borrow Pits Road: DR08309 (OR Tambo District Municipality)

Department of Roads and Public Works Province of the Eastern Cape

Report Number 2011-R554

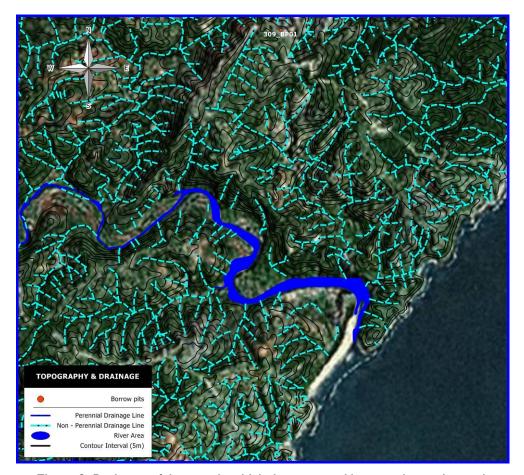
Figure 8: Drainage of the area in which the proposed borrow pits are located.

928.31 mm with a mean annual runoff of 145.1 mm.
