# ENVIRONMENTAL MANAGEMENT PLAN

## The Proposed Utilisation of Borrow Pits Road: DR08273 (OR Tambo District Municipality)

Department of Roads and Public Works  
Province of the Eastern Cape

Report Number: 2011-R614

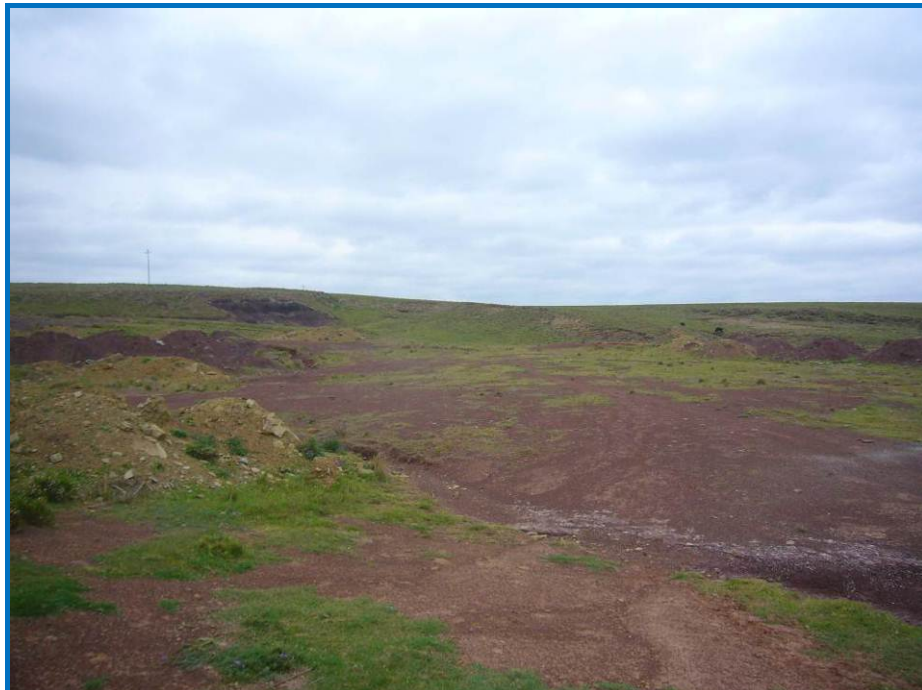
Figure 4: Photo - 273-BP02.

As this is a permitted borrow pit, the utilization of the borrow pit is subject to the mitigation and conditions of the EMP that has already been approved by the Department of Mineral Resources. The File Reference Number for this Approval is EC30/5/1/2/2/0087 MR. As this borrow pit has already been permitted for use it will not be assessed further in this EMP.

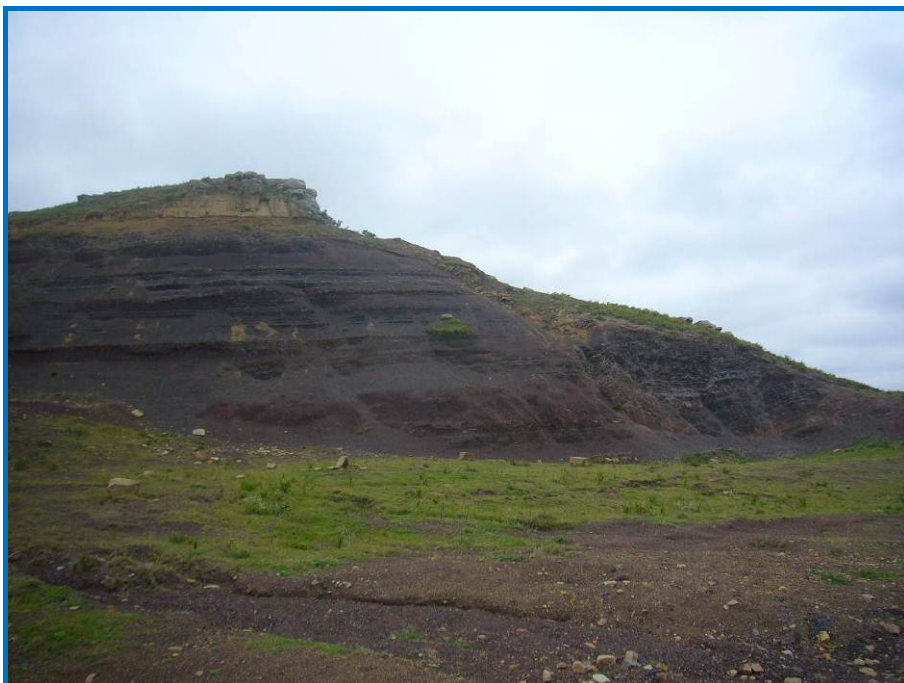
Figure 8: Photo - 273-BP02N.

which includes quick-growing pioneers and climax species. The stormwater berms and dissipation beds will be retained on closure. Additionally, near vertical slopes (1:1 to 1:2) should be stabilised by natural rock wall structures using conventional building methods or in forms with slurry forced between the structures. All structures must have a 'natural' look and facilities for plants to grow in. All areas where the slopes are 1.3 to 1:6 should be logged or otherwise stepped (using stabilisation cylinders or similar) in order to prevent soil erosion. Logs/ cylinders should be laid in continuous lines following the contours and spaced vertically 0.8-1.2 m apart, depending on the steepness of the slope. These logs/ cylinders must be secured by means of steel pegs and wire in rocky areas, and treated wooden pegs in other areas. Inspections will be undertaken during the project liability period (one year after completion of the contract) to ensure that no erosion has taken place and to monitor the success of the revegetation. Should any damage occur, the necessary repair works will be undertaken. The intention is to establish an 80% grass cover within two years of rehabilitation. Should this not be achieved, it may be necessary to lightly rip, fertilise and reseed the site. The fence will be maintained by the contractor until the end of the contracts liability period.

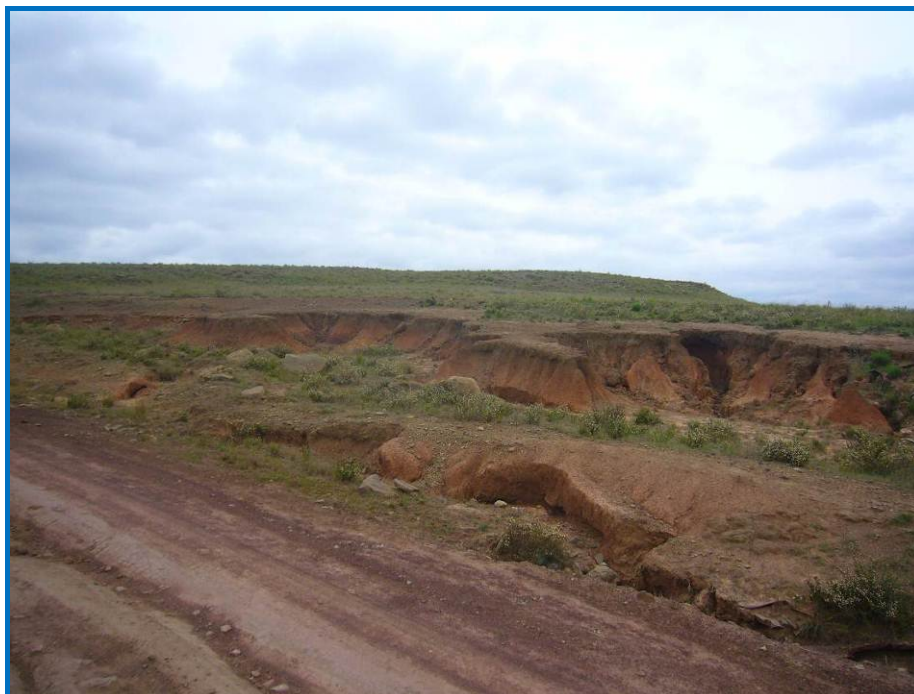
Figure 10: Photo - 273-BP03N.

between the structures. All structures must have a 'natural' look and facilities for plants to grow in. All areas where the slopes are 1.3 to 1:6 should be logged or otherwise stepped (using stabilisation cylinders or similar) in order to prevent soil erosion. Logs/ cylinders should be laid in continuous lines following the contours and spaced vertically 0.8-1.2 m apart, depending on the steepness of the slope. These logs/ cylinders must be secured by means of steel pegs and wire in rocky areas, and treated wooden pegs in other areas. Inspections will be undertaken during the project liability period (one year after completion of the contract) to ensure that no erosion has taken place and to monitor the success of the revegetation. Should any damage occur, the necessary repair works will be undertaken. The intention is to establish an 80% grass cover within two years of rehabilitation. Should this not be achieved, it may be necessary to lightly rip, fertilise and reseed the site. The fence will be maintained by the contractor until the end of the contracts liability period.
