ENVIRONMENTAL MANAGEMENT PLAN

The Proposed Utilisation of Borrow Pits Road: DR08147 (OR Tambo District Municipality)

Department of Roads and Public Works Province of the Eastern Cape

Report Number 2011-R626

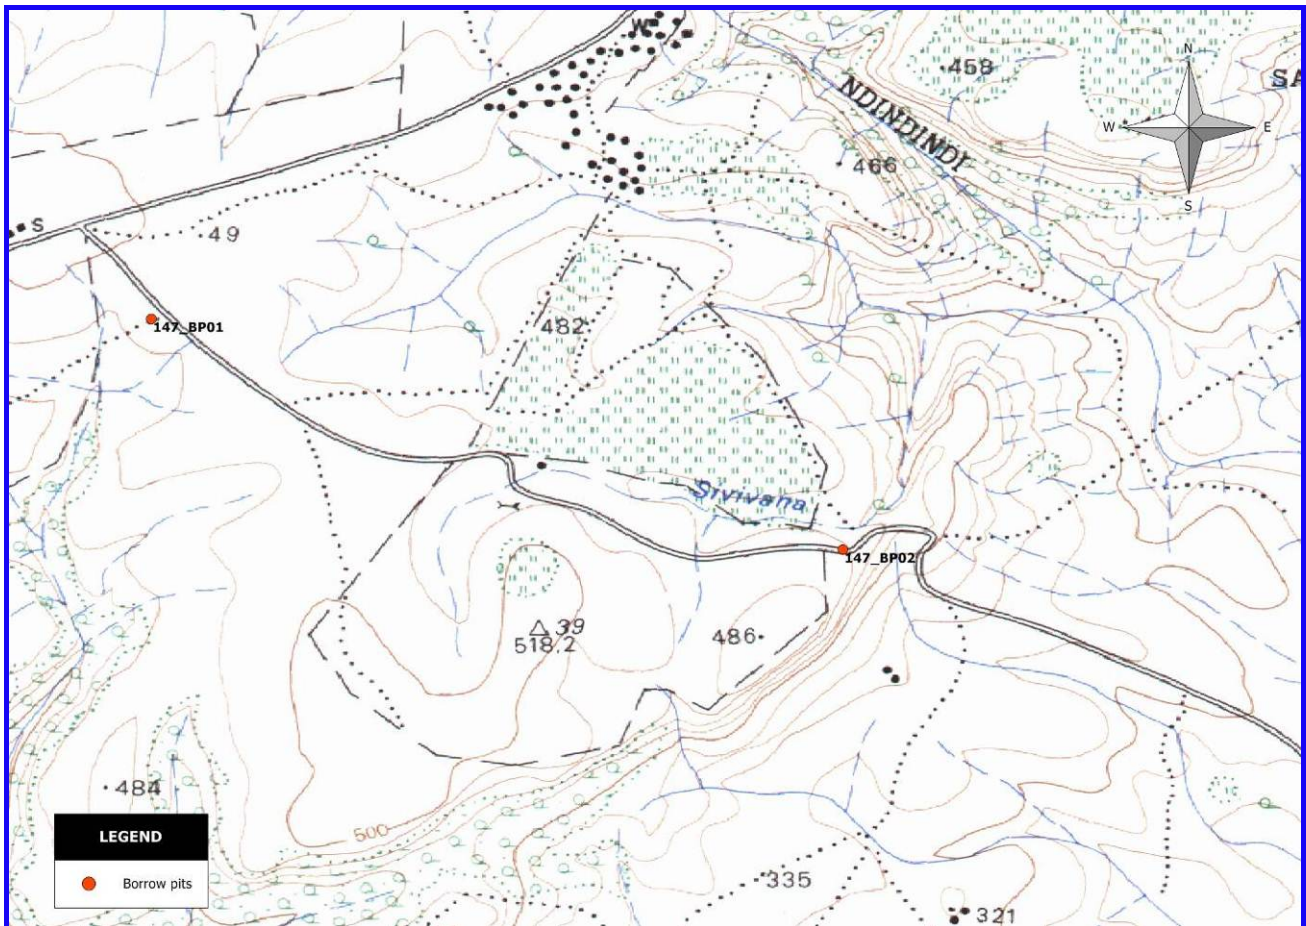
Figure 1: The location of the borrow pits (1: 50 000 map).

Two (2) borrow pits were identified in the initial investigation for material sources along the DR08147; and, were identified to be suitable for utilisation as material sources for the re-gravelling. The location of the borrow pits are as follows:

Road #	Borrow Pit #	Latitude	Longitude
DR08147	147_BP01	31°20'23.6" S	29°46'01.9" E
DR08147	147_BP02	31°20'56.7" S	29°47'40.5" E

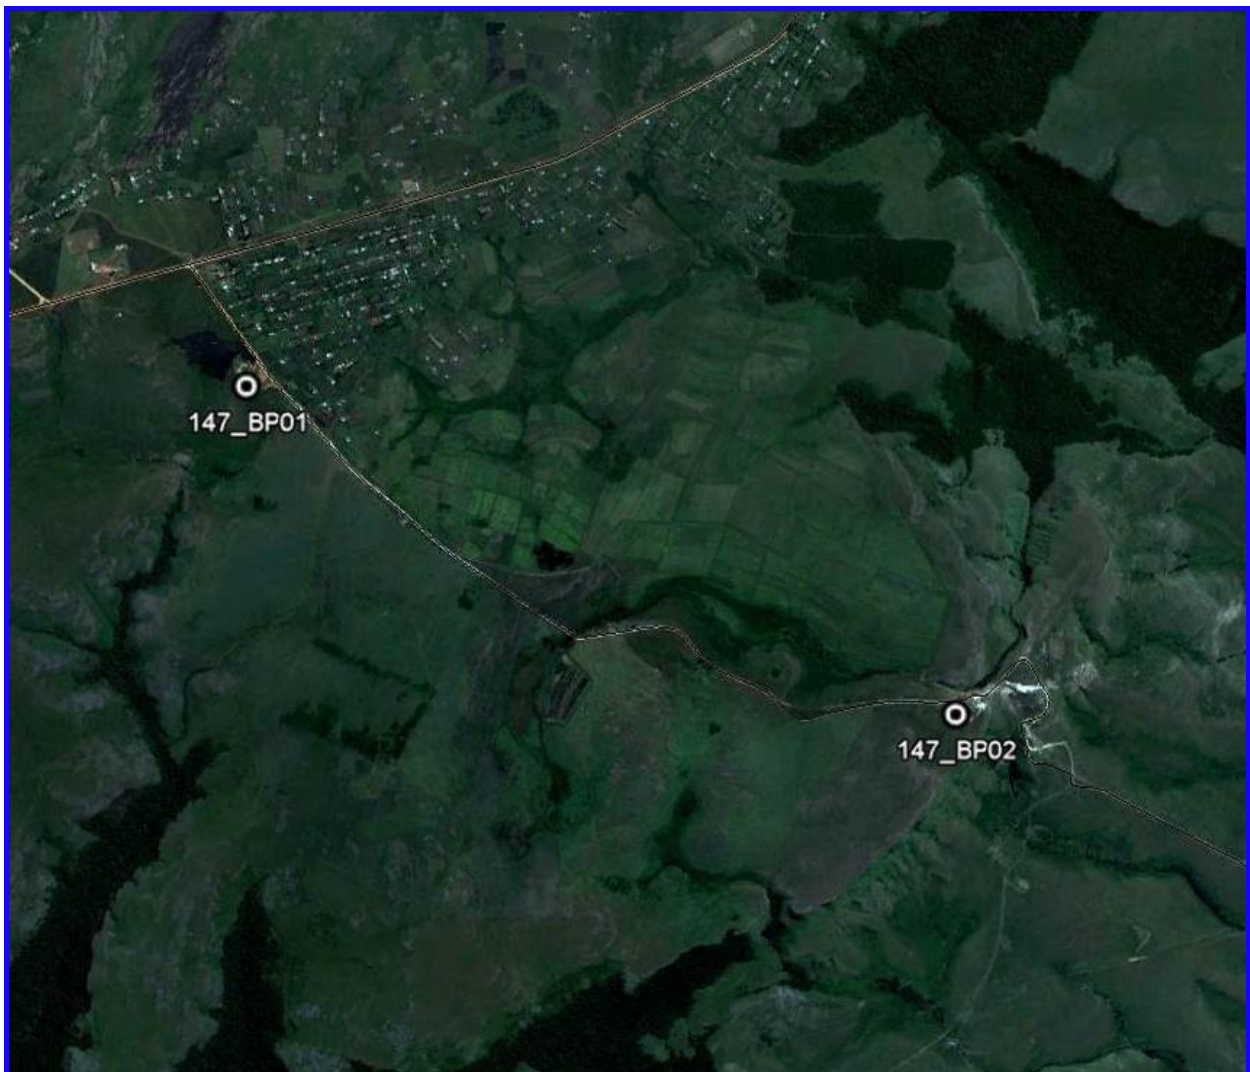
Figure 2: Aerial Image - Road DR08147 & associated BP's.

It is proposed here to utilise two (2) borrow pits identified along the DR08147, for the routine maintenance/re-gravelling of this district road. The nearest formal town is Lusikisiki. The borrow pits are located adjacent to the DR08147.

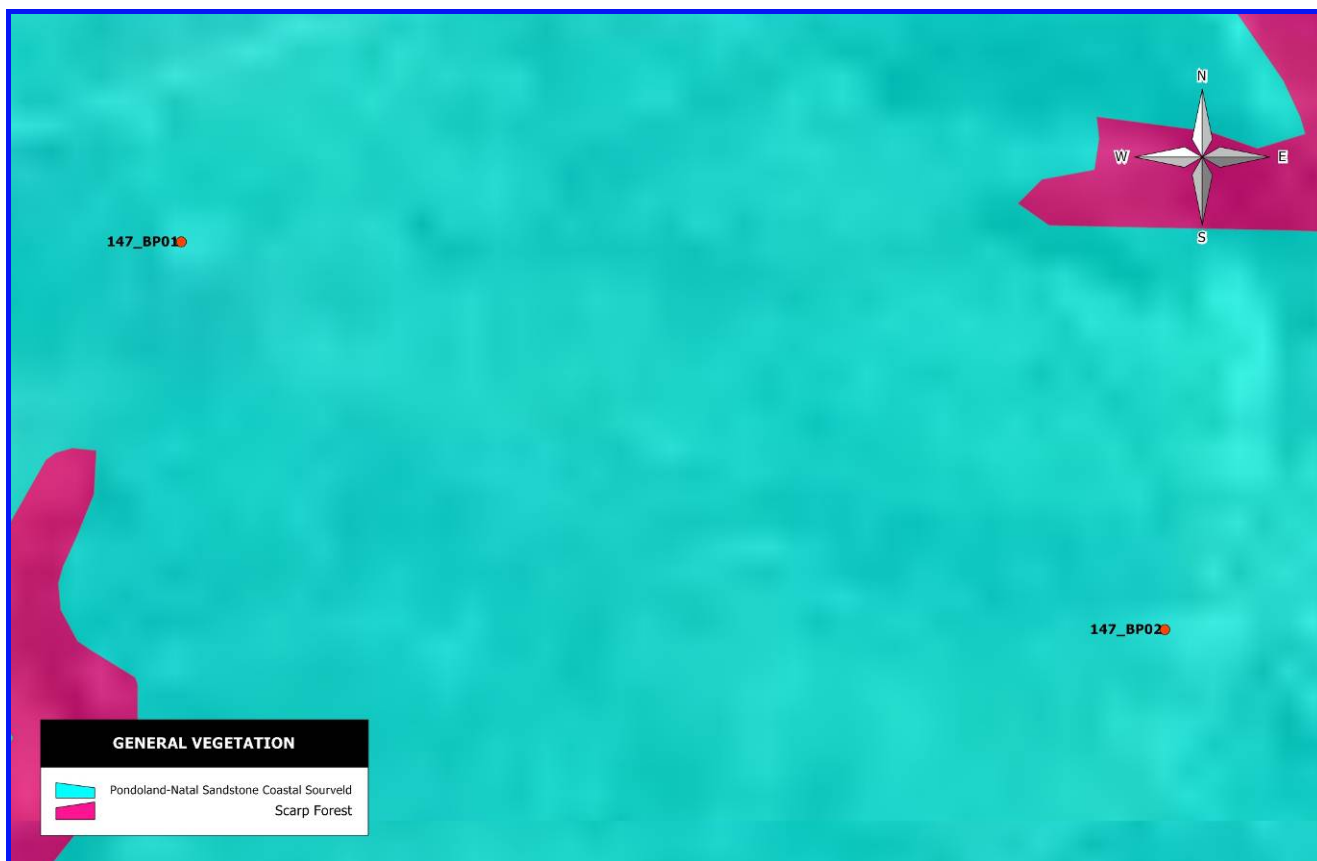
Figure 7: General vegetation and the location of the borrow pits.

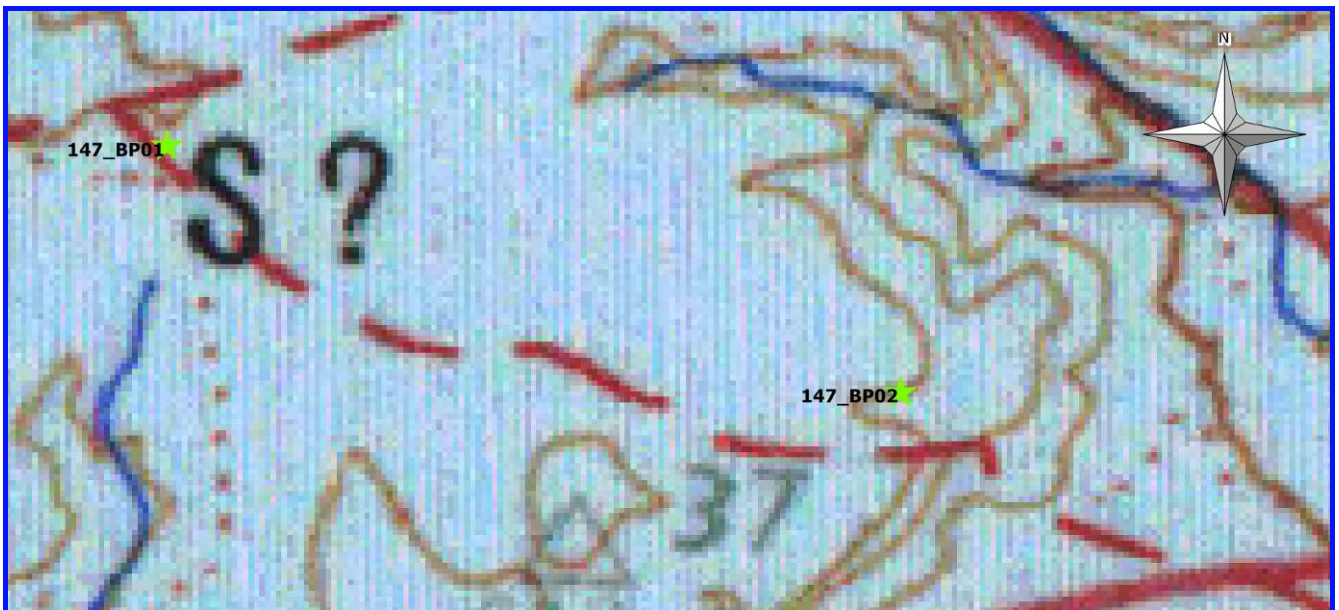
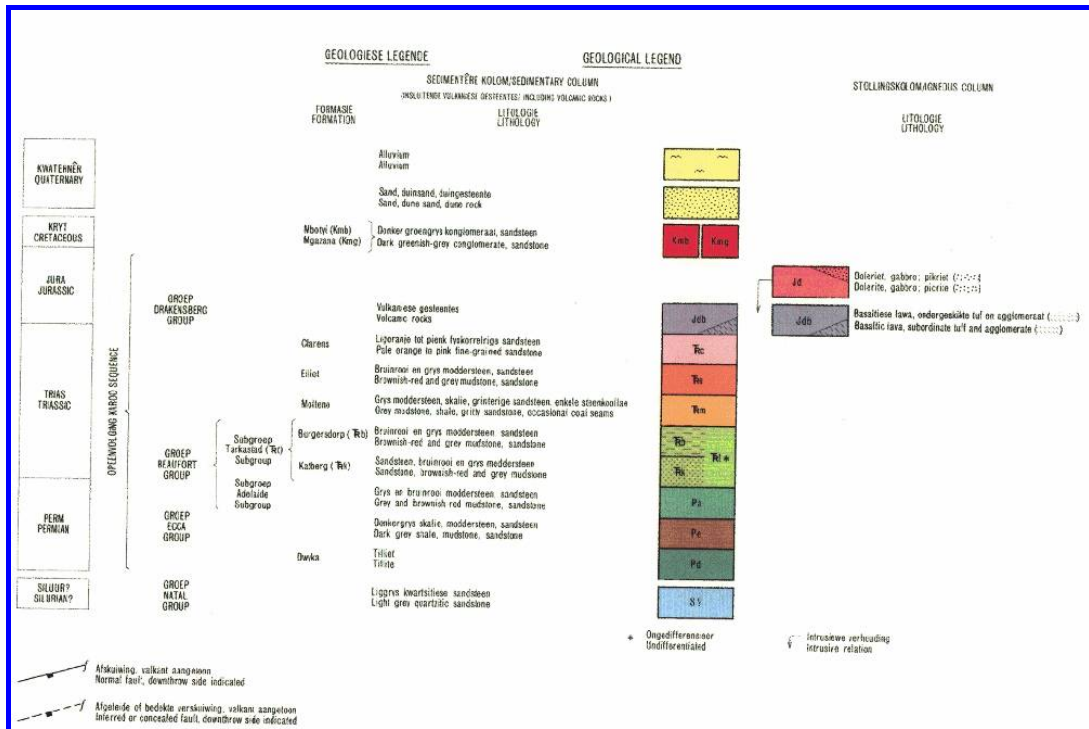
The Natal Group is represented by between 900 m (in the north) and 1300 m (in the south) of white to grey, siliceous quartzose and subfeldspathic sandstone with the subordinate conglomerate. Scattered small pebbles of white or greyish vein quartz and less commonly, white and black chert are present. Cross-bedding is common. The sandstones are composed largely of quartz, with feldspar and small amounts of muscovite making up the remainder.

The investigation undertaken by Controlab (section 21.1) indicated that the type of material found at the borrow pits was Sandstone.

Figure 8: The geology of the area in which the Borrow pits are located (3128 Umtata)

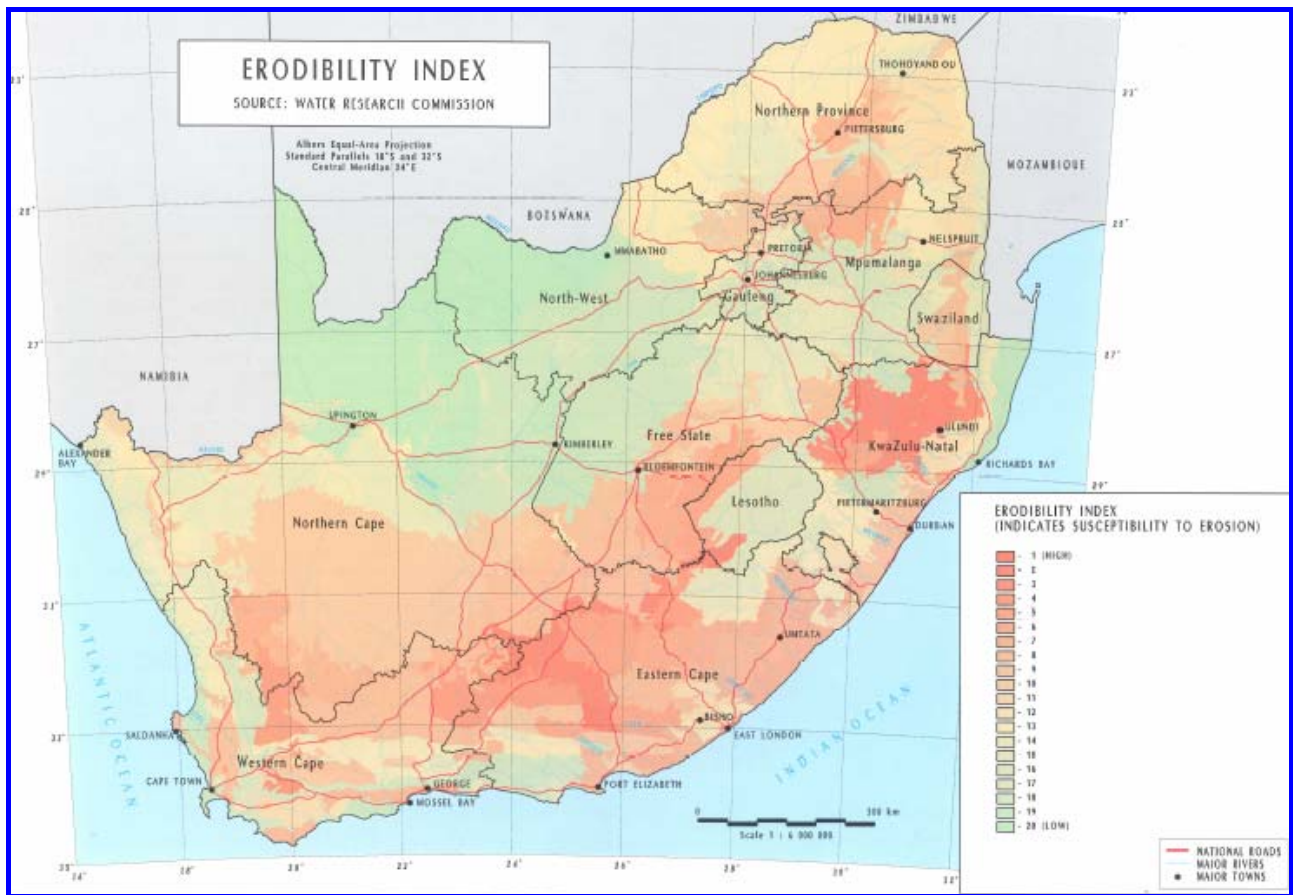
Figure 9: Erodibility Index

Erodibility of soils can be described as the sensitivity of soils to the effects of wind and water on the soil structure. This property is expressed as an erodibility index, where low values indicate high potential for erosion, and high values correspondingly indicate a low potential for erosion.

The erodibility index is determined by combining the effects of slope and soil type, rainfall intensity and land use. These aspects are represented by terrain morphology, mean annual rainfall and broad land use patterns.

According to the Environmental Potential Atlas for South Africa, the study area falls within an Erodibility Index of between 7 and 9, which is at the lower end of the scale (1 being High and 20 being Low), indicating that the area is moderately to highly susceptible to erosion (Figure 9).

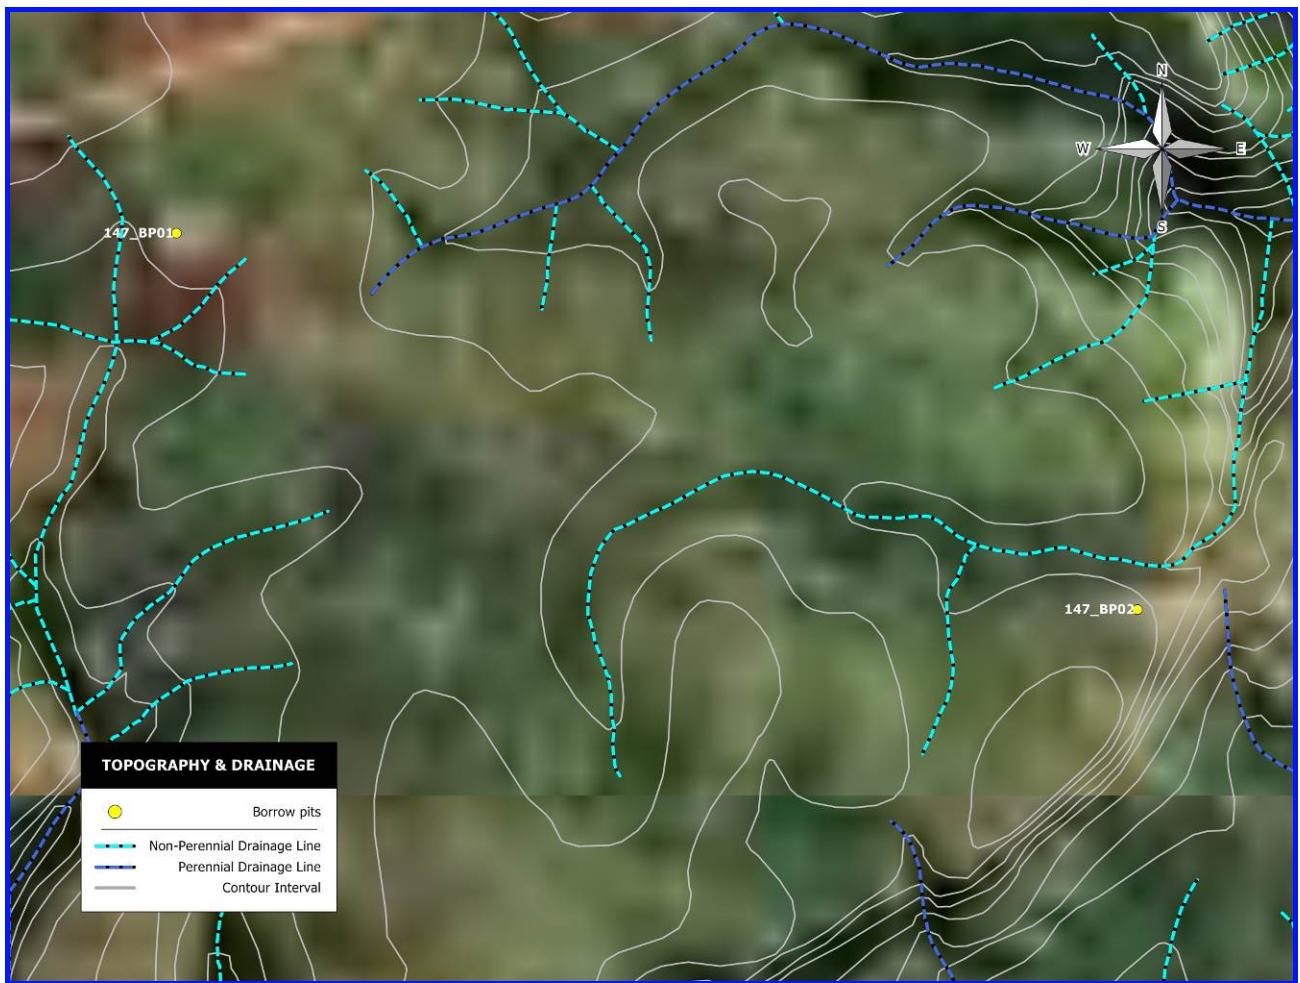
The study area falls in the primary drainage area T60. Within the primary drainage T60, the borrow pits fall within the quaternary catchment area of T60H. The mean annual precipitation of T60H quaternary is 1277.17 mm with a mean annual runoff of 389.9 mm.

Figure 10: Drainage of the area in which the proposed borrow pits are located.

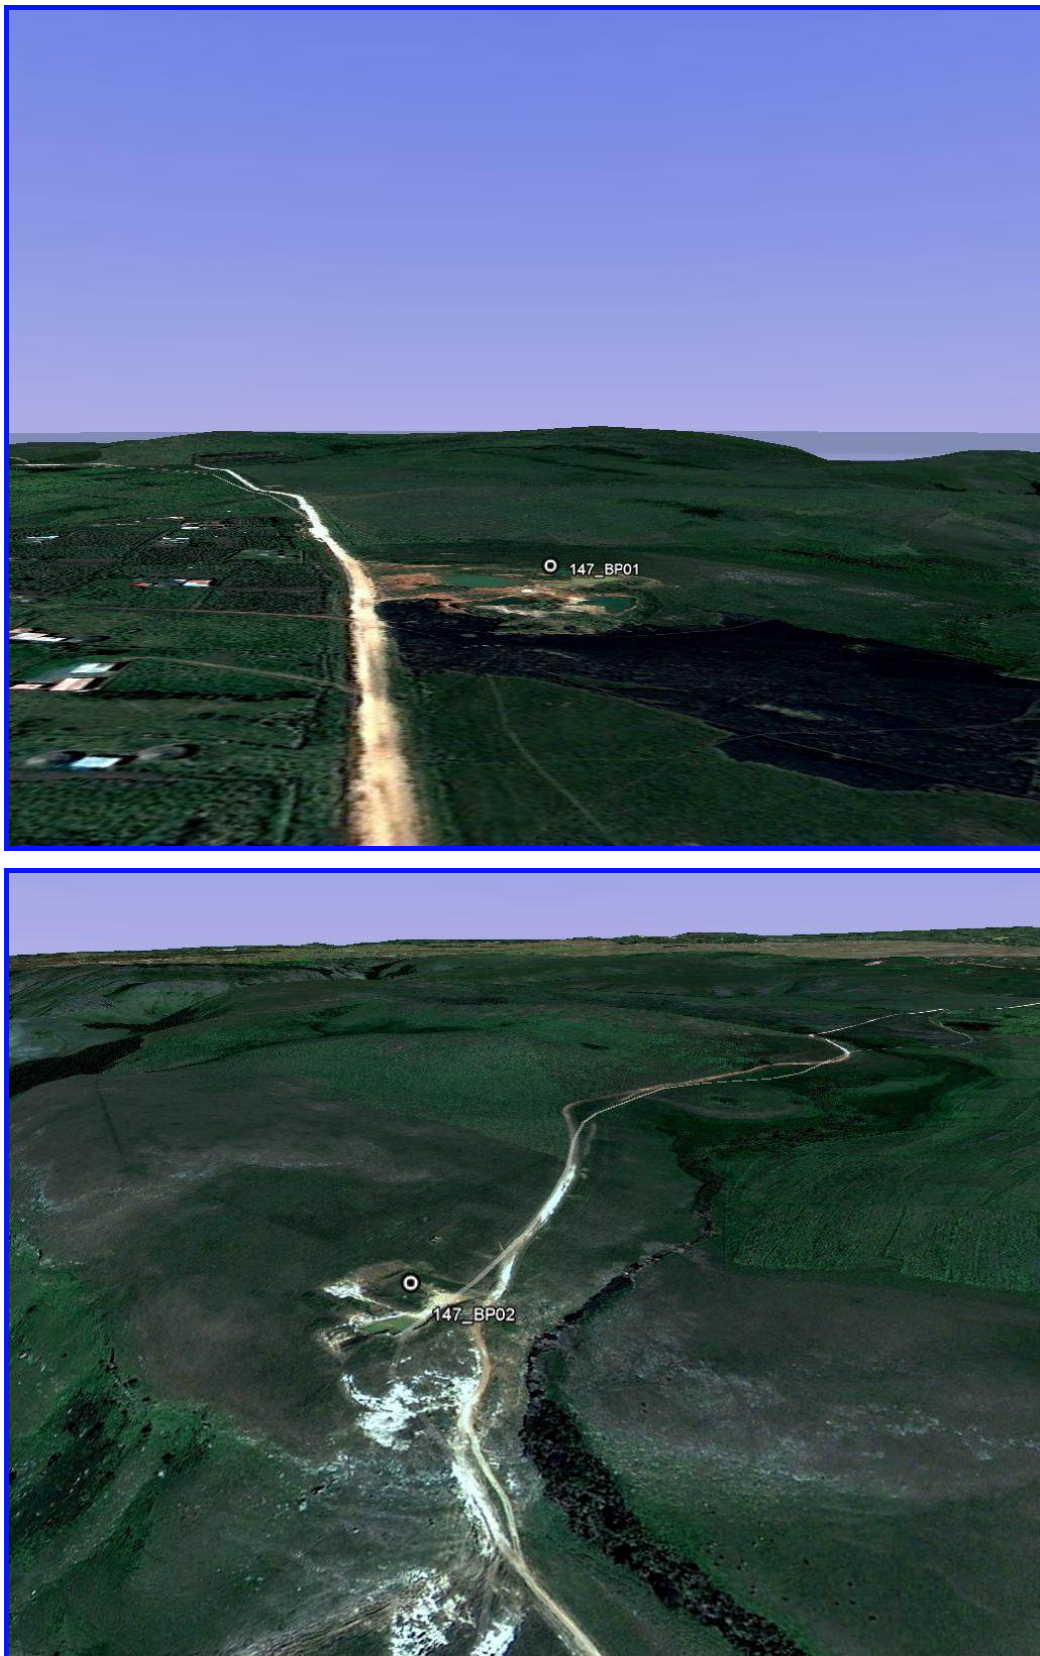
As borrow pits are existing and have been utilised previously, the topography has been altered by the excavation of material from the hill slopes.

Figure 11: Terrain view indicating the position of the borrow pits in the landscape.

The topography may be impacted upon by the excavation of the existing borrow pits which in turn could have an effect on the storm water runoff and drainage of the immediate surrounding area. Areas of concentrated storm water runoff could be subject to increased erosion if not mitigated against appropriately by means of erosion control techniques and/or structures dissipating the velocity and flow of storm water runoff. The non-perennial drainage lines are referred to as such due to the fact that they are dry for the majority of the year, and some instance only flow during periods of high rainfall.

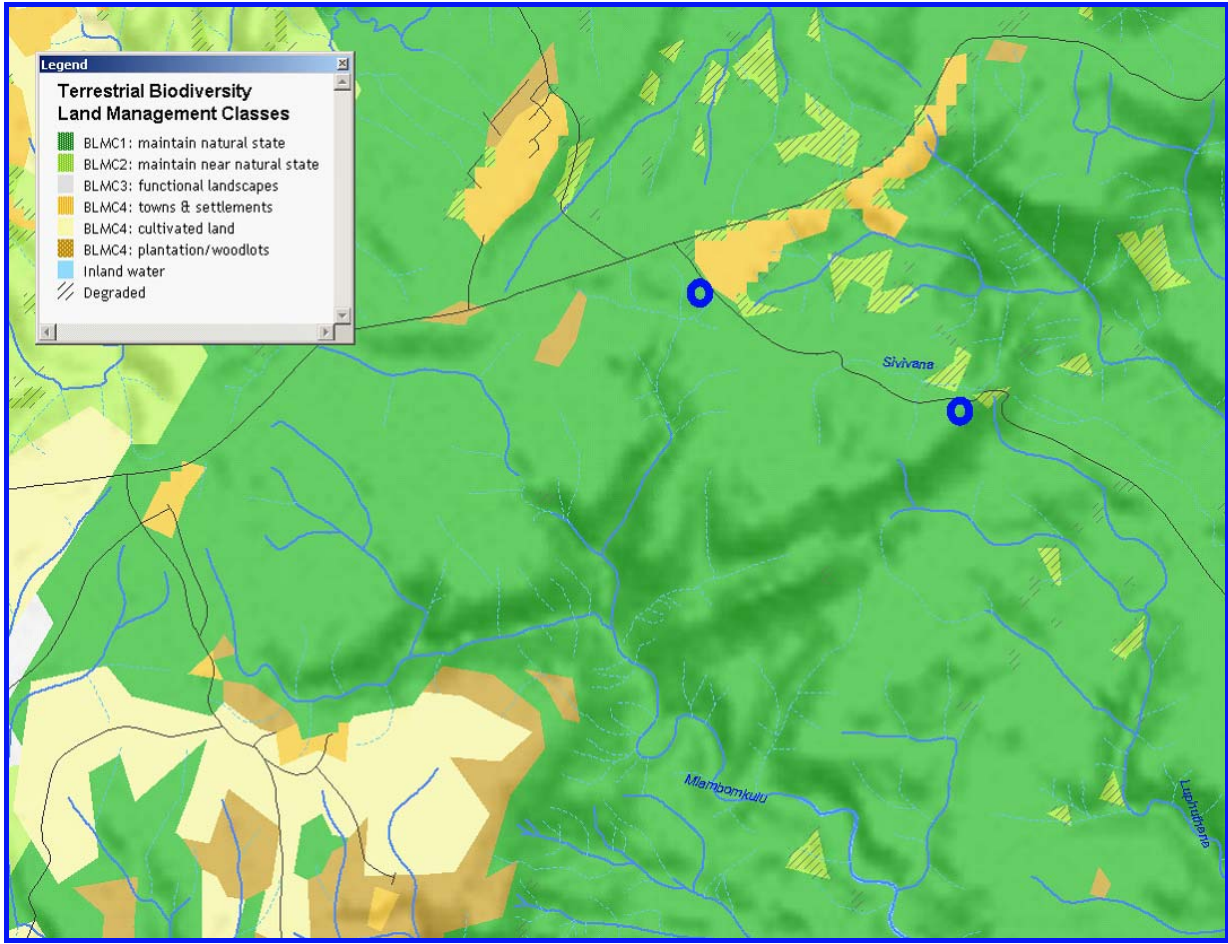
No more than 0.98 hectares of indigenous vegetation will be removed from the borrow pit mining footprints.

Figure 12: Eastern Cape Biodiversity Conservation plan and the location of the Borrow pits.
