# Wetland Delineation and Assessment for the Proposed Humansrus Solar Thermal Energy Plant near Postmasburg, Northern Cape

**Reference: 734/2011**

**PROJECT:** **Wetland Delineation and Assessment for the  
Proposed Humansrus Solar Thermal Energy Plant  
near Postmasburg in the Northern Cape**

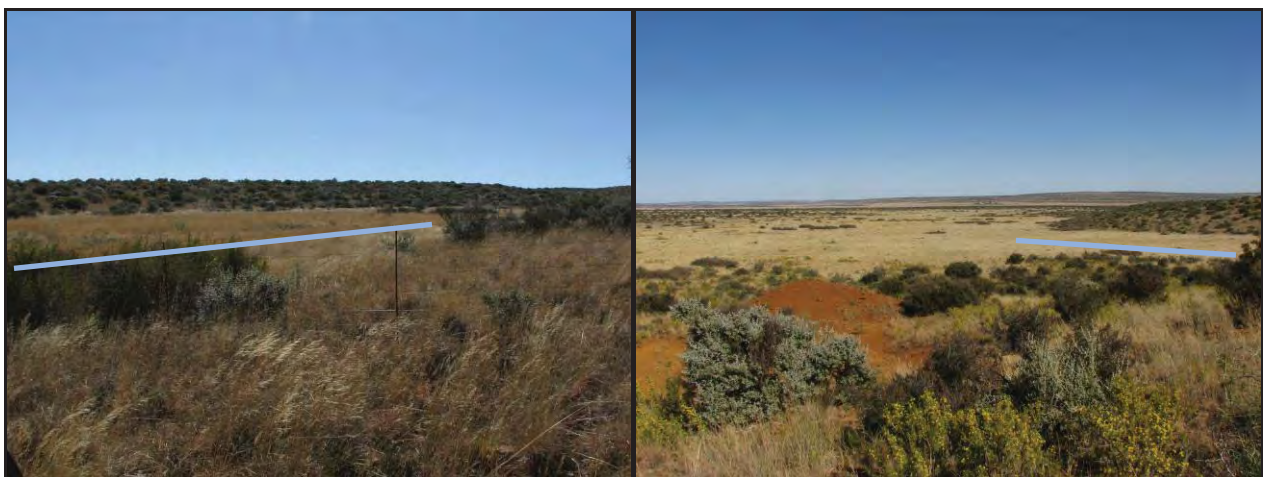
**Figure 5.** Photographs of the ephemeral “drainage lines” indicated in Figure 4. Drainage lines are indicated by a blue line.

The field work undertaken during July 2011 revealed that only the Groenwater Spruit and its tributary have associated riparian habitat. The remaining drainage lines indicated on the 1:50 000 topographical maps represent low points within the landscape along which water is expected to flow only occasionally following heavy storm events, but which do not differ in vegetation structure or composition from the adjacent vegetation, and do not have a defined channel. The soils within these areas also showed no hydromorphic features and were typical reddish brown terrestrial soils, presumably of the Hutton soil form. These “drainage lines” were thus not classed as either wetlands or riparian zones. A map of these drainage lines entering the site, as well as some photographs of these areas, are reproduced in Figures 4 and 5 below.

Following heavy rain, surface runoff from the rocky hills to the north and east of the study area is expected to accumulate within these low points where the sandy soil allows easy infiltration of surface water into the soil. Water is thus not retained within the upper reaches of the soil profile for an extended period that would allow the formation of wetland or riparian habitat. Rainfall that has infiltrated the soil is expected to be mostly lost to evapo-transpiration or deeper infiltration into groundwater, though some lateral seepage at depth through the soil profile is possible. To the north of the Farm Humansrus a spring is located on the Farm Groenwater (as indicated by the local farmer) at the northern end of the plain that extends into the central portions of the study area. It is possible that water infiltrating the sandy soil on site plays a role in supporting this spring. This is however mere speculation and will need to be confirmed by the groundwater and geo-technical studies of the site.

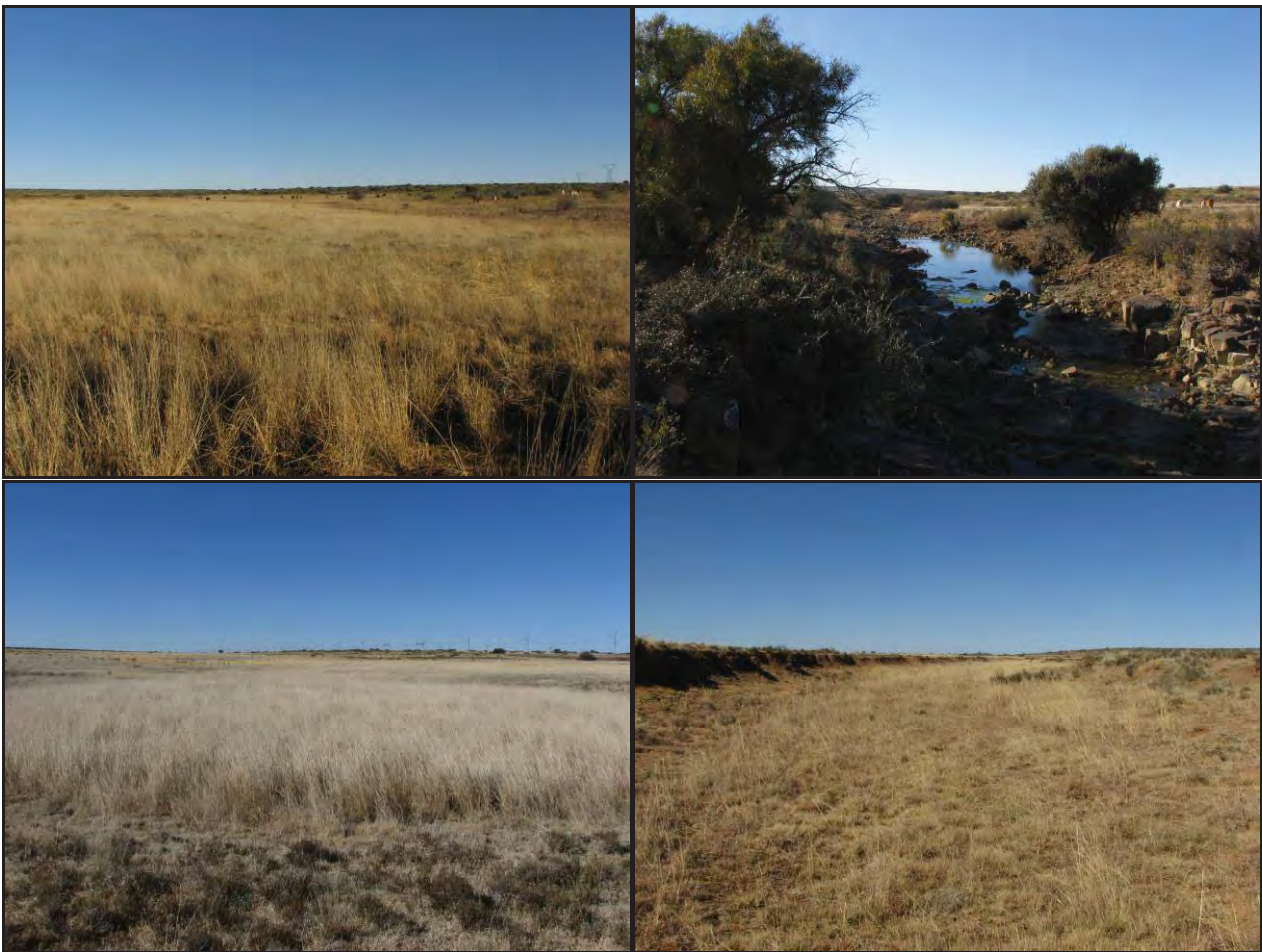
**Figure 7.** Photographs of the riparian habitat associated with the Groenwater Spruit (clockwise from top left): immediately upstream of the study area; directly below the old farm house; lower reaches of Groenwater Spruit on site looking upstream from northern boundary fence; and upper shallow impoundment.

The reach of the Groenwater Spruit located upslope of the railway line and gravel road is characterised by a clearly defined, incised channel characterised by a rocky substrate. Adjacent side slopes were also generally rocky. Isolated pools of water were observed in this area. Along this section of the riparian habitat a number of tree and shrub species were observed, including *Olea europea*, *Rhus lancea* and *Acacia tortilis*. Grass species included *Themeda triandra*, *Aristida congesta*, *Aristida spp.*, *Eragrostis chloromelas* and *Juncus rigidus*. Though classified as a riparian zone, isolated patches along the water course did display some wetland characteristics and sub-surface water seepage, most notably a small spring located upslope and outside of the study area in close proximity to the site boundary, as well as the area located immediately below the old farm house.

To the north of the railway line upstream and immediately downstream of the small dam, the Groenwater Spruit and its tributary flow along a poorly defined channel. This section of the riparian habitat is completely devoid of trees and is dominated by various grass species. The timing of the study precluded accurate identification of many of the grass species due to the significant frosting back of vegetation that had already taken place, as well as heavy grazing by livestock. Typical species however included various *Aristida* spp., *Themeda triandra*, *Juncus rigidus*, *Eragrostis* spp, *Melinis repens*, *Sporobolus* spp. and *Cynodon dactylon*.

The lower reaches of the Groenwater Spruit on site are again characterised by a clearly defined, incised channel, the channel being broad and fairly shallow. Once again the riparian habitat is tree-less and dominated by grass species. Soils along this section of the riparian zone were typical of terrestrial soils with no signs of seepage into the stream channel. The channel was also completely dry downslope of the railway crossing.
