REPORT No. 1: ROBBEN ISLAND BLUE STONE QUARRY; SITING OF PROPOSED BIRD HIDE.

INTRODUCTION

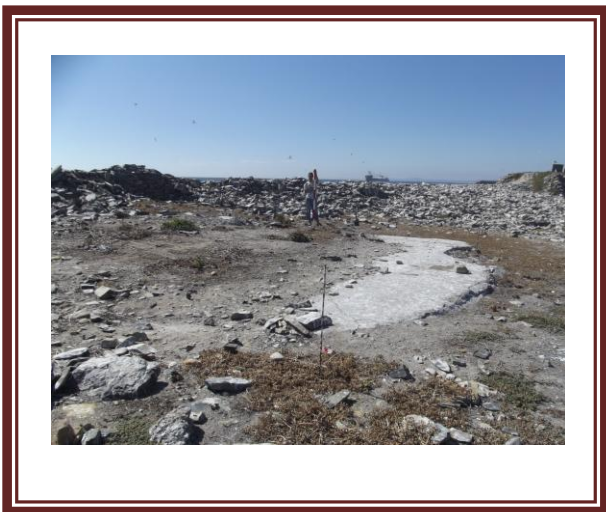
Fig.3. View from SE for option 1

The platform is situated inside the quarry immediately adjacent to the interior of the dry packed stone wall. The wall has however deteriorated significantly since the first photographic survey done by Matenga in 2004. The wall still has a section of approximately 10 metres that is still protecting the platform from the sea.

The platform runs from the packed wall towards the east for approximately 14 metres and has a width of 8 metres. Approximately 80% of the surface is a hard aggregate of sea sand, sea shells and Portland cement with a smooth cemented finish. A smaller area immediately adjacent to the

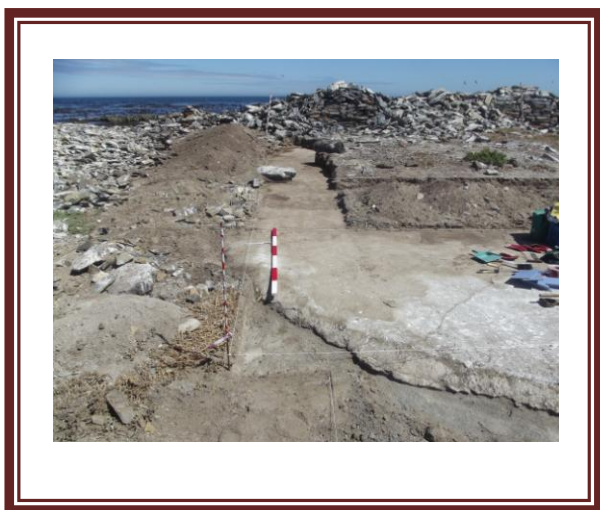
Fig. 5. View due West of uncovered platform

A small section on the eastern side is uncovered with the remainder covered by debris from the sea wall. Sections of this were removed from 26 February 2013 to 28 February 2013 to determine the extent and condition of the platform.

The proposed reconstruction of the quarry wall will fully uncover the platform. Some sections of the platform are very friable and sensitive to weathering and the build up of bird guano. The harder sections will also be subject to weathering and build up of bird guano once the platform is uncovered.

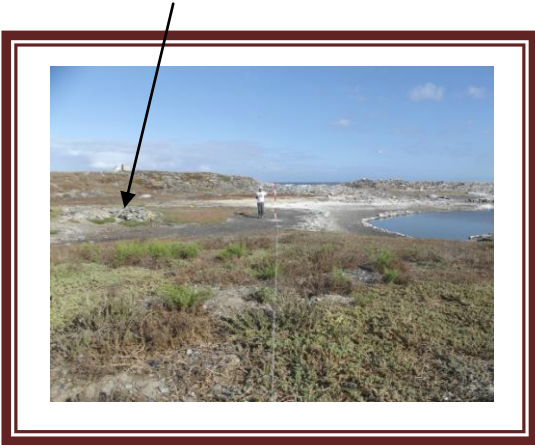
A large rock with packed dry stone walls about half a metre high in sections to the east and west of it is situated in the quarry approximately at the survey point TS15 3.067 on the WSP survey diagram. The walling forms a square of approximately 2 metres by 2 metres. A similar square can be identified in the Babenia drawing. The feature was used as a loading platform for finished bricks and stone work. [N. Tongo: pers. Comm.] The site is situated inside the quarry and subject to periodic flooding. No excavation was carried out to find the floor or the height and length of the walls.

Fig.9. Position of Large rock

2. Option 2 is subject to flooding when the quarry water level is at its highest. No covered structure can be motivated historically. Birds nest inside and around the structure.

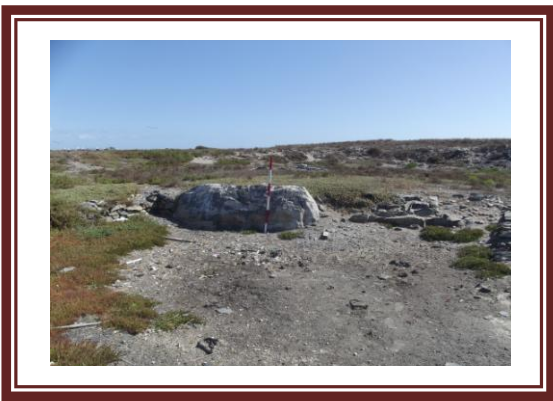
Fig.10. View of structure from North

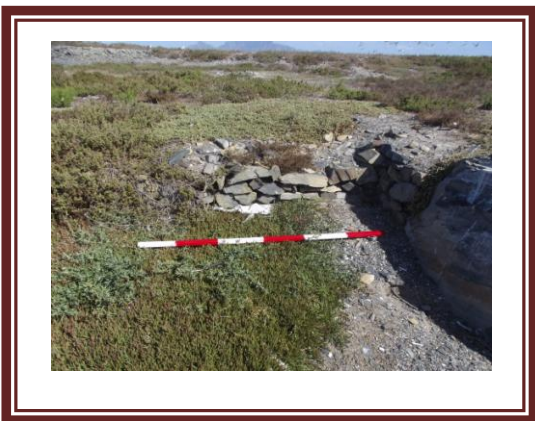
Fig.12. NE corner

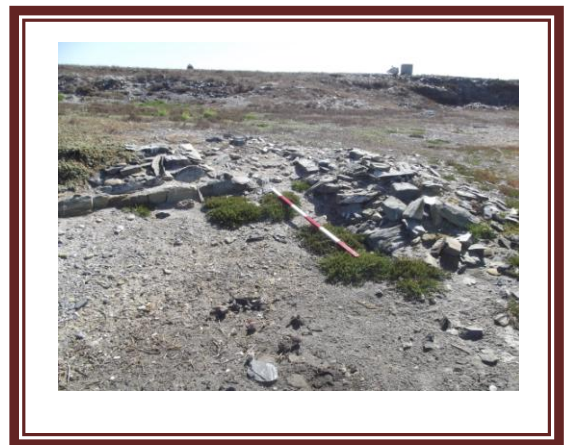
Fig.13. NW corner

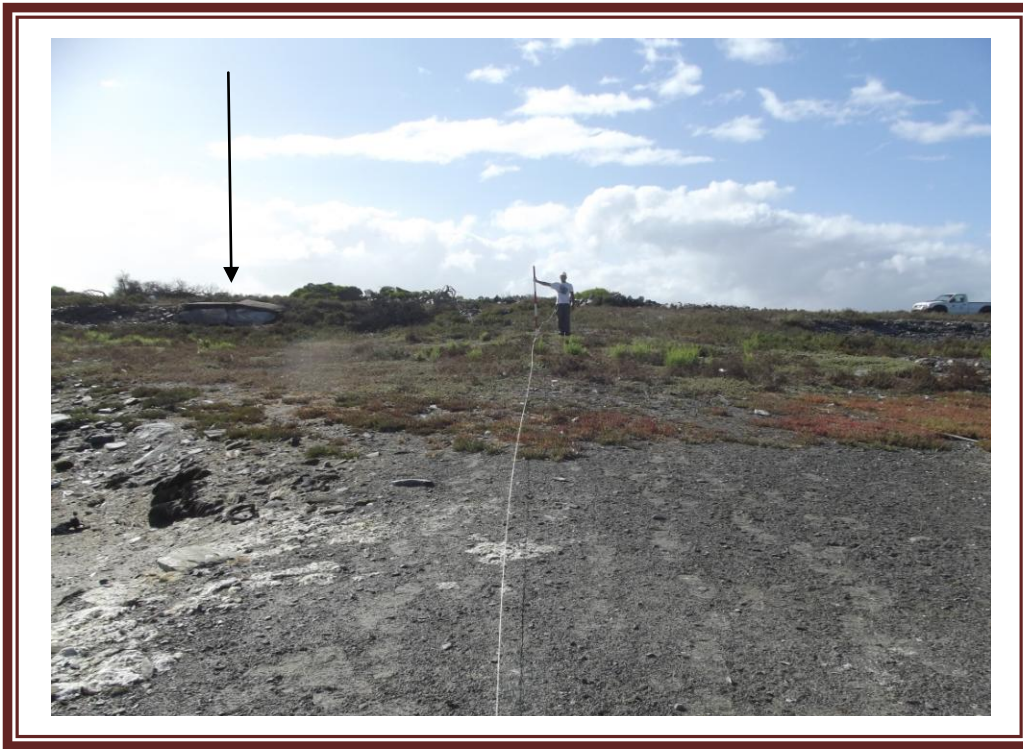
A collapsed concrete platform is situated adjacent to the road one metre south of “BSQ 2” on the eastern edge of the quarry. The provenance of the platform is not known. The platform measures approximately 2 metres by 2 metres and is about 10 centimetres thick.

Fig. 14. Position view towards East

3. Option 3, where the provenance is not known, may be visually disruptive because of its elevation and close proximity to the road.

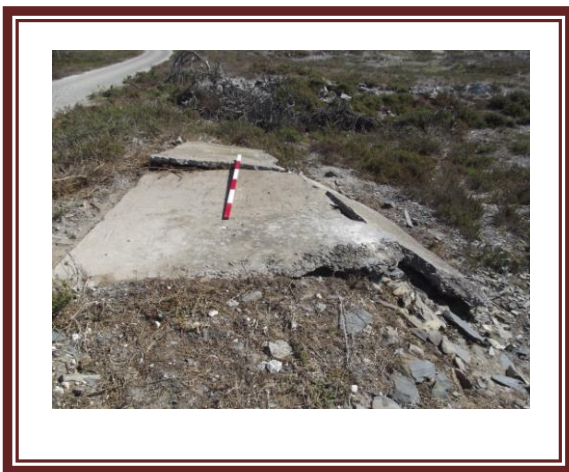
Fig.15. View towards south. Intact section

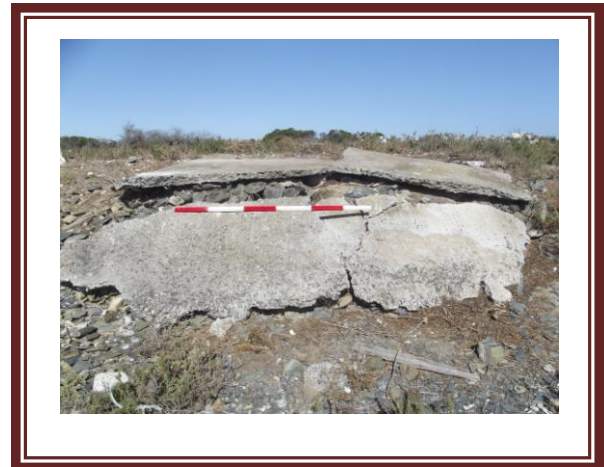
Fig.16. Collapsed west face

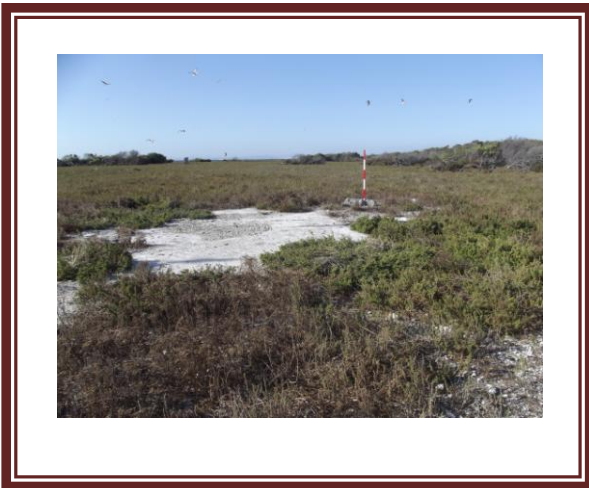
Fig.18. NE view

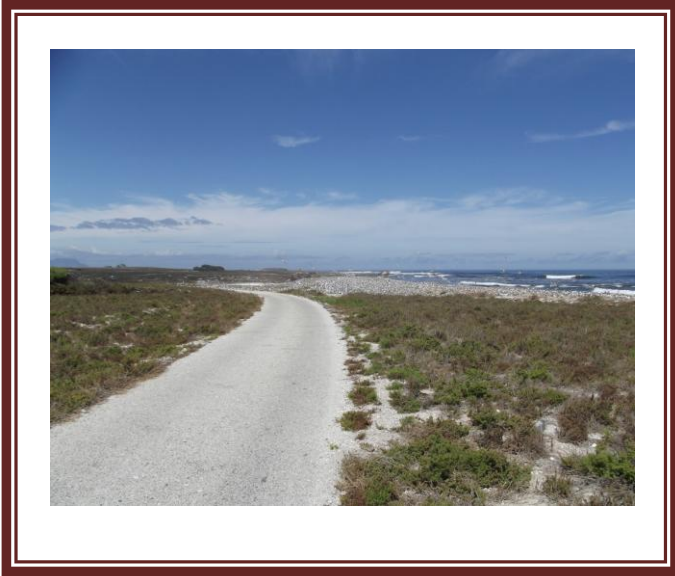
Fig. 20. View towards south

The site could not be adequately assessed from a heritage perspective as a colony of Swift Terns is nesting on the Northern section of the wall and its surroundings. There is no historical evidence for any structures, other than the wall, on this part of the quarry camp.

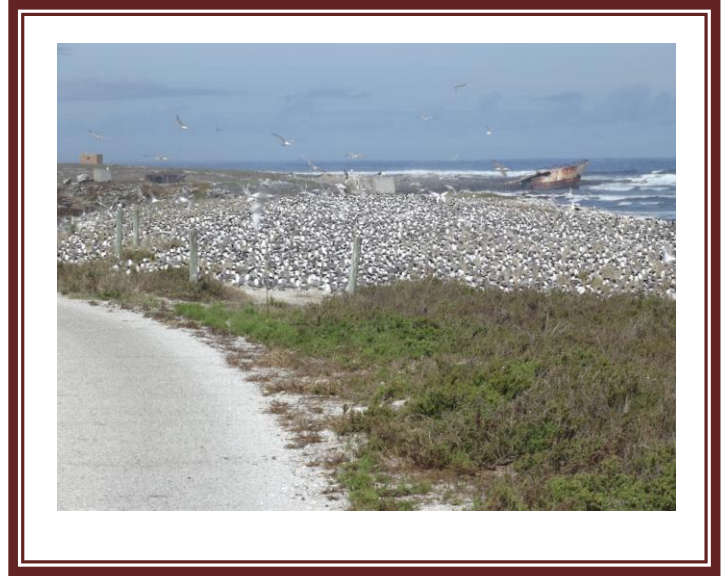
Fig.21. Close up of bird colony on N section of wall

Option 5 cannot be motivated from a heritage perspective and would be an intrusion on the cultural landscape.
