MSP 'A' SECTION EXHIBITION BOARDS AS A CONSERVATION INDICATOR.

The exhibition in 'A' Section was opened in 1998. Exhibition boards were mounted flush with the walls in each cell. There are usually two boards per cell, one larger telling a story, the other smaller identifying an Ex-political prisoner.

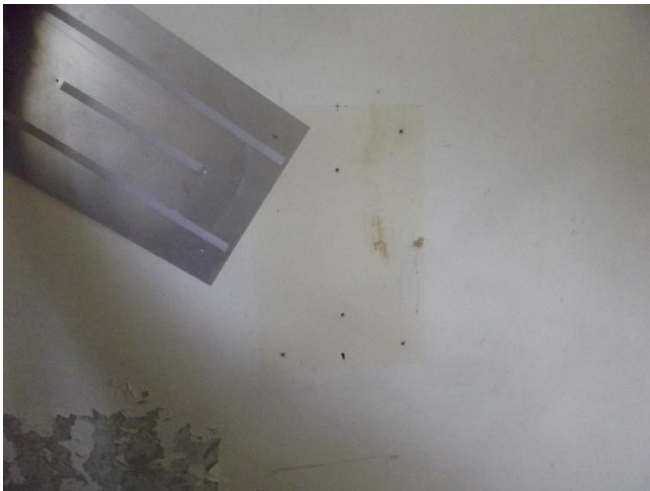
CELL 29 DSCF 6242

Despite the discolouration the area behind the boards appeared to be stable and not deteriorating, even in cell 29 which has rising damp in the SE corner [image 6244, 6247]

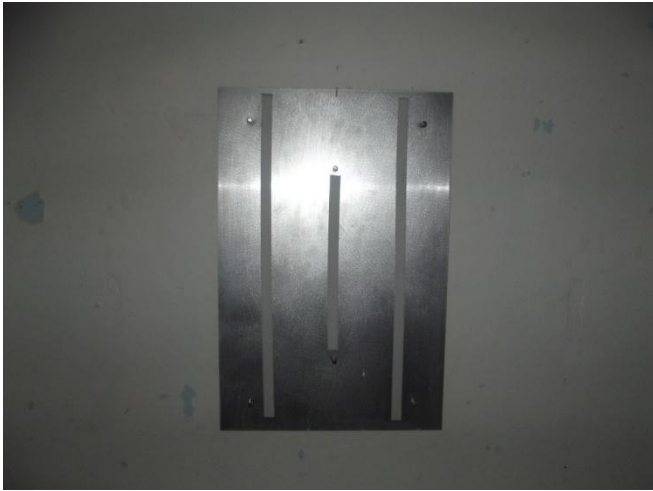
6295

Holes were drilled into the walls and filled with wooden plugs [image 6303]. A galvanised sheet of metal was then attached with screws to the wall.[image 6295] The metal sheets then had Velcro stuck on for the main storyboard of either glass or Perspex to be attached.
