**Biological Monitoring Conducted** in a tributary of the Woestalleen Spruit

Roodepoort 151 IS (Portion 17)

September 2013

Biological monitoring to determine the baseline class for the unnamed tributary of the Woestalleen Spruit.

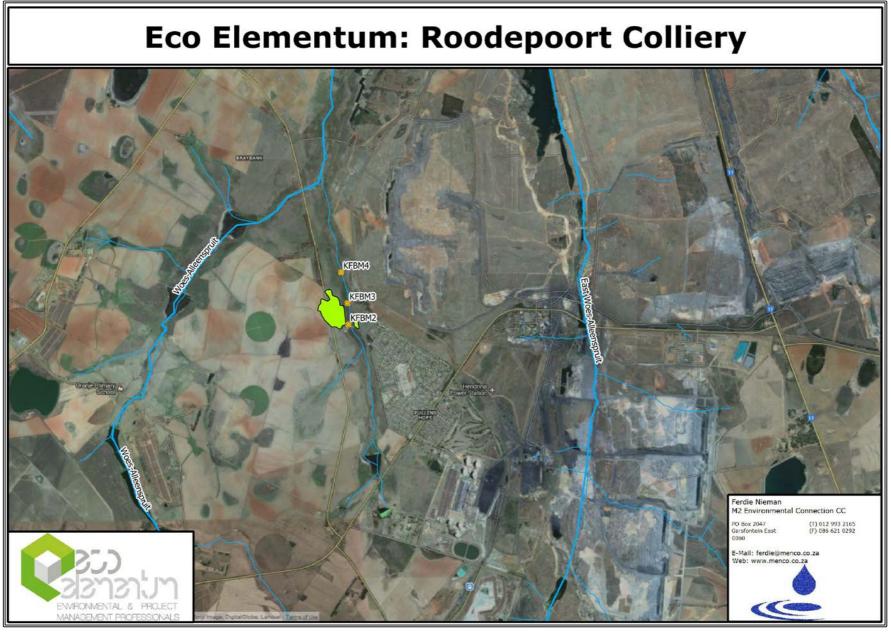
Figure 3-1: Bio-monitoring sites

The identified monitoring points are indicated in Figure 3-1, and described in Table 3-1. More detailed descriptions are provided in **Section 6**. Monitoring points were selected to obtain baseline data representative of upstream and downstream conditions in relation to the proposed activity.

➤ Sites were allocated in the tributary of the Woestalleen Spruit for the sole purpose of upstream, downstream and parallel to the proposed activity to serve as baseline data and support the WULA (refer **Table 3-1**).

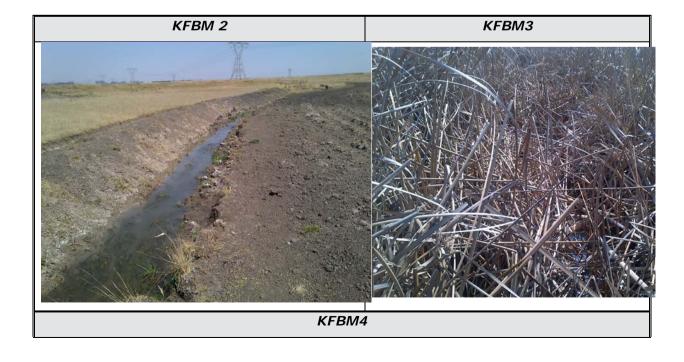
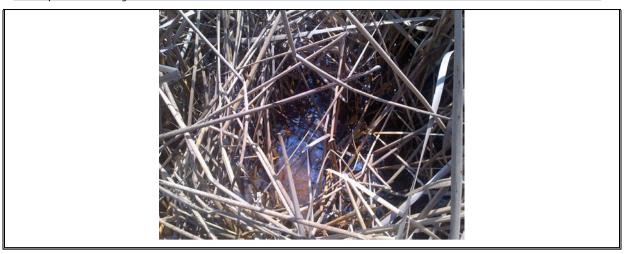
Figure 6-1: Site photographs for bio-monitoring sites in the Tributary of the Woestalleen Spruit

Site	Date	рН	EC (mS/m)	DO ( <i>mg/l</i> )	SASS5	ASPT	Health Class	IHAS
KFBM2	Sept'13	8.8	78.6	10.52	42	5.3	Class B	61
KFBM3	Sept'13	7.2	76.5	6.49	37	4.6	Class C	39
KFBM4	Sept'13	6.3	56.2	3.82	60	5	Class B	39

The water qualities are indicative that there are form of pollution entering the system in the area between KFBM3 and KFBM4. The increase in the phosphates is indicative of the biological pollution taking place at point KFBM4. The higher levels in Turbidity, Suspended Solids, and COD's are supportive to this form of pollution. The decrease in DO is another indicator of biological pollution that is clearly taking place. Upon the site visit it was noticed that there were a sewerage leakage in the town of Pullenshope and it is therefore assumed that this is the cause of this pollution as the stormwater drains into the tributary.

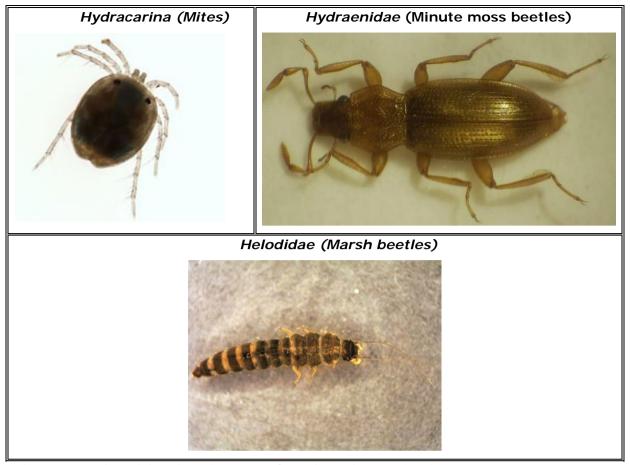
Figure 6-2: Sensitive Species Found During Bio-Monitoring

- Helodidae (Marsh beetles)
- Hydraenidae (Minute moss beetles)

Even though the in stream habitat was found to be insufficient to support sensitive biota, there were still some sensitive species identified. These species included the likes of *Helodidae* (Marsh beetles); *Hydraenidae* (Minute moss beetles) and *Hydracarina* (Mites). It was found at KFBM2 that the IHAS showed the necessary habitat, yet there were no sensitive species found. The ASPT was however evident of a Class B. The main reason found that there were no sensitive species is the fact that this is however the overflow of the dam situated in the stream. This is also the closest point to the dam of all the points monitored and the assumption is that the sensitive species has not yet established at this point.

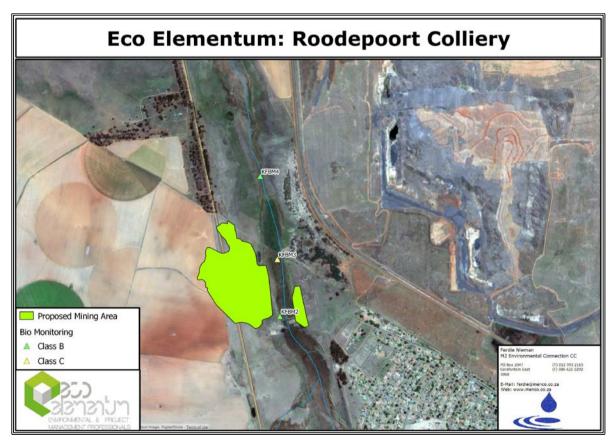
Figure 8-1: SASS 5 Classifications

The asp for the sites respectively was found as 4.6 and 5.3. That indicates a resource class of B/C. The background for the catchment is class D/C. It is however clear that this

catchment is severely impacted by the activities found within, but this stream is in a very good condition in relation to the rest of the catchment.
