# **Basic Assessment**

# **Background Information Document**

## **Cedarville Middle Income Housing Development**

Ref no: EC41/AN/LN1/LN3/M/14/15-33 Report Number 2015-R058

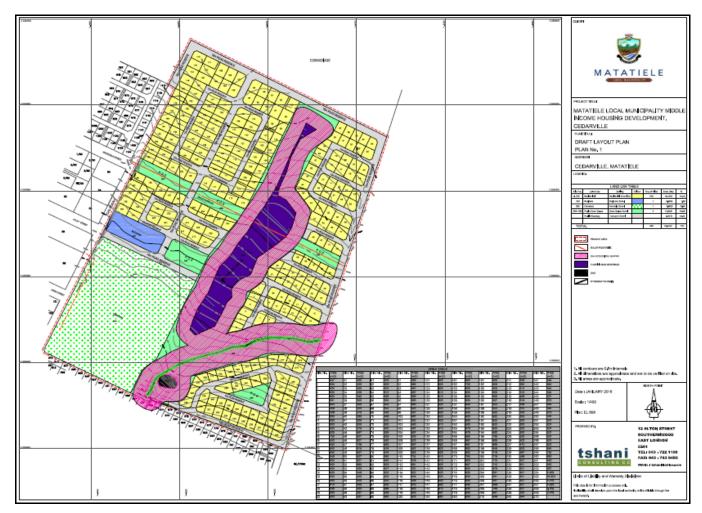
Figure 1C: Layout

The outcome of the design layout (Figure 1C) produced the following:

- 263 Residential Erven with an average Erf size of 586m2 in extent (13.1500Ha).
- 1 Business Erf (0.6563ha).
- 4 Public Open Spaces (14.3641ha).
- Public Roadways (6.0016ha).

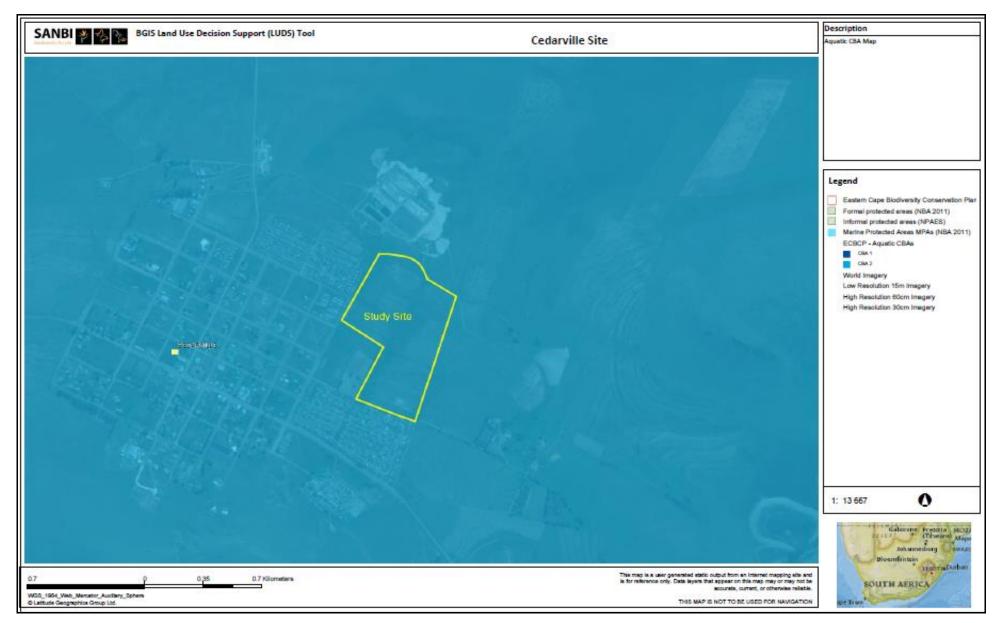
Figure 3: Aquatic CBA map

The Eastern Cape Biodiversity Conservation Plan (ECBCP) has classified the study site as Terrestrial CBA2 (Figure 2) and Aquatic CBA 2 (Figure 3). Associated with each of CBAs are biodiversity land management classes (BLMC), which refer to how these categories should be managed. The BLMC assigned to the terrestrial CBA 2 is a BLMC 2 (Table 1). BLMC 2 areas should be maintained in a near-natural state, where wetlands and streams are afforded buffers and natural vegetation is kept intact.

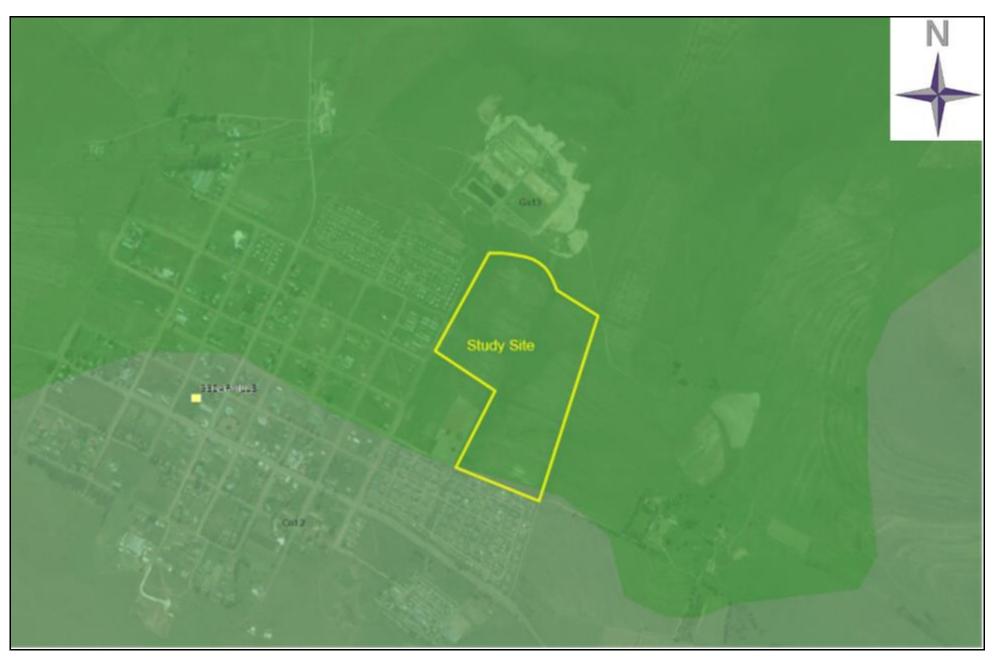
Figure 4: Eastern Cape Biodiversity Plan – Vegetation map (Gs13 = Mabela Grassland)

The Eastern Cape Biodiversity Plan has classified the vegetation on site as Mabela Sandy Grassland (Gs13) (Figure 4). A portion of the site is also regarded as alien invasive vegetation. Mabela Sandy Grassland is distributed in the KwaZulu-Natal and Eastern Cape Provinces. Distribution of this vegetation type occurs in the Cedarville Flats (basin draining into the Umzimvubu River) in the region of Cedarville-Matatiele, Eastern Cape. This vegetation is also found in a small area in the basin of Simi and Ramohlakoana in the Kinira Valley, west of Matatiele. Mabela Sandy Grassland grows at an altitude of 1 440 – 1 500m, but up to 1 550m in a few places.

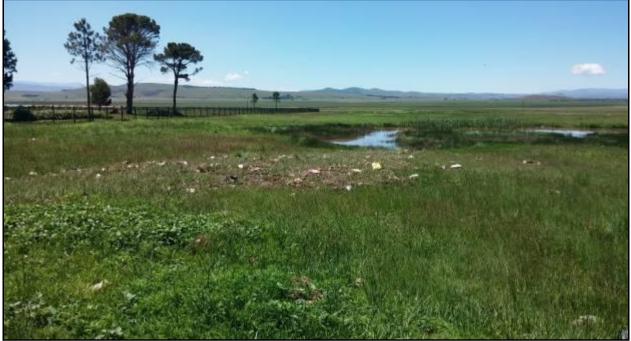
There is a sewage overflow from a manhole located outside the southwestern border of the site. The sewage is then flowing into a dam located on the south-western corner if the site (Figure 5). It is unknown at this stage if this dam/wetland is a natural wetland or created from the sewage and stormwater runoff. There is also another manhole located further downstream, as indicated in the layout plan (Appendix A), which is overflowing (Figure 6). These sewage leakages are creating a large wet area that runs from the south of the site to the north. There is a strong sewage stench in the vicinity of the sewage overflow areas.

Figure 5: Sewage overflow from outside the site and into the on-site dam

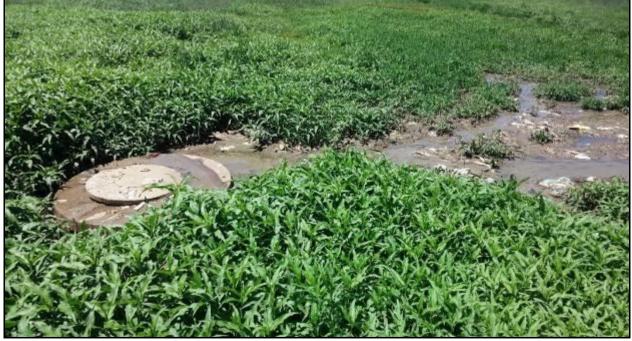
Figure 6: Sewage overflow from manhole on site creating a large wet area

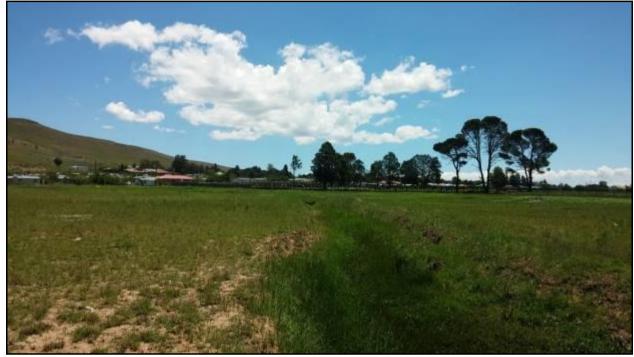
There is a stormwater drainage channel which enters the site at the south-western boundary. ). It appears to be a modified/built water course with no riparian vegetation present. The channel travels in a north-easterly direction before exiting at the eastern boundary of the site (Appendix A). A sewage stench was noted at the drainage exit point on the eastern boundary, indicating that sewage is entering the drainage course.

Figure 7: Stormwater drainage channel

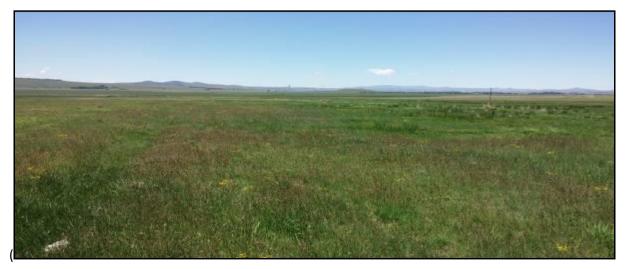
The majority of the site consists of grassland (Figure 8). The occurrence of Sporobolus pyramidalis was noted (Figure 9). Sporobolus pyramidalis is an indicator species of Mabela Sandy Grassland, as determined by the ECBP.

Figure 8: Grassland vegetation

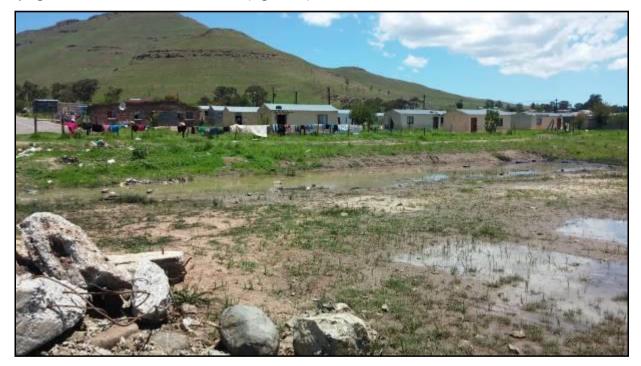
Soil excavation was noted on the south eastern corner of the site (Figure 10). At the same vicinity, the dumping of soil and rubble was also noted (Figure 11).

Figure 10: Soil excavation

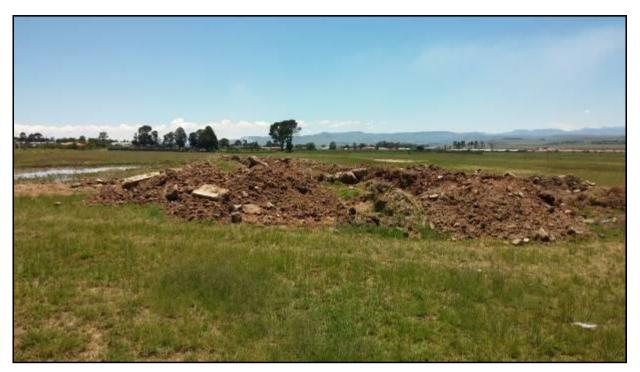
Figure 11: Soil excavation and soil/rubble dumping

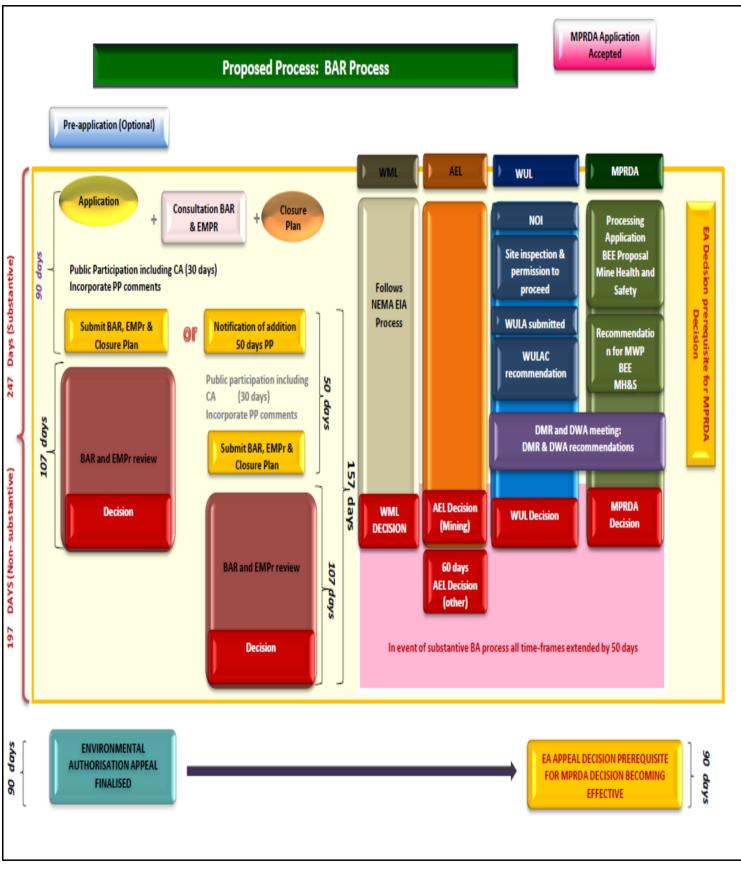
Figure 13: Basic Assessment flowchart

- Identify I&APs that may be affected by a development.
- Allow I&APs to provide input during the public participation process regarding:
  - o Any concerns resulting from the proposed development
  - Indigenous knowledge on the study site and surrounding environment
  - The enhancement of positive impacts by the proposed development.
- Allow I&APs to comment on the public draft basic assessment report (Figure 13)
