# PROPOSED 132KV POWERLINE, WALMER PORT ELIZABETH

## AQUATIC IMPACT ASSESSMENT

**February 2016**

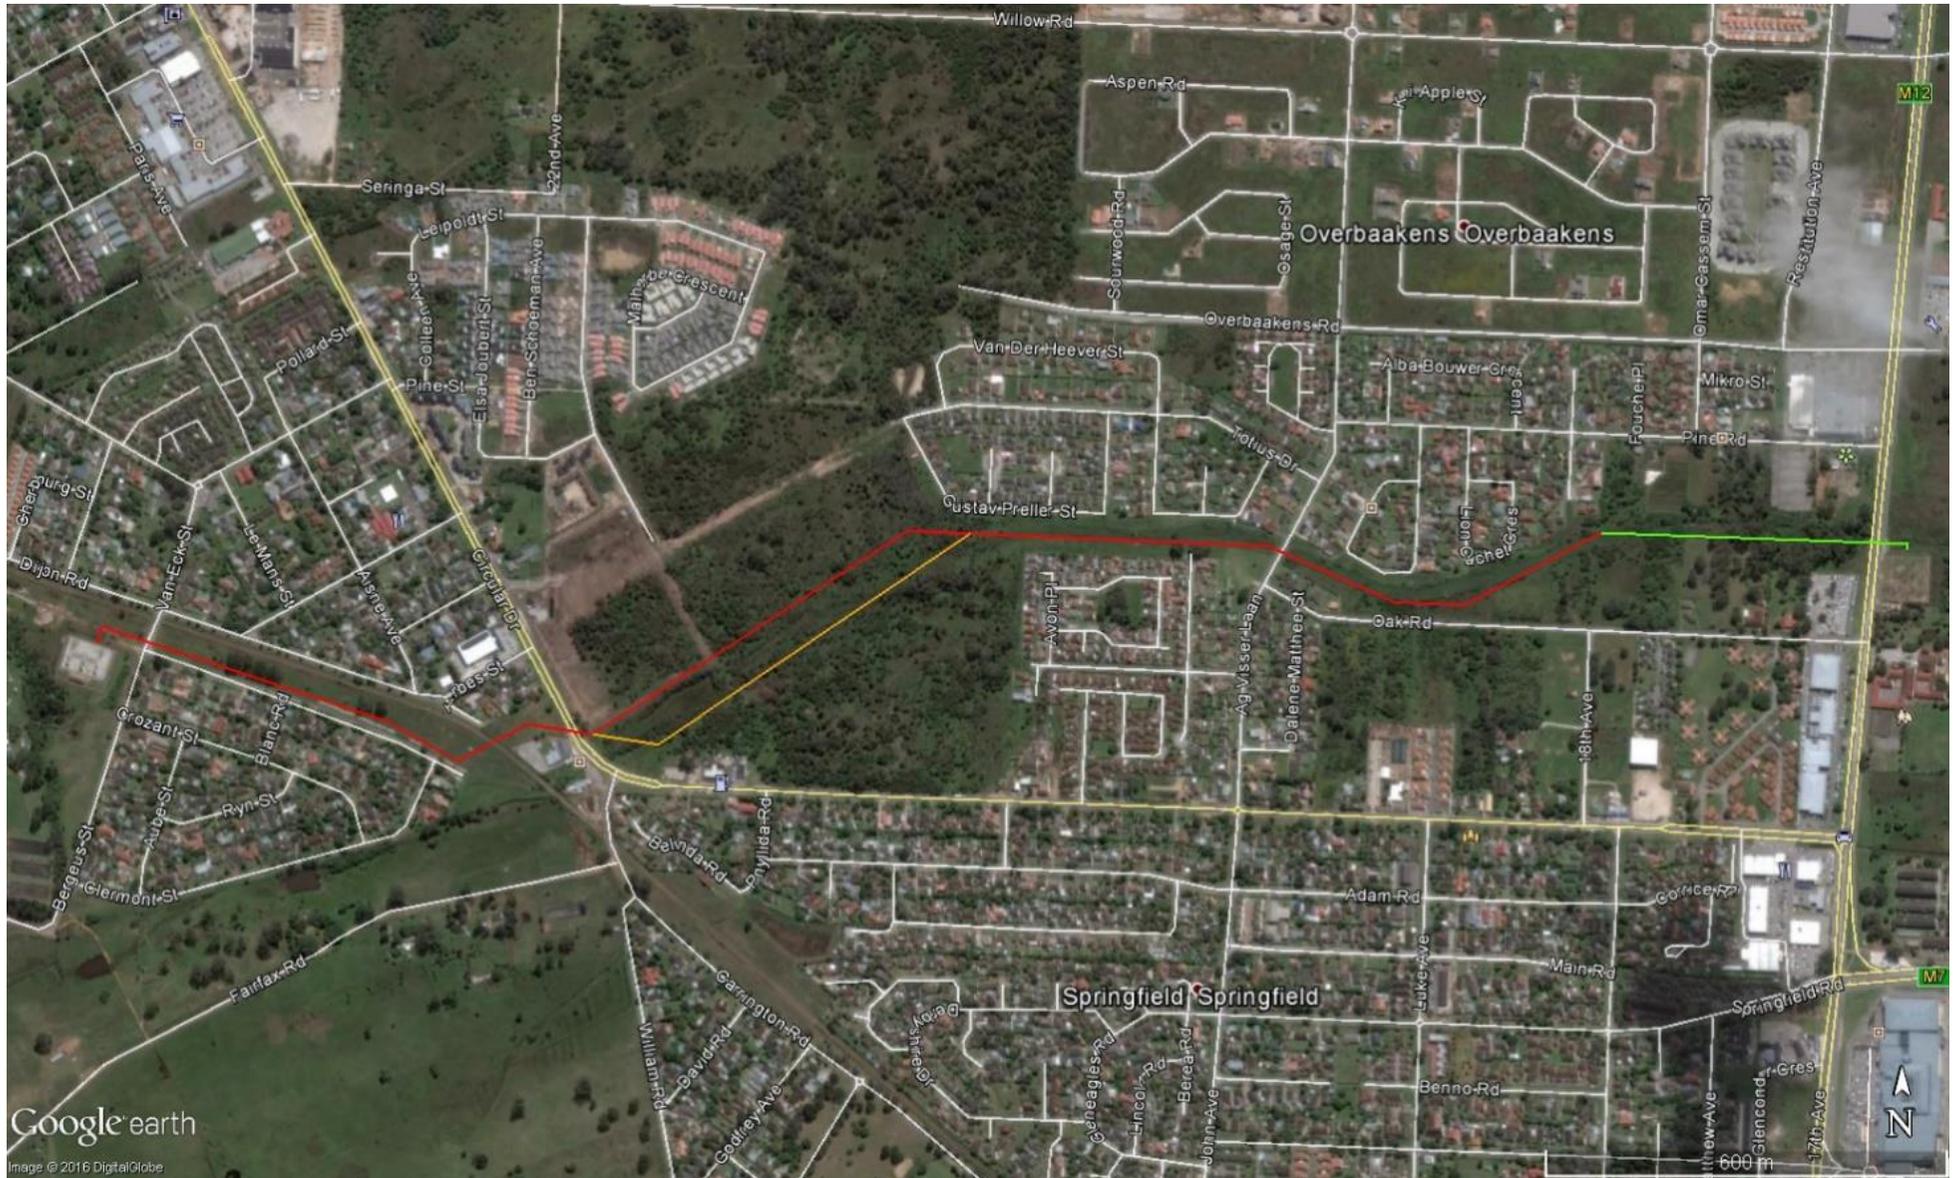
Figure 1: Google Earth image of study area indicating the alternative alignments and the underground cable section (Green line)

- Tower footprints must be kept to a minimum and if possible outside of the demarcated water courses
- The number of towers that would need to be placed within or directly adjacent to the observed water courses / wetland areas would be lower if Option 1 is selected (i.e. red route as shown in Figure 1)

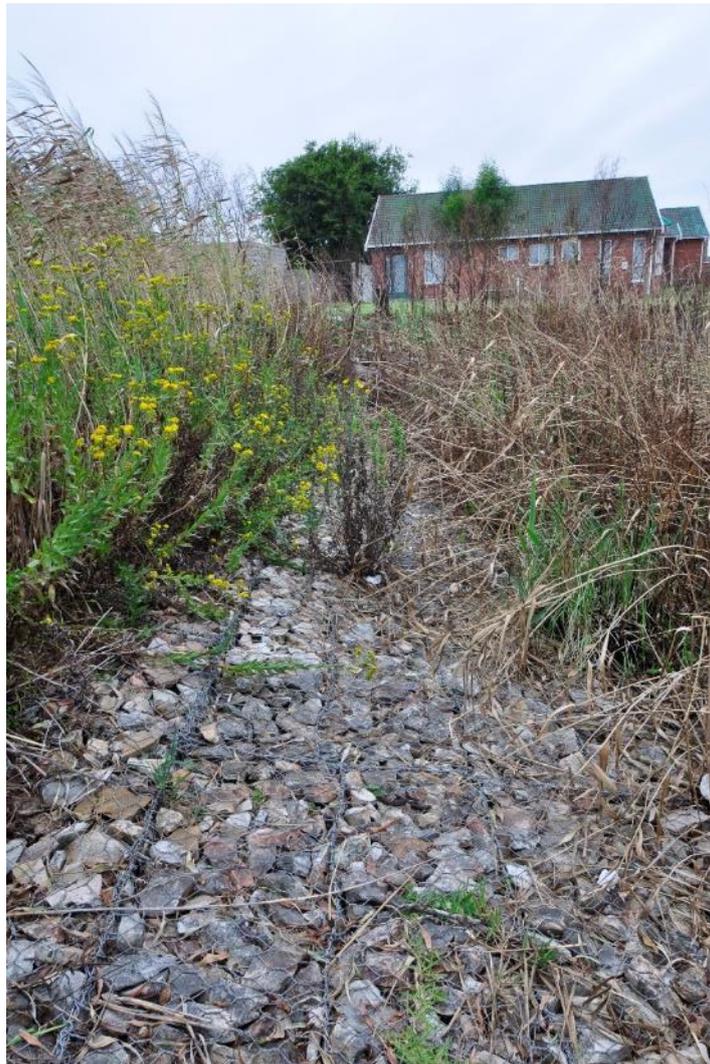
**Plate 1: A typical gabion structure, one of approximately seventeen located within the study area, used to impeded surface water flows and now colonised by reeds and bulrushes.**

- The inclusion of storm and flood water management structures such as the gabions walls that span the system in several areas and have created artificial reed bed wetlands (Plate 1);
- Land reclamation and infill of riverbanks to reduce the risk of flooding of adjacent properties (Plate 2); and
- Alien vegetation stands (Plate 3)

The study area hydrology was characterised mostly ephemeral flows entrained by a series of detention gabions along the length of the water course from where it intersects with Circular Drive until Hanover Place in Overbaakens. These gabion walls thus entrap / slow any flows which was then colonised by dense reedbeds. The natural riverine channel with instream vegetation and some aquatic habitat only reappears for a short section where it intersects with William Moffett / 17<sup>th</sup> Ave. The upper regions of the study area (along Macon Rd) do not form part of any natural water course, and the observed water courses are canals / channels (Plate 4 & 5) that have been dug to divert surface water runoff away from the Lorraine area, under the rail line and Circular Drive and into a large detention pond (Plate 6).

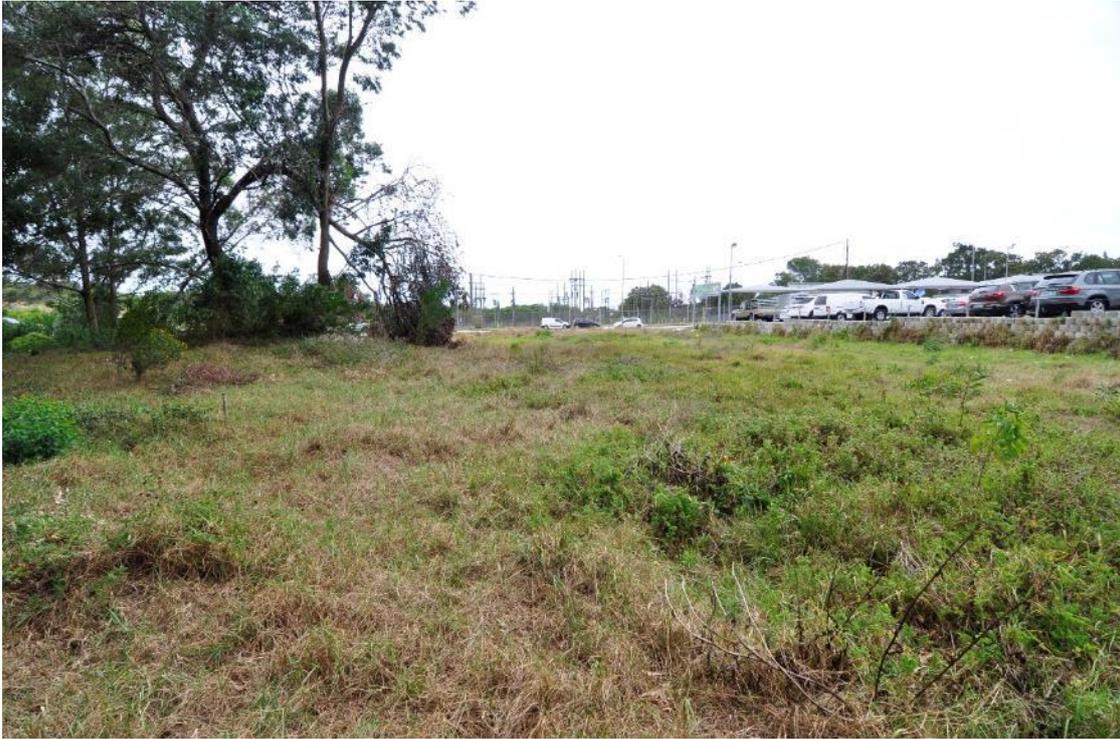
**Plate 2: Clearing (brush cutting) as well as infill has occurred on the upper banks of the water course**

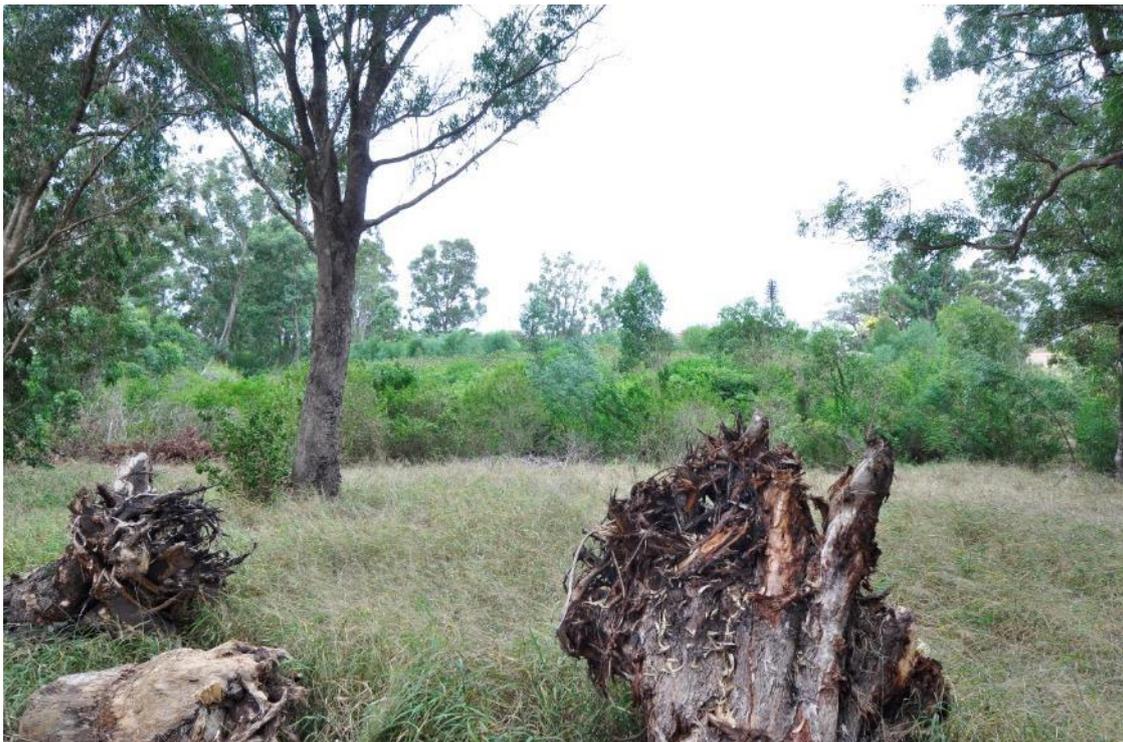
**Plate 3: Large stands of alien trees, some cleared occur along the western and eastern portions of the study area**

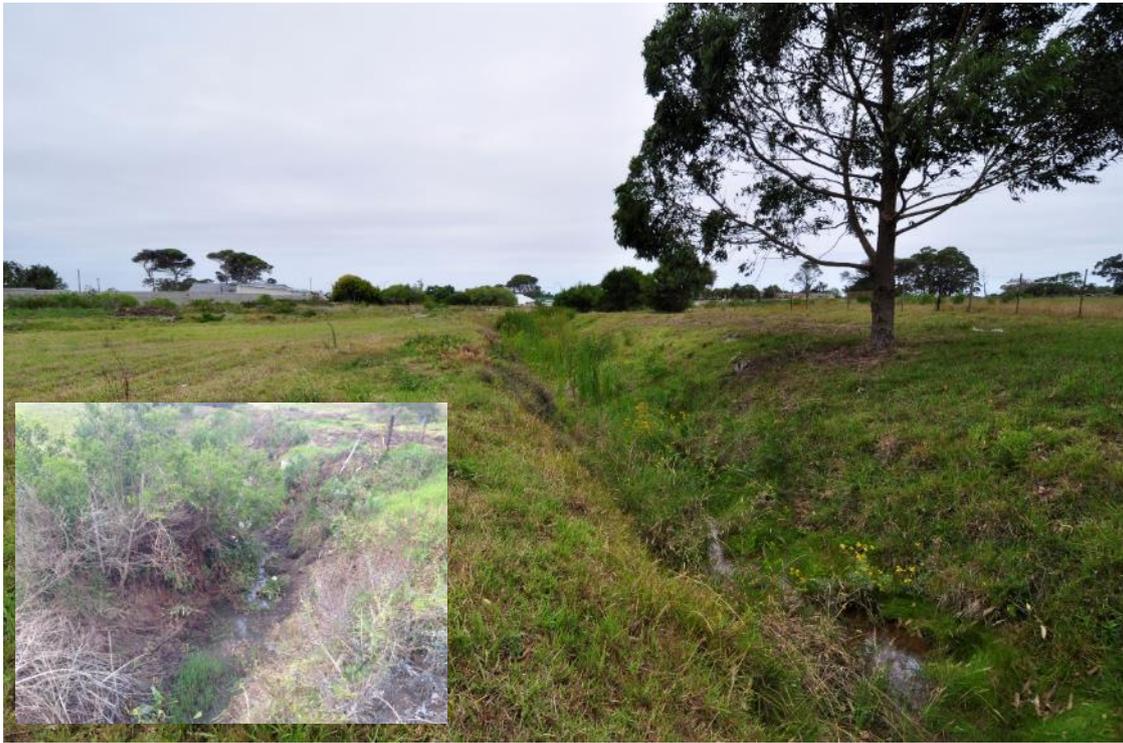
**Plate 4:** The western portion of the study area dominated by the hand dug channels to divert water from the roads and homes in Lorraine towards Circular Drive. Note the inset with alien vegetation and clearing operations as seen in a survey conducted in November 2013

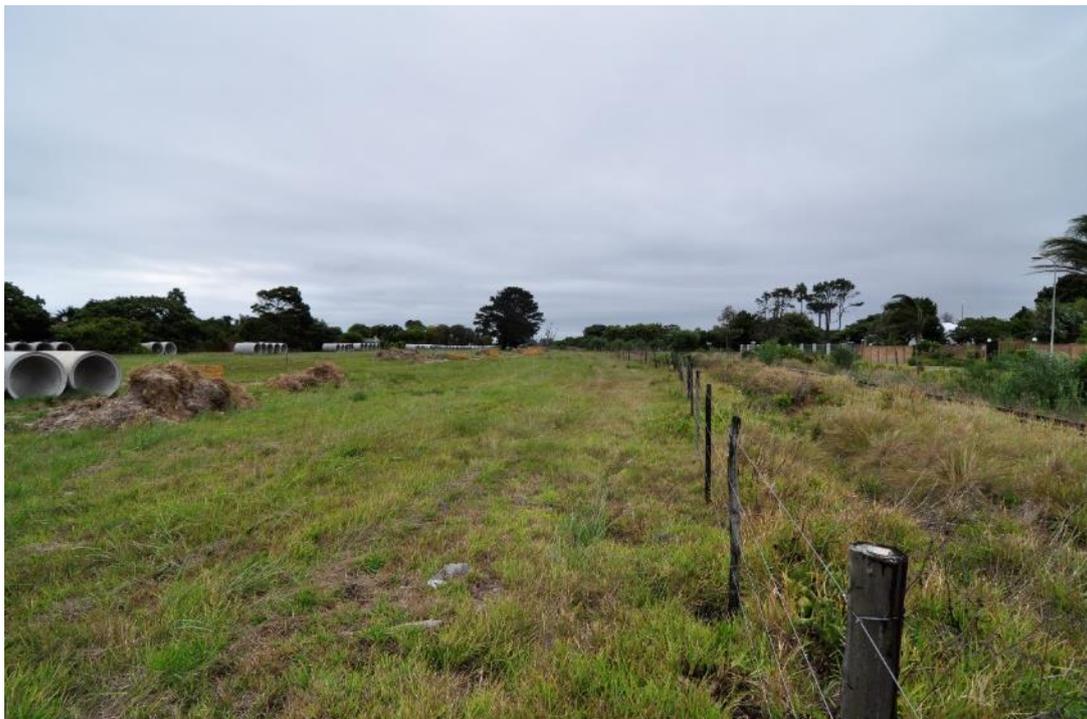
**Plate 5:** A view towards the Lorraine Substation with the small channel used to direct water away from the rail line visible along the right side of the fence. The area to the left of the is currently being prepared for the Lorraine stormwater pipeline

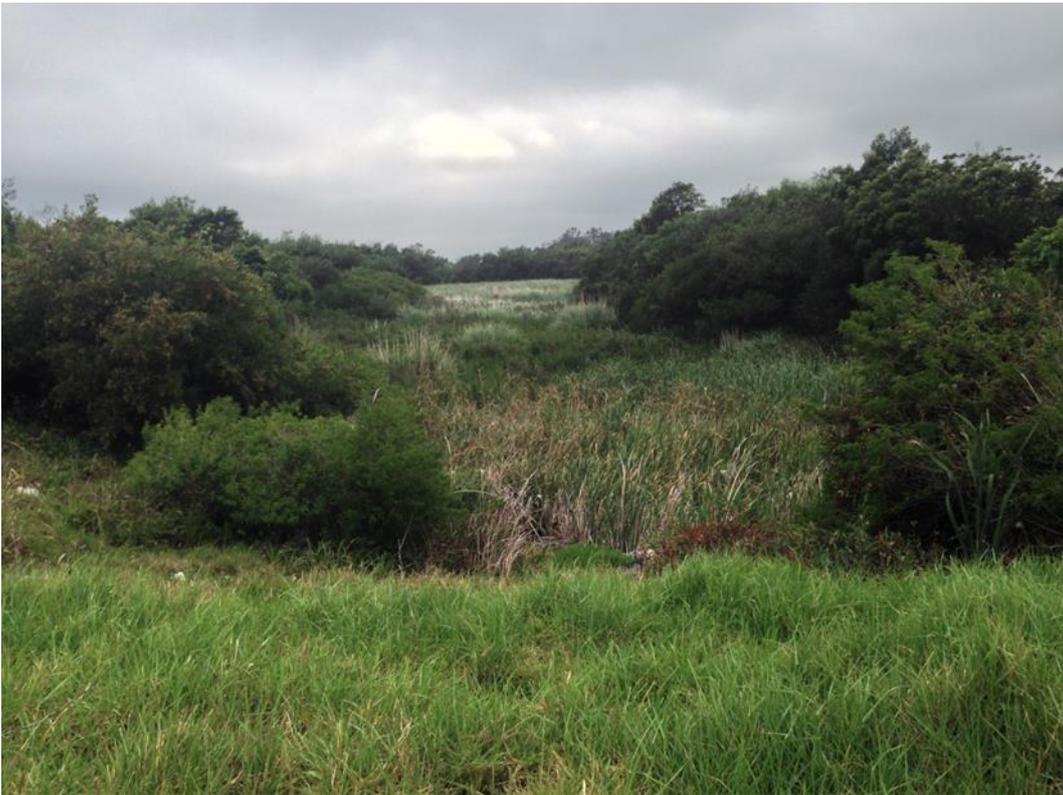
**Plate 6: A view of the stormwater detention pond located above the water course located adjacent to the Circular Drive / Carrington Way intersection**

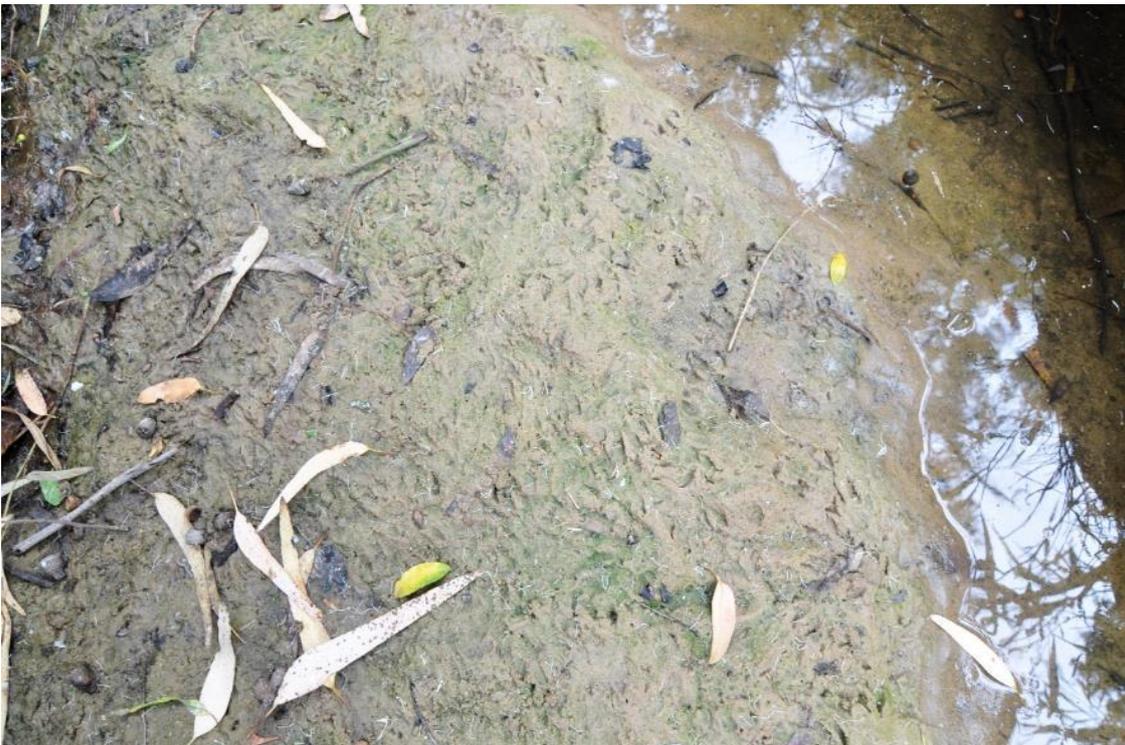
**Plate 7: The only signs of animals within the study area was these mongoose footprints on exposed sand bars within the incised channel near the 17<sup>th</sup> Ave Substation. Nail imprints are visible thus the spoor was not made by the Cape clawless otters known to occur downstream near Dodd's Farm**

With regard instream habitat and aquatic biodiversity, for the remainder of the study area, this is limited by the dense reed (*Phragmites australis*) and bulrush (*Typha capensis*) growth within the observed areas, and although would be considered modified wetlands these contain a low number of obligate aquatic species. The only other animals associated with these areas included Bishops and Weavers, while the open channel area (Plate 7) is used by Mongoose, possibly foraging for small crabs in the open water areas.

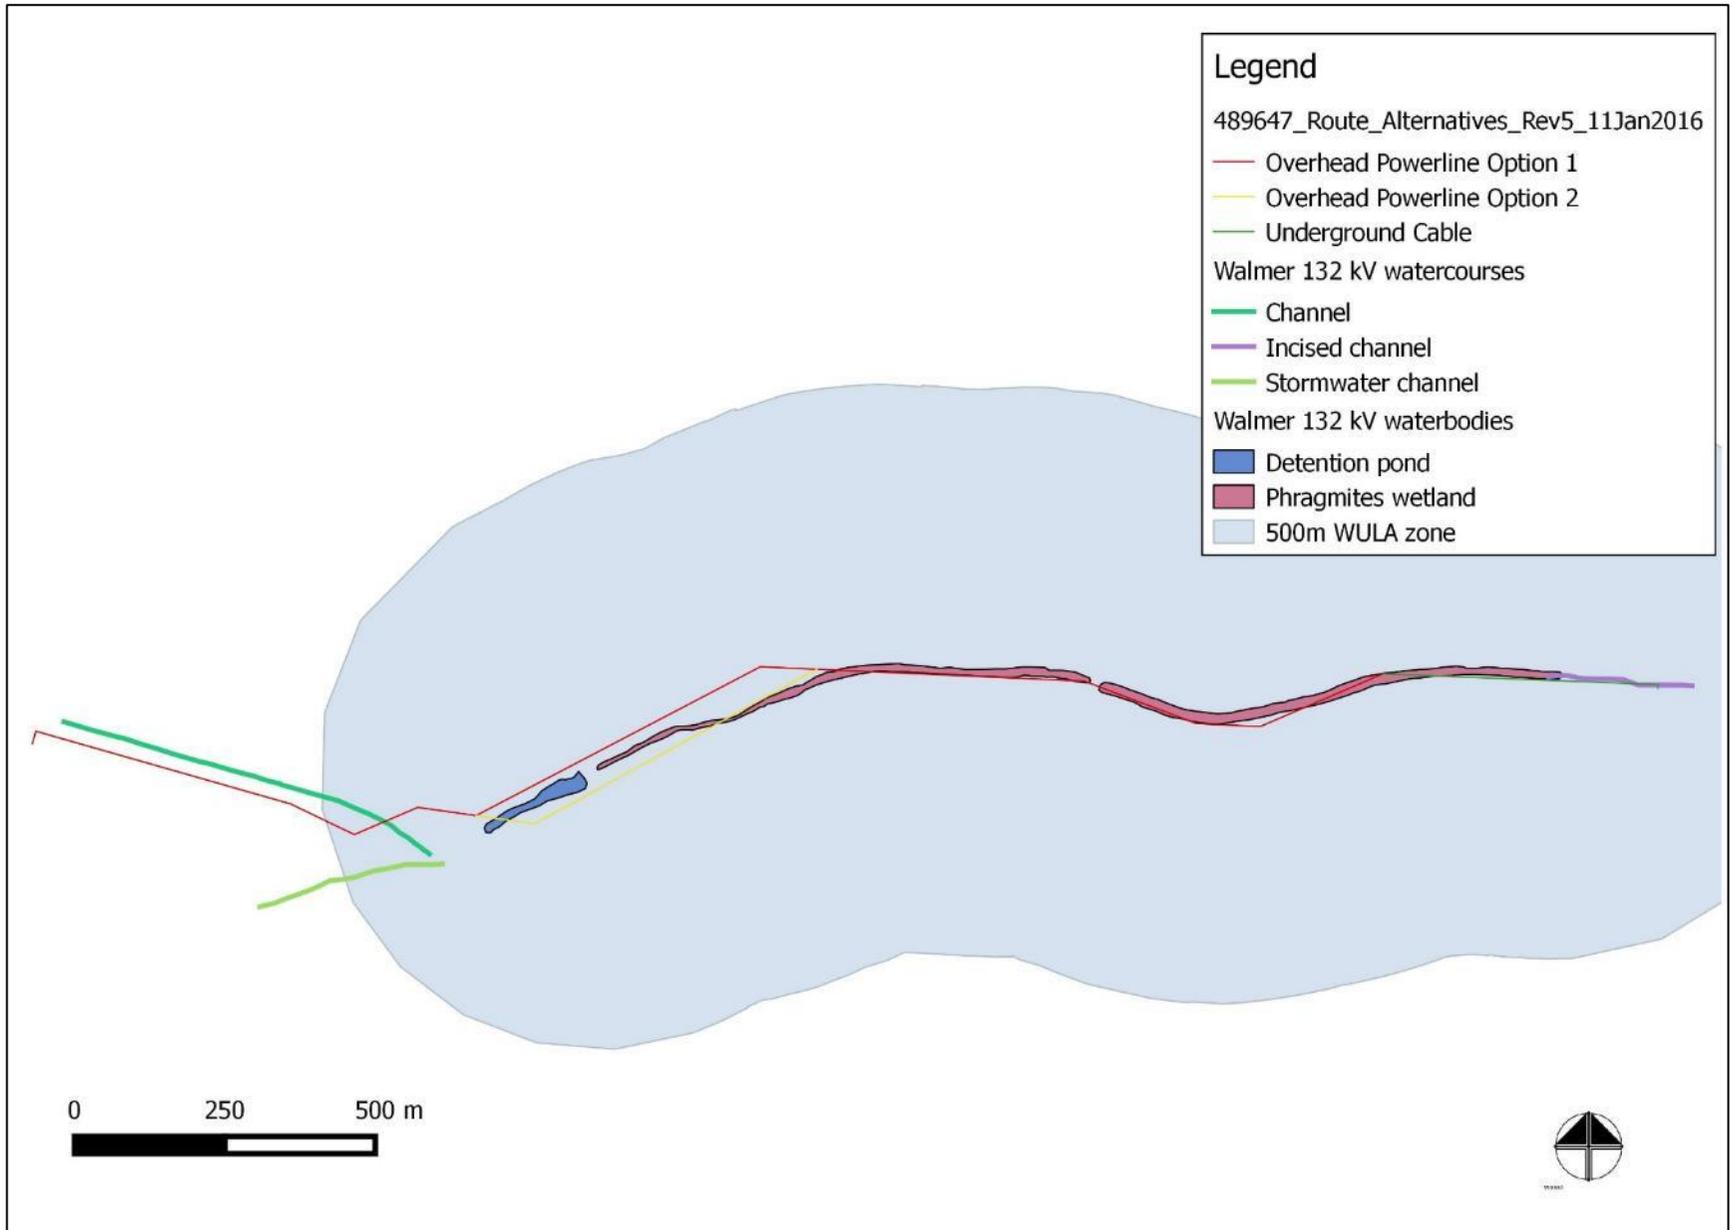
Figure 7: Delineated waterbodies for the study area and the 500m WULA regulated zone

The impact assessment was derived from the methodology provided by SRK Consulting and the design layout, which was measured against the current state of the observed water courses. Several impacts have been highlighted and have been rated based on the project actions / impacts, as well as any potential cumulative impacts during the construction and operational phases of the project. These were also assessed with and without mitigation. The impact ratings are relevant to both alignment options. To reiterate the assumptions, the proposed transmission line will span as far as possible any of the shown watercourses, while existing access roads and tracks will be used. Furthermore, no laydown / temporary works areas will be located within any of the observed aquatic habitats (Figure 7).
