WORKING FOR WETLANDS REHABILITATION PROGRAMME, KWAZULU-NATAL

REHABILITATION PLAN PROJECT: ISIMANGALISO

REHABILITATION PLAN FOR THE ISIMANGALISO PROJECT,
KWAZULU-NATAL PLANNING YEAR 2018/2019
AS PART OF
THE WORKING FOR WETLANDS PROGRAMME
FOR THE
DEPARTMENT OF ENVIRONMENTAL AFFAIRS
DIRECTORATE: WORKING FOR WETLANDS

MAIN REPORT
June 2019

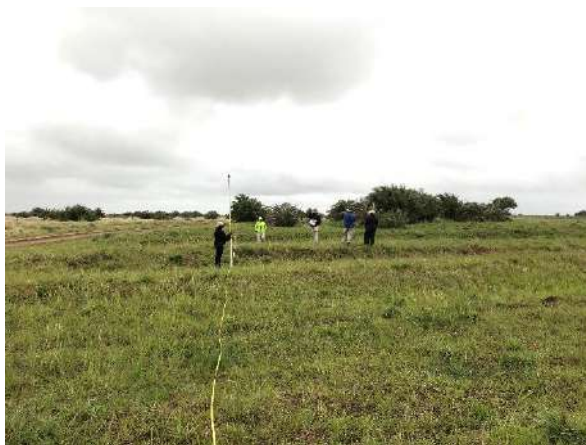
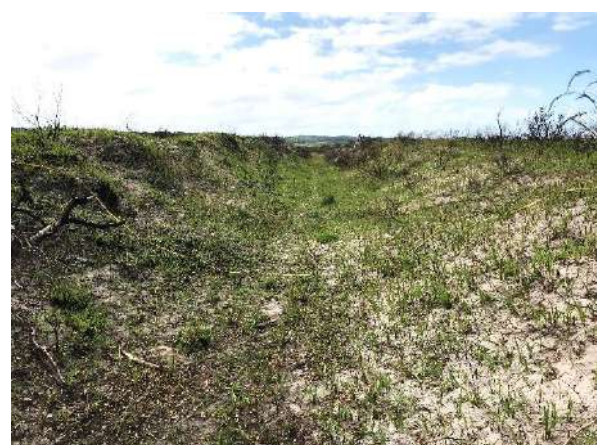
Plate 7 and Plate 8: Drains and associated fill-berms on either side of forestry road embankments, exacerbating the interception of natural flow and disruption of wetland functioning caused by the roads.

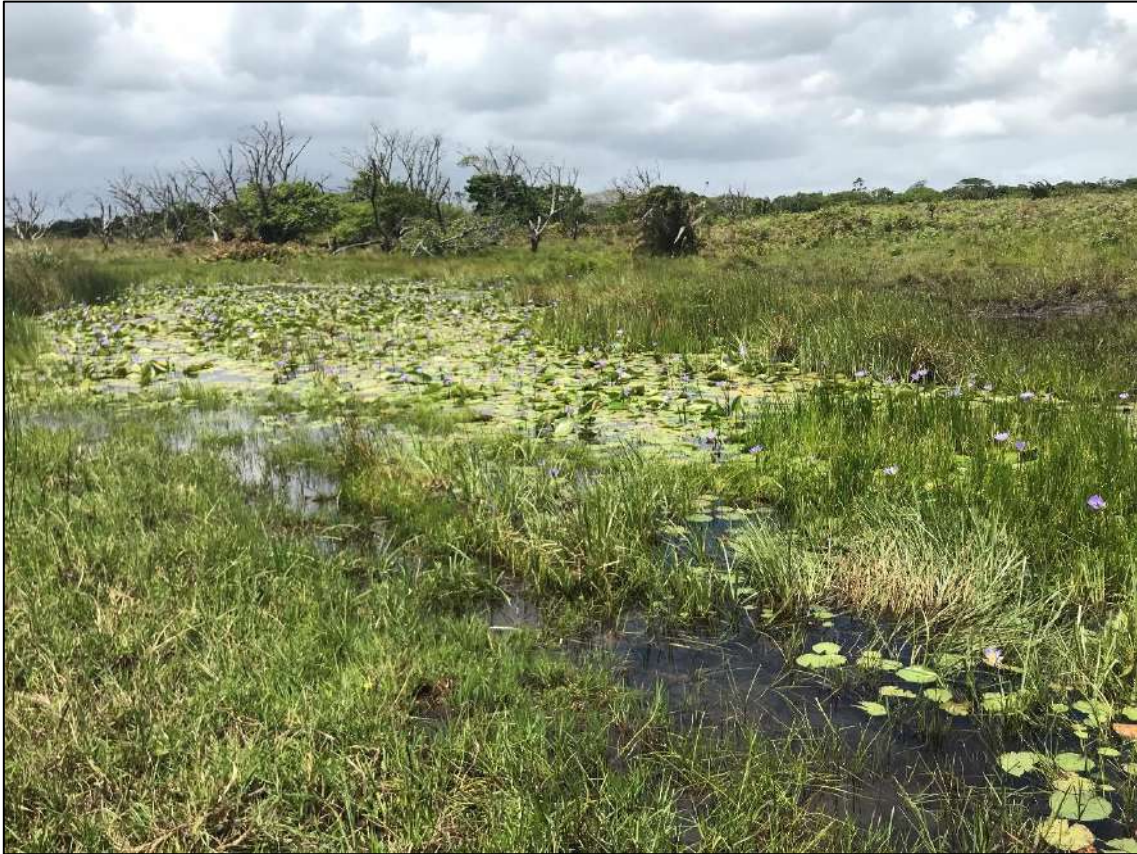
Figure 4.8 Photographic evidence of damming on the upstream side of old forestry road

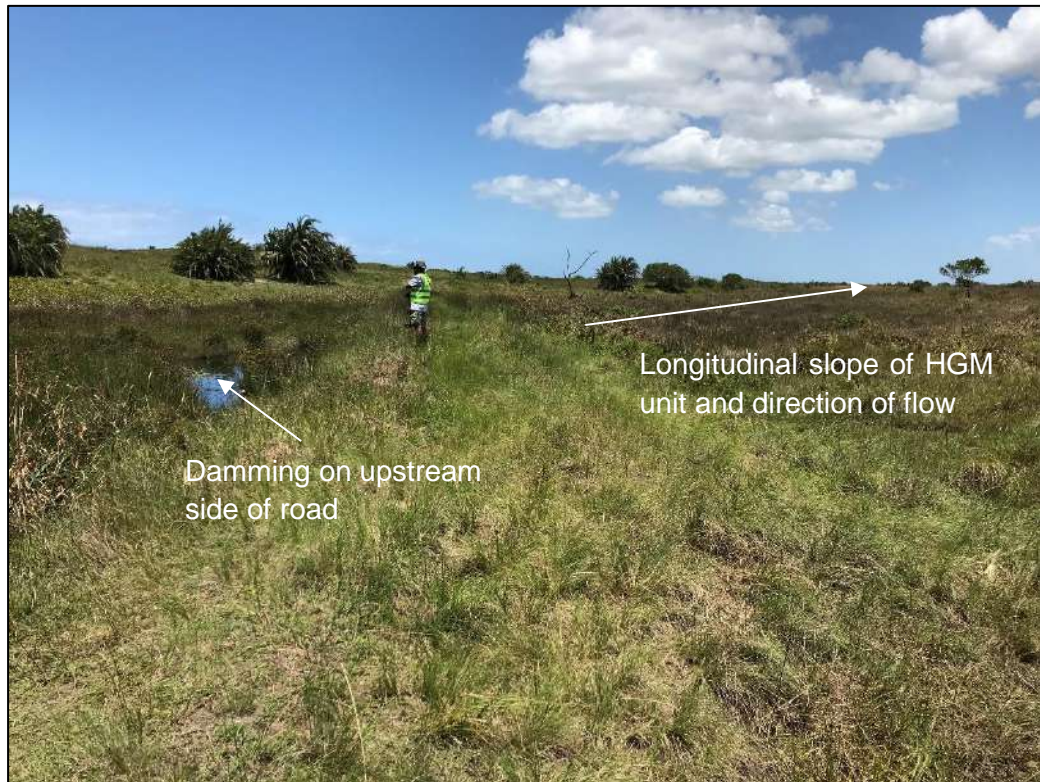
Figure 4.13 Photographic evidence of damming on the upstream side of a forestry road.

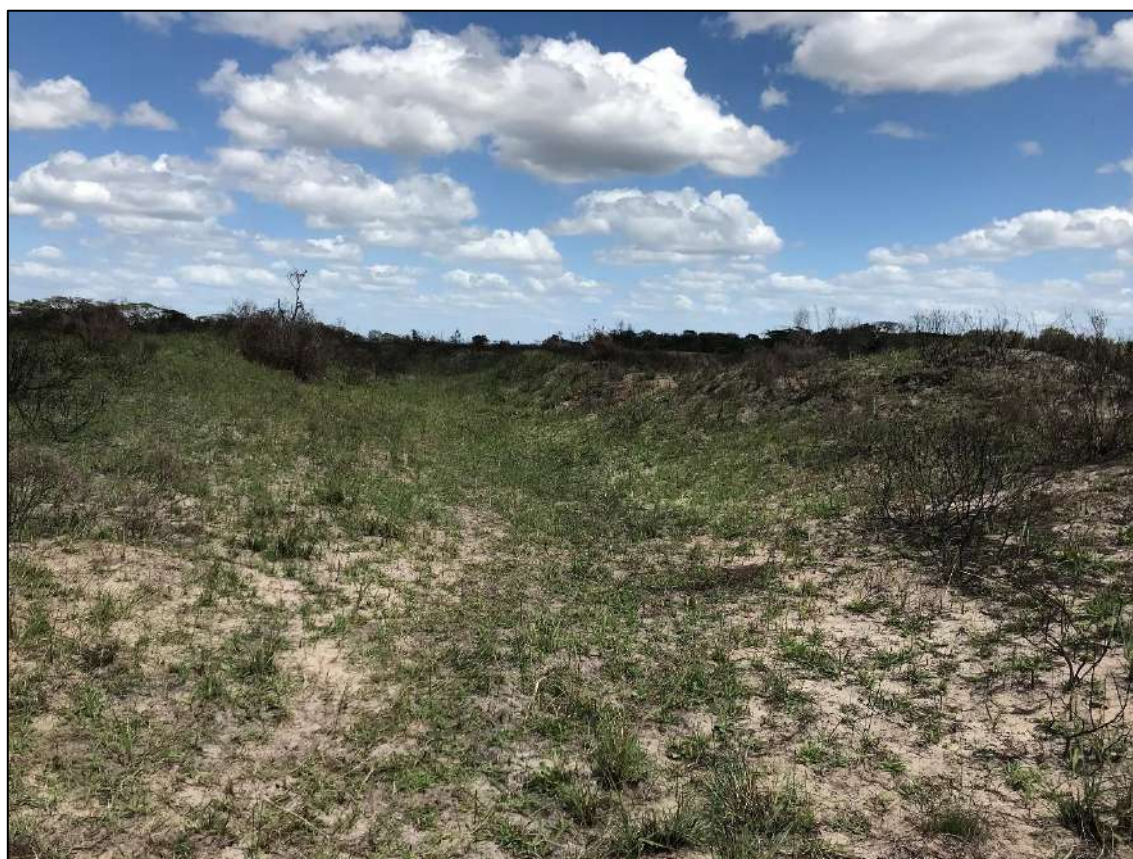
Figure 4.15 Photographic evidence of the excavated drain and the spoil deposits running along either side of the drain.

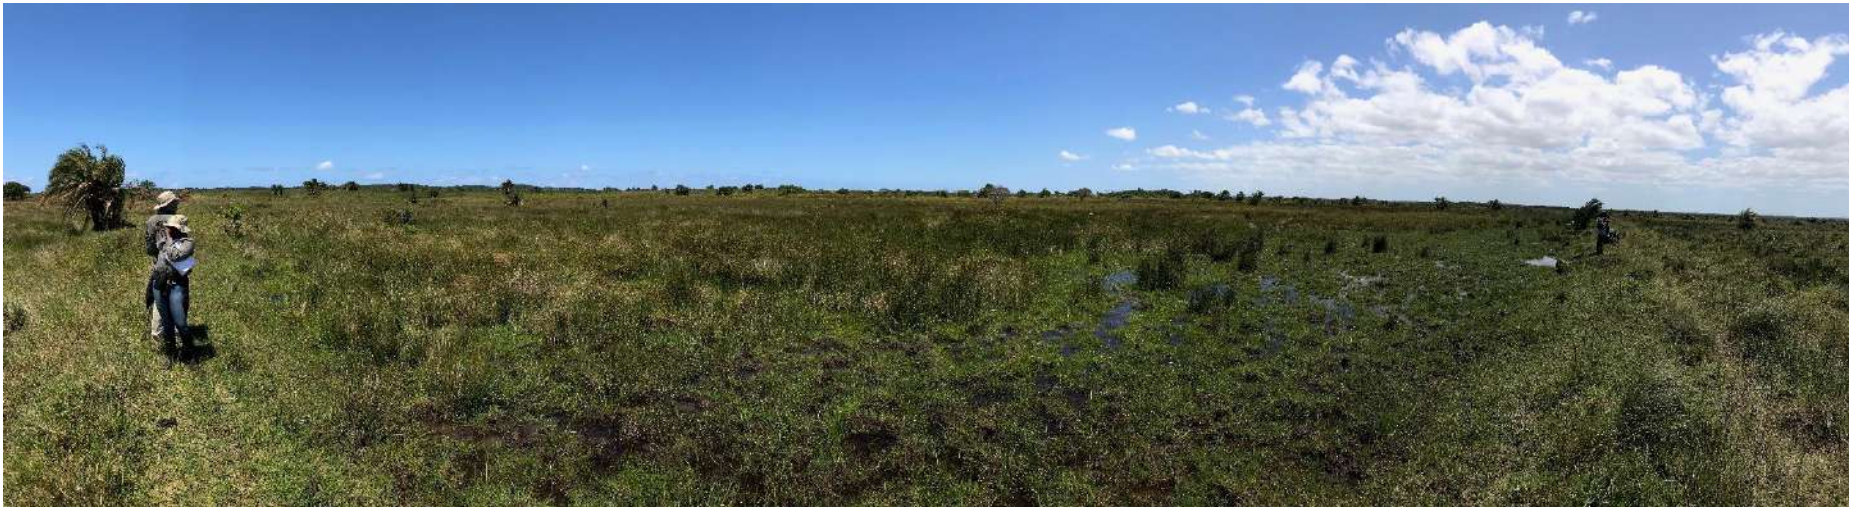
Figure 4.17 Photographic evidence of the extent of damming that occurs behind roads within Wetland 13 (W32H-13)

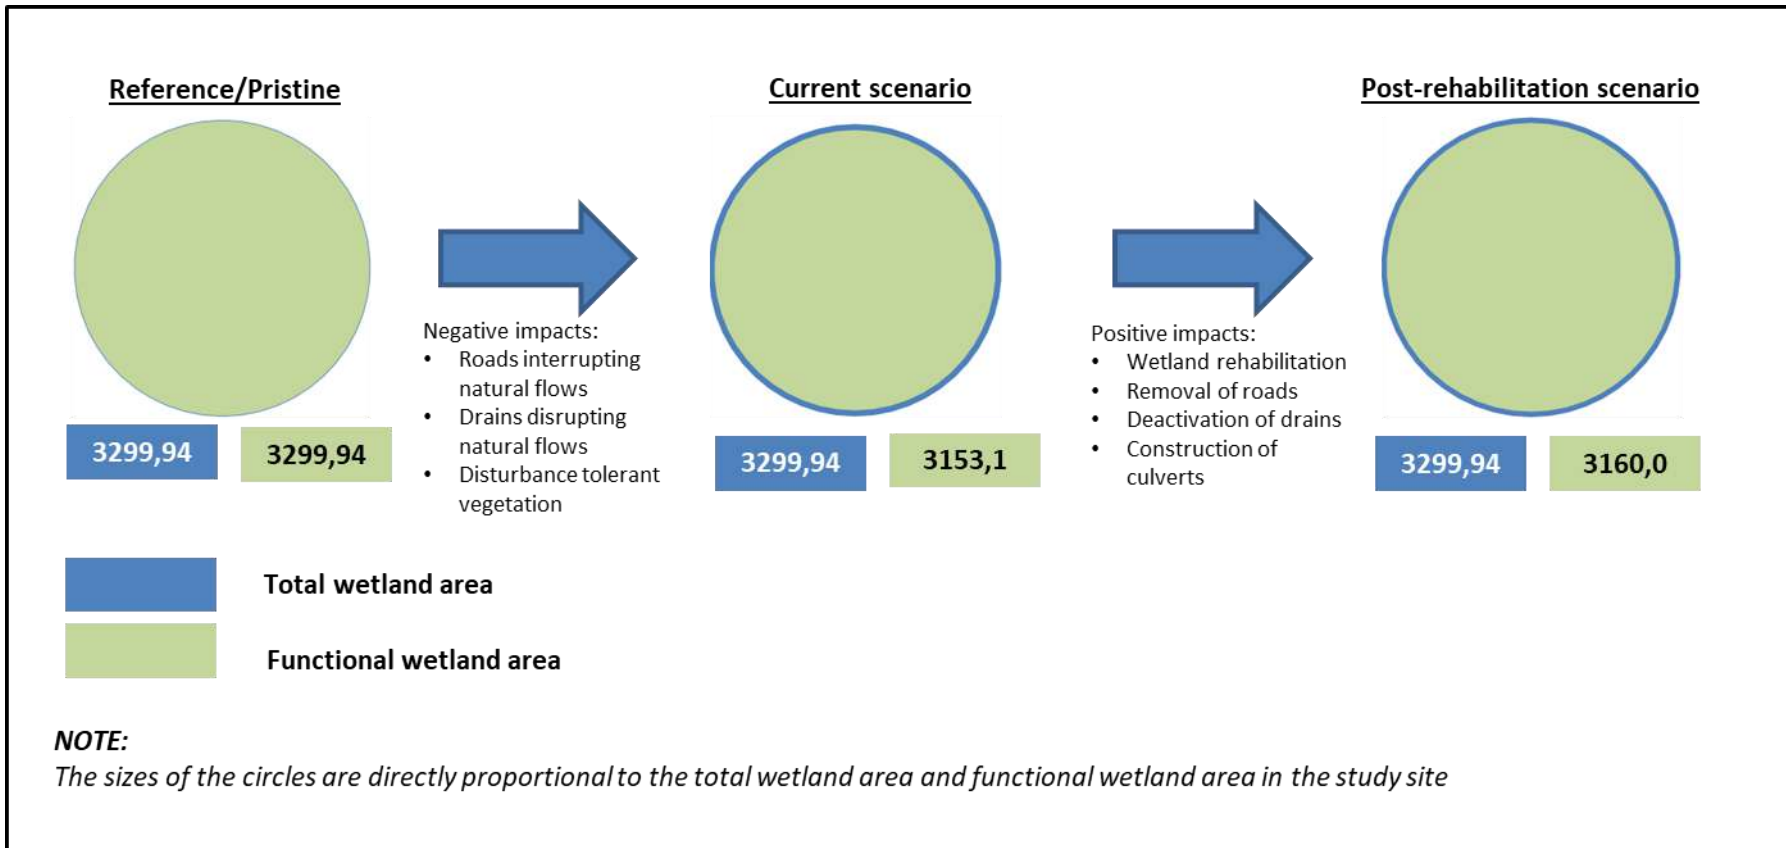
Figure 5.1 A graphic representation of the wetland habitat within the landscape, in terms of both spatial extent and functional area, from reference conditions through to the post-rehabilitation scenario (Cowden et al. 2013).

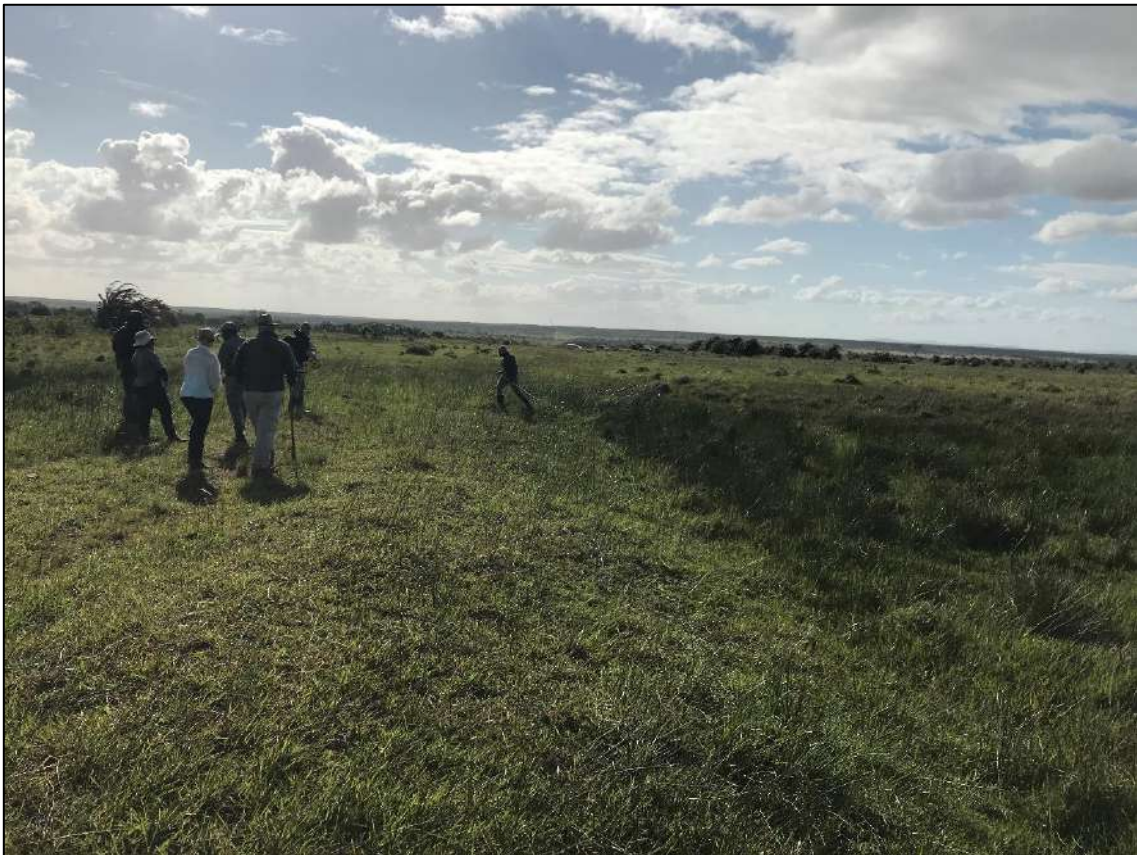
Figure 1.3 Photographic evidence of road interrupting natural flows in wetland. Area to the right of the road is the hillslope seep and area to the left (outside frame) is the bowl shaped wetland area.

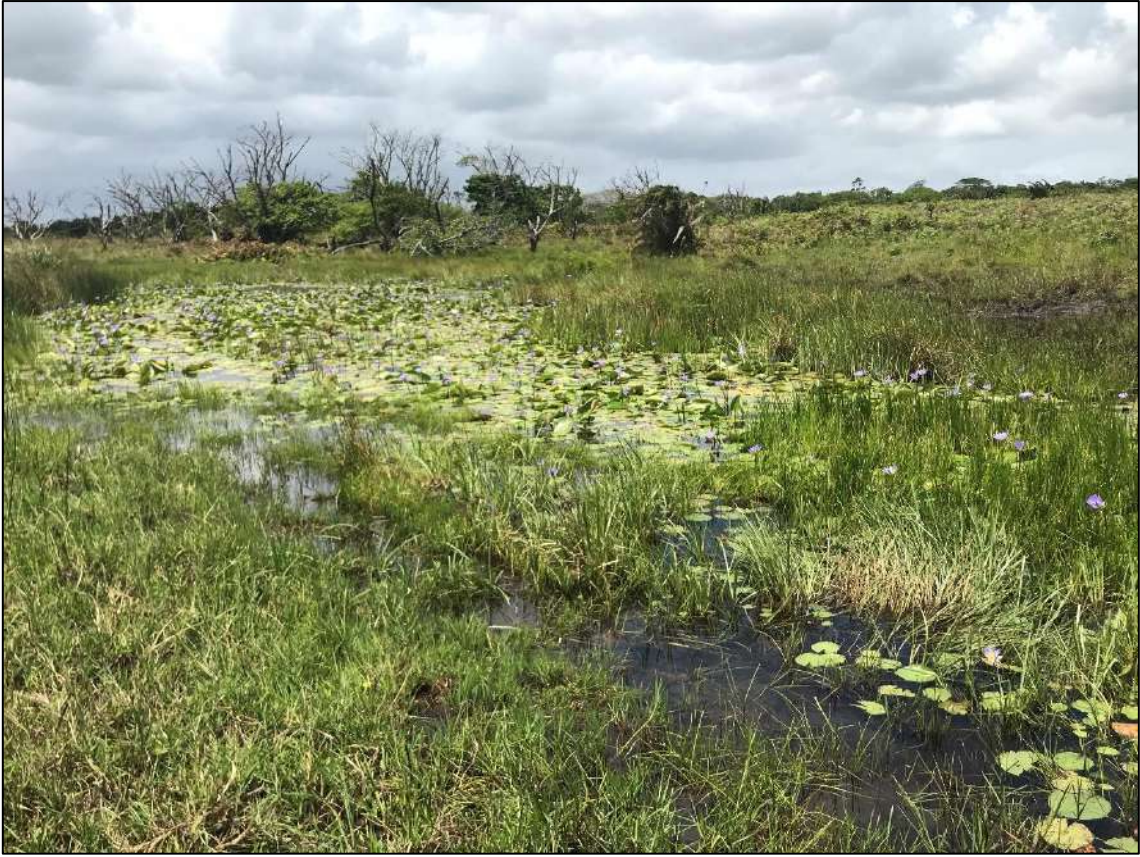
Figure 1.8 Photographic evidence of damming on upstream side of old forestry road

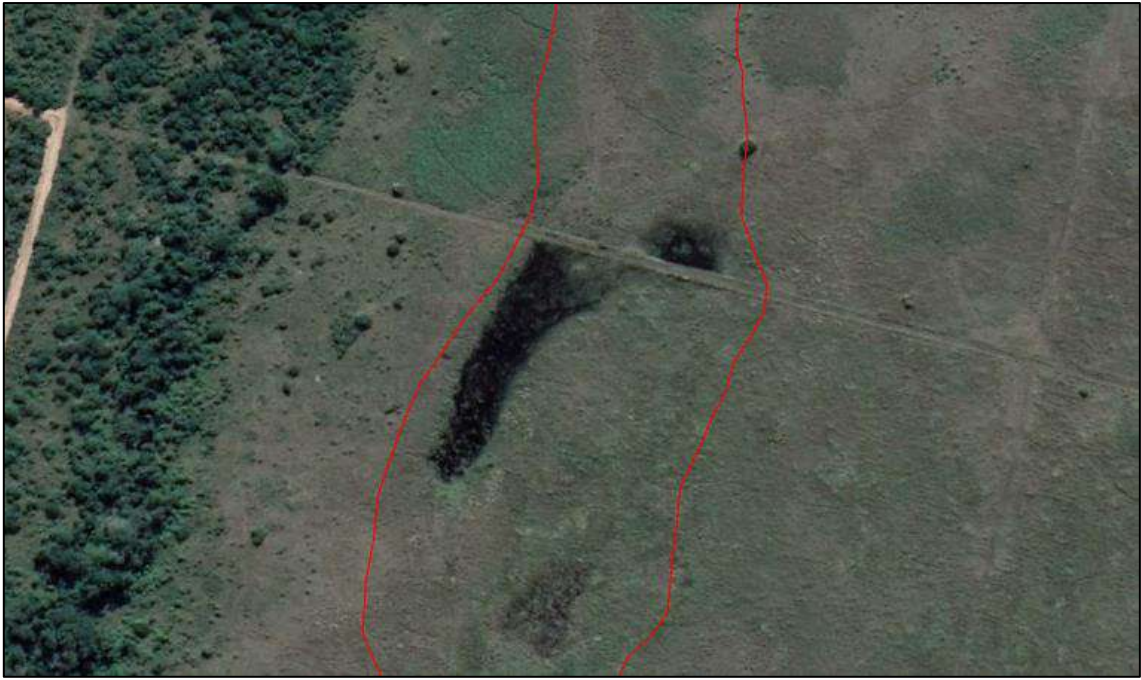
Figure 1.12 - 2017 Google Earth satellite imagery showing disruptions to hydrological flows in wetland during wet season.

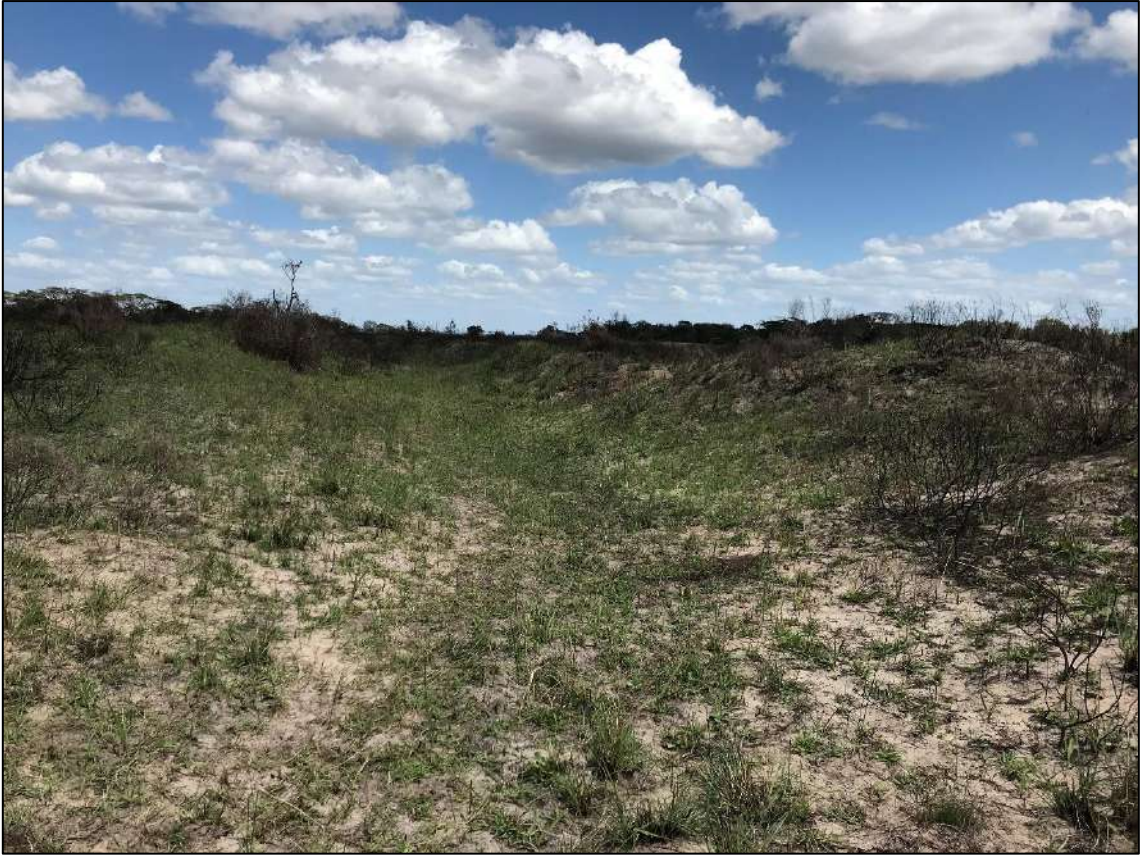
Figure 1.17 Photographic evidence of the excavated drain and the spoil deposits running along either side of the drain.
