# WORKING FOR WETLANDS REHABILITATION PROGRAMME, EASTERN CAPE

## REHABILITATION PLAN PROJECT: AMATHOLE S32E

**REHABILITATION PLAN FOR THE AMATHOLE WETLAND PROJECT,  
EASTERN CAPE: PLANNING YEAR 2018/2019  
AS PART OF  
THE WORKING FOR WETLANDS PROGRAMME  
FOR THE  
DEPARTMENT OF ENVIRONMENTAL AFFAIRS  
DIRECTORATE: WORKING FOR WETLANDS**

**MAIN REPORT  
June 2019**

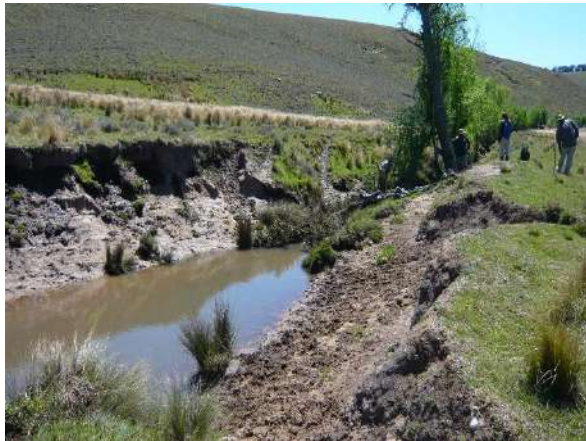
Damage to the banks of the main channel caused by livestock crossing.

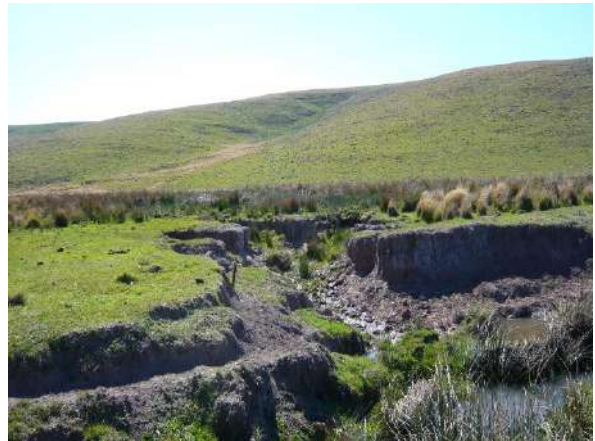
One of the unstable entry points where water from a seep enters the main channel

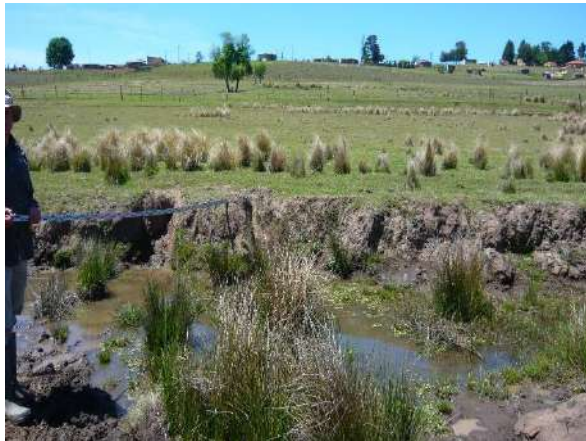
One of the drains that will be deactivated in the channel that has avulsed.

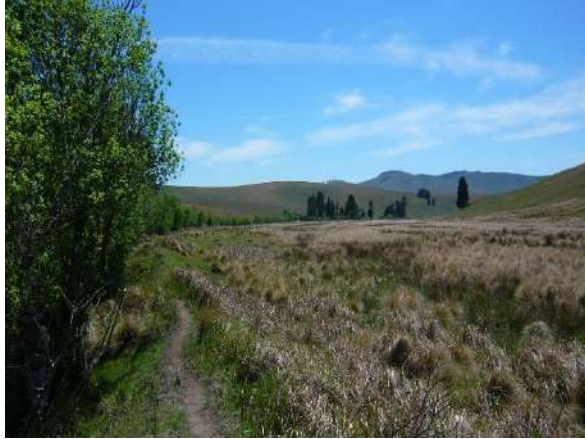
View up the wetland system from the banks of the main channel. The alien trees along the channel and the berm running adjacent to the channel are notable

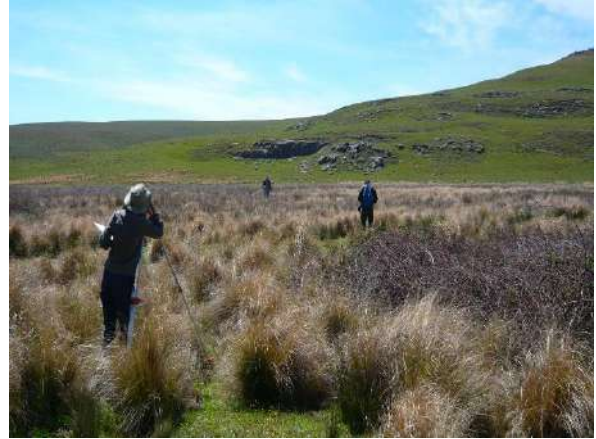
View across the upper reaches of the HGM unit where deactivation of ridges and furrows is planned. Patches of brambles are evident

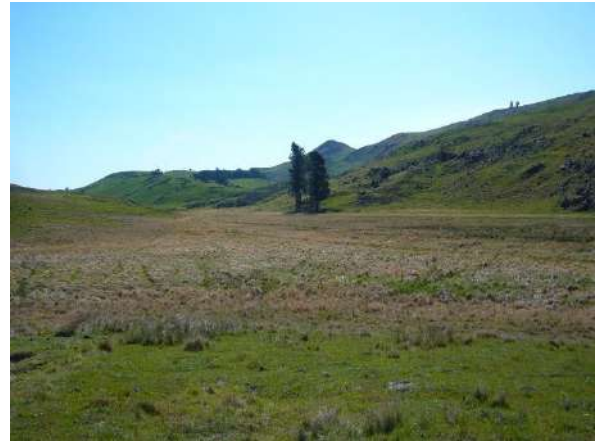
View up the wetland system. The main drain runs along the base of the slope to the right in the photo.

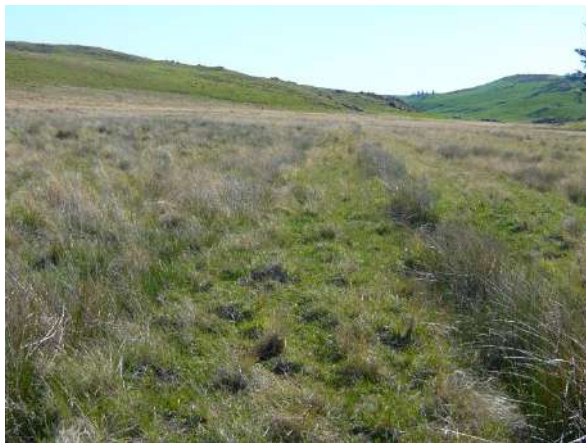
Ridge and furrow to be evened out by cutting and filling

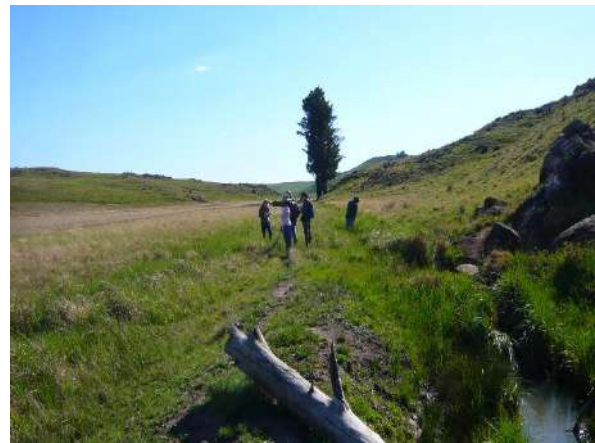
The main drain in the system that will be deactivated. The berm adjacent to the channel will be removed where necessary

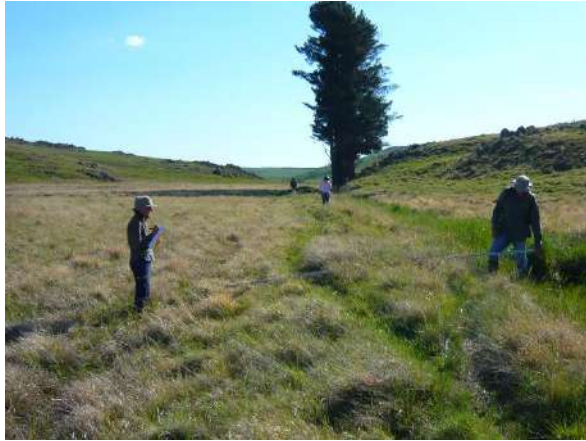
A diversion structure is planned at this point to help divert water out of the main channel and promote a more diffuse flow

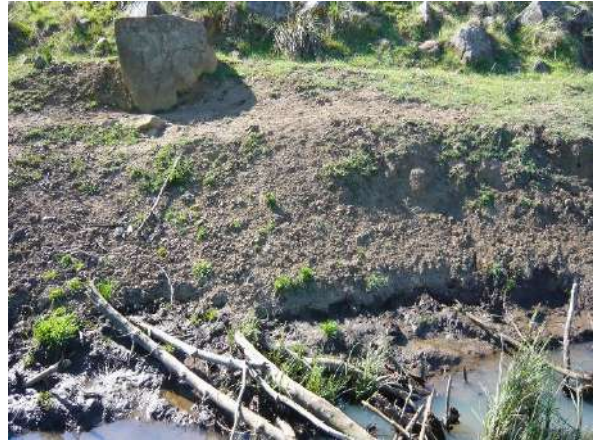
Livestock in the wetland have resulted in some damage to the channel banks and have also trampled paths through the wetland

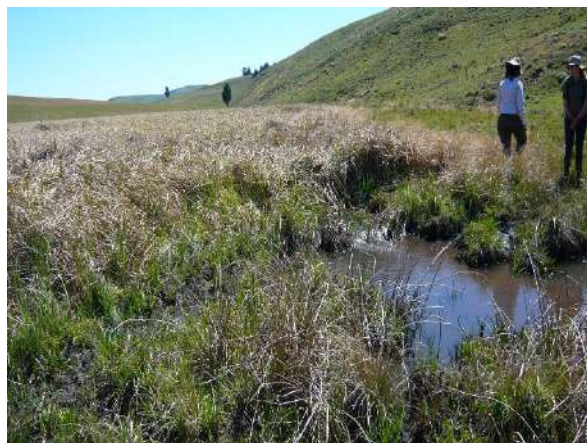
One of the active small headcuts to be stabilised. Livestock have also created a path (visible lower left in photo) leading to trampling damage

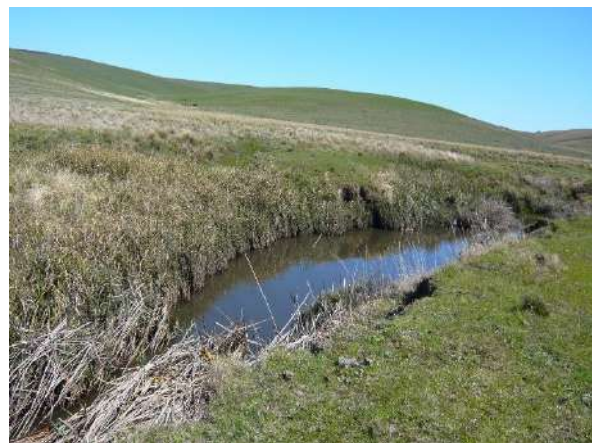
The main channel towards the lower reaches of the wetland where a drop inlet weir is proposed

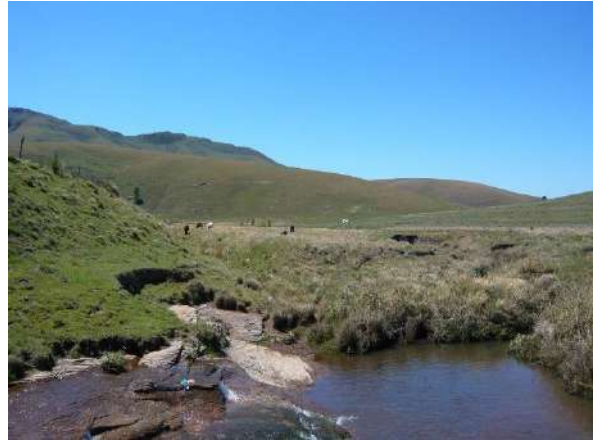
View down the lower reaches of the wetland towards Kolomane 16. Erosion of the channel at this point has taken place down to bedrock

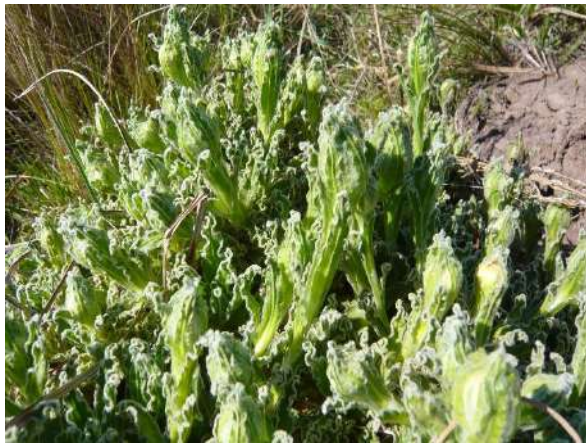
*Helichrysum* sp that is present in the very over-grazed areas just above the wetland at the base of the system. It's presence suggests that livestock management practices are needed

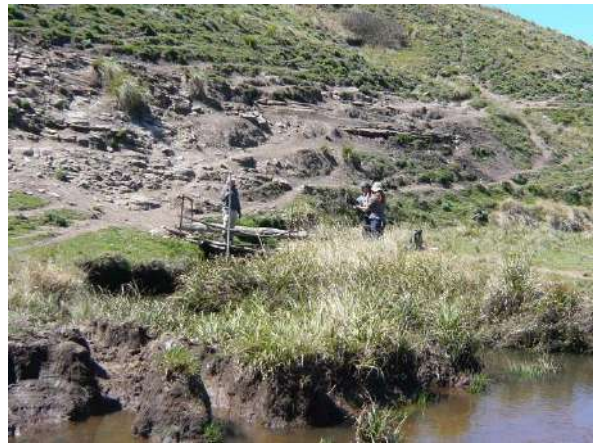
One of the cattle crossing places and the informal "bridge" that will be replaced by formal structures for both livestock and pedestrians

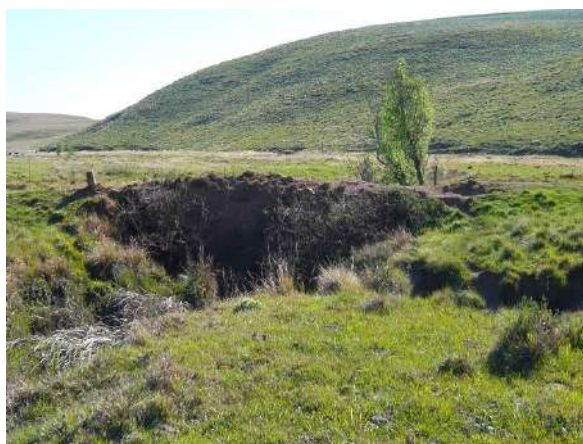
View from the toe of the wetland looking upstream across the gravel road and towards Kolomane 5. The eroded area is at the discharge point of the culverts that run under the road

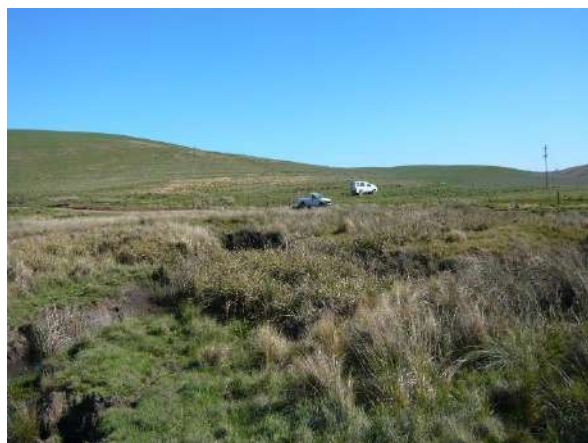
Looking across part of the toe of the wetland towards one of the headcut features to be stabilised (visible below the vehicles in the photograph)

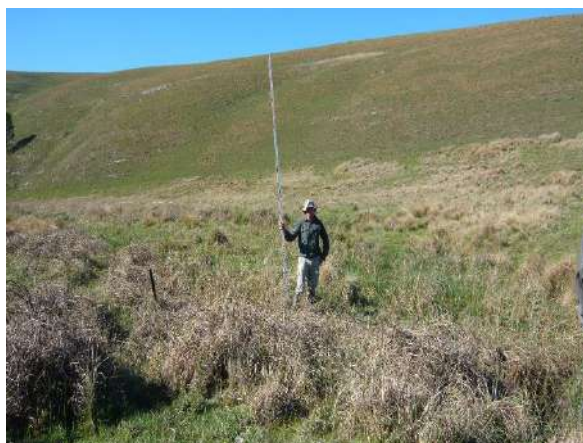
Location of weir in channel. Patches of bramble are evident to the forefront of the photo

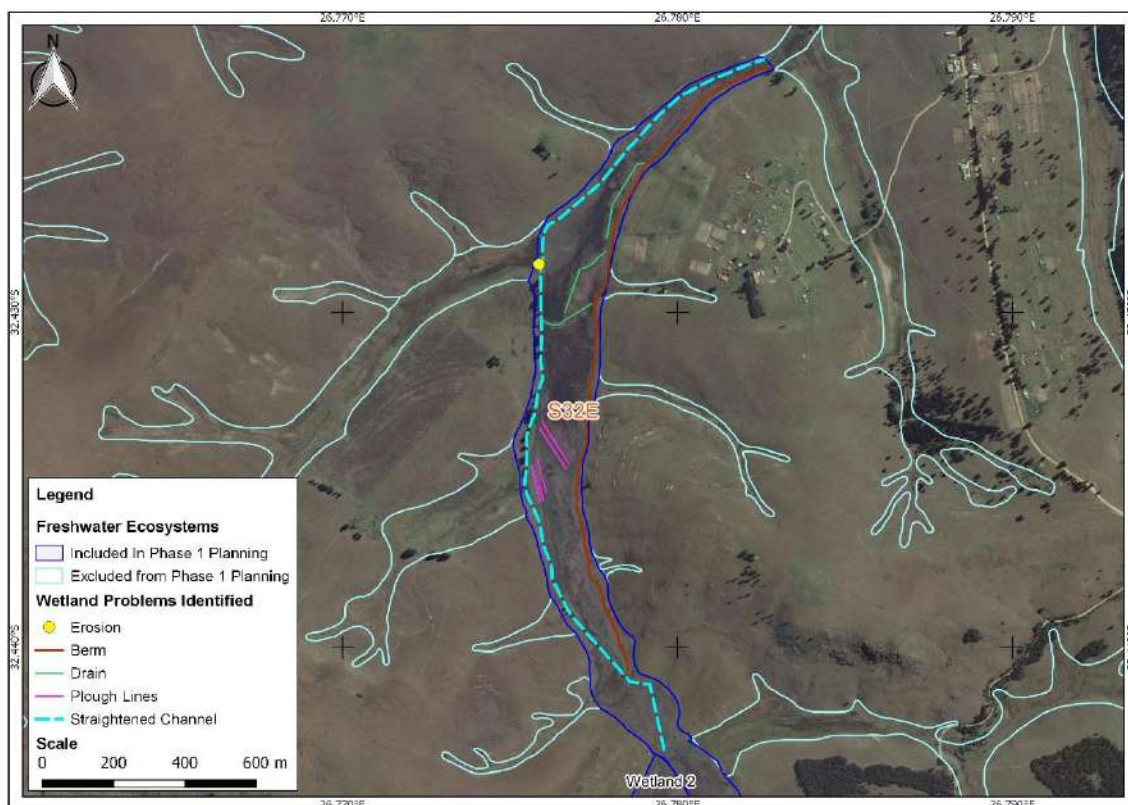
Figure 4.3 Overview of Wetland 1 and the location of the channel and drain

It should be noted that the middle to lower portion of Wetland 1 was earmarked for rehabilitation only, since the upper reaches appeared to be fairly intact. The HGM unit was, therefore, defined at where the excavated channel and berm began and ended.

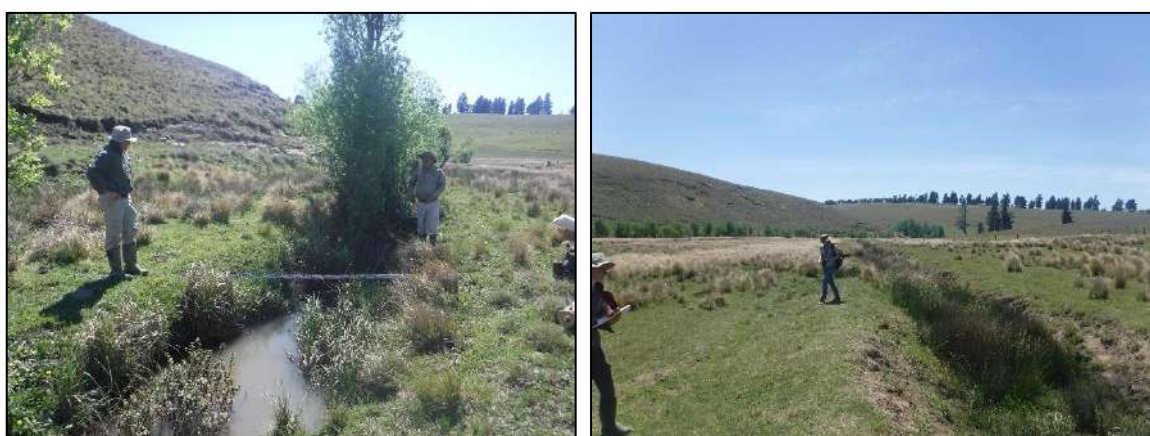
Figure 4.4 Straightened channel colonised by alien invasive tree species (left), and large berm running down the right-hand side of the wetland (right)

Wetland 1 is a large valley-bottom wetland system, fed by valley-bottom and hillslope seepage wetlands (**Figure 4.3**). Historically, it was assumed that the system functioned as a weakly channelled valley-bottom, with very diffuse flows moving through the system and supporting wetland habitat by permanent wetness regimes. However, as the land was transformed from natural to cultivation, the functioning of the system changed fundamentally. A channel was excavated along the left bank of the wetland (looking downstream), which led to the desiccation of the mid-section of the wetland as the channel served to draw down the water table of the wetland. Alien invasive tree and shrub species have colonised a large section of the channel. In addition, a cut-off berm and drain was excavated along the right-hand bank of the wetland, preventing the seepage from the adjacent banks from entering the main valley bottom. Cut-off drains, berms and plough lines were identified running through portions of the wetland, altering the functioning of the system substantially. Despite the attempts at draining the wetland, the wetland comprised a mosaic of seasonal to permanent wetness zones within the middle to lower reaches of the system, with drier more desiccated areas towards the middle reaches of the wetland. Impacts associated with channel straightening, cut-off drains, berms and unstable re-entry points motivated for further detailed planning associated with the Phase 2 component of the study.

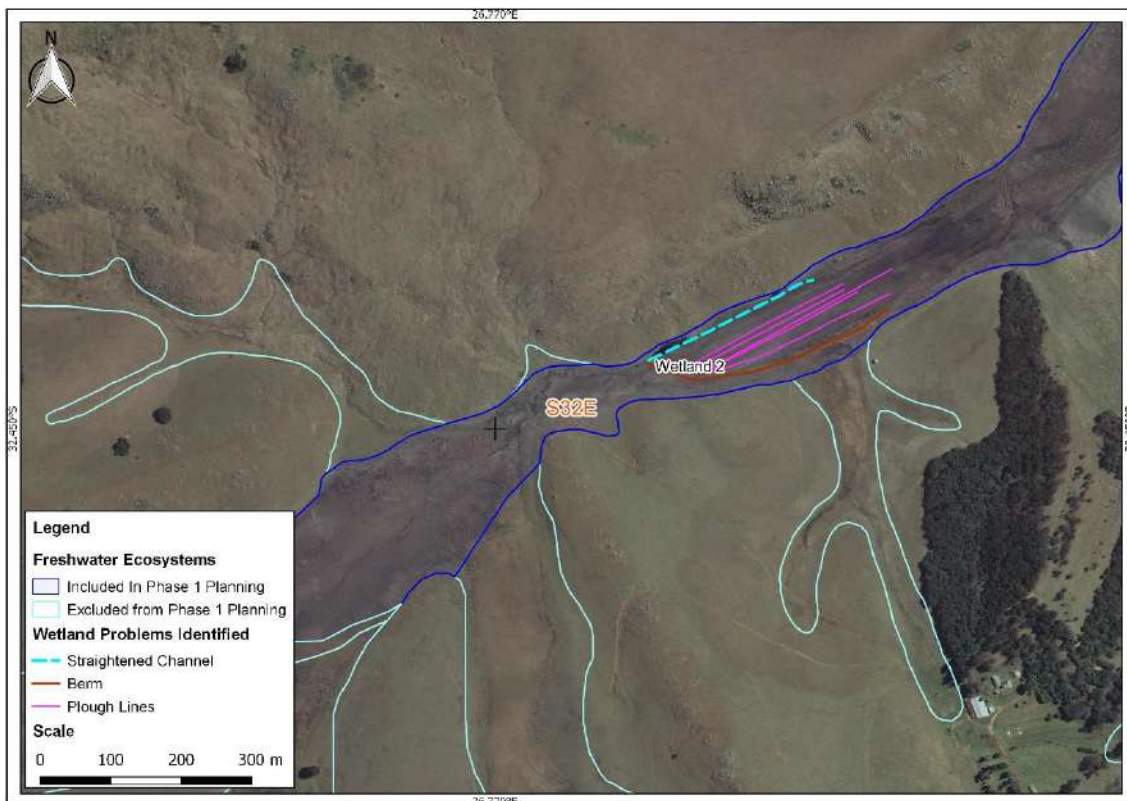
Figure 4.5 Overview of Wetland 2 indicating the location of the wetland problems

*Arundinella nepalensis*, *Eragrostis plana*, were the main vegetation types identified within the system. As with the case of Wetland 1, Wetland 2 extends further upstream than what the HGM unit has been defined as, since the area of focus for this study was the middle to lower reaches of the system. Signs of livestock grazing were noted within the system, and, should it be an option, better grazing management systems should be employed into these systems to ensure sustainable land use. Tributaries associated with Wetland 2 were visited during the Phase 1 fieldwork, however, issues associated with land owner permission and site access were of a concern. As such, these features were flagged infield during Phase 1, but were excluded from the Phase 2 planning.

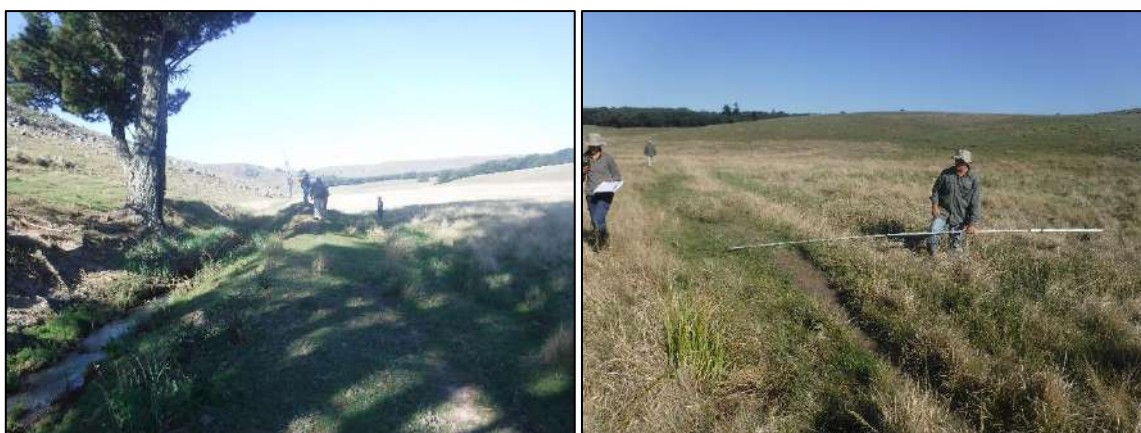
Figure 4.6 The straightened channel running down the left-hand bank of the wetland (left), and a berm limiting diffuse flows through the wetland (right)

Wetland 2 is a weakly channelled valley-bottom wetland, which drains into the larger Wetland 1 system. The system is roughly 39ha in extent and is fed by a number of hillslope seepage wetland systems (**Figure 4.5**). It is anticipated that Wetland 2 was historically characterised by permanent and seasonally wet conditions, with diffuse flows moving through majority of the system. However, as a result of historical cultivation practises, the hydrology of the system has been largely altered. A combination of berms, drains, plough lines and stream channel modifications has led to the desiccation of portions of the HGM unit, making the system much drier than what the system would have been under natural conditions (**Figure 4.6**). Due to the changes in the natural hydrology of the system, disturbance tolerant vegetation such as

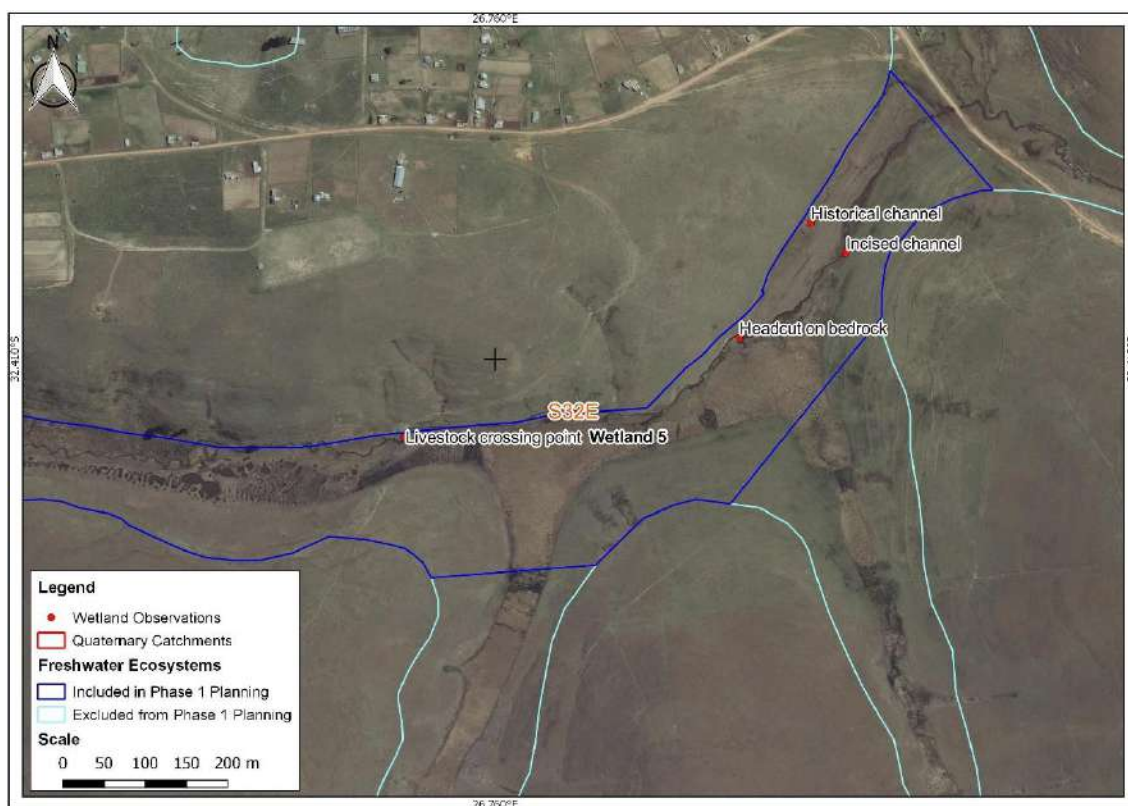
Figure 4.7 Overview of Wetland 5 and some observation points

Upstream of the livestock crossing the system was noted to be in a stable condition and no signs of erosion or rehabilitation potential was noted during the desktop and infield assessment. As such, rehabilitation potential was focussed mainly on the lower to middle reaches of the system.

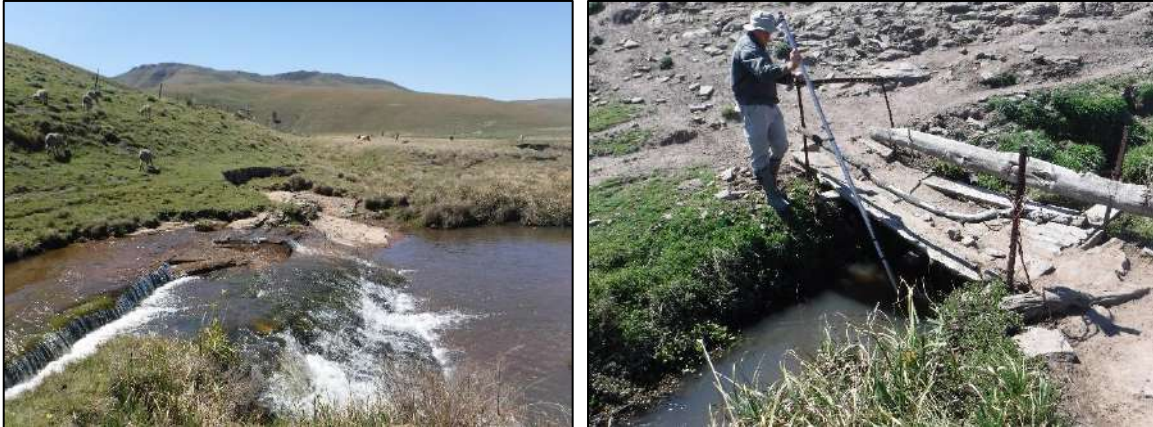
**Figure 4.8 The headcut erosion on bedrock (left), and the livestock stream crossing that requires attention (right)**

Wetland 5 is a channelled valley-bottom wetland, however it may have been less channelled historically before anthropogenic changes to the system took place (**Figure 4.7**). The movement of water is largely through a channel, which flows along the left bank of the wetland, moving across to the right-hand bank closer to the toe of the wetland before it is directed underneath an existing road. Remnants of the natural channel are clearly visible along the left-hand bank of the wetland towards the toe of the system. However, the lower-most section of the channel has since avulsed and flows through an incised channel to the right of the historical channel. This portion of the *new* channel is fairly incised, and some of the channel banks are eroding. A headcut is located just above where the channel avulsion has occurred, however the headcut has eroded to bedrock, limiting any threats of continued erosion and scour in that portion of the channel. Multiple unstable re-entry points were identified along the *new* channel, which may pose a threat to the wetland habitat upstream of these erosion features and should, therefore be secured to avoid the loss of wetland habitat. An informal sheep crossing was noted upstream of the headcut that should be stabilised to ensure that the crossing can be used safely by sheep and/or goats and the herdsman, especially during times of high flood waters through the system (**Figure 4.8**).

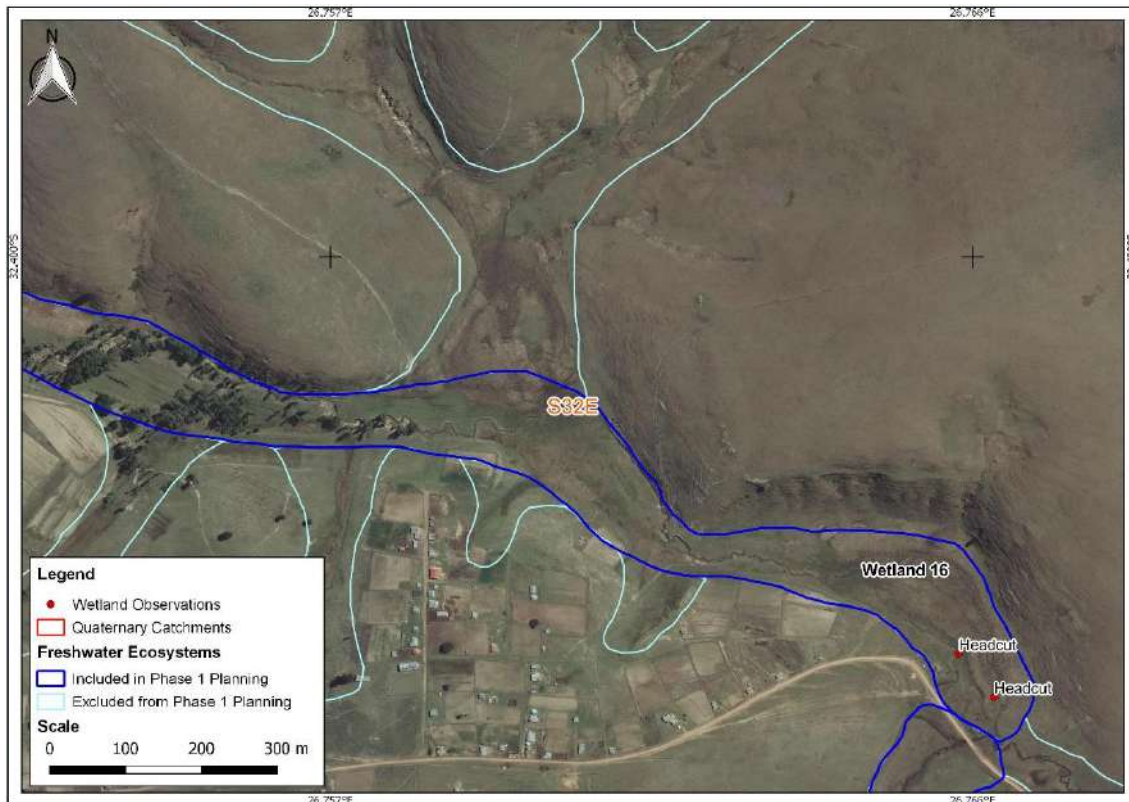
Figure 4.9 Overview of Wetland 16 and some observation points

Wetland 16 is a fairly large channelled valley-bottom system, which has been affected by historical cultivation practises which have negatively altered the functioning and integrity of the system. The HGM unit has been defined from the confluence of this wetland and Wetland 5 up to where the gradient change was noted. A number of hillslope seeps feed into the HGM unit, as well as lateral flows from the upstream valley-bottom system. The HGM unit is characterised by a fairly incised channel, which moves through the upper to middle portion of the wetland and dissipates towards the toe of the wetland. The upper reaches have sections of actively farmed portions, with drains and cultivated vegetation and alien invasive vegetation species. Since this wetland largely falls out of the permitted land access, only the toe of the wetland was considered, so as not to encroach further onto a site where no permissions had previously been arranged. The toe of the wetland had multiple headcuts and active erosion. These areas were prioritised for rehabilitation to stabilise the localised erosion before it led to further loss of wetland habitat further upstream.

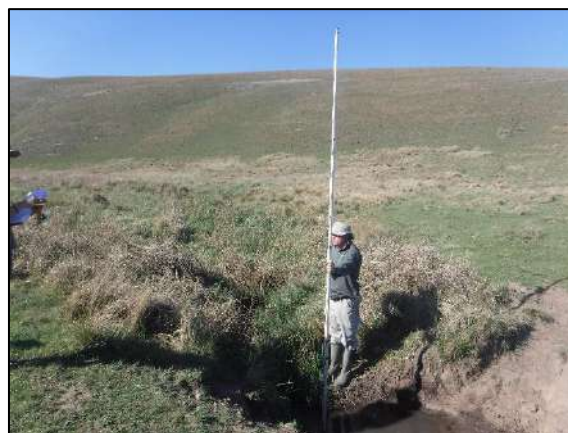
Figure 4.10 The headcut erosion identified at the toe of Wetland 16

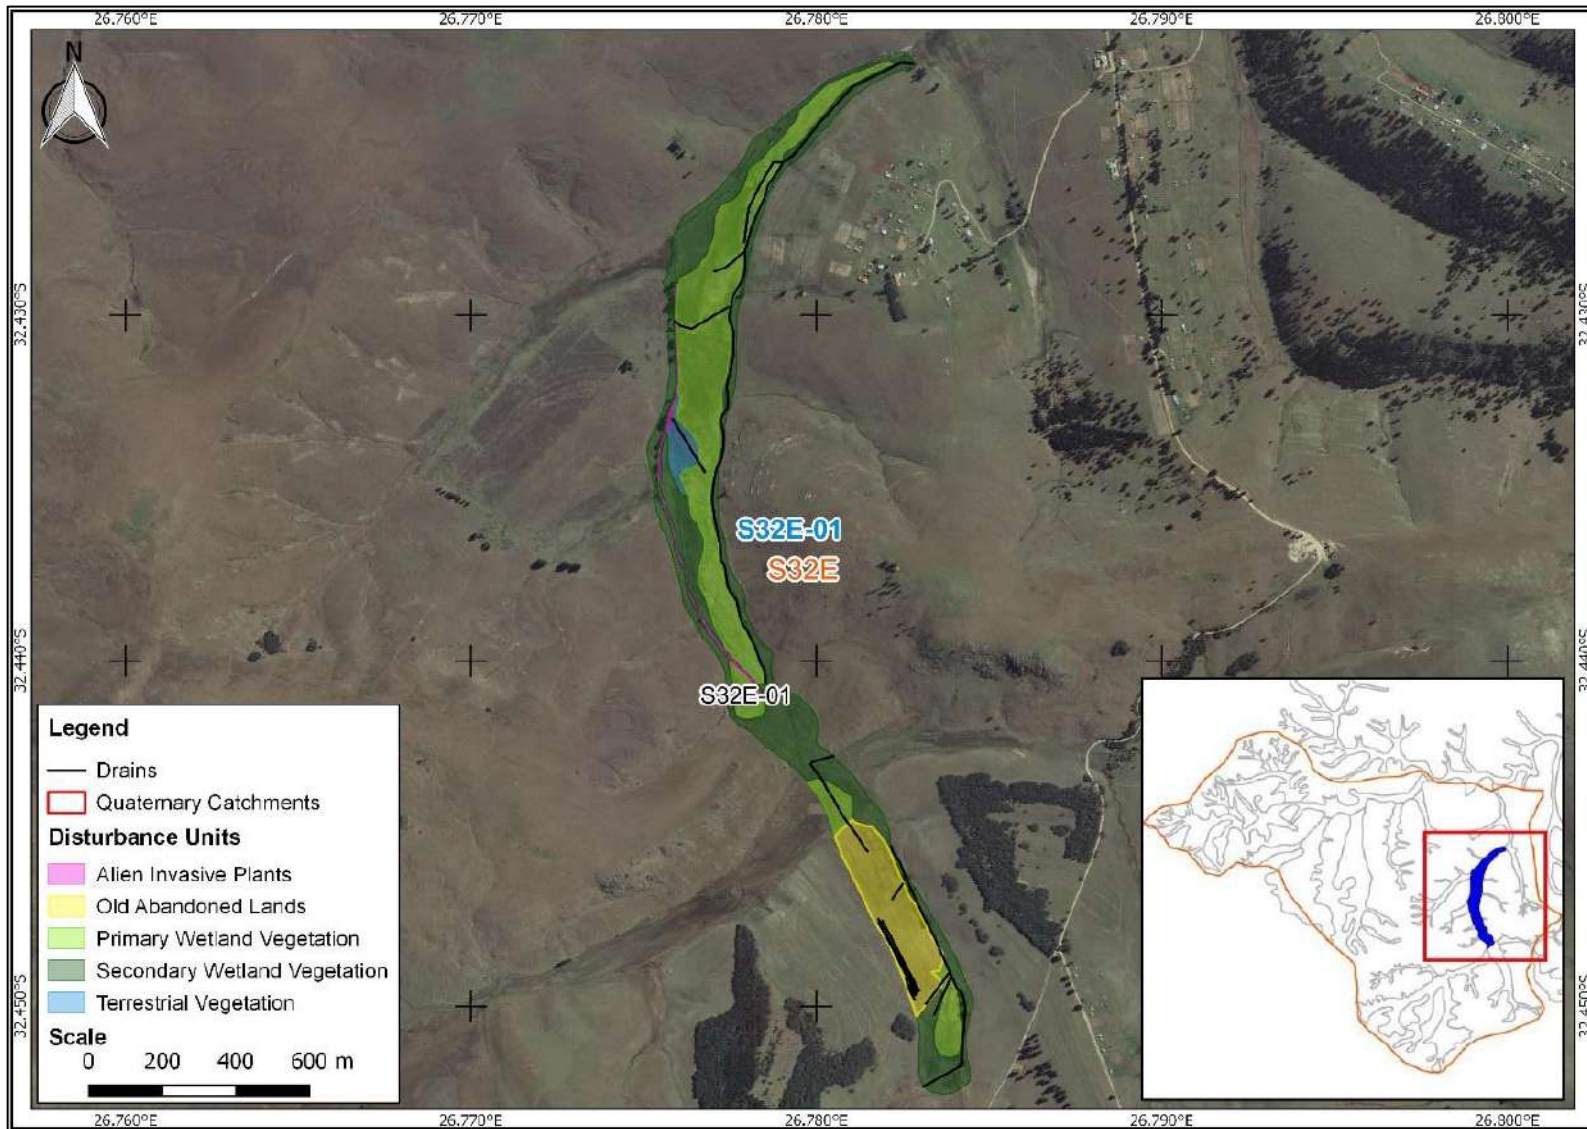
Figure 4.2 Current wetland impacts for wetlands S32E-01

The wetland appeared to be in a fairly stable condition, despite the impacts of the berms, drains, channel modifications, alien invasive vegetation encroachment and slightly unstable re-entry points. As such, the rehabilitation of this system is anticipated to be greatly beneficial in improving the overall functioning and integrity of the system.

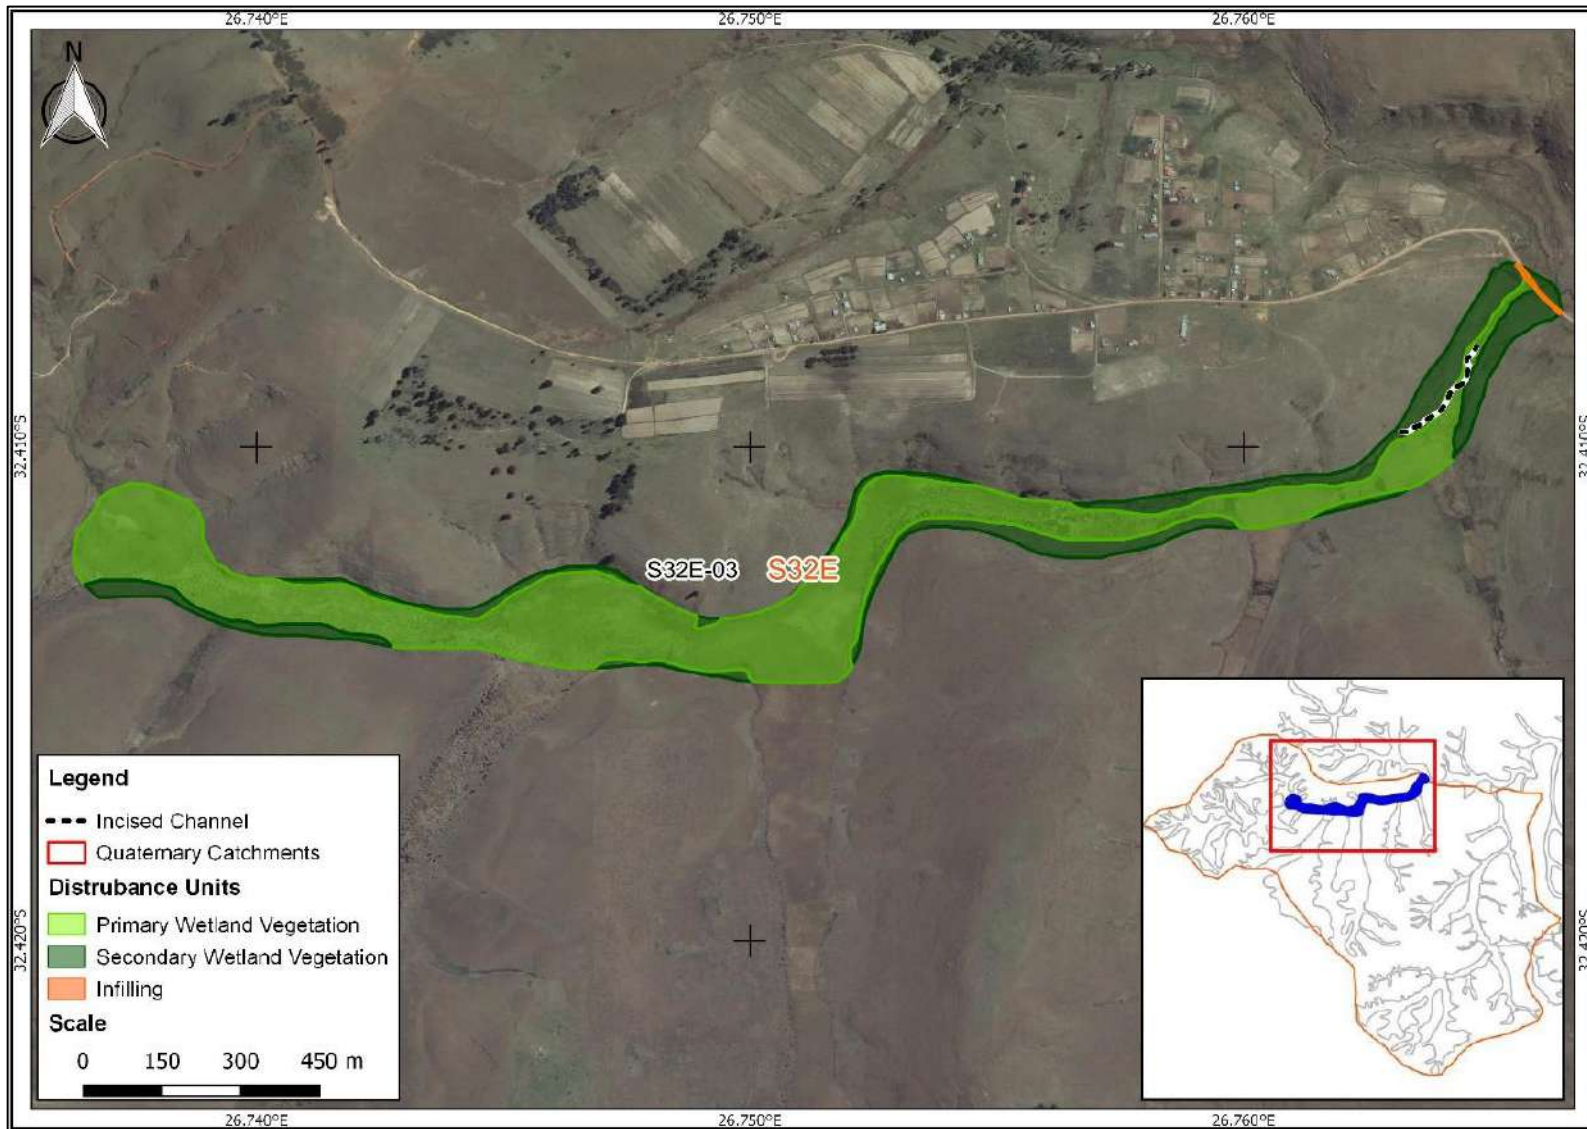
Figure 4.4 Current wetland impacts for wetland S32E-03

The movement and presence of livestock within the wetland has led to a slight degradation of wetland features, such as trampling of wetland vegetation and informal stream crossings, however over-grazing of the vegetation within the wetland was not identified as a serious concern at this point in time. A semi-formal livestock crossing was noted towards the middle to upper reaches of the HGM unit. A community member had raised this crossing as fairly dangerous and unstable, especially during high rainfall events, posing a threat to both the community and their livestock. As such opportunities to upgrade the stream crossing was included in the Phase 2 planning.

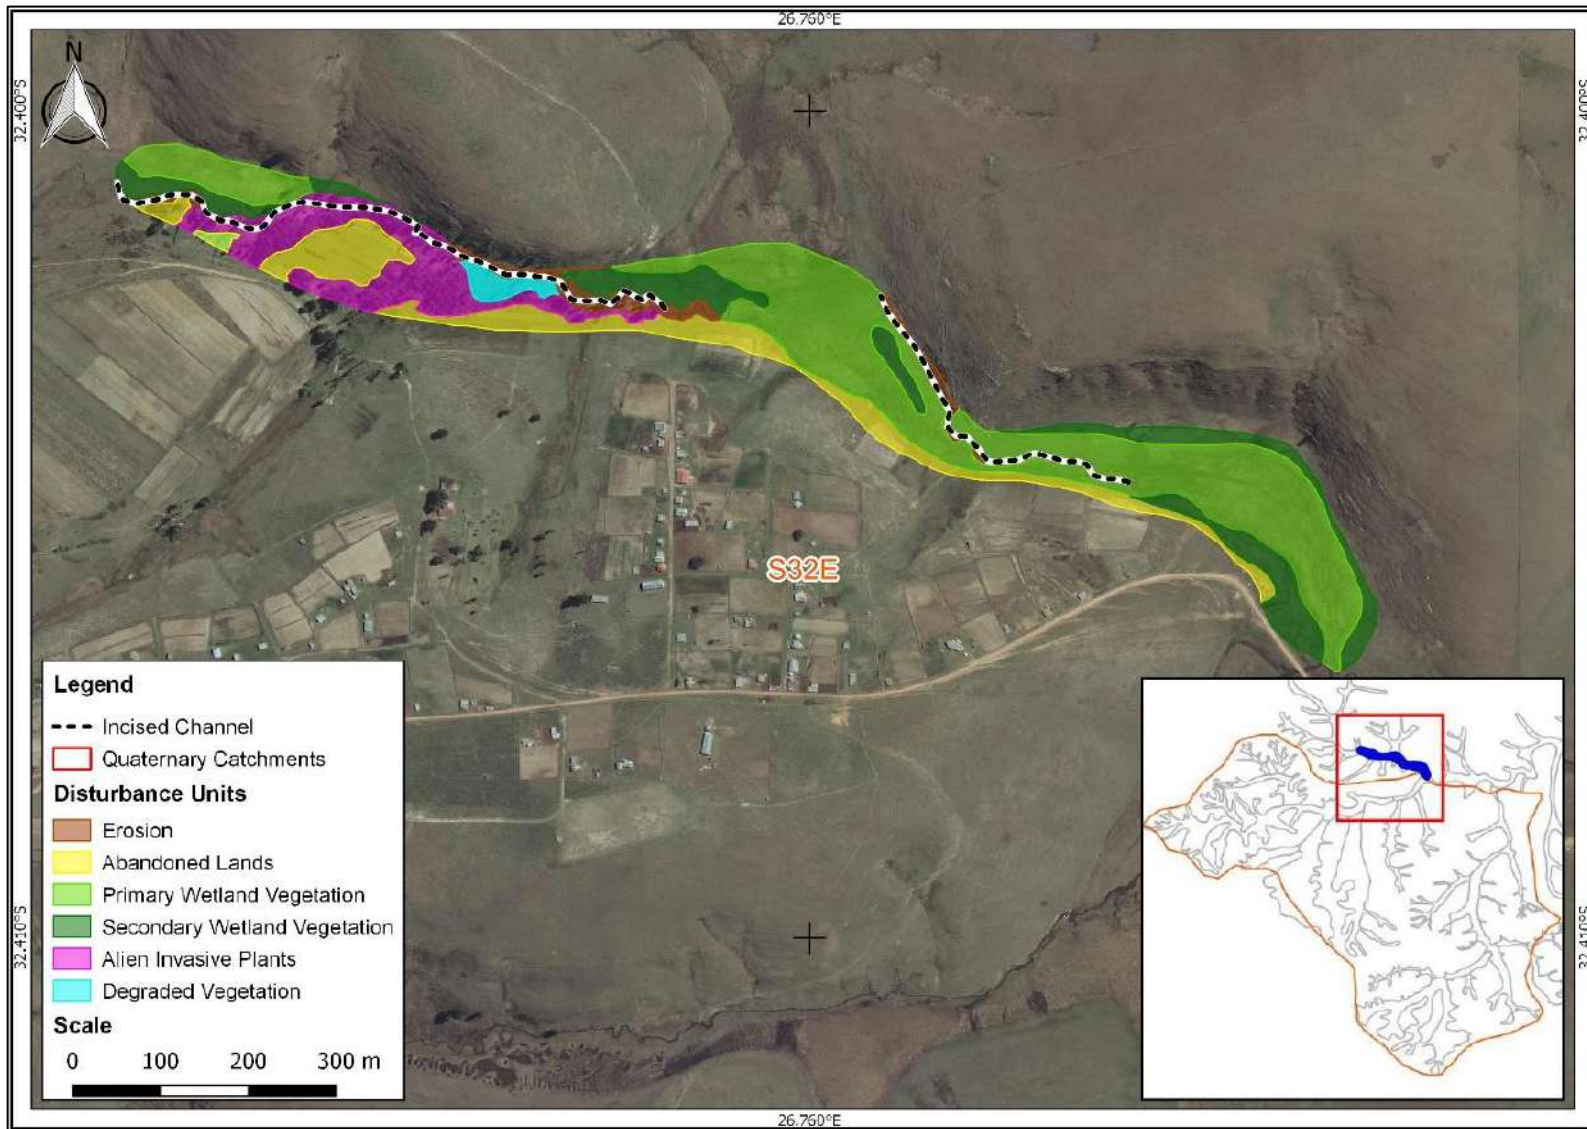
Figure 4.5 Current wetland impacts for wetland S32E-04

The movement and presence of livestock within the wetland, such as trampling of wetland vegetation, were evident within the HGM unit, however over-grazing of the vegetation did not look to be a major issue, especially within the lower reaches of the system.

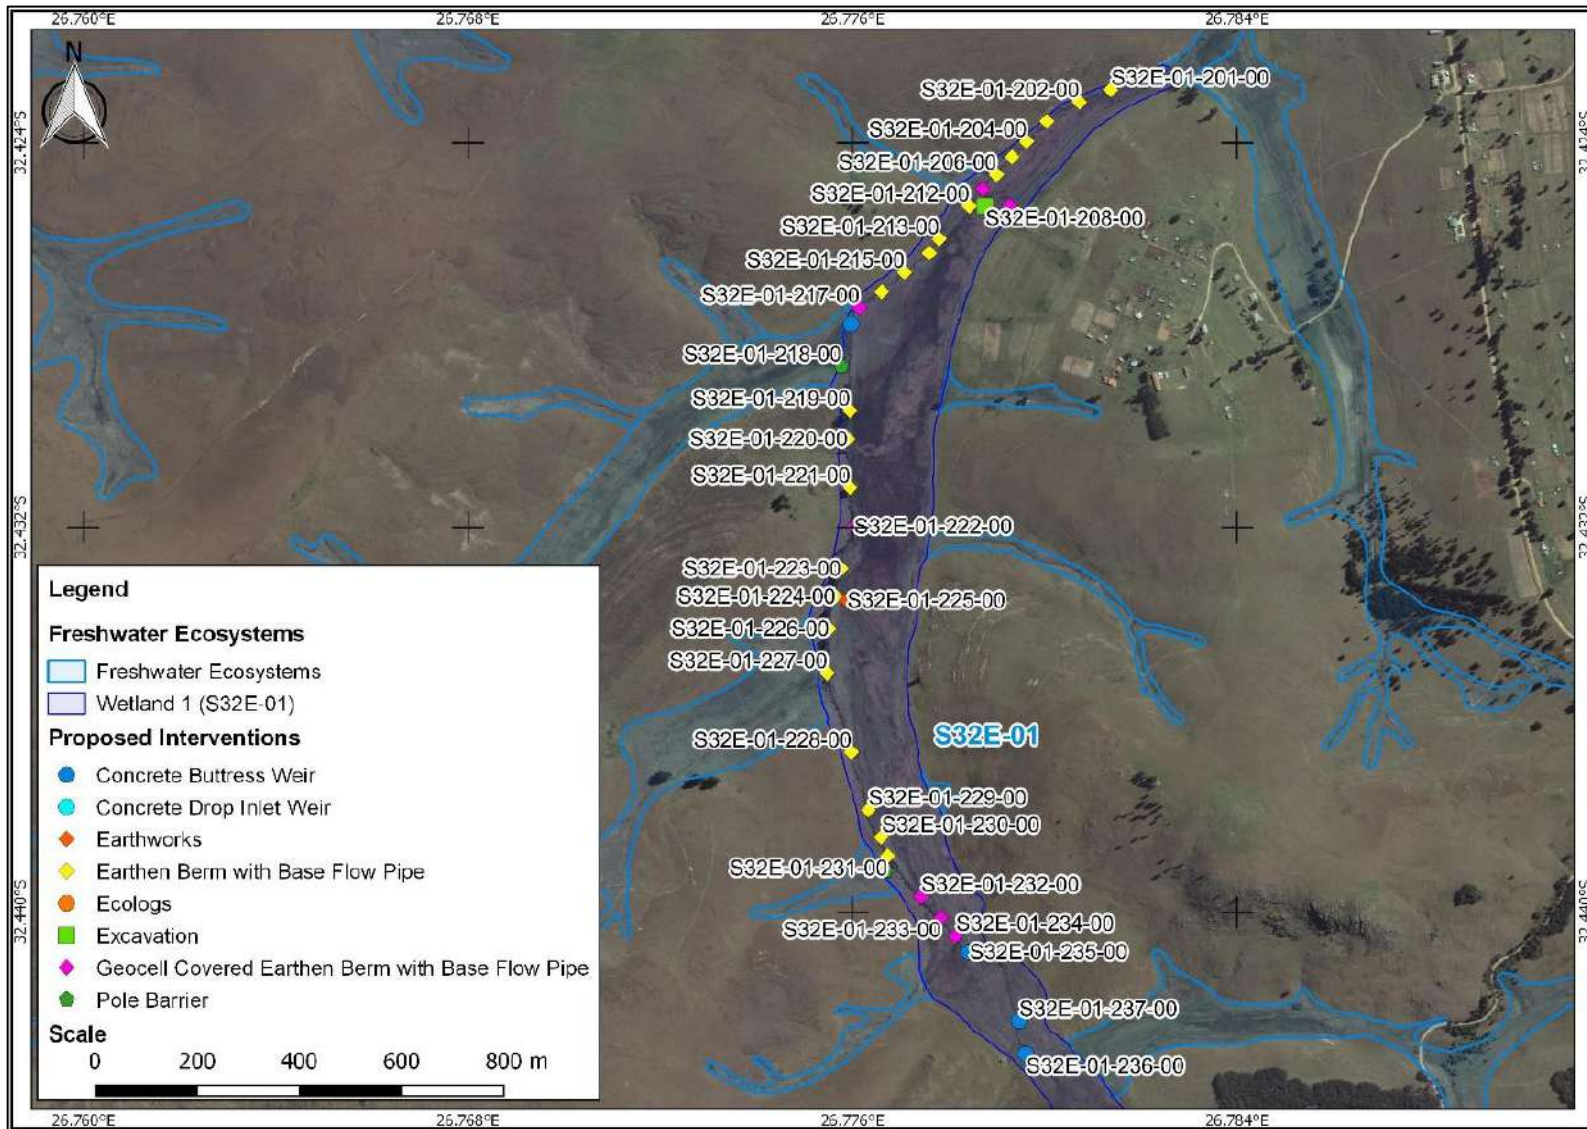
Figure 6.1 S32E-01 wetland rehabilitation strategy

The identified berm that runs in parallel to the channel along the right-hand bank will be deactivated through the implementation of a cut-and-fill activity, levelling out the berm to be aligned with the natural ground level. This will allow for a more diffuse movement of water through the main valley line and also allow seepage from the adjacent slopes and wetlands to link into the valley-bottom. Plough lines that were noted within the valley-bottom will also be deactivated and levelled to encourage more of a diffuse movement of water across a larger section of the HGM unit. It should be noted that some of the remnant drains within the system have not been specified in the rehabilitation, since it was noted that they are having a limited effect on the hydrology of the system; either since they have been deactivated or the natural water table is fairly close to the surface, and diffuse movement of water through the system has still been achieved (**Figure 6.1** and **Table 6.1**). Through the implementation of these initiatives it is anticipated that the integrity and functioning of the system will significantly improve.

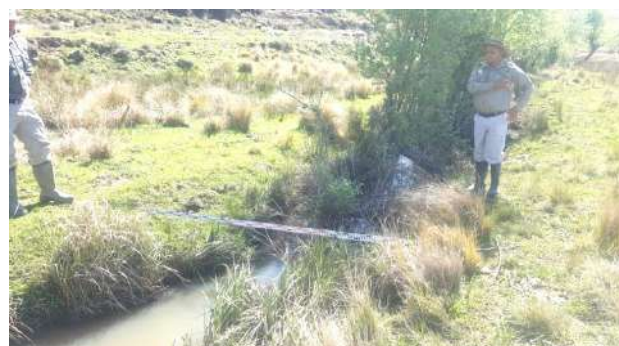
**Location Photograph: S32E-01-201-00**

<b>Intervention</b>	S32E-01-201-00
<b>Designer</b>	T. Pike
<b>Design Date</b>	01 February 2019
<b>Type</b>	New
<b>Description</b>	Earthen berm with base flow pipe
<b>Rehabilitation Objectives</b>	To raise water levels within the channel to flood adjacent wetland, while still maintaining base flow through the channel.
<b>Latitude (D°M'S")</b>	32°25'22.41"S
<b>Longitude (D°M'S")</b>	26°46'52.95"E

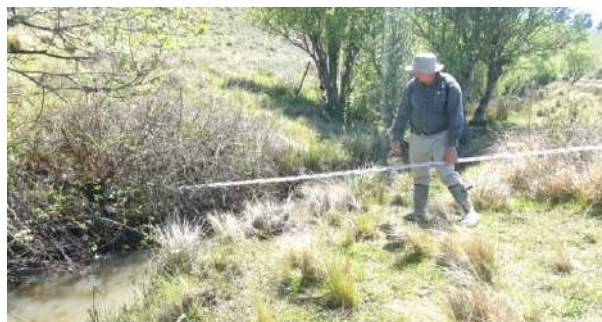
**Location Photograph: S32E-01-202-00**

<b>Intervention</b>	S32E-01-202-00
<b>Designer</b>	T. Pike
<b>Design Date</b>	01 February 2019
<b>Type</b>	New
<b>Description</b>	Earthen berm with base flow pipe
<b>Rehabilitation Objectives</b>	To raise water levels within the channel to flood adjacent wetland, while still maintaining base flow through the channel.
<b>Latitude (D°M'S")</b>	32°25'23.33"S
<b>Longitude (D°M'S")</b>	26°46'50.59"E

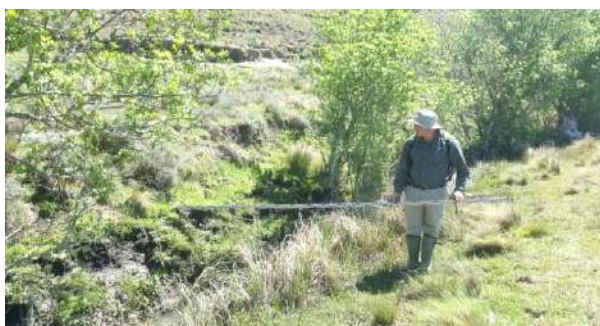
**Location Photograph: S32E-01-203-00**

<b>Intervention</b>	S32E-01-203-00
<b>Designer</b>	T. Pike
<b>Design Date</b>	01 February 2019
<b>Type</b>	New
<b>Description</b>	Earthen berm with base flow pipe and skimming of berm
<b>Rehabilitation Objectives</b>	To raise water levels within the channel to flood adjacent wetland, while still maintaining base flow through the channel. Skimming of berm to allow water to flood to wetland level.
<b>Latitude (D°M'S")</b>	32°25'24.78"S
<b>Longitude (D°M'S")</b>	26°46'48.16"E

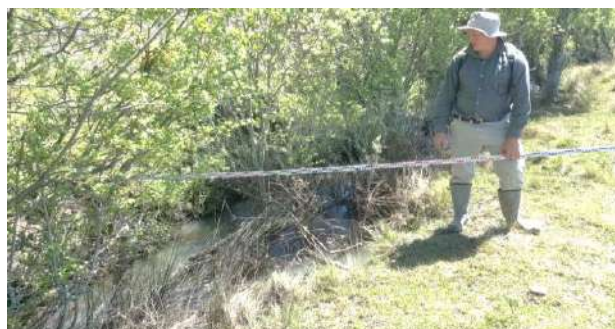
**Location Photograph: S32E-01-204-00**

<b>Intervention</b>	S32E-01-204-00
<b>Designer</b>	T. Pike
<b>Design Date</b>	01 February 2019
<b>Type</b>	New
<b>Description</b>	Earthen berm with base flow pipe
<b>Rehabilitation Objectives</b>	To raise water levels within the channel to flood adjacent wetland, while still maintaining base flow through the channel.
<b>Latitude (D°M'S")</b>	32°25'26.29"S
<b>Longitude (D°M'S")</b>	26°46'46.64"E

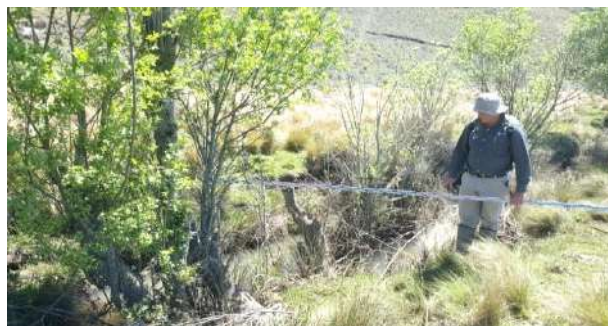
**Details****Location Photograph: S32E-01-205-00**

<b>Intervention</b>	S32E-01-205-00
<b>Designer</b>	T. Pike
<b>Design Date</b>	01 February 2019
<b>Type</b>	New
<b>Description</b>	Earthen berm with base flow pipe
<b>Rehabilitation Objectives</b>	To raise water levels within the channel to flood adjacent wetland, while still maintaining base flow through the channel.
<b>Latitude (D°M'S")</b>	32°25'27.45"S
<b>Longitude (D°M'S")</b>	26°46'45.55"E

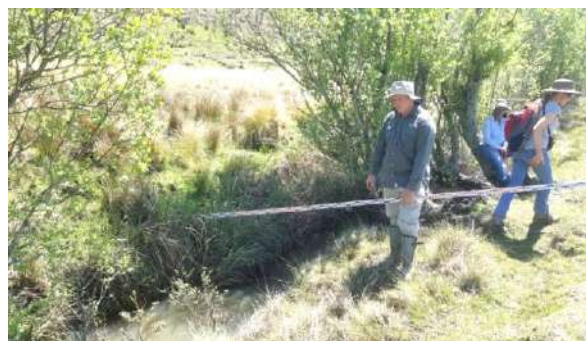
**Details****Location Photograph: S32E-01-206-00**

<b>Intervention</b>	S32E-01-206-00
<b>Designer</b>	T. Pike
<b>Design Date</b>	01 February 2019
<b>Type</b>	New
<b>Description</b>	Earthen berm with base flow pipe and skimming of berm
<b>Rehabilitation Objectives</b>	To raise water levels within the channel to flood adjacent wetland, while still maintaining base flow through the channel. Skimming of berm to allow water to flood to wetland level.
<b>Latitude (D°M'S")</b>	32°25'28.76"S
<b>Longitude (D°M'S")</b>	26°46'44.38"E
