# WORKING FOR WETLANDS REHABILITATION PROGRAMME, EASTERN CAPE

## REHABILITATION PLAN PROJECT: AMATHOLE S32E

**REHABILITATION PLAN FOR THE AMATHOLE WETLAND PROJECT,  
EASTERN CAPE: PLANNING YEAR 2018/2019  
AS PART OF  
THE WORKING FOR WETLANDS PROGRAMME  
FOR THE  
DEPARTMENT OF ENVIRONMENTAL AFFAIRS  
DIRECTORATE: WORKING FOR WETLANDS**

**MAIN REPORT  
June 2019**

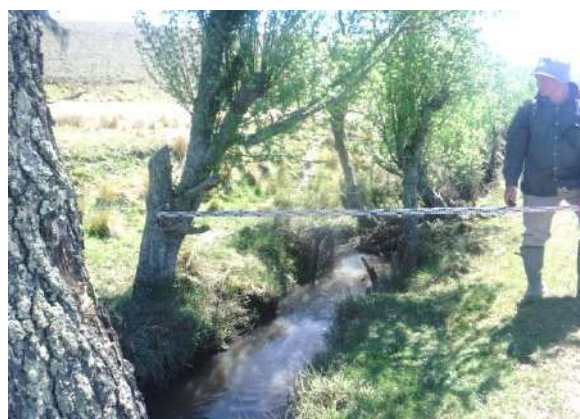
**Location Photograph: S32E-01-207-00**

<b>Intervention</b>	S32E-01-207-00
<b>Designer</b>	T. Pike
<b>Design Date</b>	01 February 2019
<b>Type</b>	New
<b>Description</b>	Earthen berm with a geocell covered crest (3m wide) with base flow pipe and skimming of berm. TriAx for cattle
<b>Rehabilitation Objectives</b>	To raise water levels within the channel to flood adjacent wetland, while still maintaining base flow through the channel. Skimming of berm to allow water to flood to wetland level. Geocell covered berm is to allow cattle to cross the channel and the TriAx to prevent the cattle damaging the wetland.
<b>Latitude (D°M'S")</b>	32°25'29.85"S
<b>Longitude (D°M'S")</b>	26°46'43.37"E

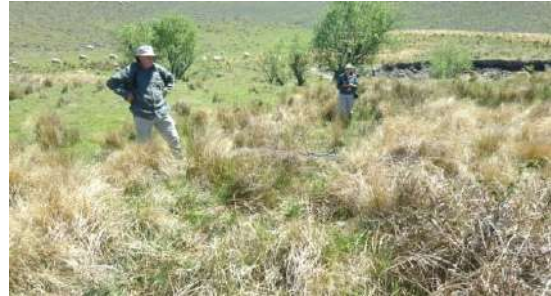
**Location Photograph: S32E-01-208-00**

<b>Intervention</b>	S32E-01-208-00
<b>Designer</b>	T. Pike
<b>Design Date</b>	01 February 2019
<b>Type</b>	New
<b>Description</b>	Excavation of berm and backfilling drain.
<b>Rehabilitation Objectives</b>	To spread flow evenly through wetland and have no preferred flow path.
<b>Latitude (D°M'S")</b>	32°25'31.13"S
<b>Longitude (D°M'S")</b>	26°46'43.53"E

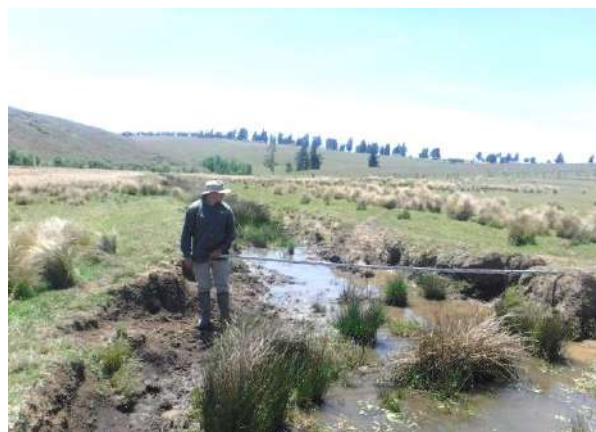
**Location Photograph: S32E-01-209-00**

<b>Intervention</b>	S32E-01-209-00
<b>Designer</b>	T. Pike
<b>Design Date</b>	01 February 2019
<b>Type</b>	New
<b>Description</b>	Slope banks. Geocell covered earthen berm
<b>Rehabilitation Objectives</b>	To deactivate the channel and flood wetland.
<b>Latitude (D°M'S")</b>	32°25'31.07"S
<b>Longitude (D°M'S")</b>	26°46'45.36"E

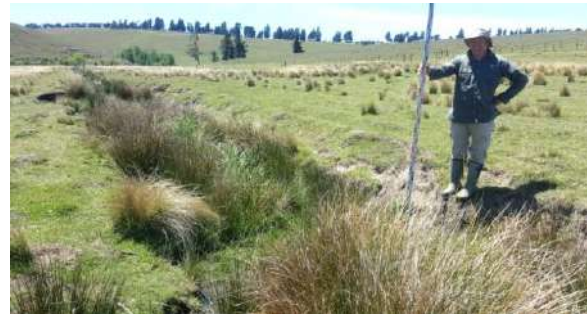
**Location Photograph: S32E-01-210-00**

<b>Intervention</b>	S32E-01-210-00
<b>Designer</b>	T. Pike
<b>Design Date</b>	01 February 2019
<b>Type</b>	New
<b>Description</b>	Slope banks. Construct earthen berm @ every 25m (start of intervention).
<b>Rehabilitation Objectives</b>	To deactivate the channel and flood wetland.
<b>Latitude (D°M'S")</b>	Start: 32°25'30.99"S Start: 32°25'21.85"S
<b>Longitude (D°M'S")</b>	End: 26°46'45.57"E End: 26°46'56.04"E

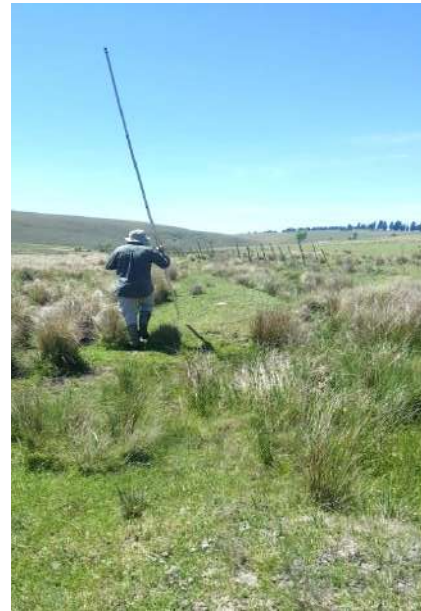
**Location Photograph: S32E-01-211-00**

<b>Intervention</b>	S32E-01-211-00
<b>Designer</b>	T. Pike
<b>Design Date</b>	01 February 2019
<b>Type</b>	New
<b>Description</b>	Excavation of berm and backfilling drain (start of intervention)
<b>Rehabilitation Objectives</b>	To allow for a more diffuse movement of water through wetland.
<b>Latitude (D°M'S")</b>	Start: 32°26'26.72"S
<b>Longitude (D°M'S")</b>	26°46'42.50"E

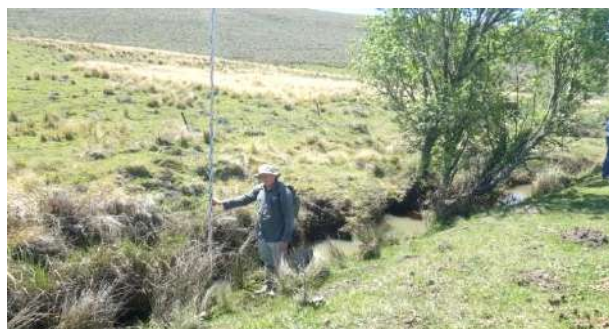
**Location Photograph: S32E-01-212-00**

<b>Intervention</b>	S32E-01-212-00
<b>Designer</b>	T. Pike
<b>Design Date</b>	01 February 2019
<b>Type</b>	New
<b>Description</b>	Earthen berm with base flow pipe
<b>Rehabilitation Objectives</b>	To raise water levels within the channel to flood adjacent wetland, while still maintaining base flow through the channel.
<b>Latitude (D°M'S")</b>	32°25'31.12"S
<b>Longitude (D°M'S")</b>	26°46'42.36"E

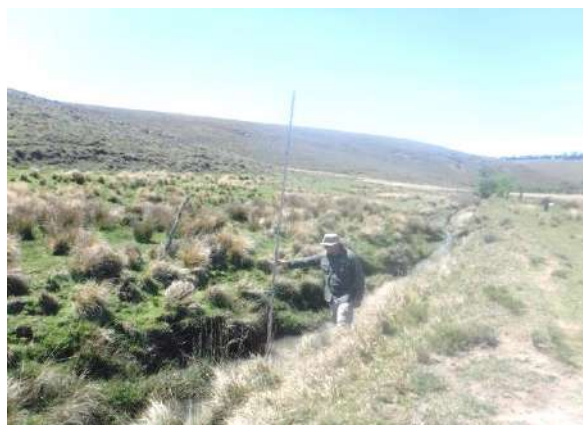
**Location Photograph: S32E-01-213-00**

<b>Intervention</b>	S32E-01-213-00
<b>Designer</b>	T. Pike
<b>Design Date</b>	01 February 2019
<b>Type</b>	New
<b>Description</b>	Earthen berm with base flow pipe
<b>Rehabilitation Objectives</b>	To raise water levels within the channel to flood adjacent wetland, while still maintaining base flow through the channel.
<b>Latitude (D°M'S")</b>	32°25'33.58"S
<b>Longitude (D°M'S")</b>	26°46'40.10"E

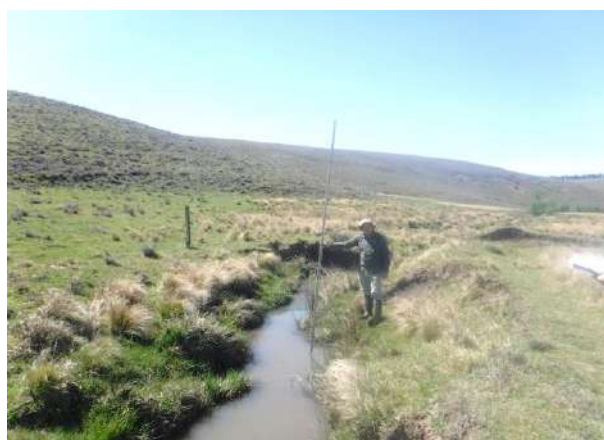
**Location Photograph: S32E-01-214-00**

<b>Intervention</b>	S32E-01-214-00
<b>Designer</b>	T. Pike
<b>Design Date</b>	01 February 2019
<b>Type</b>	New
<b>Description</b>	Earthen berm with base flow pipe
<b>Rehabilitation Objectives</b>	To raise water levels within the channel to flood adjacent wetland, while still maintaining base flow through the channel.
<b>Latitude (D°M'S")</b>	32°25'34.65"S
<b>Longitude (D°M'S")</b>	26°46'39.35"E

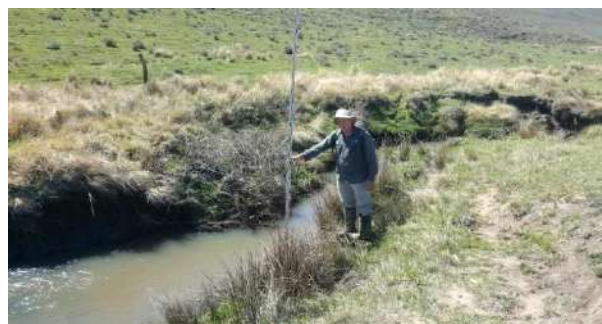
**Location Photograph: S32E-01-215-00**

<b>Intervention</b>	S32E-01-215-00
<b>Designer</b>	T. Pike
<b>Design Date</b>	01 February 2019
<b>Type</b>	New
<b>Description</b>	Earthen berm with base flow pipe
<b>Rehabilitation Objectives</b>	To raise water levels within the channel to flood adjacent wetland, while still maintaining base flow through the channel.
<b>Latitude (D°M'S")</b>	32°25'36.08"S
<b>Longitude (D°M'S")</b>	26°46'37.50"E

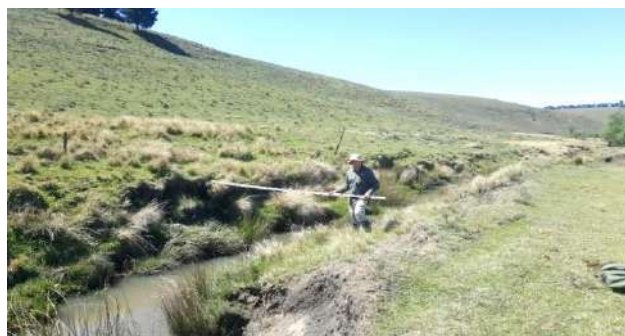
**Details****Location Photograph: S32E-01-216-00**

<b>Intervention</b>	S32E-01-216-00
<b>Designer</b>	T. Pike
<b>Design Date</b>	01 February 2019
<b>Type</b>	New
<b>Description</b>	Earthen berm with base flow pipe
<b>Rehabilitation Objectives</b>	To raise water levels within the channel to flood adjacent wetland, while still maintaining base flow through the channel.
<b>Latitude (D°M'S")</b>	32°25'37.53"S
<b>Longitude (D°M'S")</b>	26°46'35.80"E

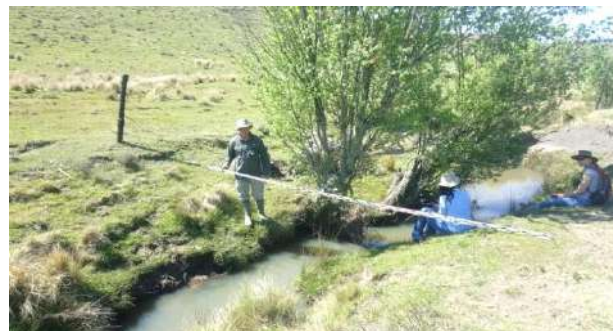
## Location Photograph: S32E-01-217-00

<b>Intervention</b>	S32E-01-217-00
<b>Designer</b>	T. Pike
<b>Design Date</b>	01 February 2019
<b>Type</b>	New
<b>Description</b>	Geocell covered earthen berm with base flow pipe and deactivation of plough lines
<b>Rehabilitation Objectives</b>	To raise water levels within the channel to flood adjacent wetland, while still maintaining base flow through the channel. Geocell covered berm is for structural stability as it is a control structure. Deactivation of plough lines for even flow through wetland.
<b>Latitude (D°M'S")</b>	32°25'38.72"S
<b>Longitude (D°M'S")</b>	26°46'34.13"E

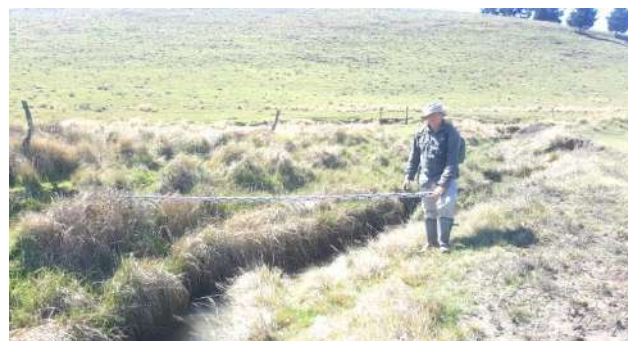
**Location Photograph: S32E-01-218-00A**

<b>Intervention</b>	S32E-01-218-00A
<b>Designer</b>	T. Pike
<b>Design Date</b>	01 February 2019
<b>Type</b>	New
<b>Description</b>	Concrete buttress weir
<b>Rehabilitation Objectives</b>	To raise water levels within the channel and flood adjacent wetland. Water levels have been determined to backflow to upstream headcuts.
<b>Latitude (D°M'S")</b>	32°25'39.95"S
<b>Longitude (D°M'S")</b>	26°46'33.49"E

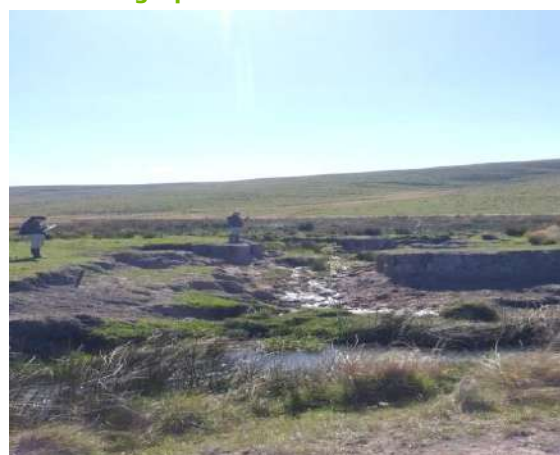
**Location Photograph: S32E-01-218-00B**

<b>Intervention</b>	S32E-01-218-00B
<b>Designer</b>	T. Pike
<b>Design Date</b>	01 February 2019
<b>Type</b>	New
<b>Description</b>	3x Pole barriers
<b>Rehabilitation Objectives</b>	To deactivate headcuts and trap sediment
<b>Latitude (D°M'S")</b>	32°25'43.13"S
<b>Longitude (D°M'S")</b>	26°46'32.77"E

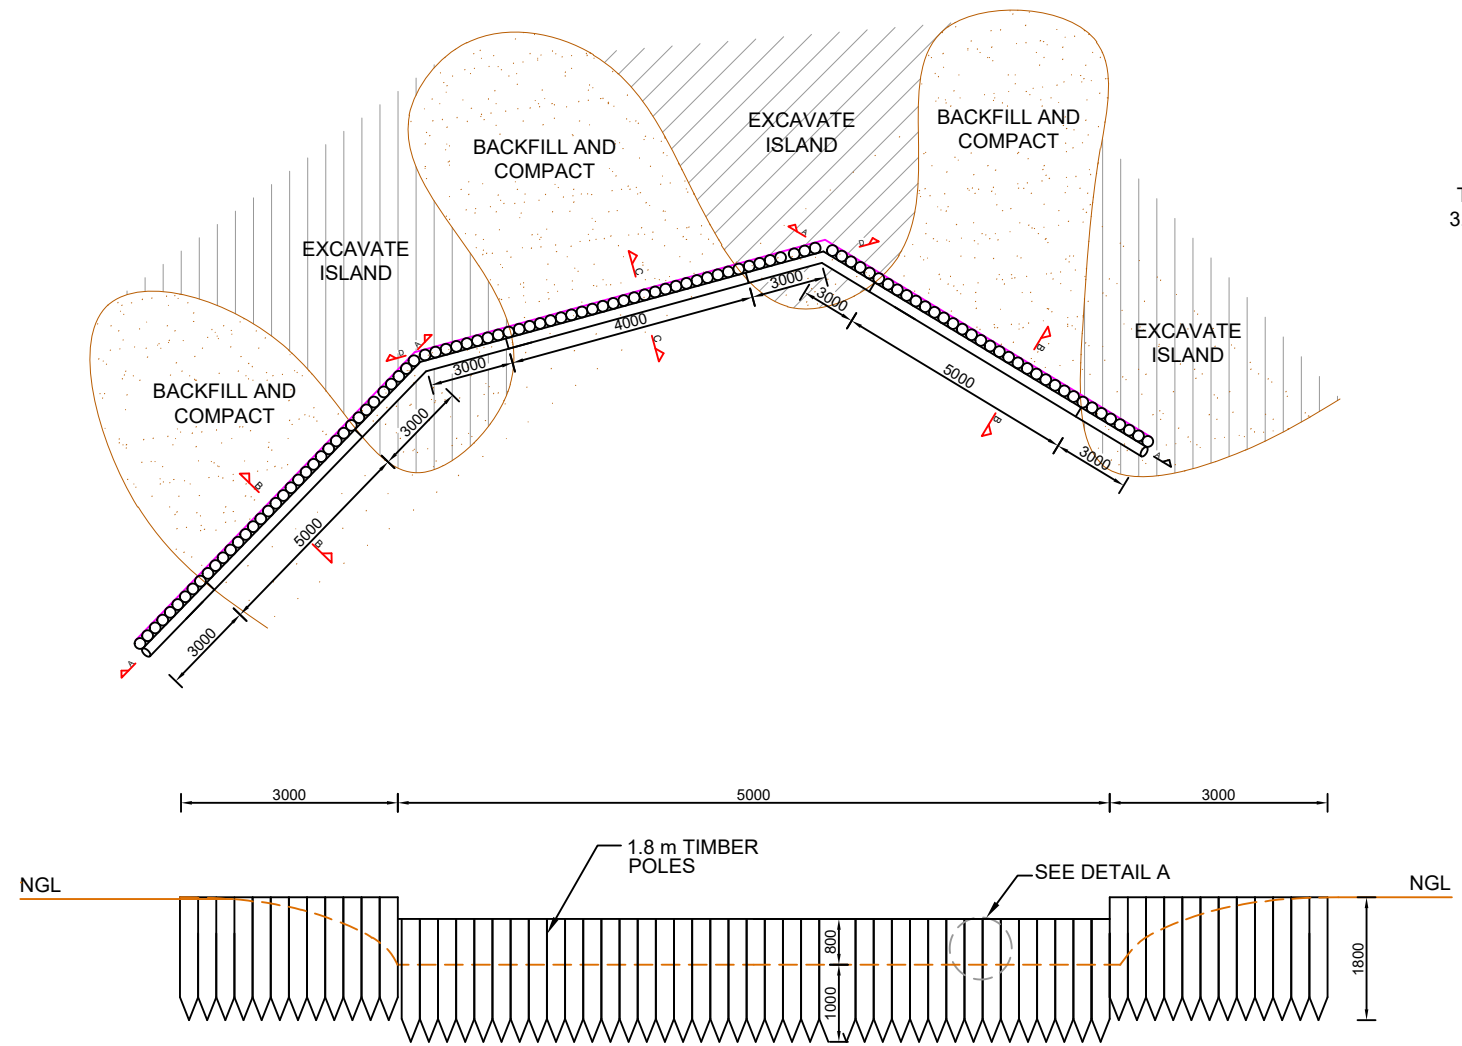
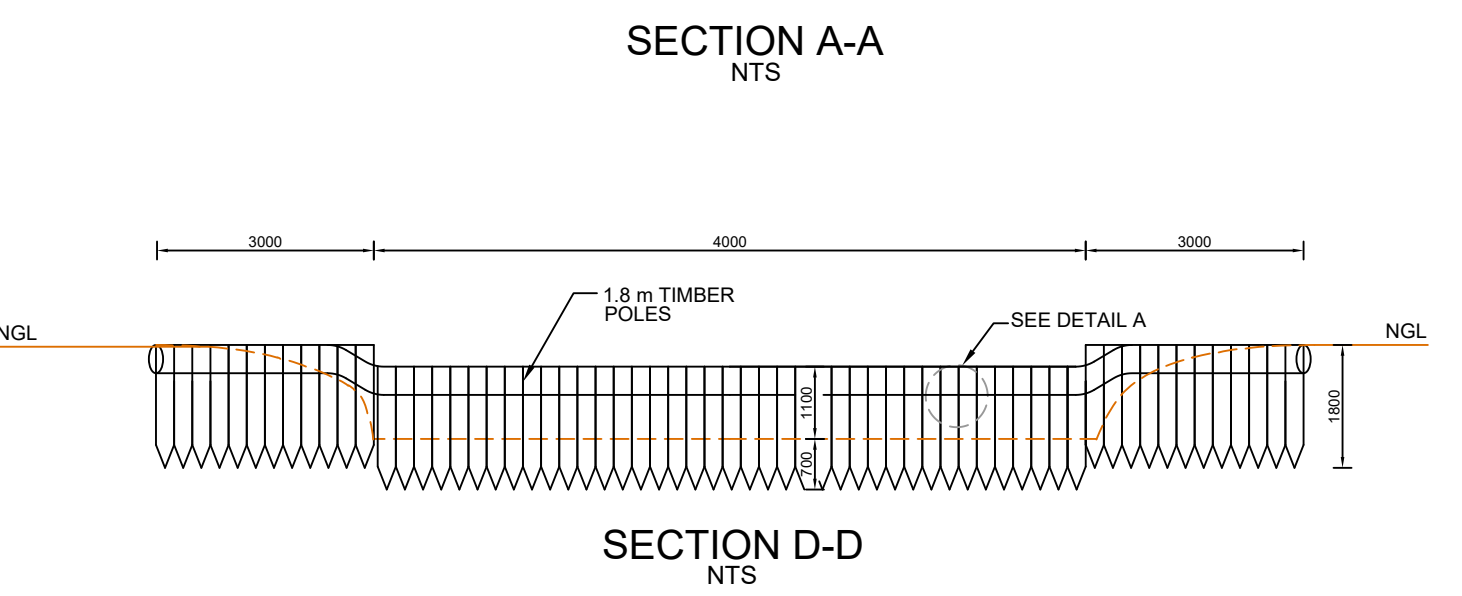
**TIMBER POLES:**

- BRACE THE TIMBER POLES AS INDICATED WHILE PLACING IN POSITION WITH PVC COATED GALVANISED WIRE OF O/D NO LESS THAN 3.4mm THROUGH THE CENTRE.
- TIMBER POLES ARE TO BE PLACED IN AN UPRIGHT POSITION ON THE TOP OF CONCRETE FOUNDATION OF 150 x 250 STRIP (20MPa).
- BRACE POLES WITH 4.0mm SANS 675: 2009 GRADE A (HEAVY) GALVANISED WIRE USING D-SHAPE BRACING AROUND POLES.
- ALL ENDS TO BE FITTED WITH THE MAXIMUM SIZED END CAPS TO PREVENT SPLITTING.

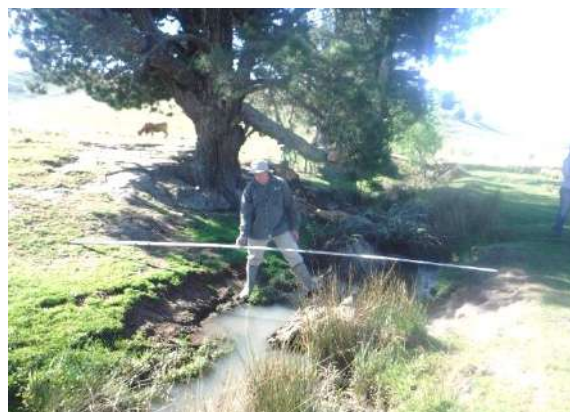
**Location Photograph: S32E-01-219-00**

<b>Intervention</b>	S32E-01-219-00
<b>Designer</b>	T. Pike
<b>Design Date</b>	01 February 2019
<b>Type</b>	New
<b>Description</b>	Earthen berm with base flow pipe and debris removal
<b>Rehabilitation Objectives</b>	To raise water levels within the channel to flood adjacent wetland, while still maintaining base flow through the channel.
<b>Latitude (D°M'S")</b>	32°25'46.44"S
<b>Longitude (D°M'S")</b>	26°46'33.42"E

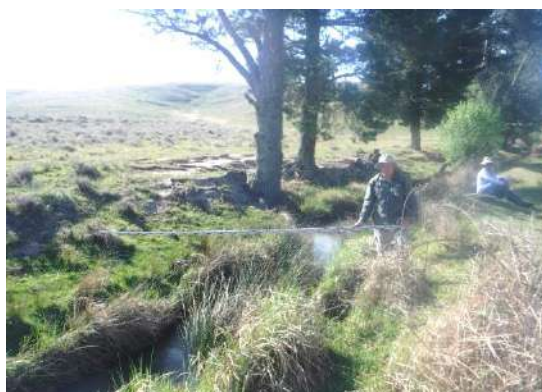
**Location Photograph: S32E-01-220-00**

<b>Intervention</b>	S32E-01-220-00
<b>Designer</b>	T. Pike
<b>Design Date</b>	01 February 2019
<b>Type</b>	New
<b>Description</b>	Earthen berm with base flow pipe
<b>Rehabilitation Objectives</b>	To raise water levels within the channel to flood adjacent wetland, while still maintaining base flow through the channel.
<b>Latitude (D°M'S")</b>	32°25'48.56"S
<b>Longitude (D°M'S")</b>	26°46'33.24"E

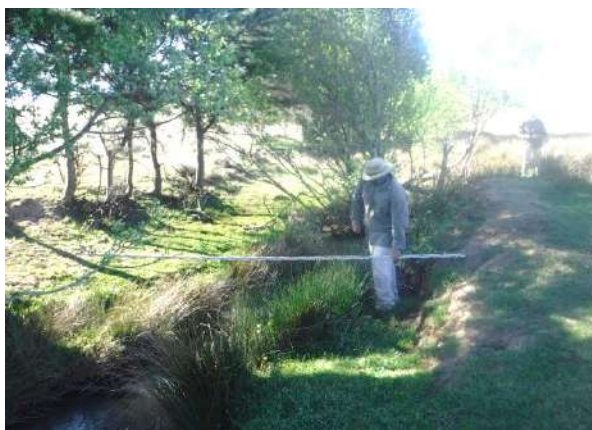
**Location Photograph: S32E-01-221-00**

<b>Intervention</b>	S32E-01-221-00
<b>Designer</b>	T. Pike
<b>Design Date</b>	01 February 2019
<b>Type</b>	New
<b>Description</b>	Earthen berm with base flow pipe
<b>Rehabilitation Objectives</b>	To raise water levels within the channel to flood adjacent wetland, while still maintaining base flow through the channel.
<b>Latitude (D°M'S")</b>	32°25'52.20"S
<b>Longitude (D°M'S")</b>	26°46'33.43"E

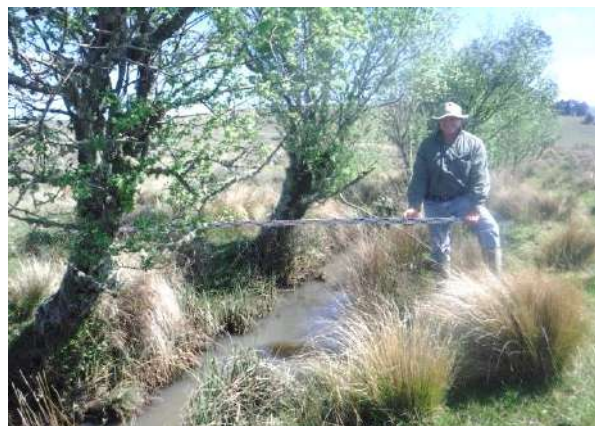
**Details****Location Photograph: S32E-01-222-00**

<b>Intervention</b>	S32E-01-222-00
<b>Designer</b>	T. Pike
<b>Design Date</b>	01 February 2019
<b>Type</b>	New
<b>Description</b>	Earthen berm with a geocell covered crest (3m wide) with base flow pipe.
<b>Rehabilitation Objectives</b>	To raise water levels within the channel to flood adjacent wetland, while still maintaining base flow through the channel. Geocell covered berm is to allow cattle to cross the channel.
<b>Latitude (D°M'S")</b>	32°25'55.11"S
<b>Longitude (D°M'S")</b>	26°46'33.70"E

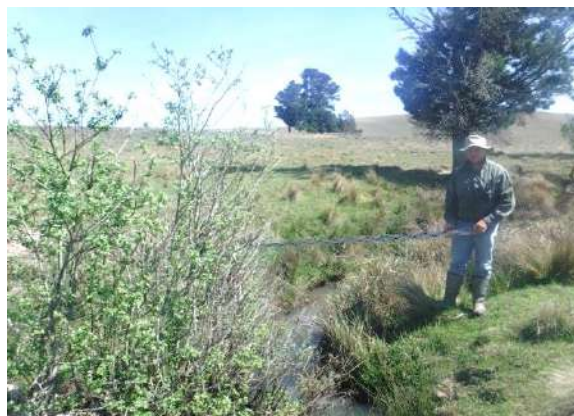
**Location Photograph: S32E-01-223-00**

<b>Intervention</b>	S32E-01-223-00
<b>Designer</b>	T. Pike
<b>Design Date</b>	01 February 2019
<b>Type</b>	New
<b>Description</b>	Earthen berm with base flow pipe
<b>Rehabilitation Objectives</b>	To raise water levels within the channel to flood adjacent wetland, while still maintaining base flow through the channel.
<b>Latitude (D°M'S")</b>	32°25'58.26"S
<b>Longitude (D°M'S")</b>	26°46'32.75"E

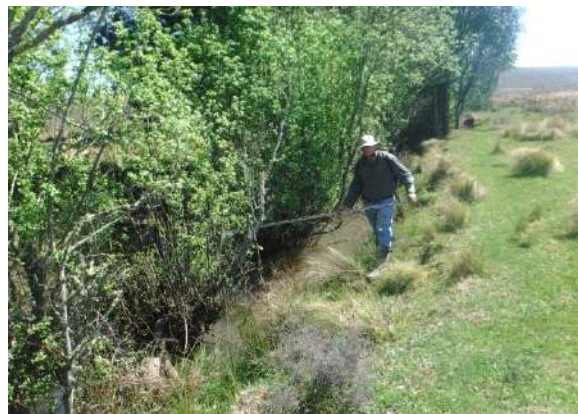
**Details****Location Photograph: S32E-01-224-00**

<b>Intervention</b>	S32E-01-224-00
<b>Designer</b>	T. Pike
<b>Design Date</b>	01 February 2019
<b>Type</b>	New
<b>Description</b>	Earthen berm with base flow pipe and skim side bank down to wetland level
<b>Rehabilitation Objectives</b>	To raise water levels within the channel to flood adjacent wetland, while still maintaining base flow through the channel.
<b>Latitude (D°M'S")</b>	32°26'0.36"S
<b>Longitude (D°M'S")</b>	26°46'32.33"E

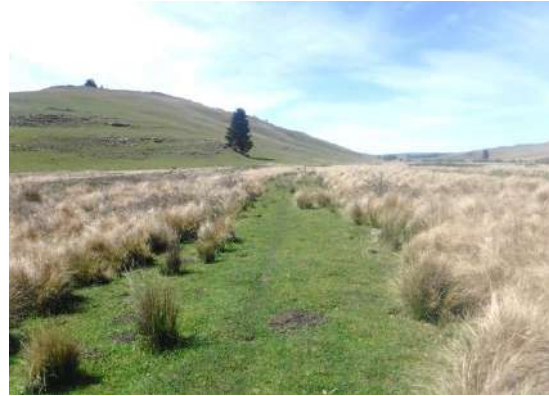
**Location Photograph: S32E-01-225-00**

<b>Intervention</b>	S32E-01-225-00
<b>Designer</b>	T. Pike
<b>Design Date</b>	01 February 2019
<b>Type</b>	New
<b>Description</b>	Deactivation of ridge and furrow
<b>Rehabilitation Objectives</b>	To even out wetland to spread flow evenly.
<b>Latitude (D°M'S")</b>	32°26'0.65"S
<b>Longitude (D°M'S")</b>	26°46'33.18"E

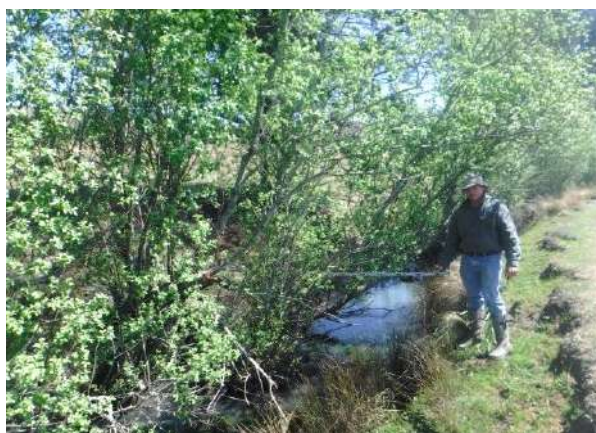
**Details****Location Photograph: S32E-01-226-00**

<b>Intervention</b>	S32E-01-226-00
<b>Designer</b>	T. Pike
<b>Design Date</b>	01 February 2019
<b>Type</b>	New
<b>Description</b>	Earthen berm with base flow pipe and skim side bank down to wetland level
<b>Rehabilitation Objectives</b>	To raise water levels within the channel to flood adjacent wetland, while still maintaining base flow through the channel.
<b>Latitude (D°M'S")</b>	32°26'2.77"S
<b>Longitude (D°M'S")</b>	26°46'31.85"E

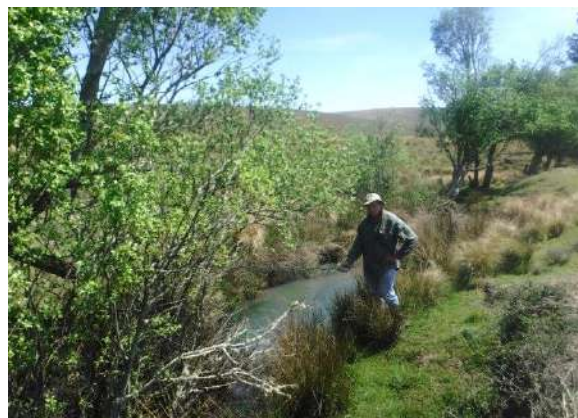
**Location Photograph: S32E-01-227-00**

<b>Intervention</b>	S32E-01-227-00
<b>Designer</b>	T. Pike
<b>Design Date</b>	01 February 2019
<b>Type</b>	New
<b>Description</b>	Earthen berm with base flow pipe
<b>Rehabilitation Objectives</b>	To raise water levels within the channel to flood adjacent wetland, while still maintaining base flow through the channel.
<b>Latitude (D°M'S")</b>	32°26'6.09"S
<b>Longitude (D°M'S")</b>	26°46'31.71"E

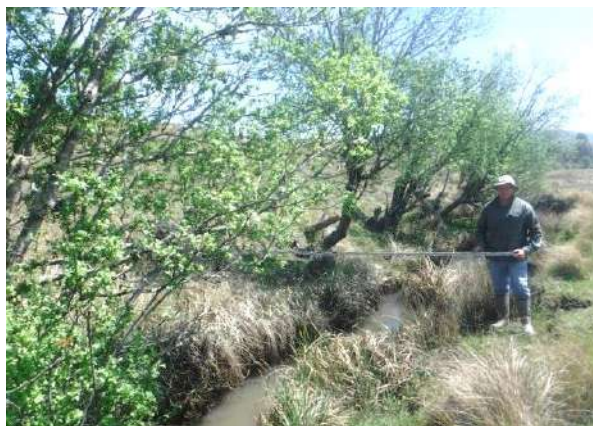
**Details****Location Photograph: S32E-01-228-00A**

<b>Intervention</b>	S32E-01-228-00A
<b>Designer</b>	T. Pike
<b>Design Date</b>	01 February 2019
<b>Type</b>	New
<b>Description</b>	Earthen berm with base flow pipe and additional berm downstream in wetland.
<b>Rehabilitation Objectives</b>	To raise water levels within the channel to flood adjacent wetland, while still maintaining base flow through the channel. Additional berm to prevent flows re-entering the channel.
<b>Latitude (D°M'S")</b>	32°26'12.01"S
<b>Longitude (D°M'S")</b>	26°46'33.52"E

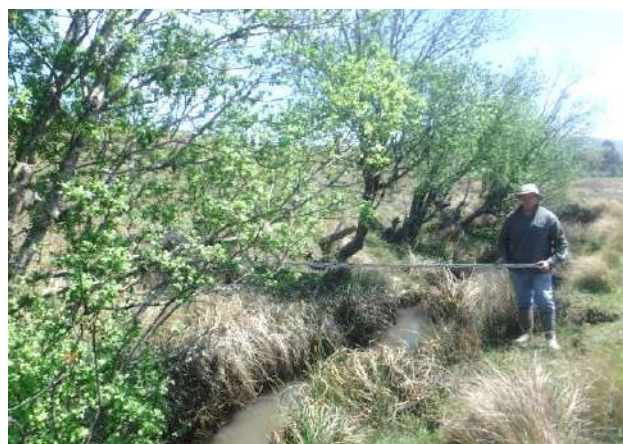
**Location Photograph: S32E-01-228-00-B**

<b>Intervention</b>	S32E-01-228-00B
<b>Designer</b>	T. Pike
<b>Design Date</b>	01 February 2019
<b>Type</b>	New
<b>Description</b>	Earthen berm with base flow pipe and additional berm downstream in wetland.
<b>Rehabilitation Objectives</b>	To raise water levels within the channel to flood adjacent wetland, while still maintaining base flow through the channel. Additional berm to prevent flows re-entering the channel.
<b>Latitude (D°M'S")</b>	32°26'12.01"S
<b>Longitude (D°M'S")</b>	26°46'33.52"E

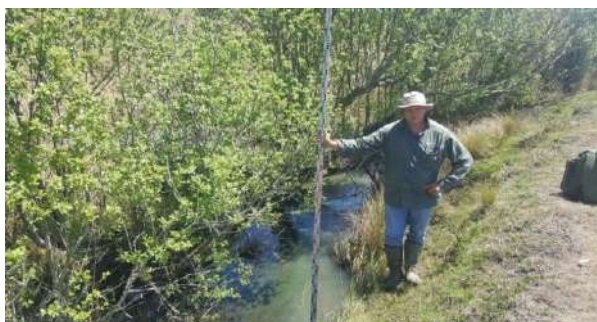
**Details****Location Photograph: S32E-01-229-00**

<b>Intervention</b>	S32E-01-229-00
<b>Designer</b>	T. Pike
<b>Design Date</b>	01 February 2019
<b>Type</b>	New
<b>Description</b>	Earthen berm with base flow pipe and skim levy to wetland level
<b>Rehabilitation Objectives</b>	To raise water levels within the channel to flood adjacent wetland, while still maintaining base flow through the channel.
<b>Latitude (D°M'S")</b>	32°26'16.34"S
<b>Longitude (D°M'S")</b>	26°46'34.78"E

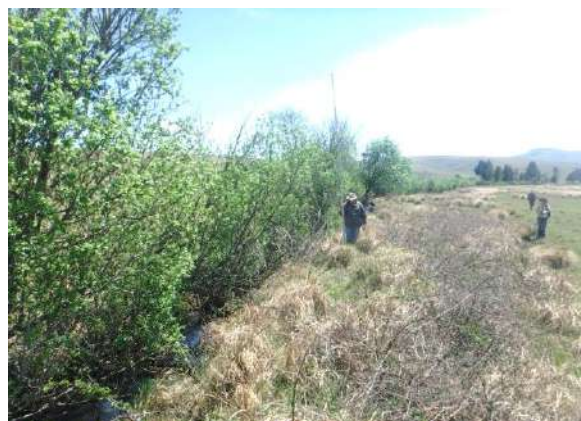
**Location Photograph: S32E-01-230-00**

<b>Intervention</b>	S32E-01-230-00
<b>Designer</b>	T. Pike
<b>Design Date</b>	01 February 2019
<b>Type</b>	New
<b>Description</b>	Earthen berm with base flow pipe and skim levy to wetland level
<b>Rehabilitation Objectives</b>	To raise water levels within the channel to flood adjacent wetland, while still maintaining base flow through the channel.
<b>Latitude (D°M'S")</b>	32°26'18.37"S
<b>Longitude (D°M'S")</b>	26°46'35.76"E

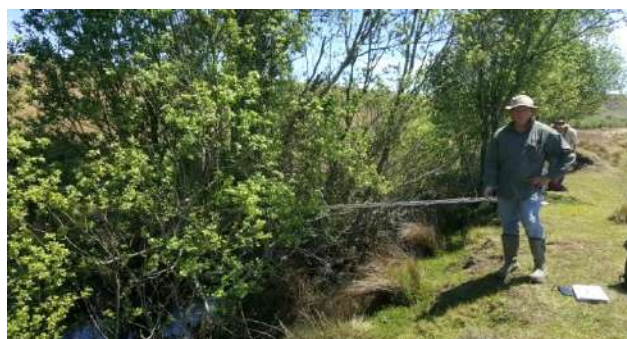
**Location Photograph: S32E-01-231-00A**

<b>Intervention</b>	S32E-01-231-00A
<b>Designer</b>	T. Pike
<b>Design Date</b>	01 February 2019
<b>Type</b>	New
<b>Description</b>	Earthen berm with base flow pipe and skim levy to wetland level
<b>Rehabilitation Objectives</b>	To raise water levels within the channel to flood adjacent wetland, while still maintaining base flow through the channel.
<b>Latitude (D°M'S")</b>	32°26'19.79"S
<b>Longitude (D°M'S")</b>	26°46'36.22"E

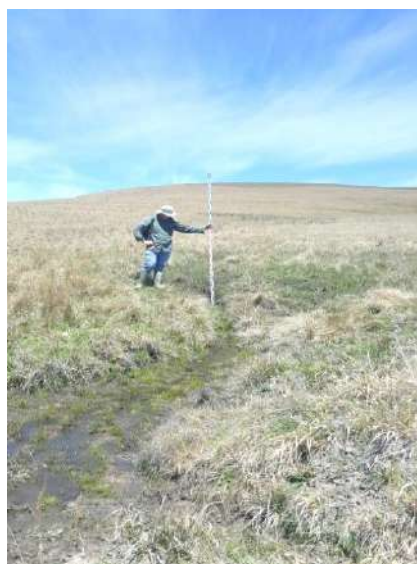
**Location Photograph: S32E-01-231-00B**

<b>Intervention</b>	S32E-01-231-00B
<b>Designer</b>	T. Pike
<b>Design Date</b>	01 February 2019
<b>Type</b>	New
<b>Description</b>	Pole barrier upstream of berm
<b>Rehabilitation Objectives</b>	To deactivate headcuts
<b>Latitude (D°M'S")</b>	32°26'20.92"S
<b>Longitude (D°M'S")</b>	26°46'36.06"E

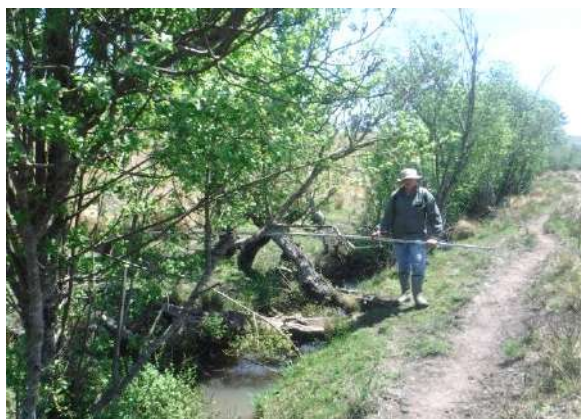
**Location Photograph: S32E-01-232-00**

<b>Intervention</b>	S32E-01-232-00
<b>Designer</b>	T. Pike
<b>Design Date</b>	01 February 2019
<b>Type</b>	New
<b>Description</b>	Geocell covered earthen berm with base flow pipe and skim levy to wetland level
<b>Rehabilitation Objectives</b>	To raise water levels within the channel to flood adjacent wetland, while still maintaining base flow through the channel. Skimming of berm to allow water to flood to wetland level.
<b>Latitude (D°M'S")</b>	32°26'22.83"S
<b>Longitude (D°M'S")</b>	26°46'38.73"E

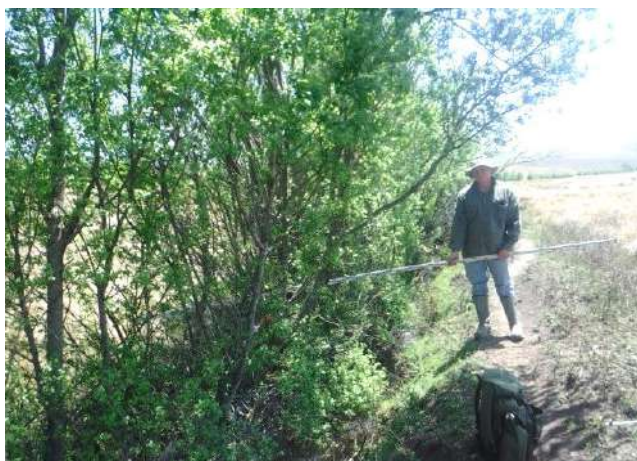
**Details****Location Photograph: S32E-01-233-00**

<b>Intervention</b>	S32E-01-233-00
<b>Designer</b>	T. Pike
<b>Design Date</b>	01 February 2019
<b>Type</b>	New
<b>Description</b>	Geocell covered earthen berm with base flow pipe and skim levy to wetland level. 33m concrete sill at ground level.
<b>Rehabilitation Objectives</b>	To raise water levels within the channel to flood adjacent wetland, while still maintaining base flow through the channel. Skimming of berm to allow water to flood to wetland level.
<b>Latitude (D°M'S")</b>	32°26'24.42"S
<b>Longitude (D°M'S")</b>	26°46'40.22"E

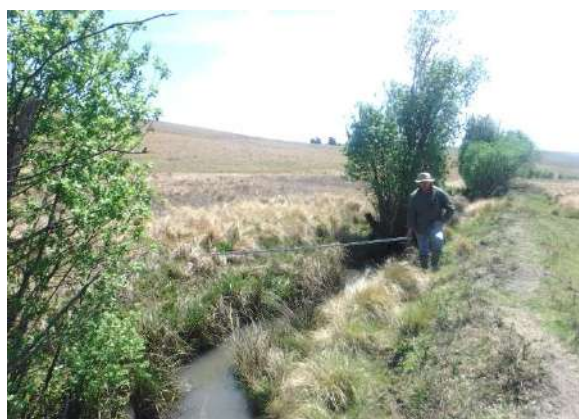
**Details****Location Photograph: S32E-01-234-00**

<b>Intervention</b>	S32E-01-234-00
<b>Designer</b>	T. Pike
<b>Design Date</b>	01 February 2019
<b>Type</b>	New
<b>Description</b>	Geocell covered earthen berm with base flow pipe. 16m concrete sill at ground level.
<b>Rehabilitation Objectives</b>	To raise water levels within the channel to flood adjacent wetland, while still maintaining base flow through the channel. Skimming of berm to allow water to flood to wetland level.
<b>Latitude (D°M'S")</b>	32°26'25.76"S
<b>Longitude (D°M'S")</b>	26°46'41.33"E

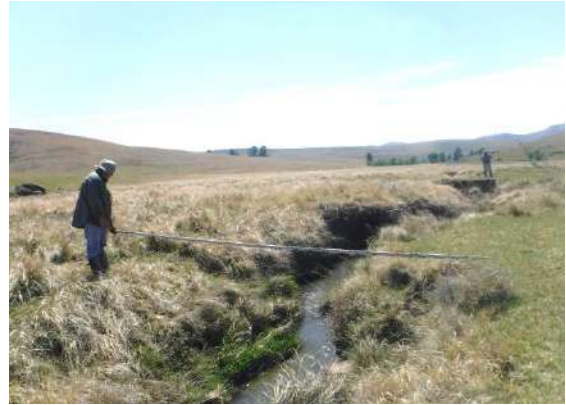
**Location Photograph: S32E-01-236-00**

<b>Intervention</b>	S32E-01-236-00
<b>Designer</b>	T. Pike
<b>Design Date</b>	01 February 2019
<b>Type</b>	New
<b>Description</b>	Concrete buttress weir
<b>Rehabilitation Objectives</b>	To raise water level in the channel and backflood to upstream weir.
<b>Latitude (D°M'S")</b>	32°26'34.62"S
<b>Longitude (D°M'S")</b>	26°46'46.59"E

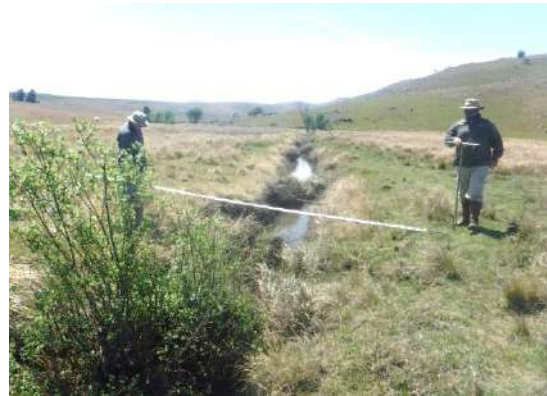
**Location Photograph: S32E-01-237-00**

<b>Intervention</b>	S32E-01-237-00
<b>Designer</b>	T. Pike
<b>Design Date</b>	01 February 2019
<b>Type</b>	New
<b>Description</b>	Concrete buttress weir
<b>Rehabilitation Objectives</b>	To raise water level in the channel
<b>Latitude (D°M'S")</b>	32°26'32.15"S
<b>Longitude (D°M'S")</b>	26°46'46.07"E

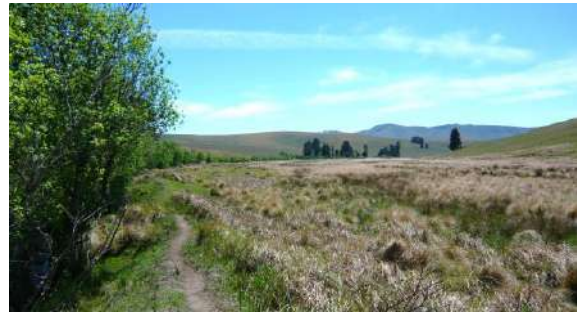
**Location Photograph: S32E-01-238-00**

<b>Intervention</b>	S32E-01-238-00
<b>Designer</b>	T. Pike
<b>Design Date</b>	01 February 2019
<b>Type</b>	New
<b>Description</b>	Alien Vegetation Removal
<b>Rehabilitation Objectives</b>	Removal of alien vegetation from the wetland
<b>Latitude (D°M'S")</b>	32°25'58.26"S
<b>Longitude (D°M'S")</b>	26°46'32.75"E

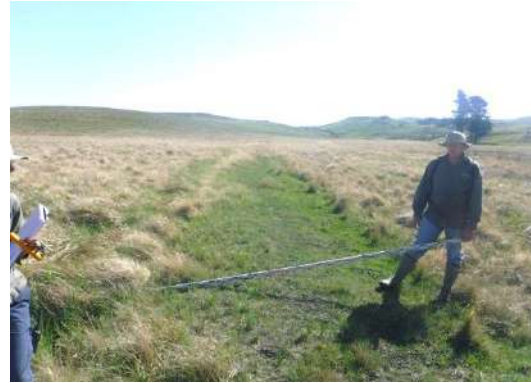
**Location Photograph: S32E-02-201-00**

<b>Intervention</b>	S32E-02-201-00
<b>Designer</b>	T. Pike
<b>Design Date</b>	01 February 2019
<b>Type</b>	New
<b>Description</b>	Deactivation of ridge and furrows
<b>Rehabilitation Objectives</b>	To allow for a more diffuse movement of water through wetland.
<b>Latitude (D°M'S")</b>	32°26'54.55"S
<b>Longitude (D°M'S")</b>	26°46'31.60"E

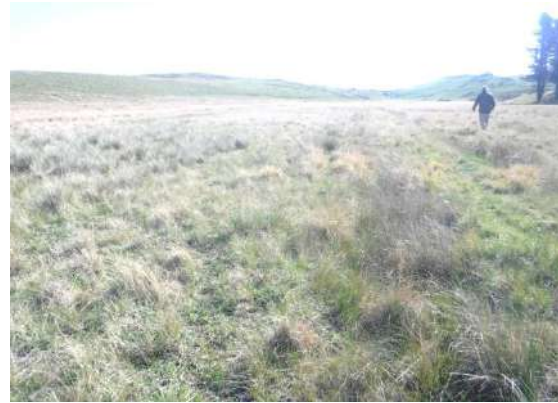
**Location Photograph: S32E-02-202-00**

<b>Intervention</b>	S32E-02-202-00
<b>Designer</b>	T. Pike
<b>Design Date</b>	01 February 2019
<b>Type</b>	New
<b>Description</b>	Ecologs every 25m along parallel drains
<b>Rehabilitation Objectives</b>	Deactivate drains
<b>Latitude (D°M'S")</b>	32°26'54.33"S
<b>Longitude (D°M'S")</b>	26°46'28.31"E

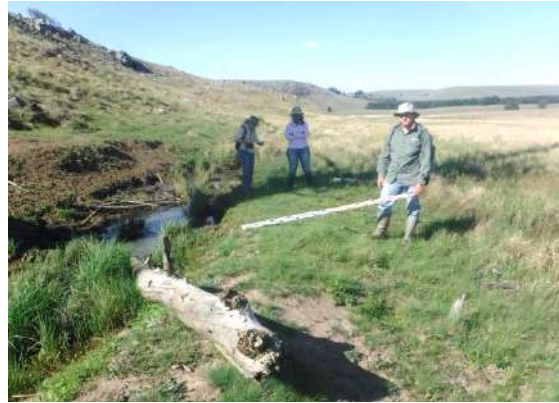
**Location Photograph: S32E-02-203-00**

<b>Intervention</b>	S32E-02-203-00
<b>Designer</b>	T. Pike
<b>Design Date</b>	01 February 2019
<b>Type</b>	New
<b>Description</b>	Deactivate berm and construct earth plug in drain
<b>Rehabilitation Objectives</b>	To raise water level in drain and flood adjacent wetland
<b>Latitude (D°M'S")</b>	32°26'52.94"S
<b>Longitude (D°M'S")</b>	26°46'27.12"E

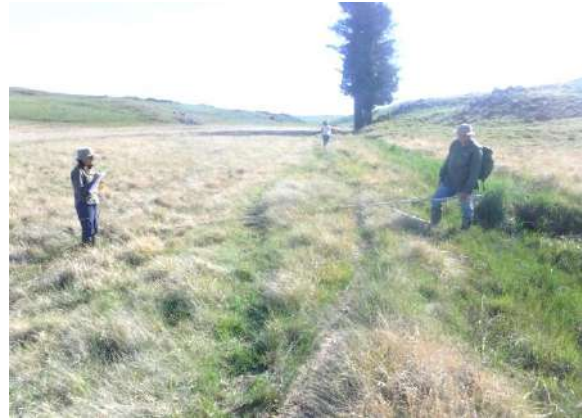
**Location Photograph: S32E-02-204-00**

<b>Intervention</b>	S32E-02-204-00
<b>Designer</b>	T. Pike
<b>Design Date</b>	01 February 2019
<b>Type</b>	New
<b>Description</b>	Deactivate berm and backfill channel
<b>Rehabilitation Objectives</b>	To allow for a more diffuse movement of water through wetland.
<b>Latitude (D°M'S")</b>	32°26'53.85"S
<b>Longitude (D°M'S")</b>	26°46'25.31"E

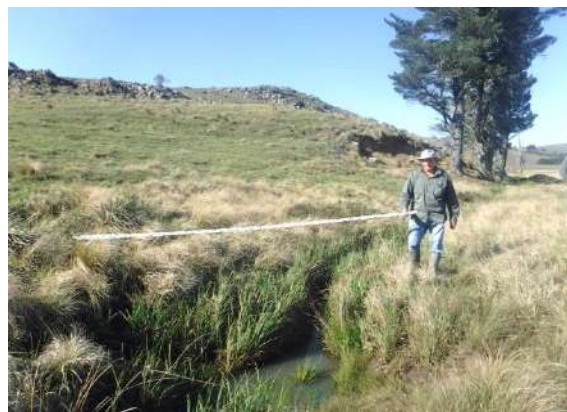
**Location Photograph: S32E-02-205-00**

<b>Intervention</b>	S32E-02-205-00
<b>Designer</b>	T. Pike
<b>Design Date</b>	01 February 2019
<b>Type</b>	New
<b>Description</b>	Geocell covered earthen berm. Removal of existing berms. Earthen plug. Rock masonry walkway.
<b>Rehabilitation Objectives</b>	To deactivate drain the drain yet allow access to cross the drain.
<b>Latitude (D°M'S")</b>	32°26'56.40"S
<b>Longitude (D°M'S")</b>	26°46'20.41"E

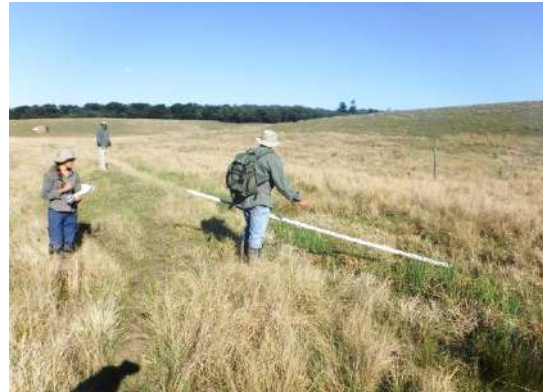
**Location Photograph: S32E-02-206-00**

<b>Intervention</b>	S32E-02-206-00
<b>Designer</b>	T. Pike
<b>Design Date</b>	01 February 2019
<b>Type</b>	New
<b>Description</b>	Earthen berm removal and construction of diversion plug
<b>Rehabilitation Objectives</b>	To raise water level and push water out to wetland level
<b>Latitude (D°M'S")</b>	32°26'57.23"S
<b>Longitude (D°M'S")</b>	26°46'23.08"E

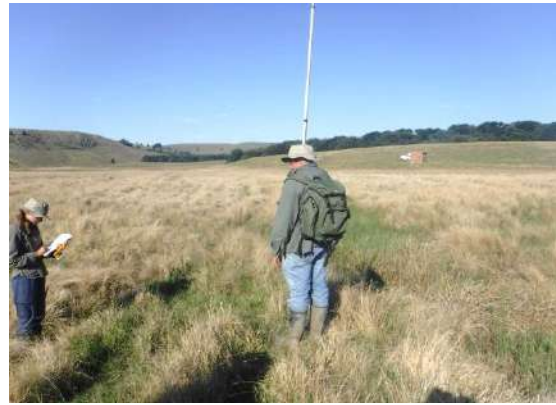
**Location Photograph: S32E-02-207-00**

<b>Intervention</b>	S32E-02-207-00
<b>Designer</b>	T. Pike
<b>Design Date</b>	01 February 2019
<b>Type</b>	New
<b>Description</b>	Construction of diversion plug
<b>Rehabilitation Objectives</b>	To raise water level and push water out to wetland level
<b>Latitude (D°M'S")</b>	32°26'56.40"S
<b>Longitude (D°M'S")</b>	26°46'27.36"E

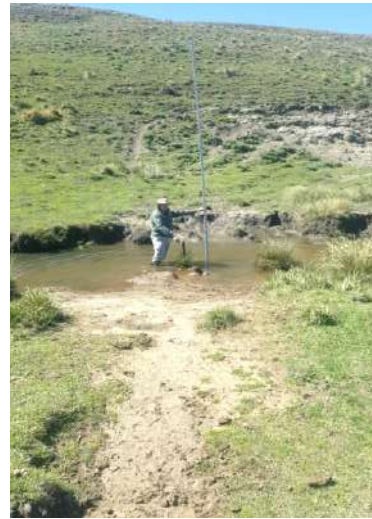
**Location Photograph: S32E-03-201-00**

<b>Intervention</b>	S32E-03-201-00
<b>Designer</b>	T. Pike
<b>Design Date</b>	01 February 2019
<b>Type</b>	New
<b>Description</b>	Concrete splash through
<b>Rehabilitation Objectives</b>	To allow access for channel crossing
<b>Latitude (D°M'S")</b>	32°24'40.01"S
<b>Longitude (D°M'S")</b>	26°45'31.08"E

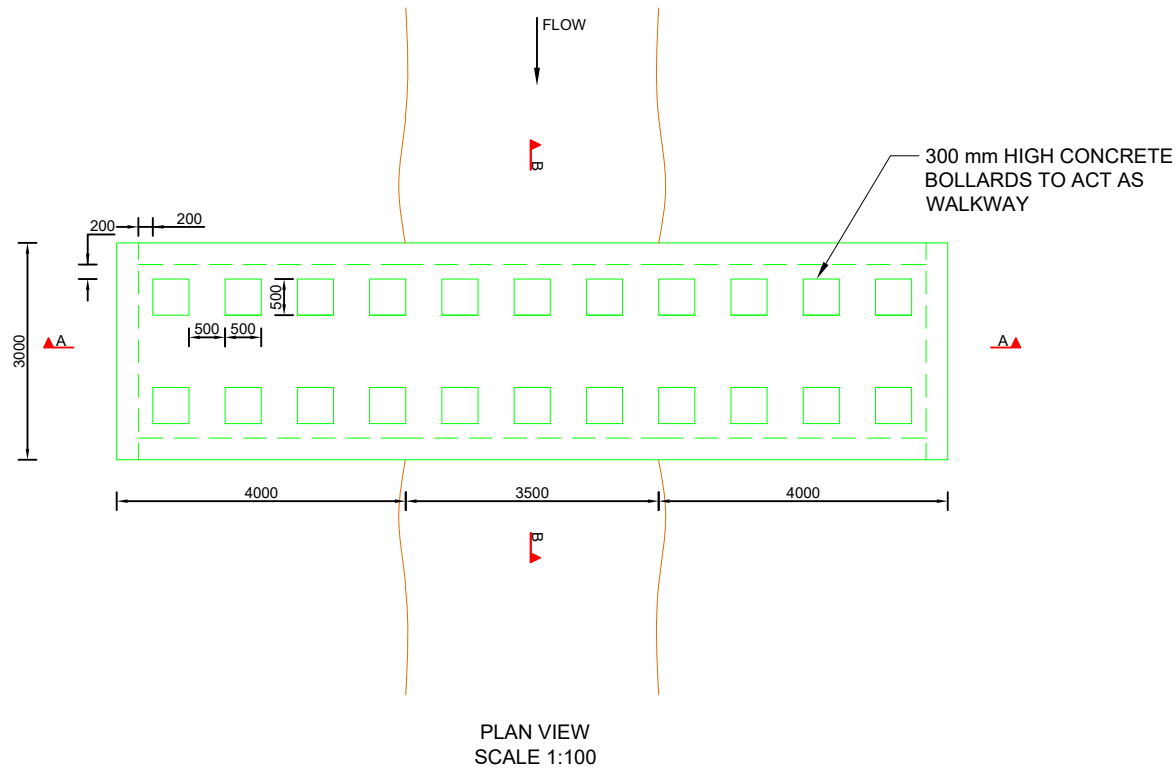
PLAN VIEW  
SCALE 1:100

Ensure community still have safe crossing point over channel during construction of the replacement crossing

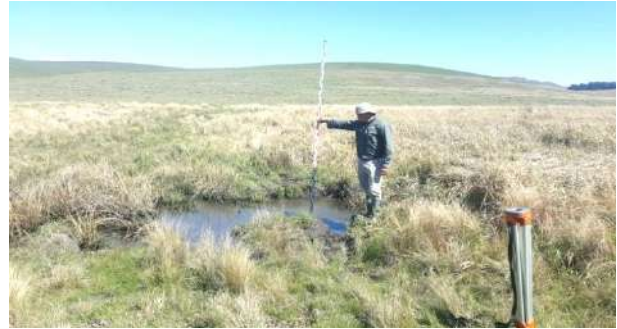
**Location Photograph: S32E-03-202-00**

<b>Intervention</b>	S32E-03-202-00
<b>Designer</b>	T. Pike
<b>Design Date</b>	01 February 2019
<b>Type</b>	New
<b>Description</b>	Rock masonry chute
<b>Rehabilitation Objectives</b>	Deactivate headcut
<b>Latitude (D°M'S")</b>	32°24'38.99"S
<b>Longitude (D°M'S")</b>	26°45'42.69"E

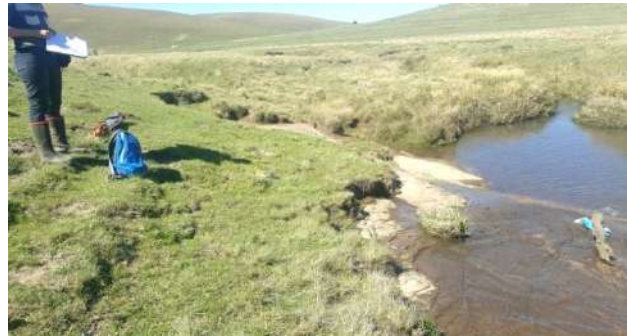
**Location Photograph: S32E-03-203-00**

<b>Intervention</b>	S32E-03-203-00
<b>Designer</b>	T. Pike
<b>Design Date</b>	01 February 2019
<b>Type</b>	New
<b>Description</b>	Concrete spillway across channel and trickle pipe
<b>Rehabilitation Objectives</b>	To divert flows into left hand drain
<b>Latitude (D°M'S")</b>	32°24'35.02"S
<b>Longitude (D°M'S")</b>	26°45'47.04"E

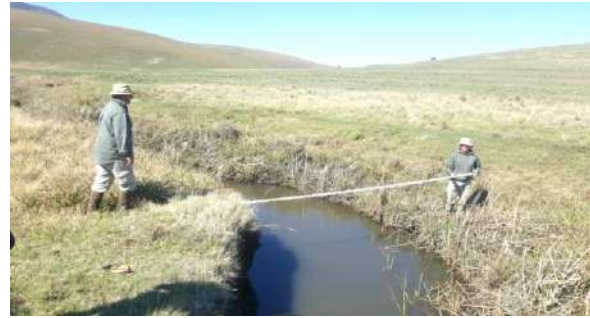
**Location Photograph: S32E-03-204-00**

<b>Intervention</b>	S32E-03-204-00
<b>Designer</b>	T. Pike
<b>Design Date</b>	01 February 2019
<b>Type</b>	New
<b>Description</b>	Concrete drop inlet weir
<b>Rehabilitation Objectives</b>	To raise water levels to backflood to upstream headcut
<b>Latitude (D°M'S")</b>	32°24'33.20"S
<b>Longitude (D°M'S")</b>	26°45'50.33"E

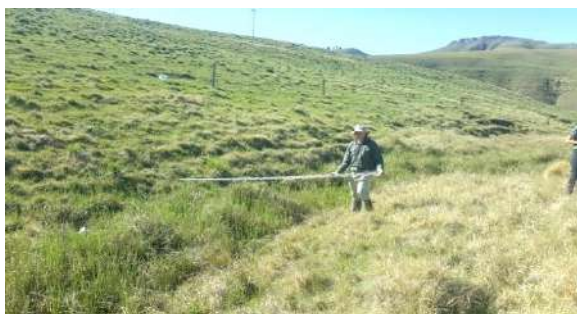
**Location Photograph: S32E-03-205-00**

<b>Intervention</b>	S32E-03-205-00
<b>Designer</b>	T. Pike
<b>Design Date</b>	01 February 2019
<b>Type</b>	New
<b>Description</b>	Earthen berm with base flow pipe
<b>Rehabilitation Objectives</b>	To raise water levels within the channel to flood adjacent wetland, while still maintaining base flow through the channel.
<b>Latitude (D°M'S")</b>	32°24'29.16"S
<b>Longitude (D°M'S")</b>	26°45'51.12"E

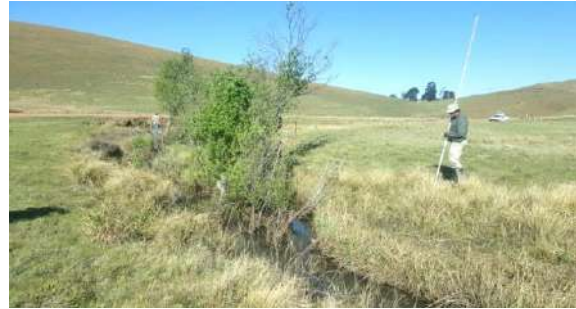
**Location Photograph: S32E-03-206-00**

<b>Intervention</b>	S32E-03-206-00
<b>Designer</b>	T. Pike
<b>Design Date</b>	01 February 2019
<b>Type</b>	New
<b>Description</b>	Concrete buttress weir
<b>Rehabilitation Objectives</b>	To raise water levels to backflood to upstream headcut
<b>Latitude (D°M'S")</b>	32°24'24.90"S
<b>Longitude (D°M'S")</b>	26°45'55.64"E

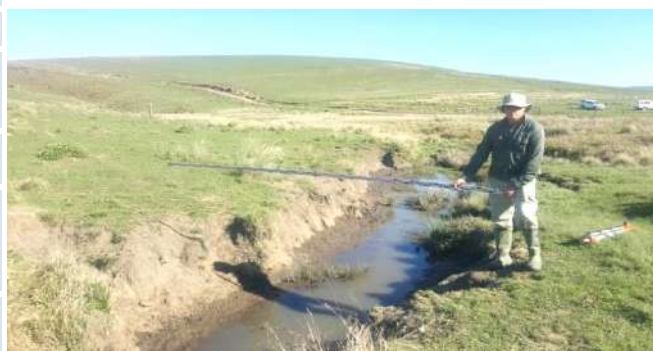
**Details****Location Photograph: S32E-04-201-00**

<b>Intervention</b>	S32E-04-201-00
<b>Designer</b>	T. Pike
<b>Design Date</b>	01 February 2019
<b>Type</b>	New
<b>Description</b>	Concrete drop inlet weir and backfilling with ecologs at gradient changes and Ecolog stack upstream
<b>Rehabilitation Objectives</b>	To deactivate drain. Ecologs to deactivate headcuts
<b>Latitude (D°M'S")</b>	Start: 32°24'23.47"S Mid point: 32°24'22.85"S Finish: 32°24'22.22"S
<b>Longitude (D°M'S")</b>	Start: 26°45'58.71"E Mid Point: 26°45'59.15"E Finish: 26°45'58.89"E
