EKURHULENI METROPOLITAN MUNICIPALITY
GEOTECHNICAL,
PAVEMENT MATERIALS INVESTIGATION, REHABILITATION AND
PAVEMENT DESIGN,
FOR
CONSTANTIA STREET, POMONA, EKURHULENI,
GAUTENG PROVINCE
FINAL REPORT
June 2018

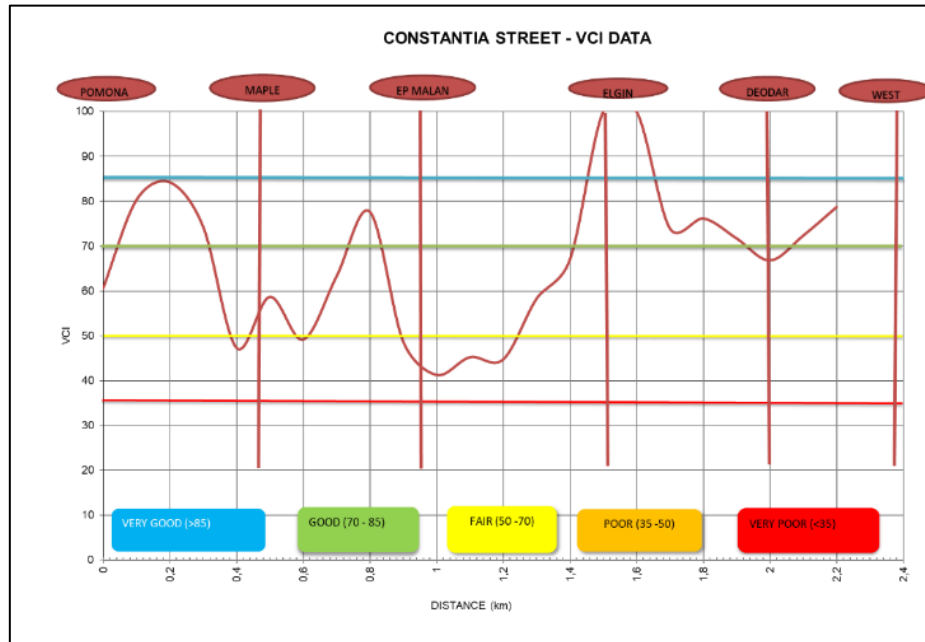
Figure 3: Visual Condition Index for constantia street according to draft TMH9

The road can be said to be in a poor to fairly good condition with surface defects ranging from transverse, block, crocodile and longitudinal cracks to bleeding, pumping and surface deformation, Figure 3. The general visual observations of the entire section from km 0.00 to

km 2.49 indicates that the upper layers require rehabilitation in terms of base repairs and patching or a reworking of the base.

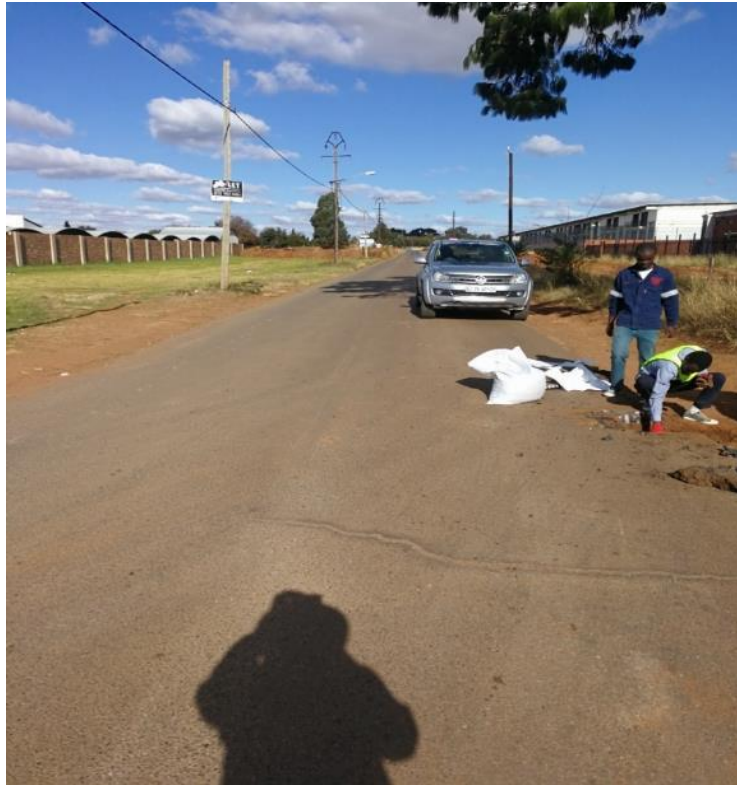
These cracks occur sporadically along most of the Constantia Street and are early indications of forming block cracks, Photo 1.

Photo 1: Transverse crack between Deodar Street and West Street

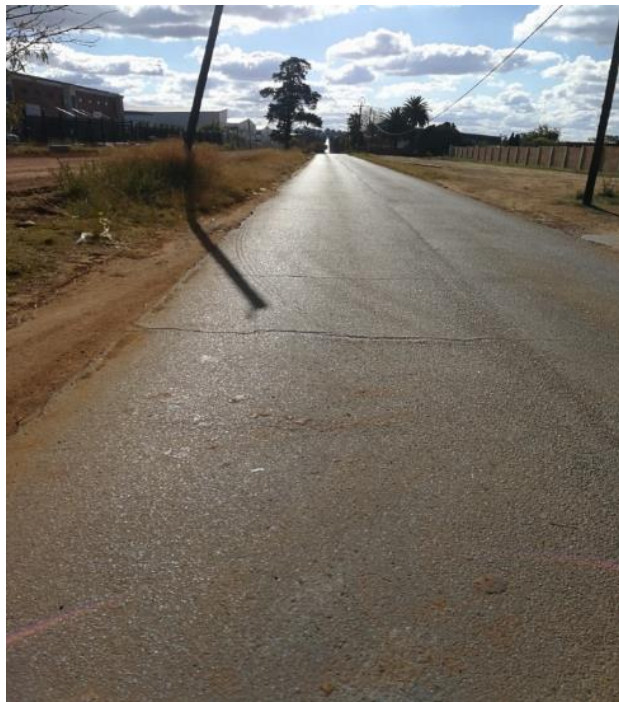
Block cracks occur sporadically throughout the entire section of the street but most notably from km 2.00 to km 2.24 (Deodar Street and West Street), Photo 2.

Photo 2: Block cracks between Deodar Street and West Street

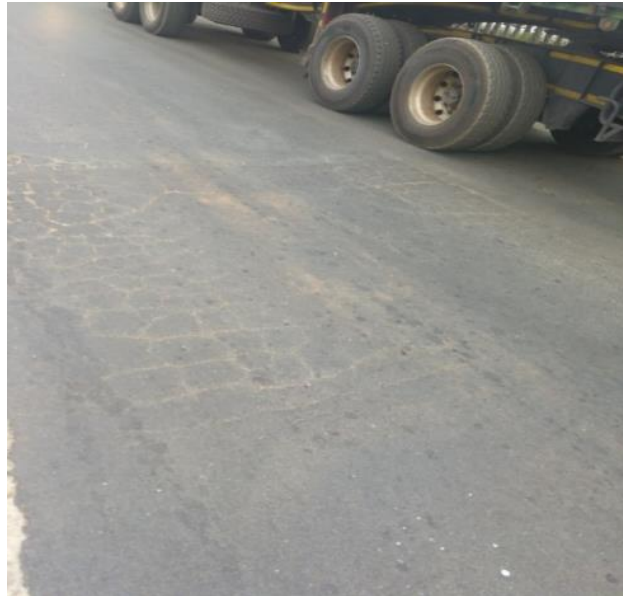
Crocodile cracks occur frequently throughout this section of Constantia Street. This is an indication of structural problems, Photo 3 and Photo 4.

Photo 3: Crocodile cracking between Pomona Road - Maple Street

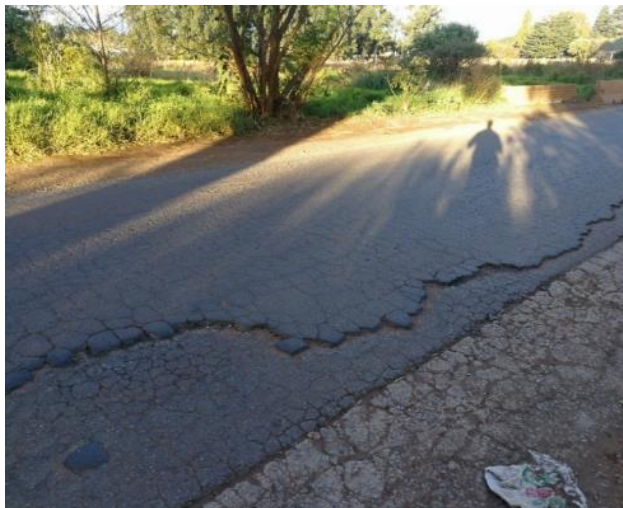
Photo 4: Advanced crocodile cracking between EP Malan Street - Elgin Street

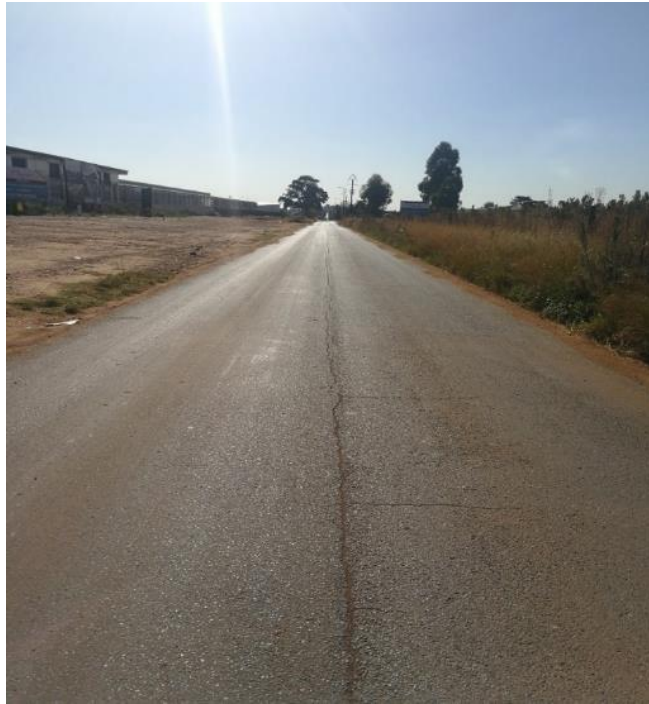
Longitudinal cracks predominate the section between Deodar Street and West Street, Photo 5.

Photo 5: Longitudinal cracks between Deodar Street and West Street

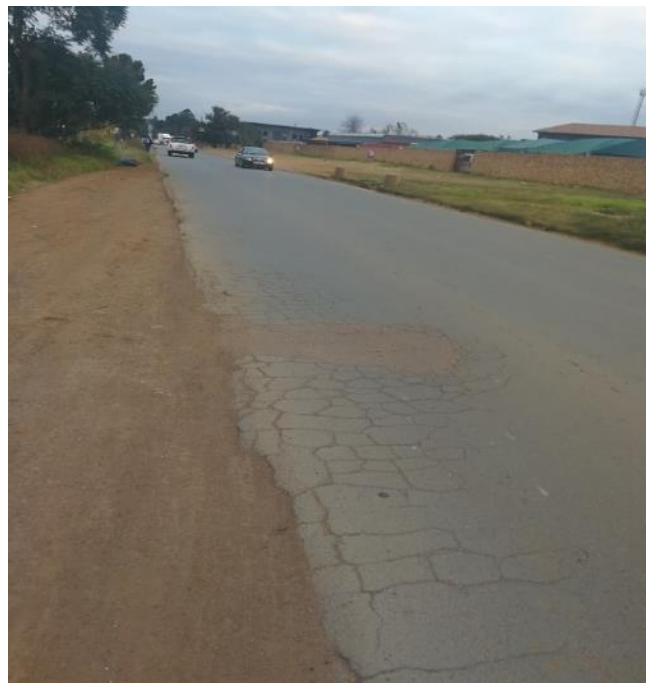
Pumping is present intermittently mostly in the wheel tracks where crocodile and block cracking occurs and this is frequent between Maple Street and EP Malan Street, Photo 6.

Photo 6: Pumping on the wheel path between Maple Street - EP Malan Street

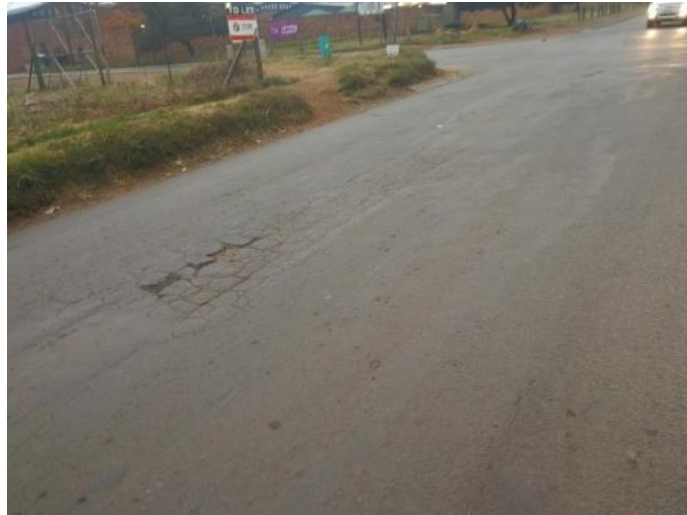
Surface failures are predominantly located in the wheel tracks and mostly due to the severity of crocodile cracking combined with rutting allowing water ingress into the base, Photo 7 and Photo 8. At intersections, surface defects manifests as shoving of an overlay due to turning heavy vehicles, Photo 9.

Photo 7: Surface failure between EP Malan Street and Elgin Street

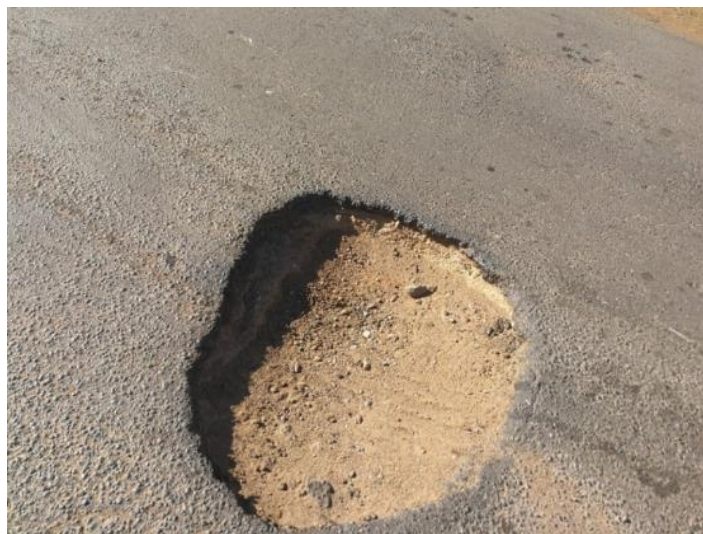
Photo 8: Potholing between Maple Street - EP Malan Street

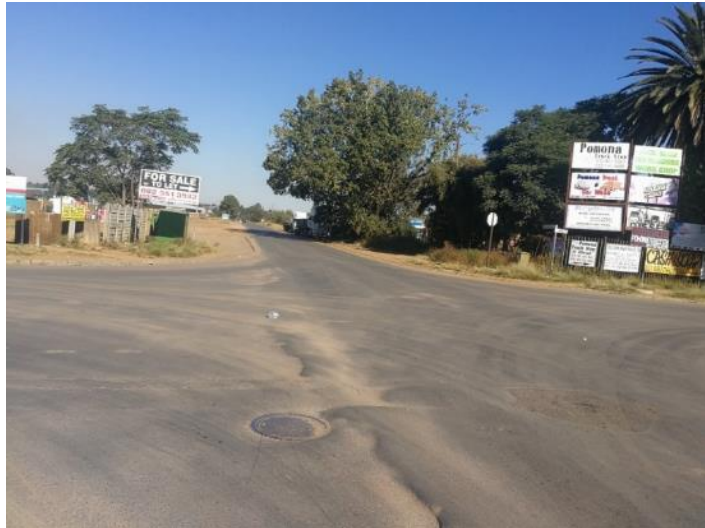
Photo 9: Shoving of surfacing at Maple Street

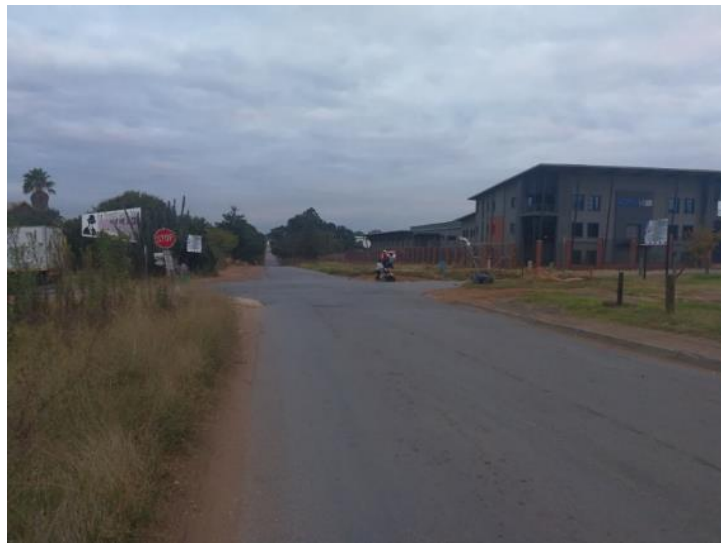
Rutting is prevalent over most of the road, but notably from Maple Street and just before Elgin Street in the outer wheel track of both westbound and eastbound directions Photo 10. Photo 11.

Photo 10: Rutting at the approach to EP Malan Street

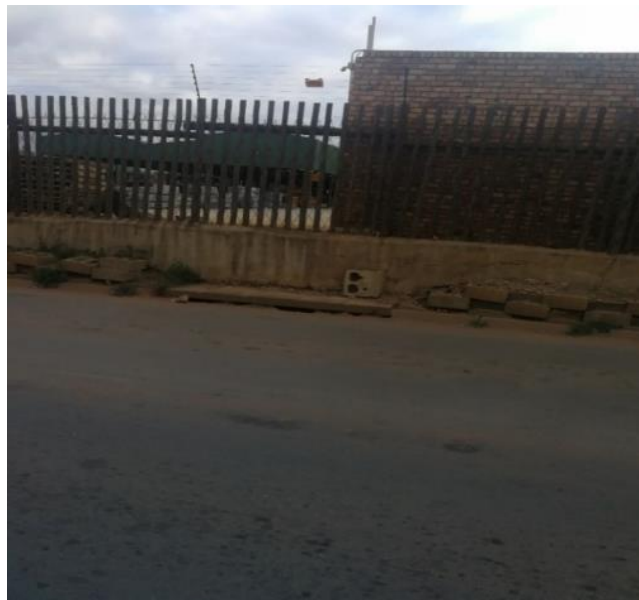
The bleeding is not severe but will have to be taken into consideration when designing a subsequent resurfacing overlay especially between Pomona Road and Maple Street, Photo 12.

Photo 12: Slight bleeding on the wheel path

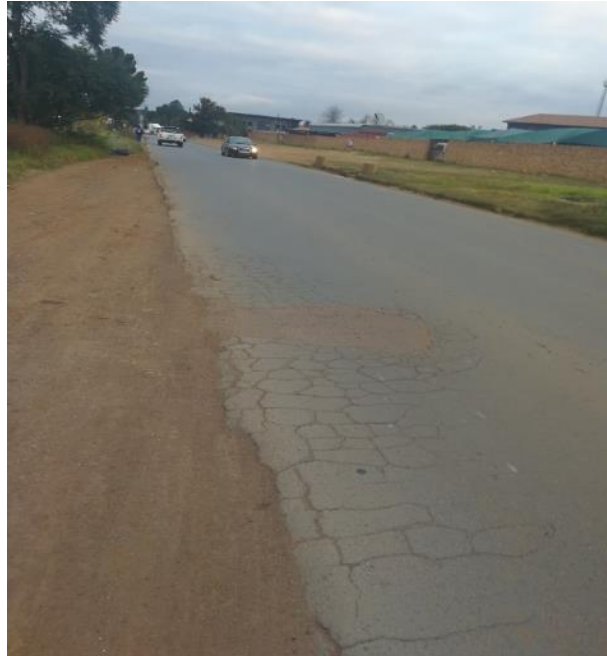
The current condition of the patches varies from fair to very poor, with some patches already failing, Photo 13. Almost the entire Constantia Street has undergone an asphalt overlay in some form on the full roadway.

Photo 13: Patchwork on the wheel path where rutting and crocodile cracking have advanced between Maple Street - EP Malan Street

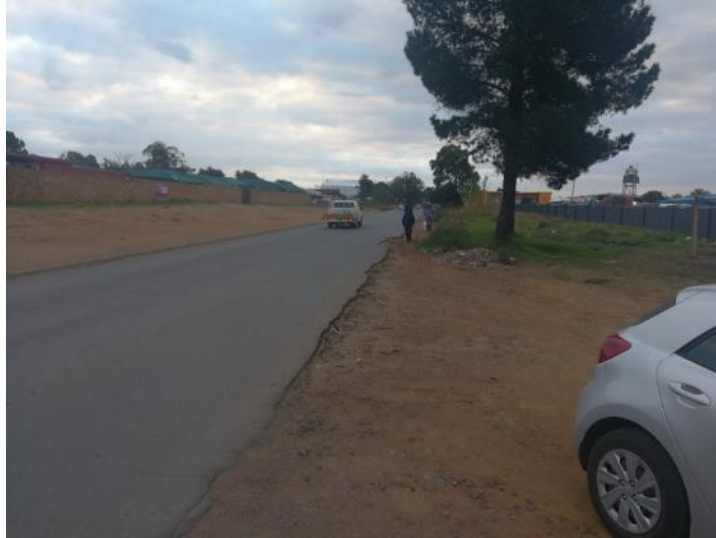
Isolated occurrences of edge breaks are present along the road, most notably from Maple Street to West Street, Photo 14. This is also the case at certain accesses along the street. Edge beams or kerbs will be required during the upgrade to minimise future damage and consideration be made for the access at the informal settlement.

Photo 14: Edge breaks between Maple Street - EP Malan Street

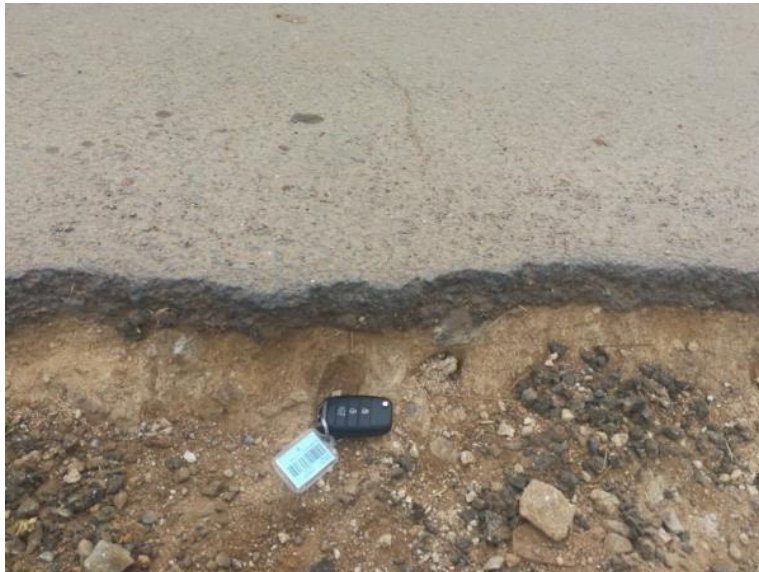
Edge drops were noticed where drainage was not properly done resulting in the scouring of the gravel shoulder during a storm, Photo 15.

Photo 15: Edge drops between Maple Street - EP Malan Street

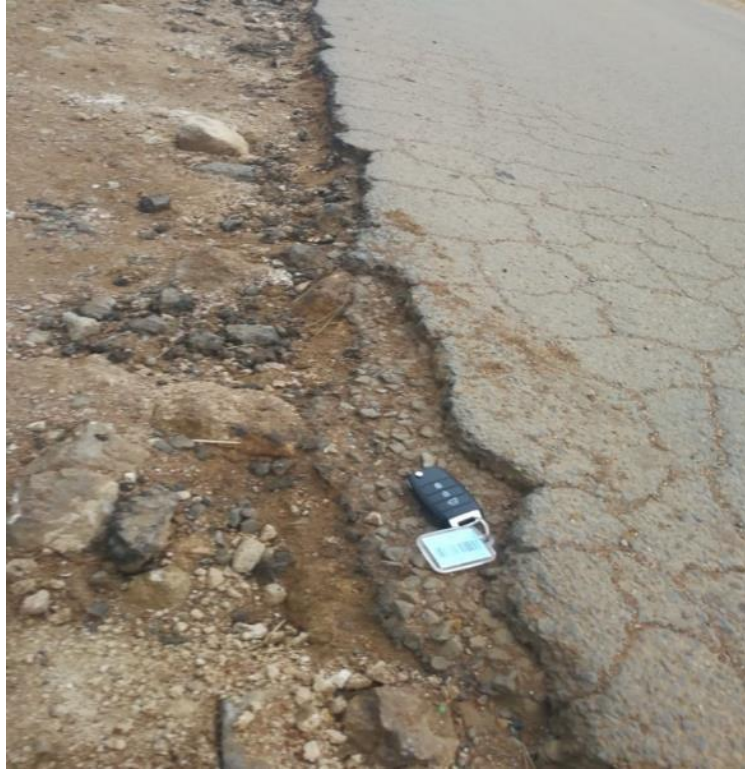
Photo 16: Edge drop resulting from scouring of the gravel shoulder

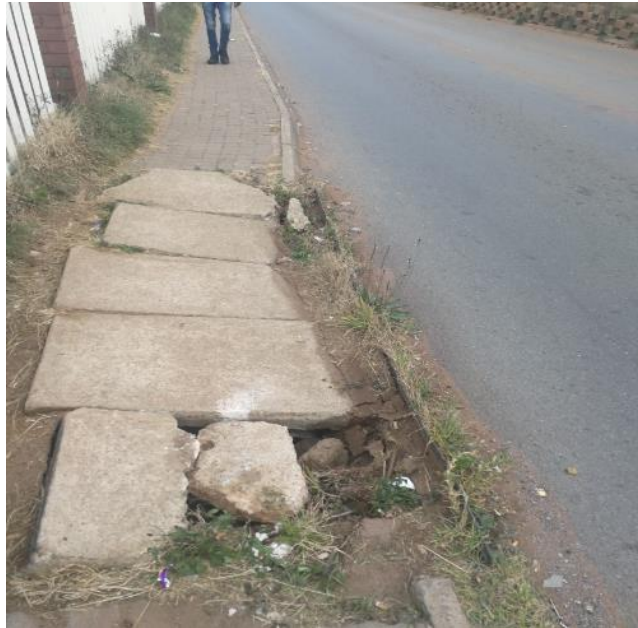
The existing storm water drainage structures are generally in a poor state with blocked kerb inlets and damaged covers, Photo 17 and Photo 18.

Photo 17: Blocked kerb inlet between Pomona Road - Maple Street

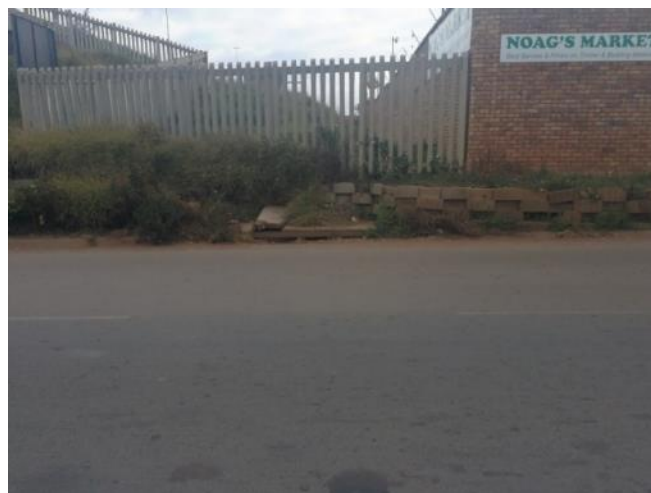
Photo 18: Blocked kerb inlet between Pomona Road - Maple Street

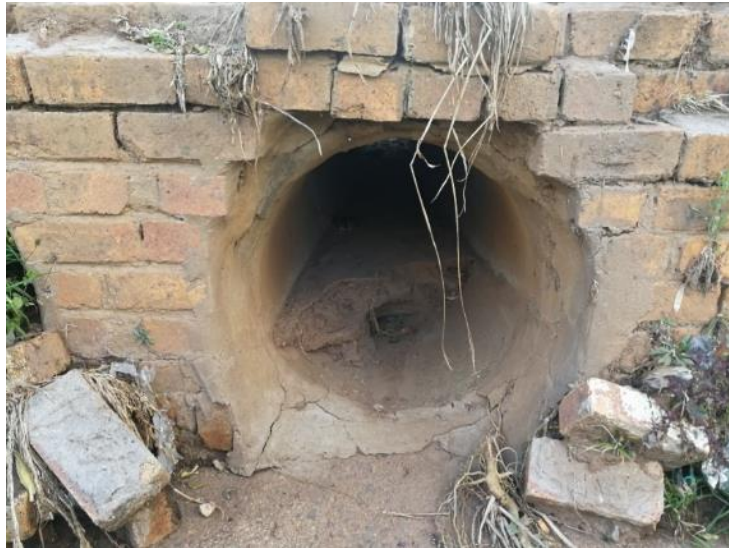
At the small stream, the pipe culverts were blocked which could result in flooding during flush rainy periods, Photo 19.

Photo 19: blocked culvert pipes at the small stream

Special attention should be given to the drainage in this area and it is proposed that the possibility be investigated to construct proper storm water drainage or gravel side drains on grade and levels separate from the road to try and resolve standing water in road prism and erosion of the shoulder. The road prisms are shown in the photos that follow.

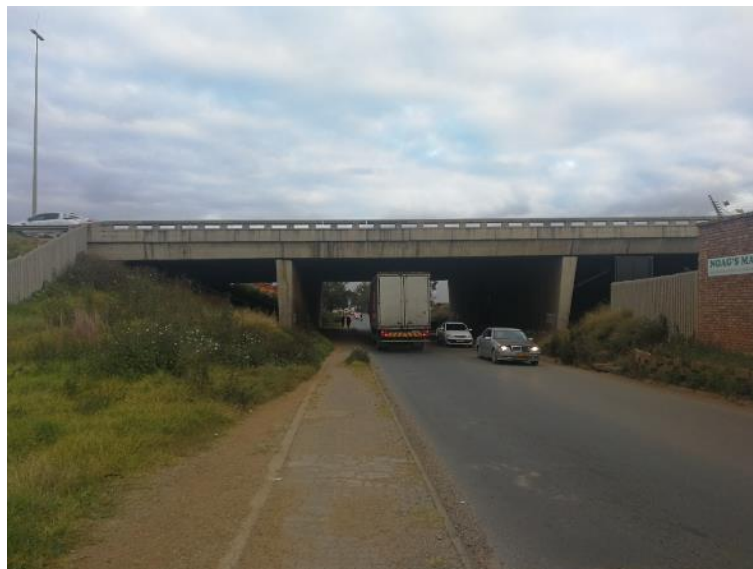
Photo 20: Road prism between Pomona Road - Maple Street

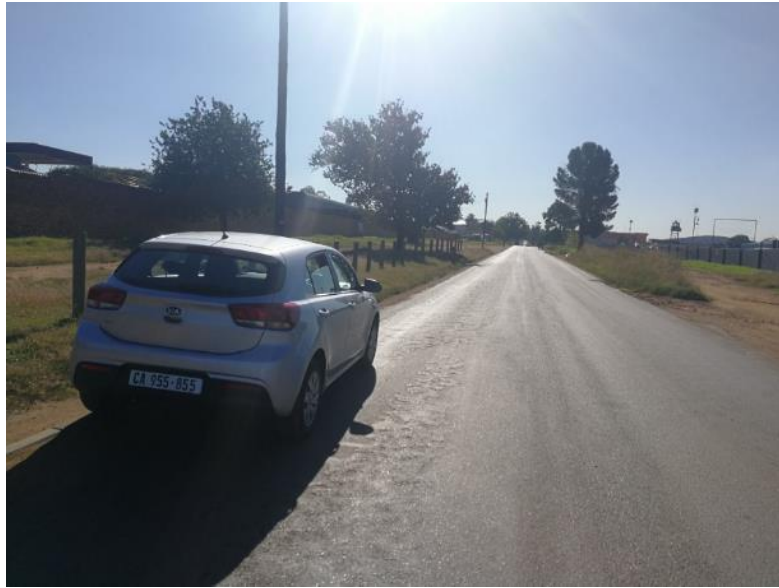
Photo 21: Road prism between Maple Street and EP Malan Street

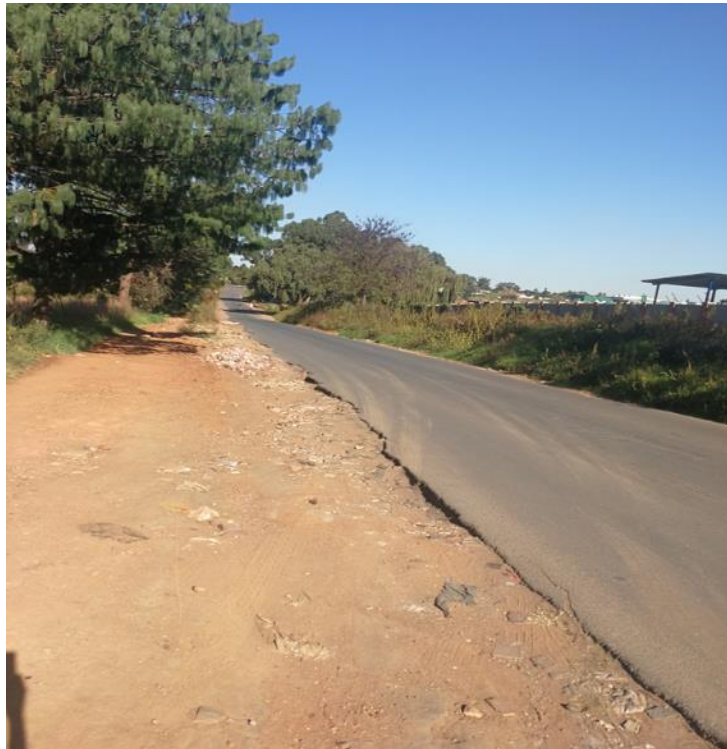
Photo 22: Road prism between EP Malan Street and Elgin Street

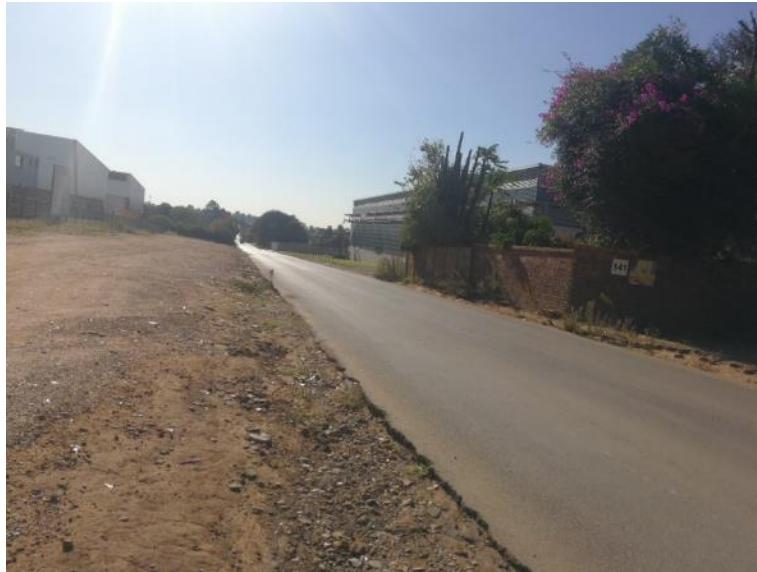
Photo 23: Road prism between Elgin Street and Deodar Street

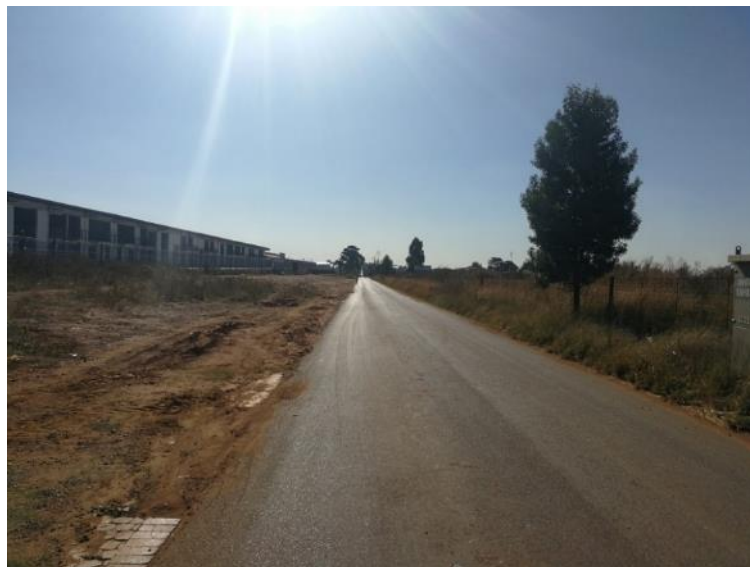
Photo 24: Road prism between Deodar Street - West Street

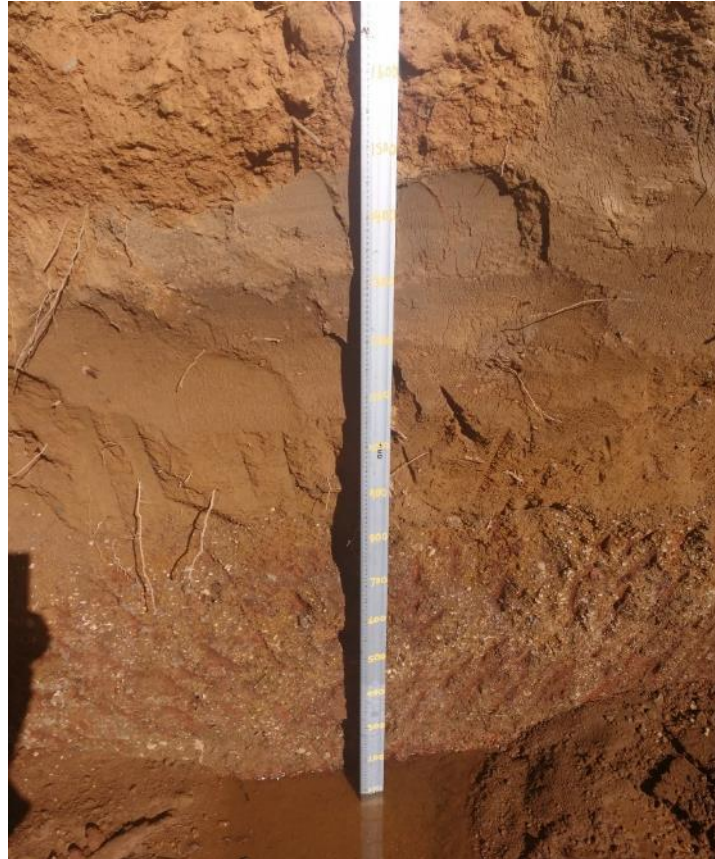
The road reserve is covered by an average 800mm thick layer of sandy and silty colluvium. No rock outcrop was observed, Photo 25. Diamictite residuals were encountered that overlain the bedrock, which is a matrix supported gravel, that is, gravel of mixed origin within clayey, silty or sandy matrix, Photo 26. From the TLB excavations, the lower portion of diamictite is cemented and would present intermediate to hard excavation.

Photo 25: Typical road reserve material encountered during hand and TLB excavations

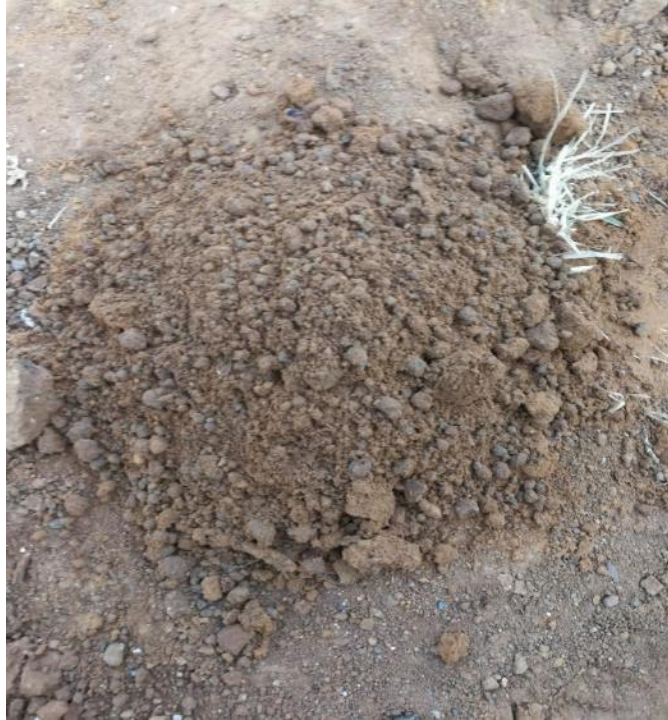
Photo 26: Residual material consisting of diamictite , nodules of a matrix supported gravel

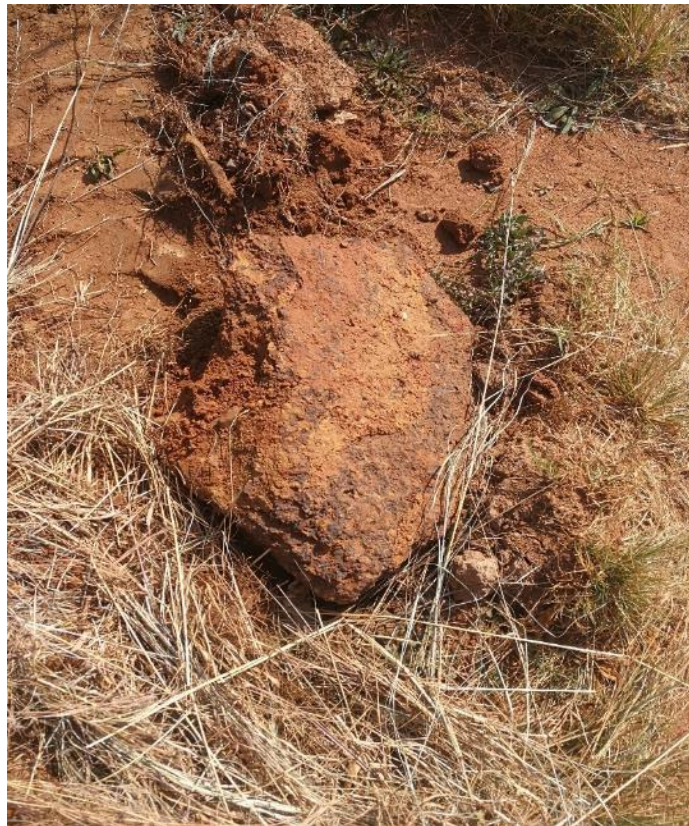
Photo 27: Cemented Diamictite encountered at a depth of 1500mm

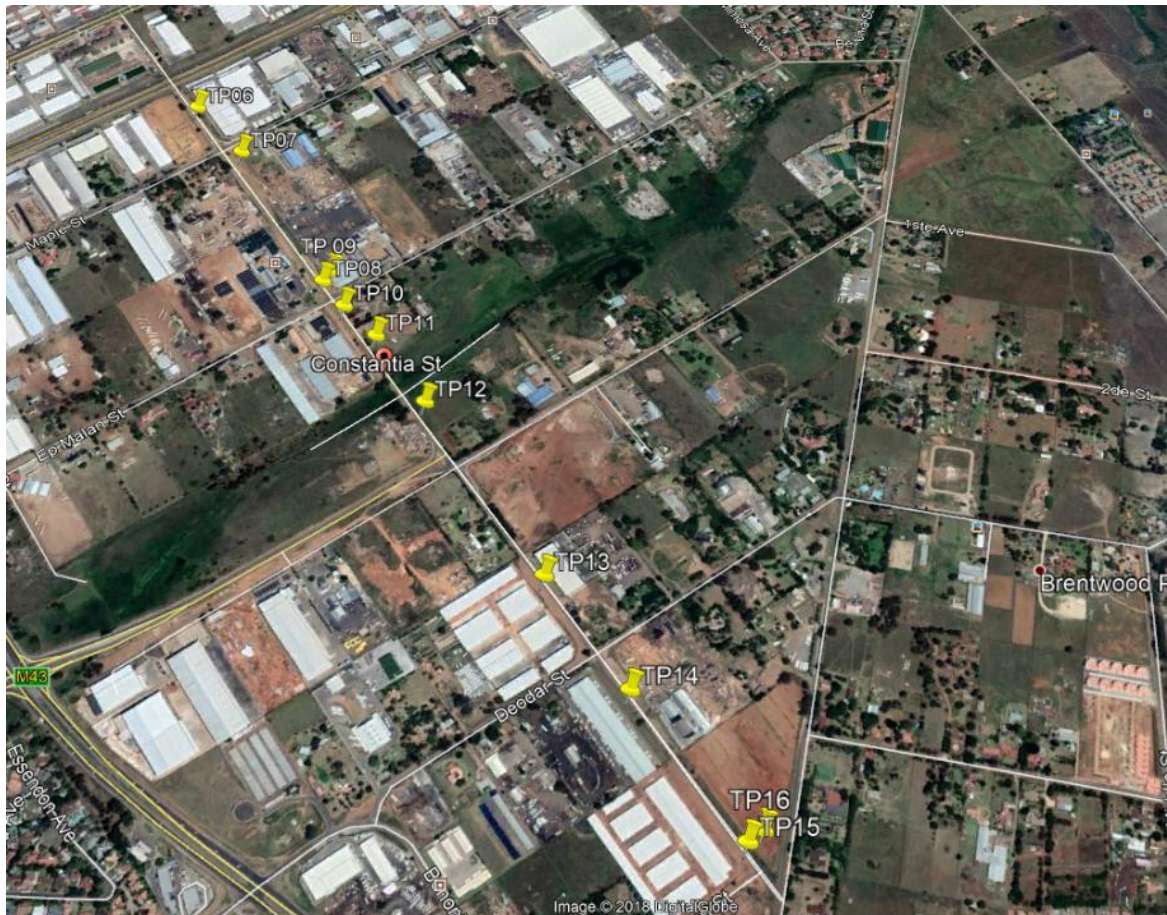
Figure 4: Position of test pit on the road reserve

The position of test pits done on the road reserve are shown in Figure 4 and Appendix A. The summary of test pit information is in Table 2.

Test Pit	Position	Description
TP06	26° 5'54.58"S 28°15'43.41"E	Between Pomona Road and Maple Street. TLB refusal at 1700mm. Underground water encountered on the bedrock.
TP07	26° 5'58.49"S 28°15'47.33"E	Intersection at Maple Street. No underground water. TLB refusal at 1300mm.
TP08	26° 6'9.27"S 28°15'54.75"E	Intersection at EP Malan at the West Bound reserve. TLB refusal at 1200mm. Very moist conditions and no underground water encountered.
TP09	26° 6'8.50"S 28°15'55.26"E	Intersection at EP Malan at the East Bound reserve. TLB refusal at 1000mm. Moist conditions and no underground water encountered.
TP10	26° 6'11.19"S 28°15'56.48"E	Intersection at EP Malan at the West Bound reserve. TLB refusal at 1300mm. Perched water encountered. Roots and building rumble.
TP11	26° 6'13.41"S 28°15'58.97"E	Between EP Malan and Elgin Street. TLB refusal at 900mm. Perched water encountered. Roots and building rumble.

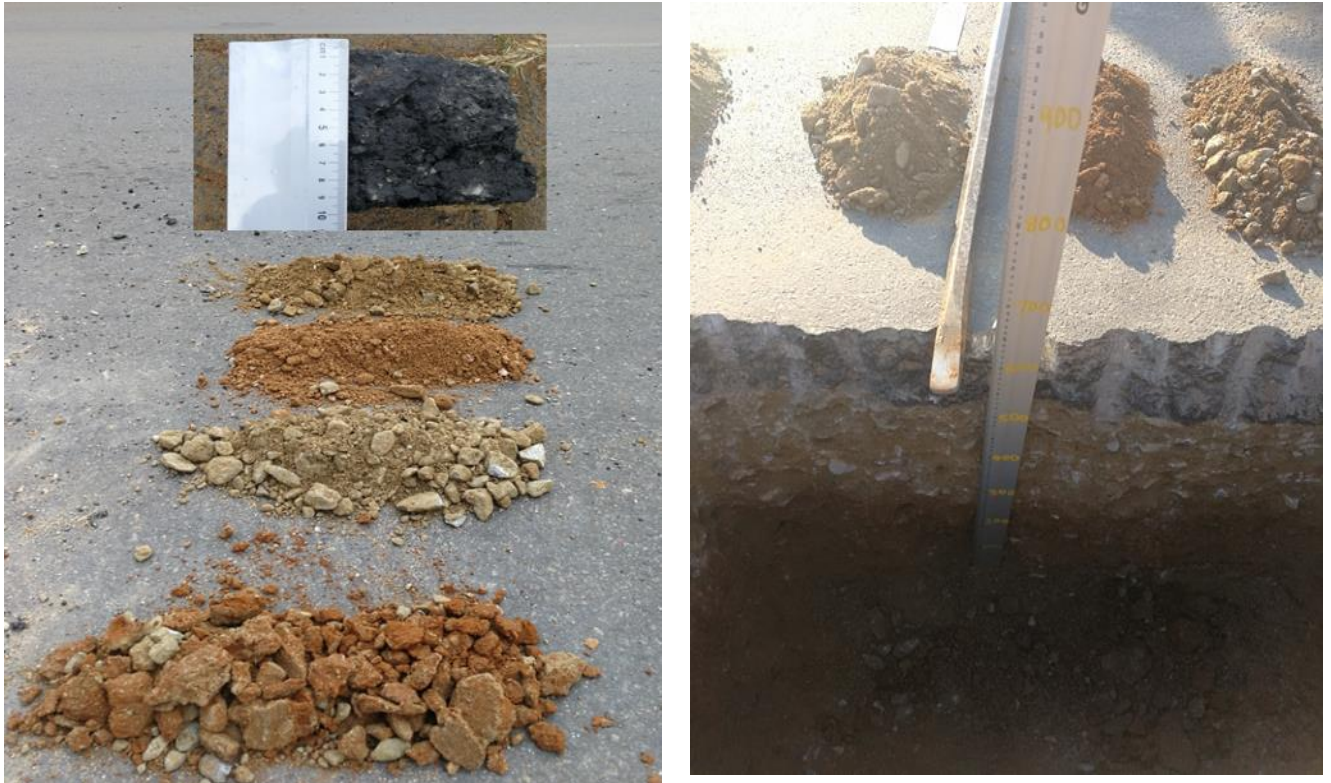
Photo 28: Pavement materials: Test Pit 1 between Pomona Road and Maple Street

The section between Pomona Road and Maple Street can be said to be in a good condition and would require rehabilitation in the form of base repair, milling and re-surfacing along the roadway. The two intersections would require re-working of the base layer and resurfacing.

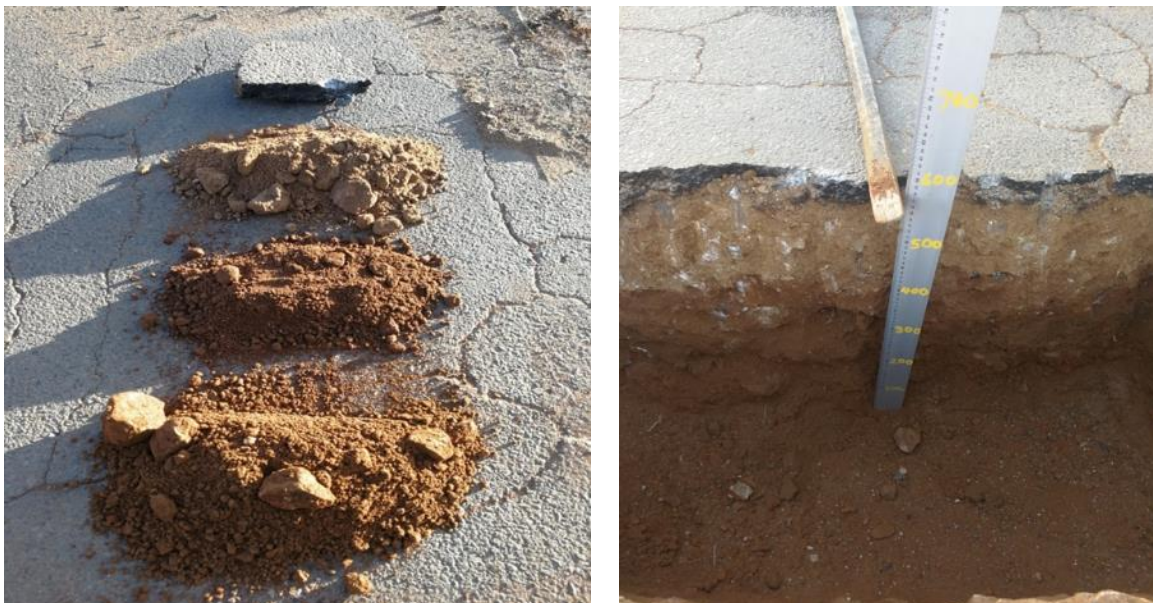
Photo 29: Pavement materials: Test Pit 2 between Maple Street and EP Malan Street

The materials recovered between Maple Street and EP Malan Street are shown in Photo 29. This section would require rehabilitation in the form of reworking the base layer and resurfacing.

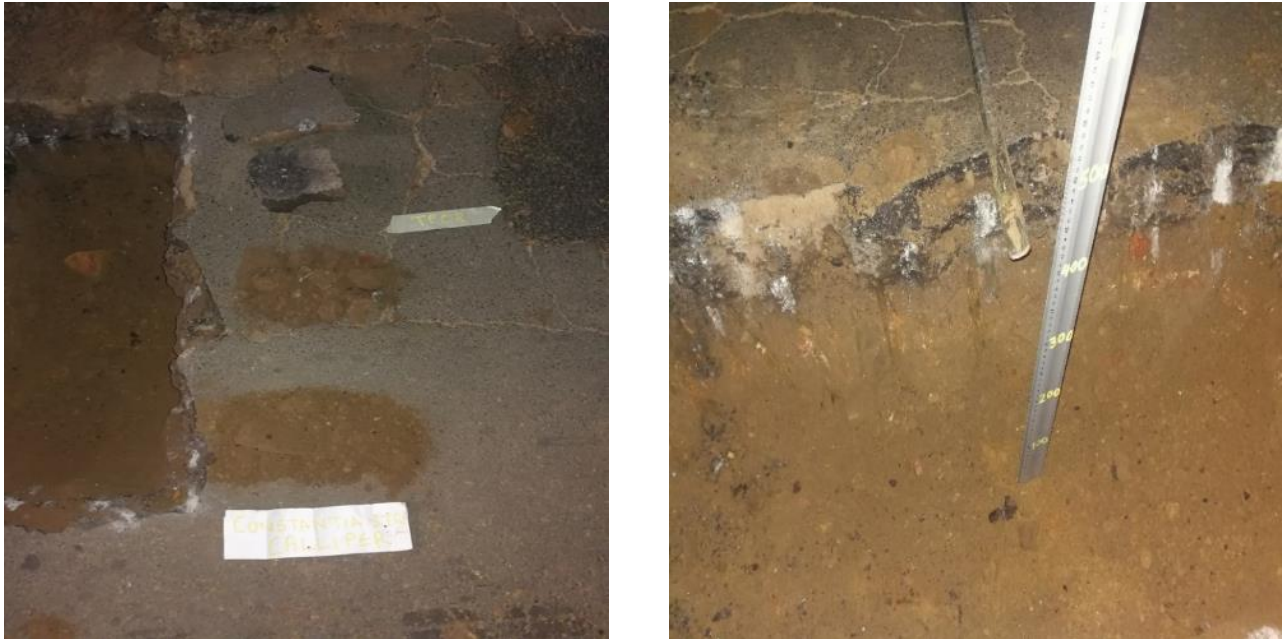
Photo 30: Pavement materials: Test Pit 3 between EP Malan Street and Elgin Street

This section would require rehabilitation in the form of reworking the base layer and resurfacing.

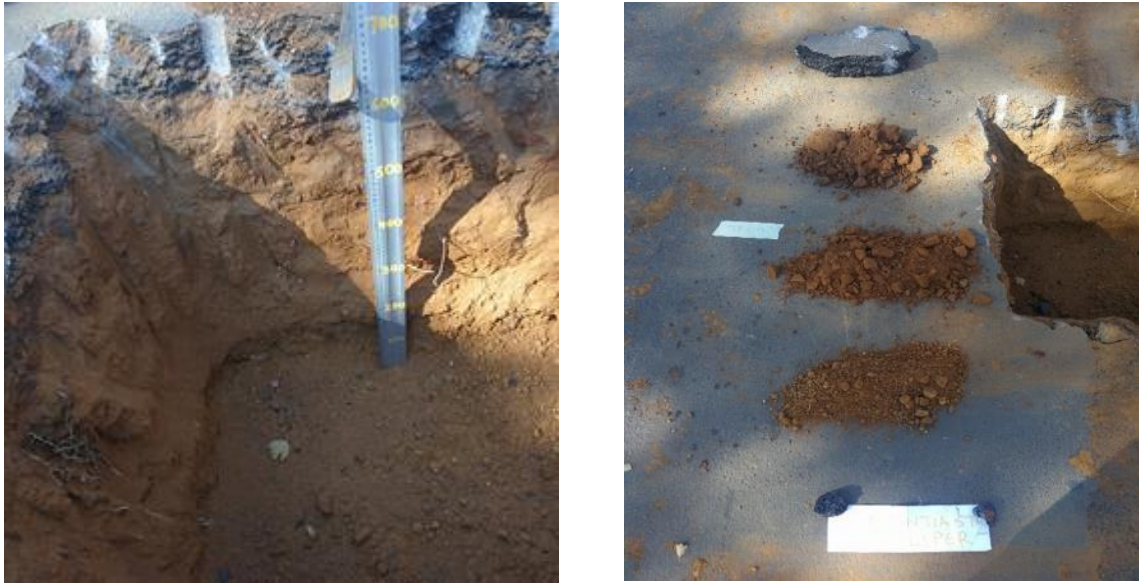
Photo 31: Test Pit 4 profile and pavement materials

This section would require rehabilitation in the form of reworking the base layer and resurfacing.

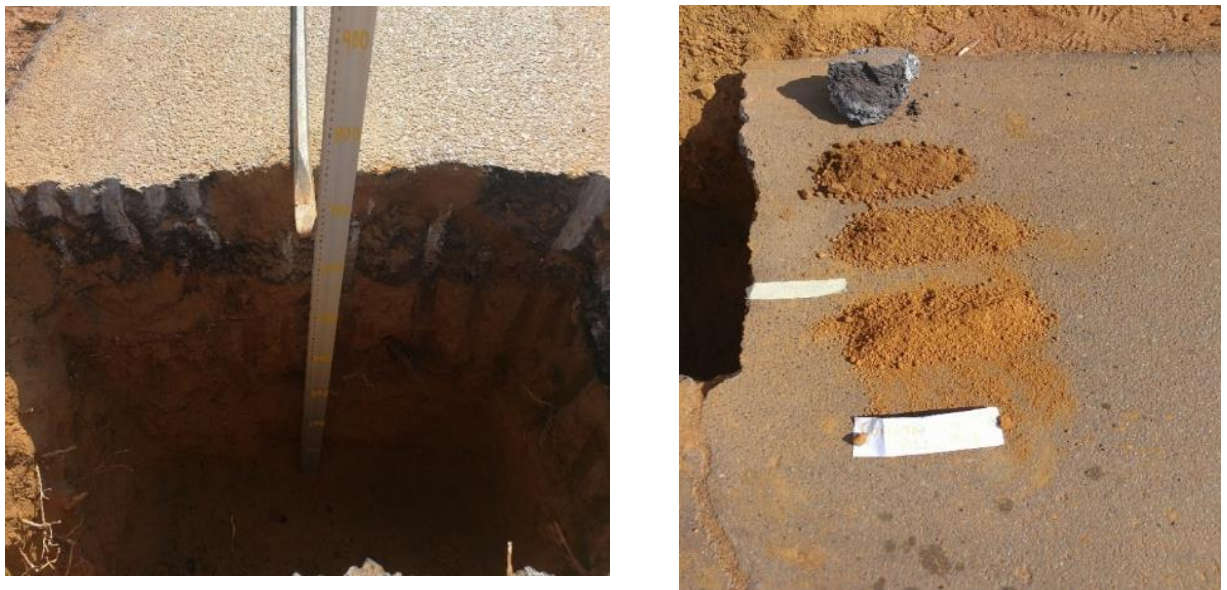
Photo 32: Test Pit 05 profile and pavement materials

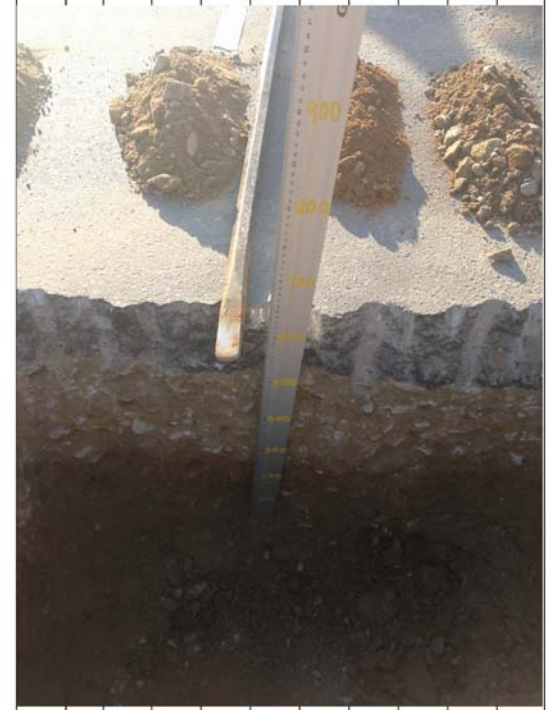
4. D				Yellow Orange Brown Silty Sandy Gravel																																					
5. D				Crusher run gravel , imported

6. D				Dark Red Orange, Clayey Sandy Gravel (diamictite)

1.20 m : End of borehole.

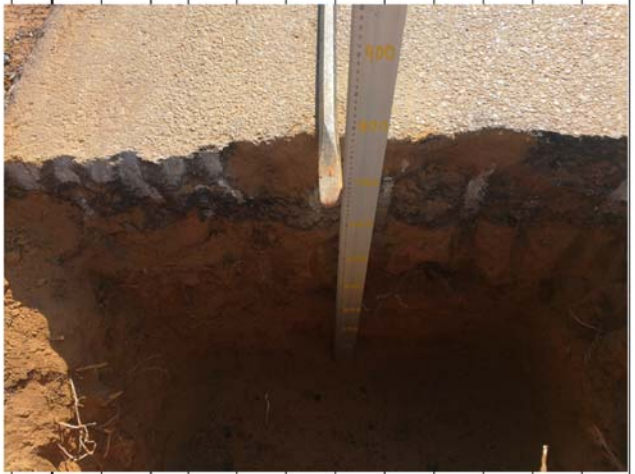
Light Orange Brown Clayey Sandy Gravel																																				
				Dark Red Speckled Black, Silty Clayey Gravel (diamictite)

1
1.00 m : End of borehole.
