REF. NO.: 2017/162

DATE: MARCH 2019

PRE-APPLICATION BASIC ASSESSMENT REPORT FOR THE PROPOSED CONSTRUCTION OF THE SOUTH EMERGENCY ACCESS ROAD AT THE KING SHAKA INTERNATIONAL AIRPORT, KWAZULU NATAL

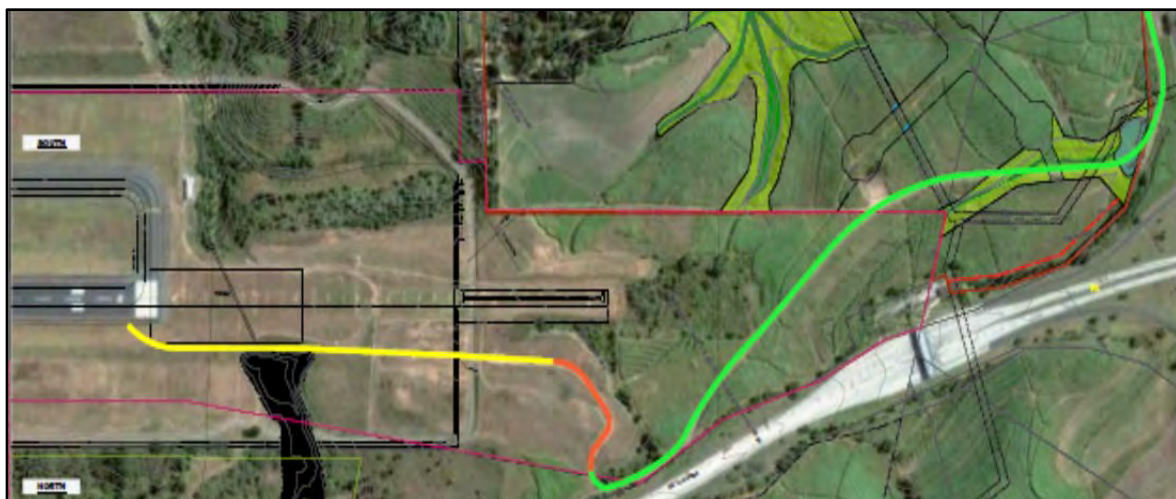
Figure 1 Proposed KSIA North Emergency Road

- The road will be constructed east of the runway and be in line with the existing emergency access gate (represented in yellow in the figure below).
- The area out the emergency access gate will be re-gravelled as it has been severely eroded over the years (represented in orange in the figure below).
- The rest of the road up until Watson Highway will be left in its current state, as it is accessible and will only require normal maintenance for gravel roads (represented in green in the figure below).

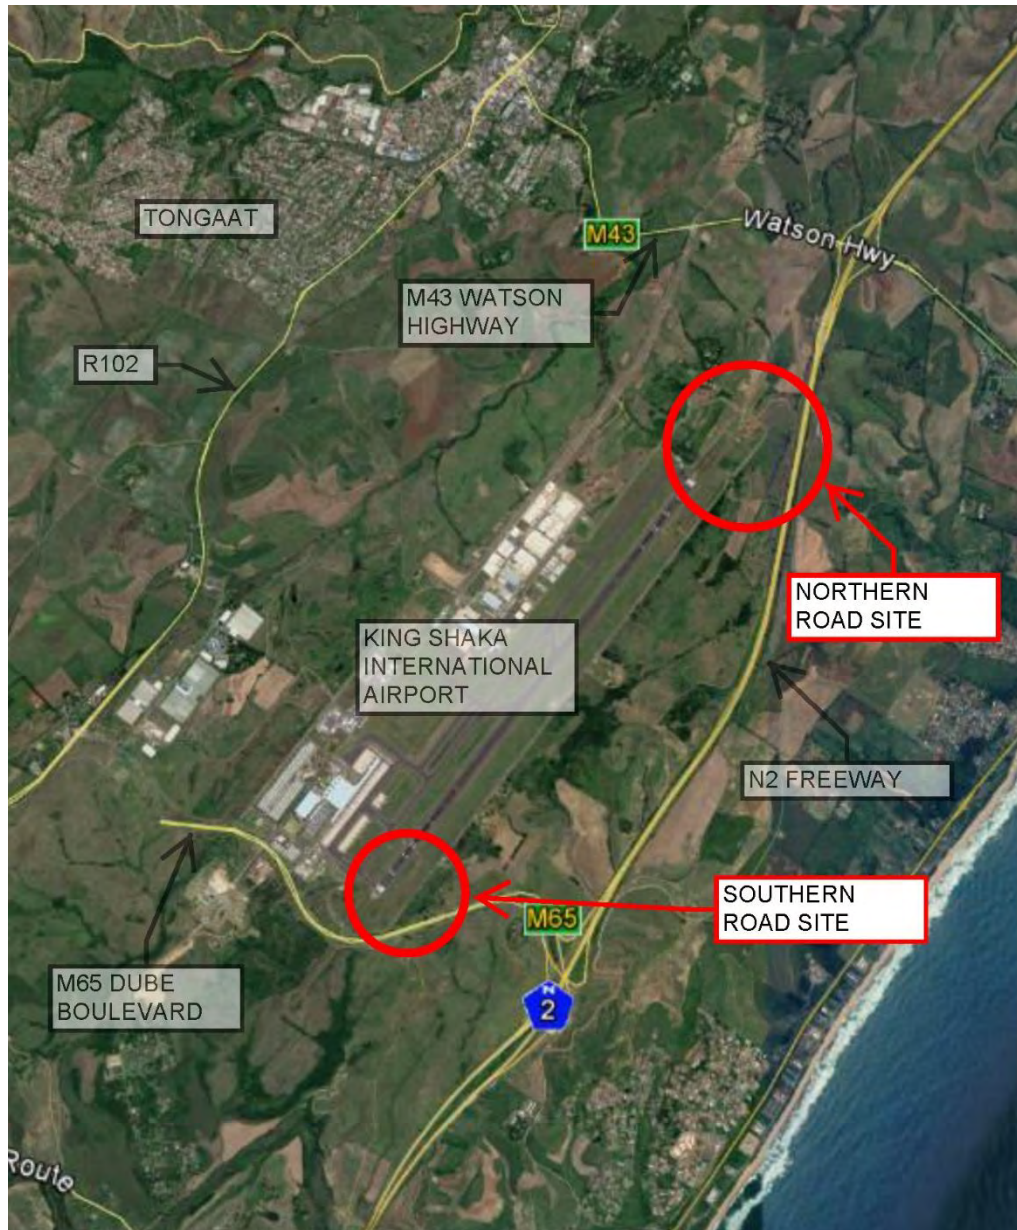
1.4 Locality Sketch

The locality sketch below indicates the position of the two roads forming part of this project

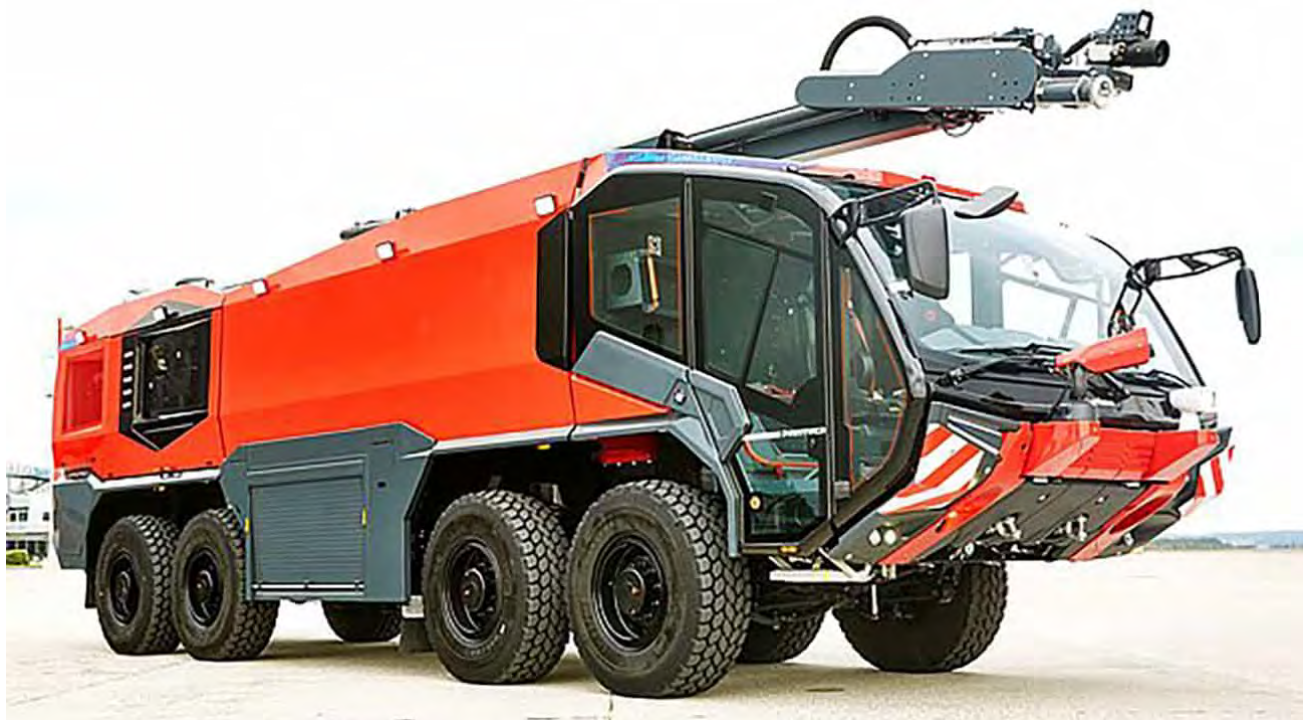
Figure 4: Picture of the design vehicle, the Panther 8x8

The criteria given in the brief regarding the loadings on this road is for an 80t vehicle. However, the most common heavy vehicle to utilise this road on a regular basis is the Panther 8x8 emergency response vehicle with a maximum operational weight of 52t, giving a wheel load of 6.5t. This vehicle and its wheel and axle loadings were used in the analysis of the pavement design. A picture of the Panther 8x8 is presented in Figure 4.

The axle configuration and spacing are important parameters for the determination of the traffic loading in pavement design. From Figure 4 it is observed that the Panther 8X8 has two tandem axles with single wheels. The length x width x height dimensions of the Panther 8x8 are 11,995 x 3,000 x 3,650mm. However, no information on the wheel and axle spacing was available. However, the axle spacing of the Panther 6x6 was available as shown in Figure 5 and it was assumed that the Panther 8x8 axles would be spaced similarly.

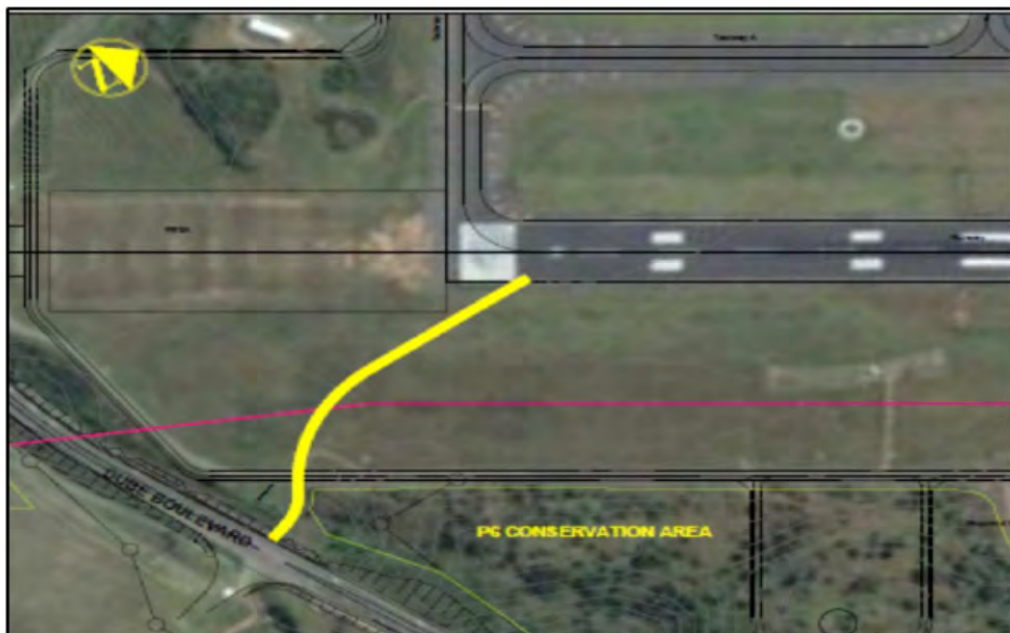
Figure 2 Proposed Alignment of the emergency road

The road is proposed to be 6m wide and 320m long, from Runway end 06 to Dube Boulevard, the road will have capacity to withstand 80 tons and will be in line with existing Emergency Access Gate 3.

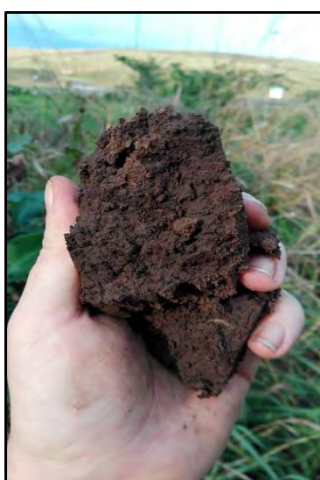
All soils sampled within the study area were dryland soils that showed no signs of wetness / hydric soil indicators. The soil texture⁶ was found to range between moderately textured soils (sandy loam) and fine textured soils (clay loam) with a brown soil matrix⁷ (hue⁸ 10yr; chroma⁹ 4/3; value¹⁰ 2/3). No redoximorphic features like a gleyed matrix or the presence of mottles were found. Strategic sampling points were taken along the moderate to steep terrain. At a number of the sampling locations, signs of soil mixing and infilling from alterations to the landscape (construction of the King Shaka International Airport) made soil sampling and the interpretation of soil colour and morphology extremely difficult. Photos A to C provide an example of soil samples collected onsite. The artificial stormwater wetland is characterised by seasonal to permanent saturated soils, however parts of the stormwater drain is lined with concrete.

A. Example of a typical terrestrial (dryland) soil sample extracted on site.

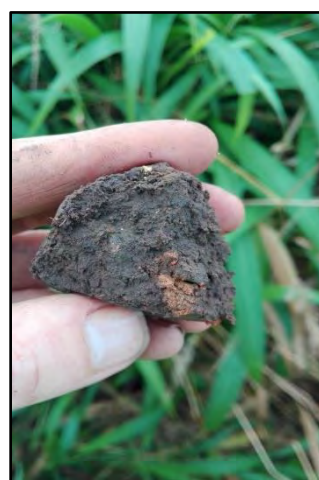
B. Example of a mixed sandy loam soils extracted on site.

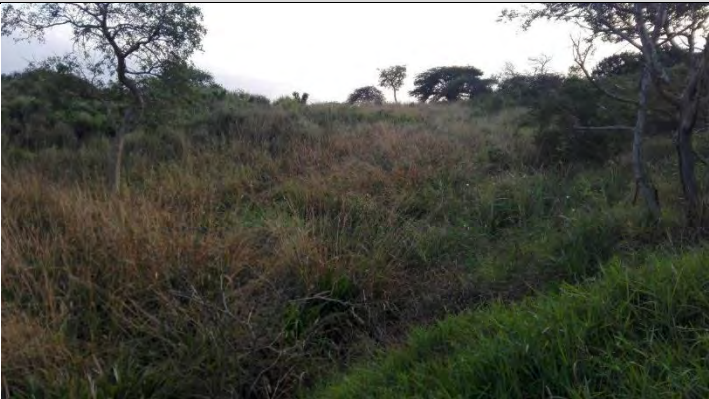
Plant community	Photo
<p>Mixed woody grassland and shrubland within modified valley head landform</p> <p>This small patch occurs upslope of the platform and the stormwater wetland. This patch occurs within an undulating valley-head like landform that appears to have been modified by earthworks in the past. The vegetation can be characterised as a mix of <i>Panicum maximum</i> grassland, scrubland and bushclumps. Other species present within the grassland assemblage include <i>Paspalum urvillei</i>, <i>Setaria megaphylla</i>, <i>Sorghum bicolor</i>, <i>Stenotaphrum secundatum</i>, <i>Cyperus sphaerospermus</i>, <i>Commelina benghalensis</i> and <i>Mimosa pudica</i>. The bushclumps comprised <i>Acacia</i> sp. and <i>Erythrina caffra</i> identified in this area along the edge. Alien species invasion is present but is in low densities. Alien species recorded include <i>Ipomoea purpurea</i>, and <i>Mimosa pudica</i>, <i>Chromolaena odorata</i>, and <i>Lantana camara</i>.</p>

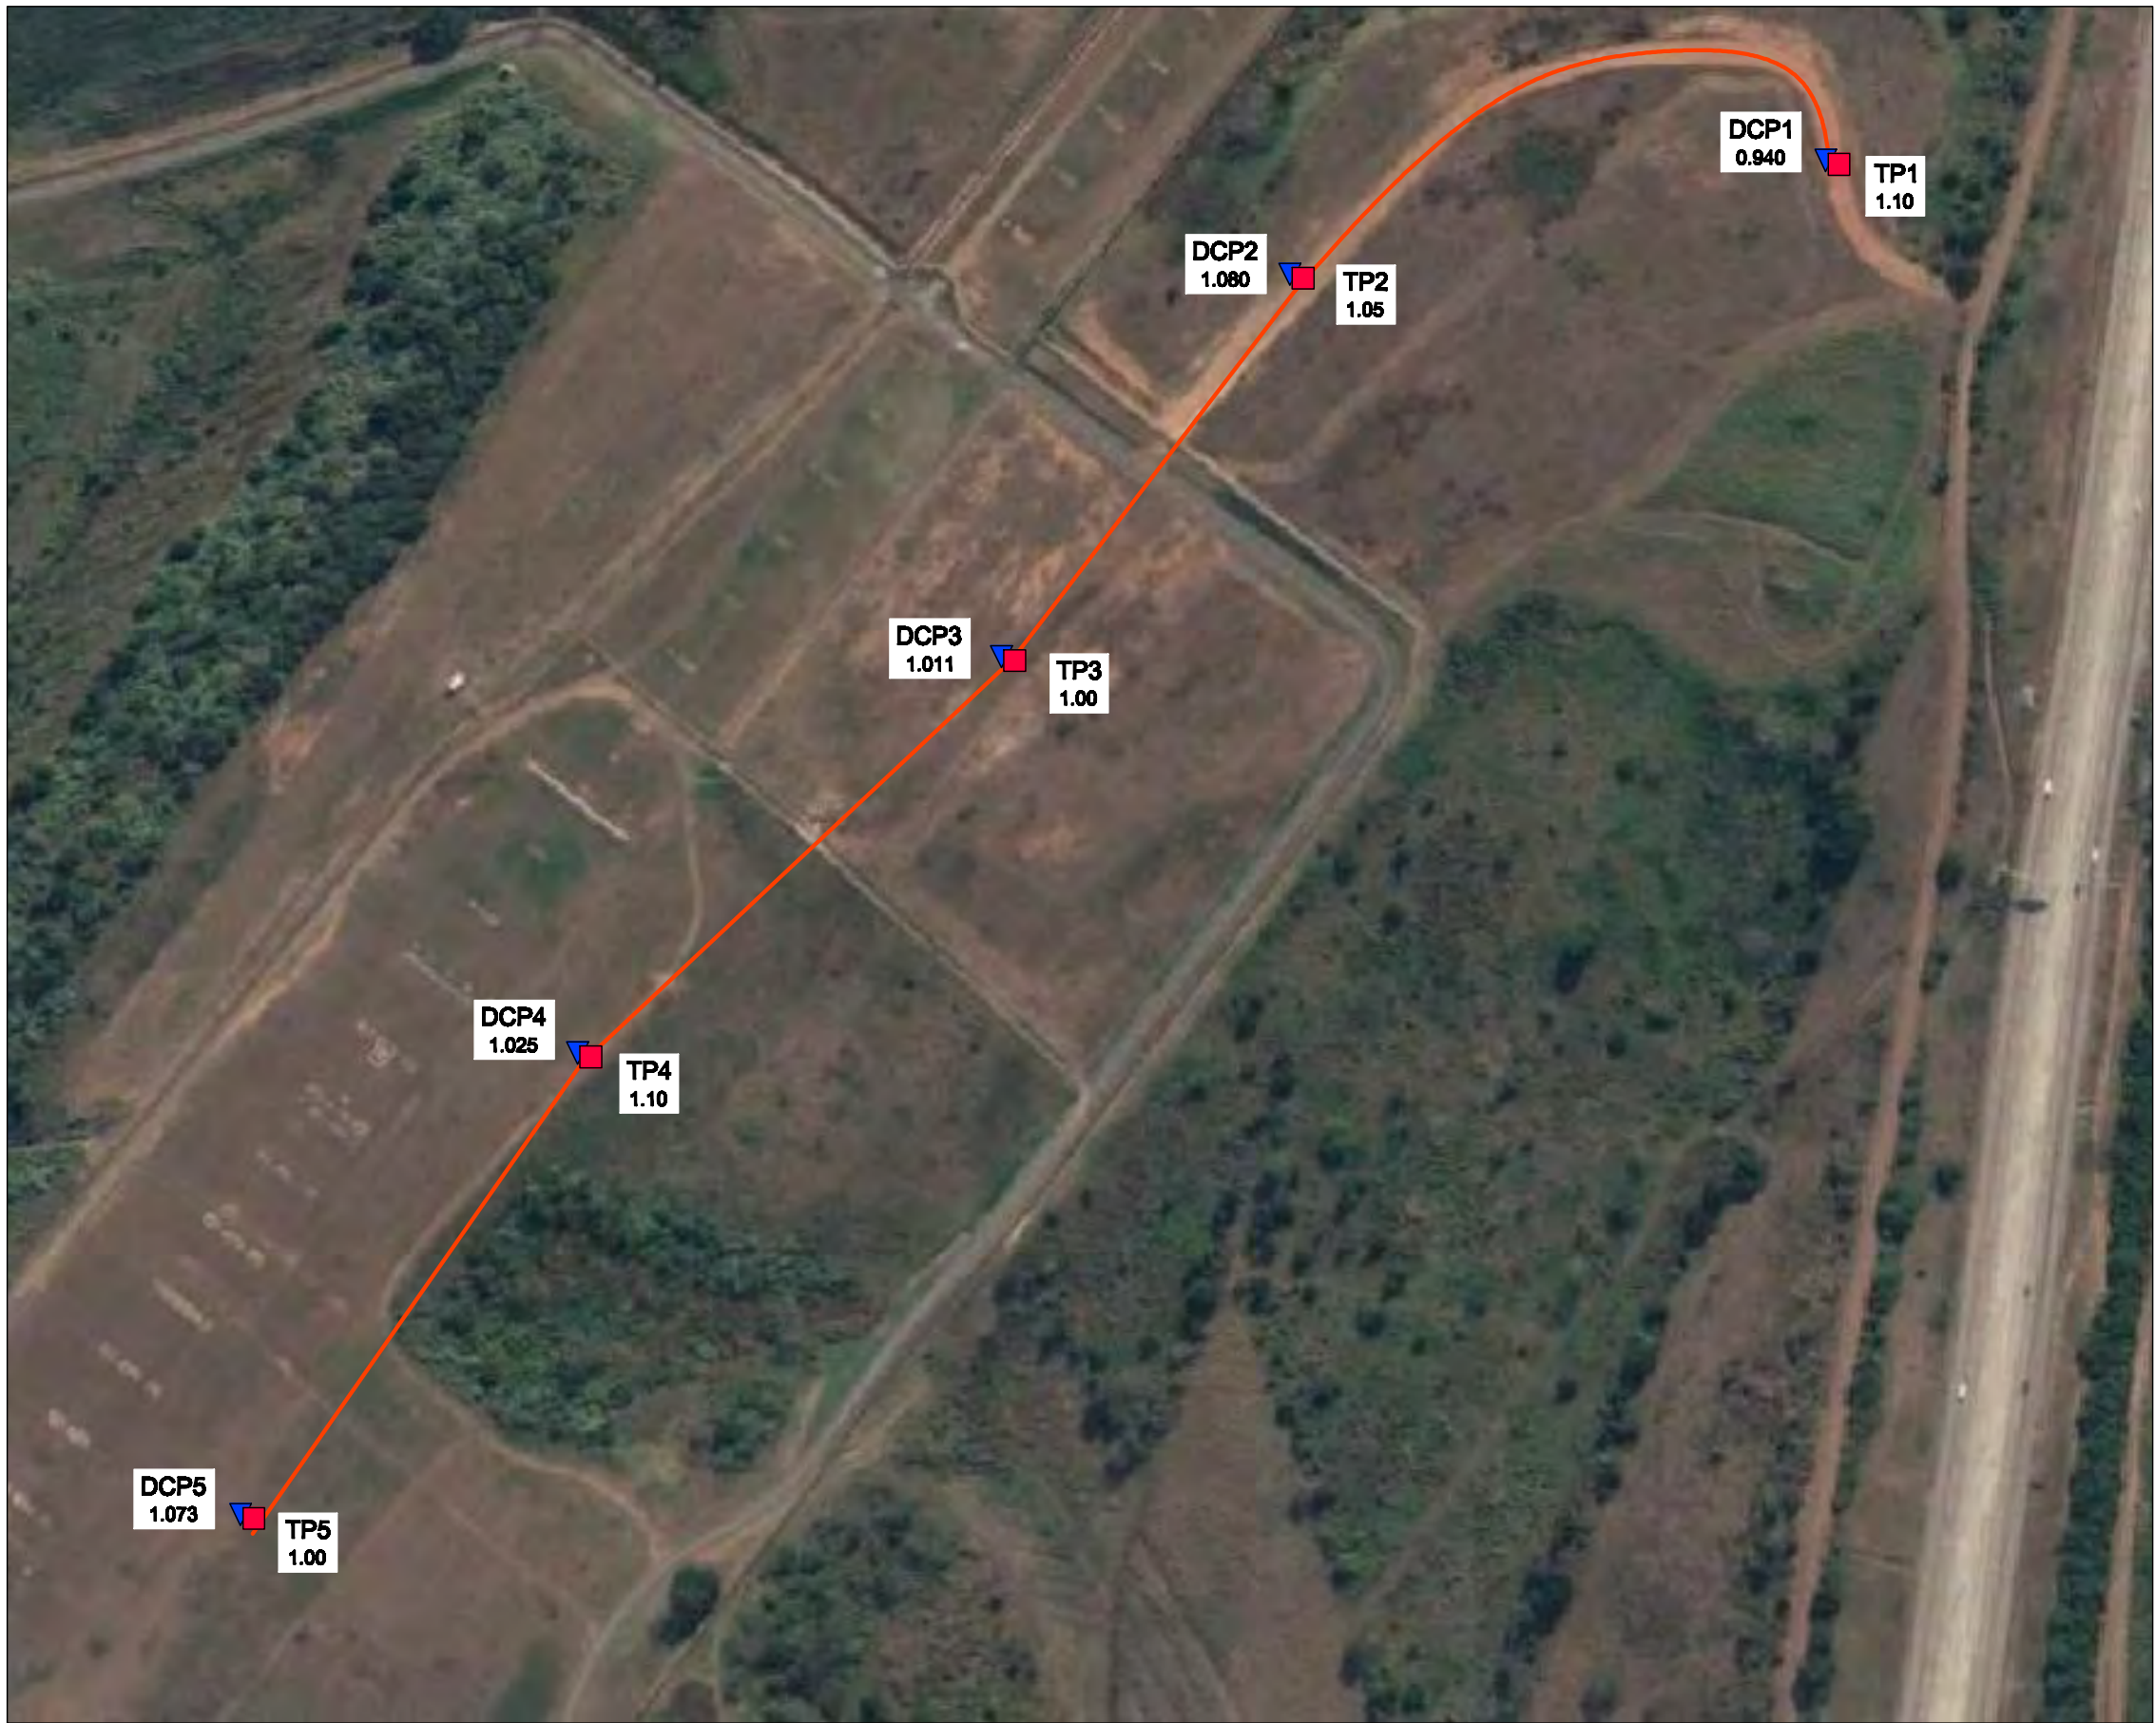
PROJECT REF. NUMBER 18013	REVISION 00	DWG. SIZE A3	FIG. No. 2a
-------------------------------------	-----------------------	------------------------	-----------------------

- TP1 1.10 ■ Approximate position of Test Pit showing final depth or depth to refusal () in metres below ground level
- DCP 1 0.940 ▼ Approximate position of CBR Dynamic Cone Penetrometer Test showing final depth or depth to refusal () in metres below ground level

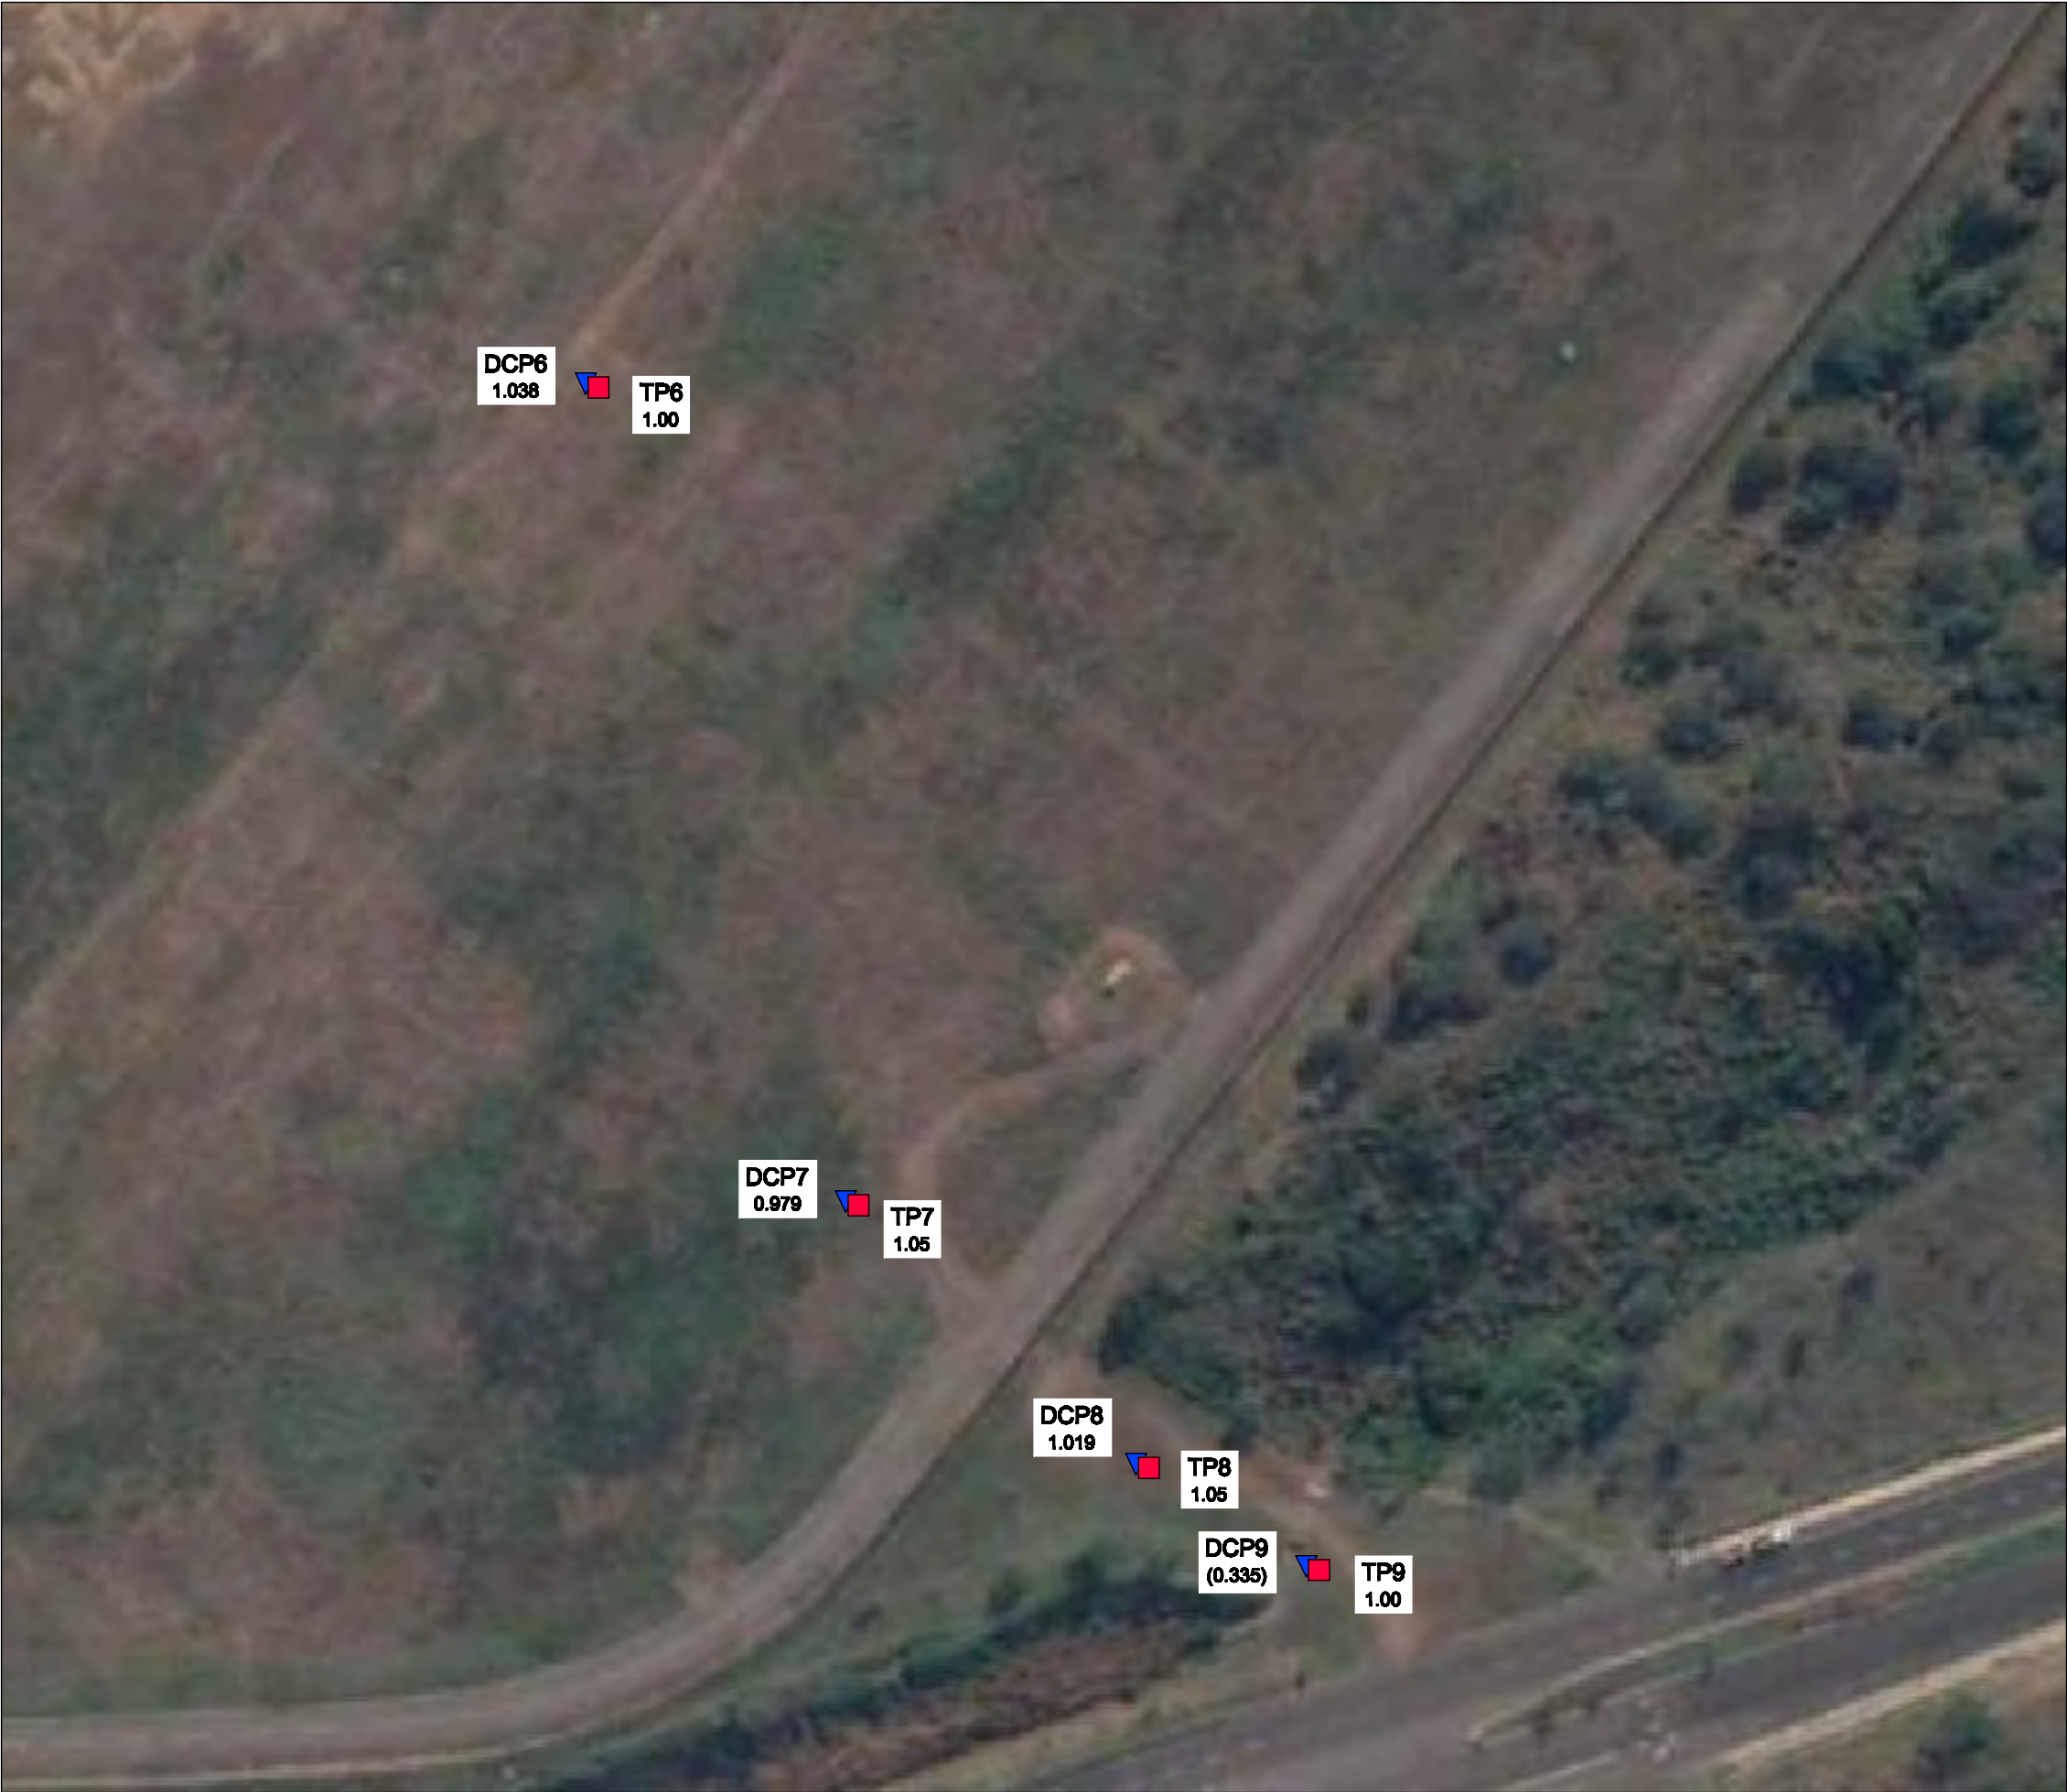
- TP6 1.00 ■ Approximate position of Test Pit showing final depth or depth to refusal () in metres below ground level
- DCP 6 1.038 ▼ Approximate position of CBR Dynamic Cone Penetrometer Test showing final depth or depth to refusal () in metres below ground level
