CLOSURE PLAN FOR THE CLOSURE OF THE KLIPGATKOP PROSPECTING RIGHT

Klipgatkop 115 JQ

SUBMITTED FOR APPLICATION FOR A CLOSURE CERTIFICATE IN TERMS OF SECTION
43 OF THE MPRDA

JULY 2019

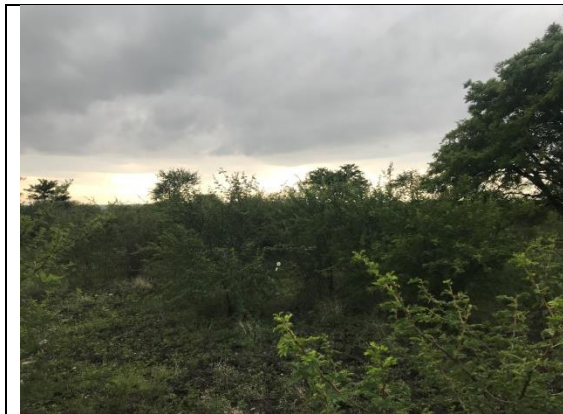
BH7025 (drilled in 2007). Vegetation has successfully re-established (photo taken in 2019)

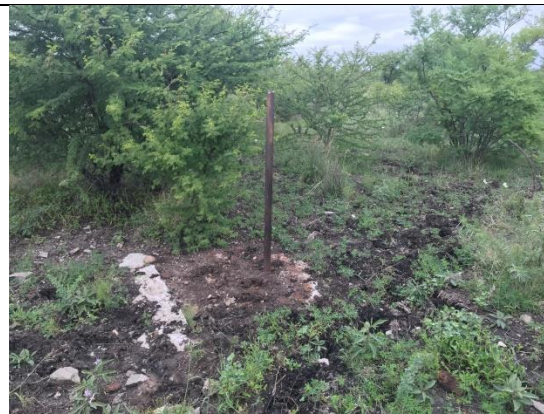
BH7599 (drilled in 2008). Very small section around drill hole re-establishing and rocky. Overall for the site vegetation has re-established, site considered successfully re-established (photo taken in 2019)

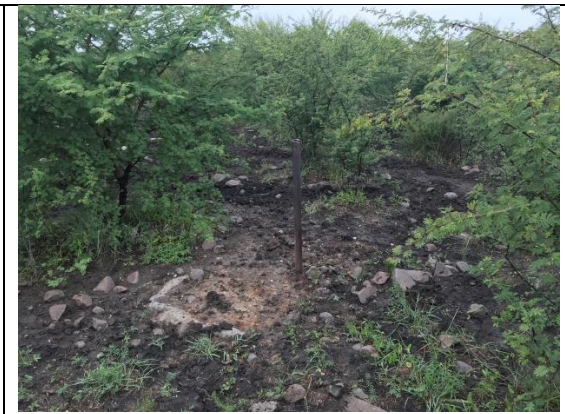
BH7600 (drilled in 2008). Very small section around drill hole re-establishing and rocky. Overall for the site vegetation has re-established, site considered successfully re-established (photo taken in 2019)

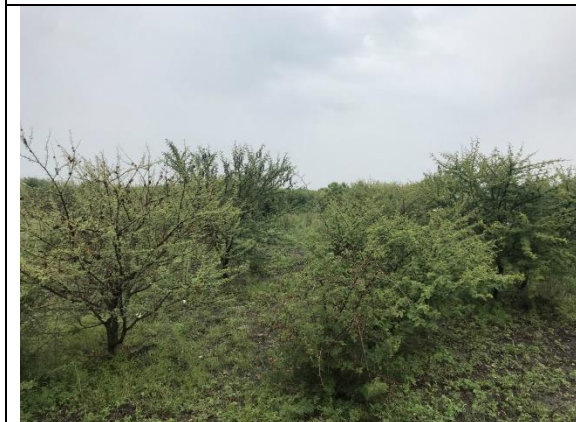
BH7856 (drilled in 2010, 2011 and 2012). Vegetation has successfully re-established (photo taken in 2019)

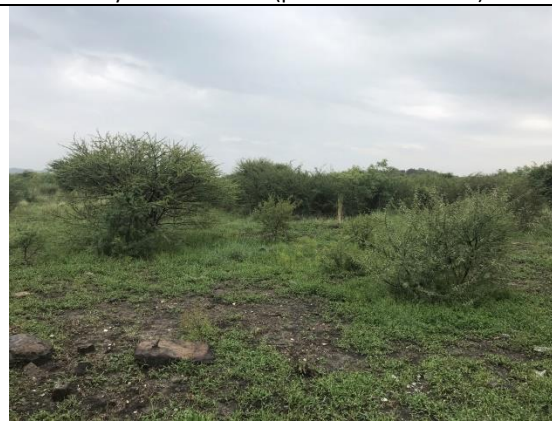
BH8062 (drilled in 2012). Small area still needing further re-establishment. Overall for the site vegetation has re-established, site considered successfully re-established (photo taken in 2019)

- Drill site BH8062 and BH8063: In the most recent Prospecting EMP Performance Assessment (SLR, November 2017) it was recommended that monitoring of the drill site be undertaken until such time as vegetation has re-established to a satisfactory level. During the most recent site visit in April 2019, vegetation was seen to have re-established well. There are still some small patches that need to be further established, though there has been a marked improvement compared to what was seen in the 2015 and 2017 site photographs taken. There is presence of invasive species. The general area around the property looks similar to this prospecting site i.e. the presence of exposed soil; it is likely that the overgrazing in the Klipgatkop prospecting right area hampers the ability of vegetation to fully recover at the drill site. BH8063 also seems less sparse now compared to the pre-

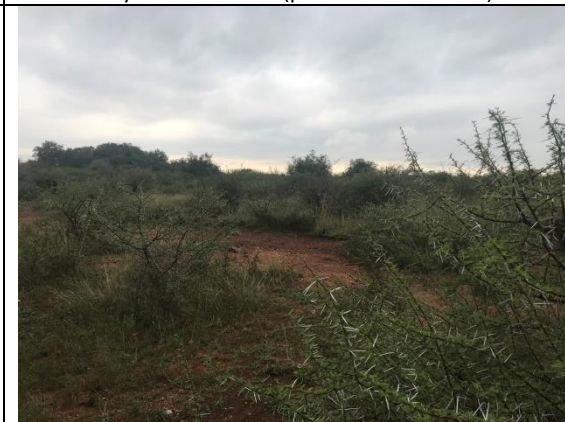
BH8063 (drilled in 2013 and 2014). Small area still needing further re-establishment. Less sparse than pre-drilling baseline. Vegetation considered to have successfully re-established (photo taken in 2019)
