Basic Assessment Report in terms of the National Environmental Management Act, 1998 (Act No. 107 of 1998), as amended, and the Environmental Impact Assessment Regulations, 2014 (Version 1)

The proposed development of the Ekangala Shopping Centre is located at the corner of the R460 and the R568. The site is currently vacant and is not being put to any productive use. There is evidence of pedestrian walking routes across the site and above ground electrical cables along with natural veld grass and isolated clumps of trees.

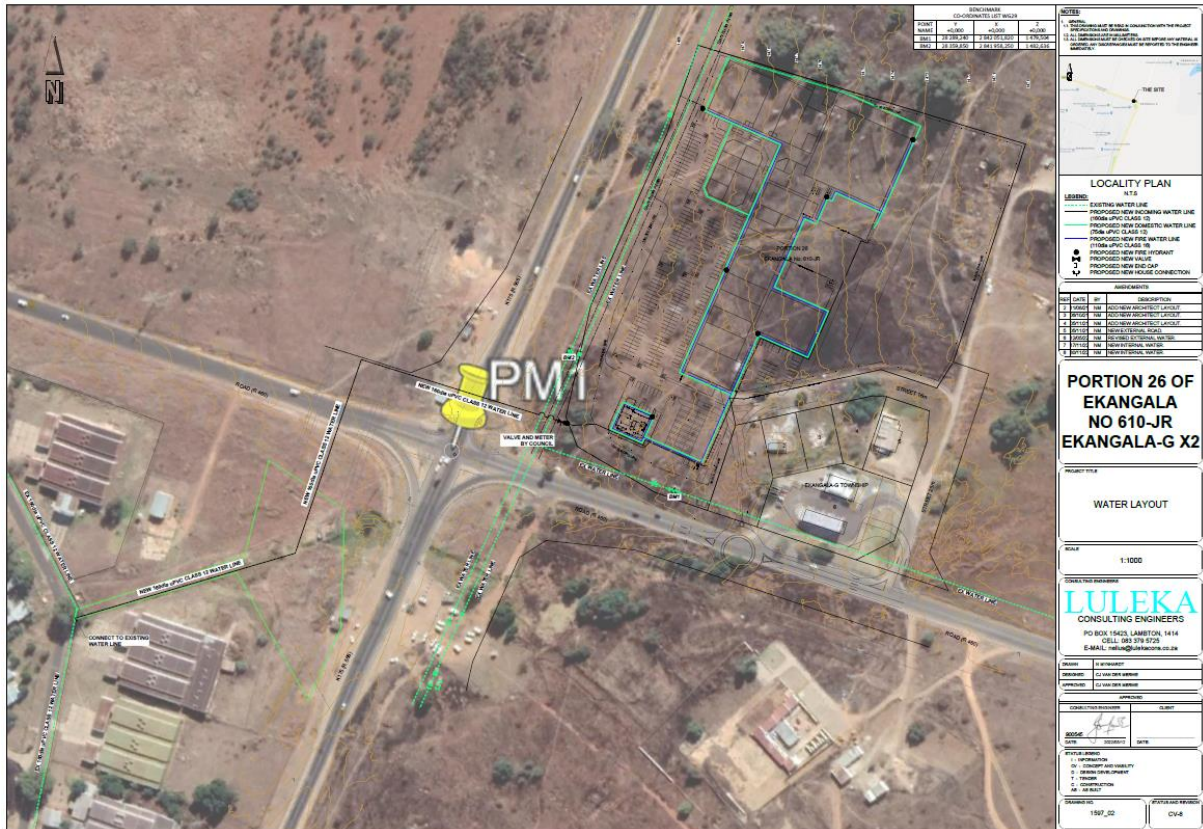
Figure 3: Water reticulation system layout

There is a bulk waterline on the western side of the site next to the K175 road. A water reticulation pipe runs on the western side of the site next to the K175 road and on the southern side of the site next to the D460 road that feeds Ekangala. There is also a complete network southwest of the K175/D460 road of Ekandustria. Most of the factories in Ekandustria has been abandoned and is not used at the moment.

There is a tender out to upgrade the pumps at the Bronkhorstspuit waterworks. The developers of the shopping center has meanwhile entered into an agreement with the Mpumalanga Economical Growth Agency (MEGA) to obtain water from the Ekandustria Industrial township whom has an adequate quota of water and who will not utilize their full quota within the next ten years. See **Figure 3** and **Annexure J2b**. MEGA will provide Litshaba Investments 55 kL AADD per day for the Ekangala Shopping Mall. The developer of the townships will be responsible to store fire flow on site and to store 48 hours domestic water on site.

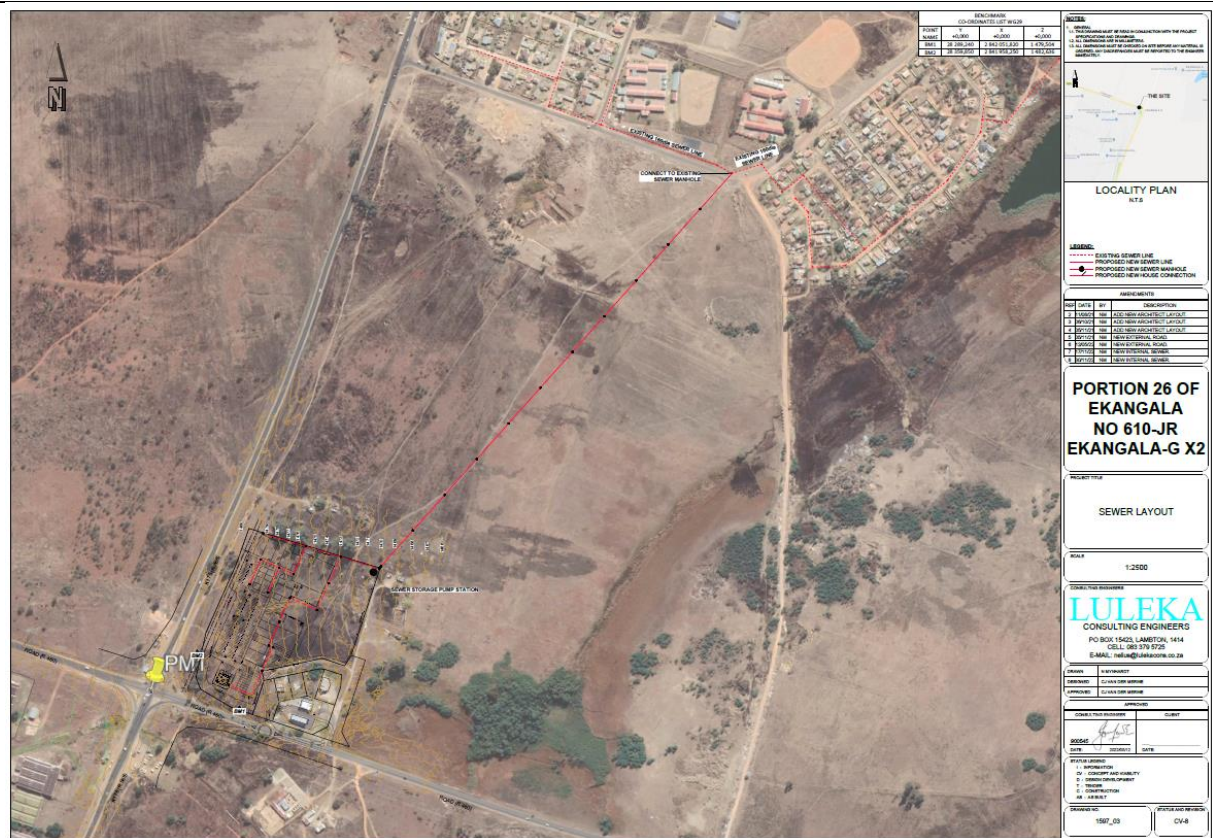
Figure 4: Proposed sewer system

If Tshwane does not want the shopping centre to discharge in peak hours to the existing outfall sewer line that is close to capacity, then a lift storage pumpstation can be constructed in the north eastern corner of the shopping centre property, as indicated in **Figure 4**. The pumpstation has the function to store the sewerage in peak hours and then discharge the sewerage to the sewerage system after peak hours. The pump station is 'safe' in the sense that if a blockage occurs, then the pump station overflow will be directly into the gravitational sewerage system and no overflow to the wetland area is expected. City of Tshwane indicated that the outfall will have sufficient capacity

The owners of the shopping centre can maintain the pumpstation and an emergency overflow can be constructed to discharge into gravity line if there is a power failure.

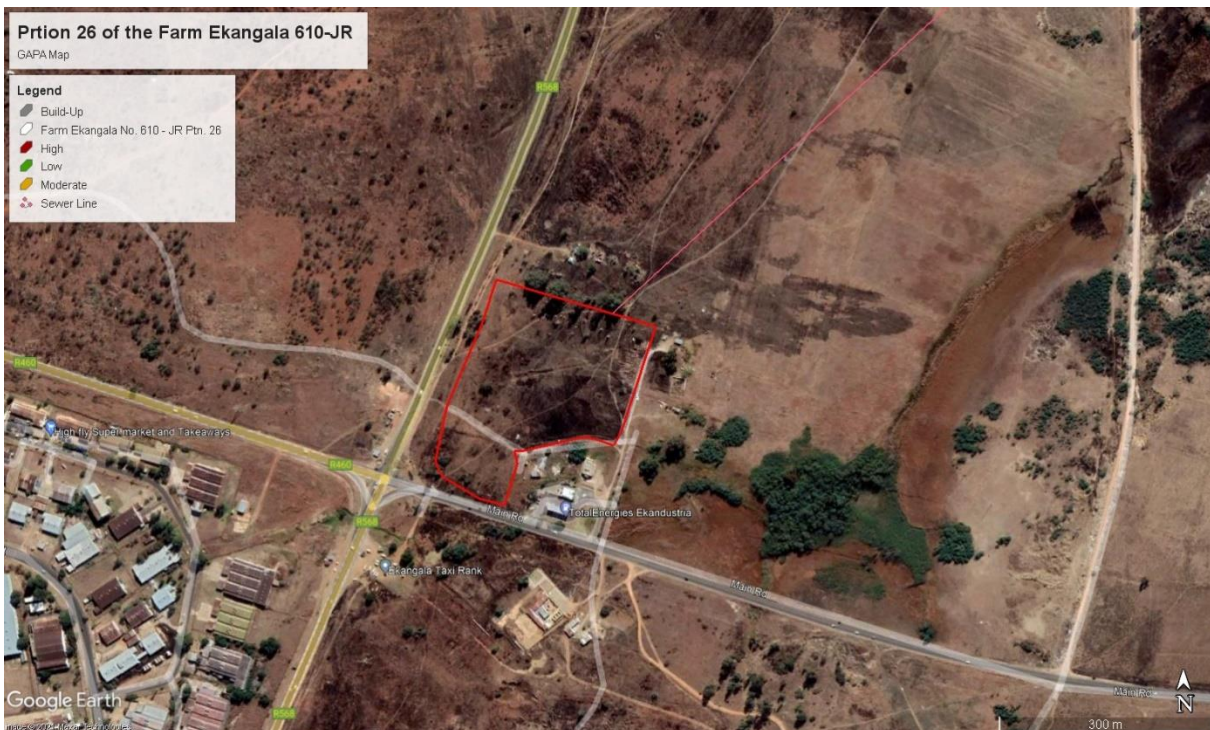
Figure 5: Gauteng Agricultural Potential Atlas (Source: GDARD)

Does the site have high potential agriculture as contemplated in the Gauteng Agricultural Potential Atlas (GAPA 4)?

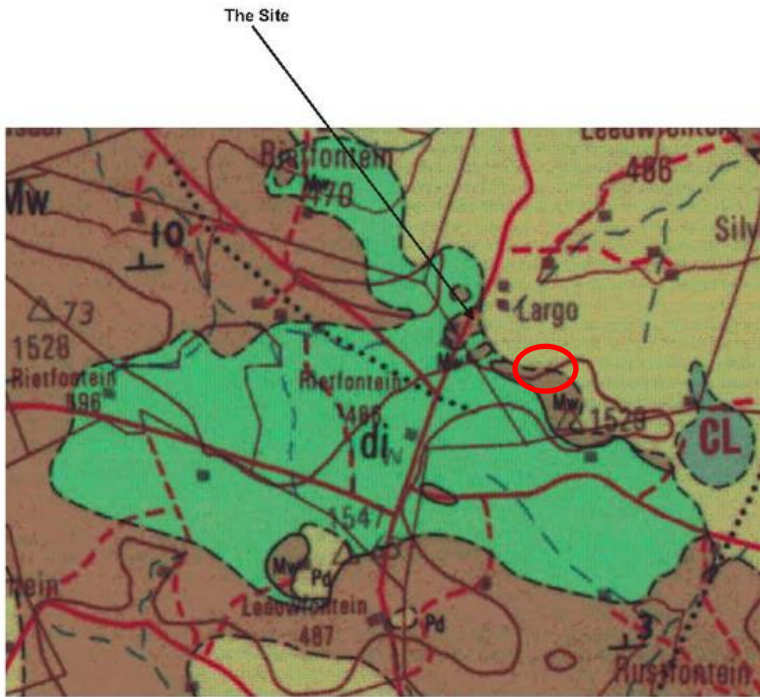
Figure 6: Regional Geology Map

According to the 1:250 000 scale geological, the site is underlain by sandstone of the Waterberg Group and by transported materials; the regional geology is shown in **Figure 6**. The geology was confirmed during the investigation; sandstone was encountered in all the test pits. The test pits are shown in **Figure 7**.

From the 1 : 250 000 Geological Series 2528 Pretoria (Council for Geoscience)

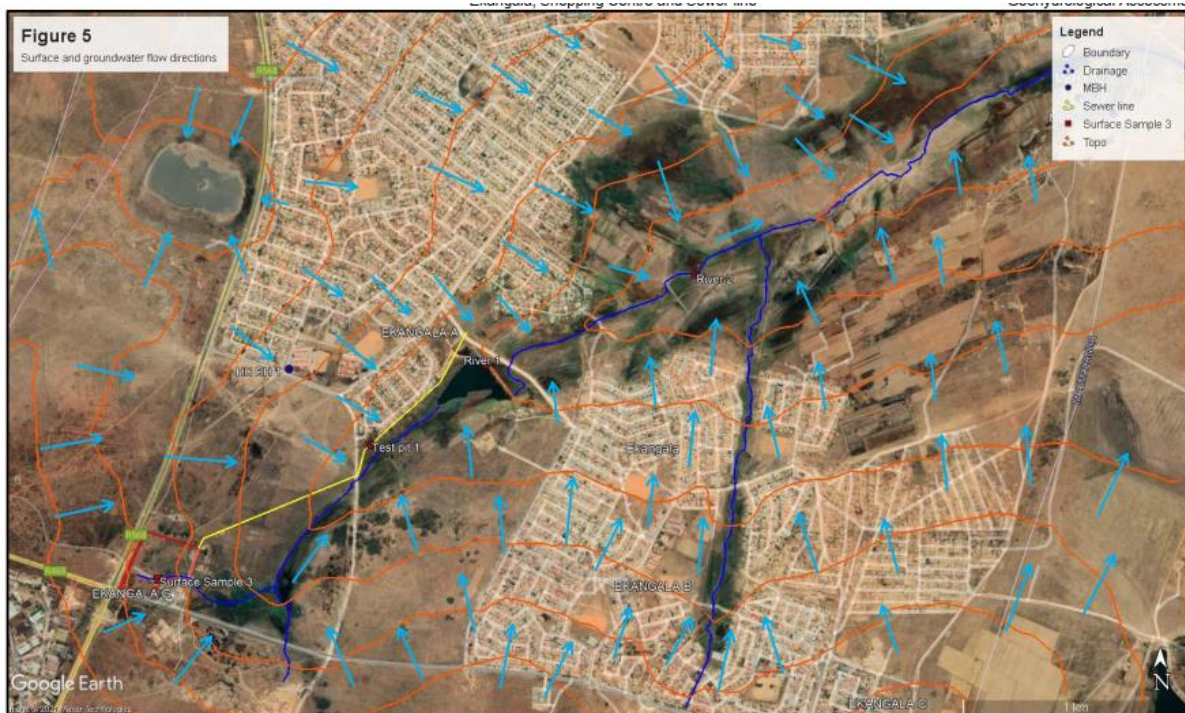
Figure 8: Groundwater flow direction

It is expected in a fractured and weathered aquifer that the groundwater contours to a large degree will follow the surface contours. It can therefore also be expected that in general the groundwater flow will mimic the surface water flow. The surface contours can be used as indicator in which direction groundwater flow will be.

The groundwater and surface water flow directions will in general be from the topographic high areas in the village site towards the topographical low areas in the east and north east, towards the Grootspuit drainage system which drains towards the north east.

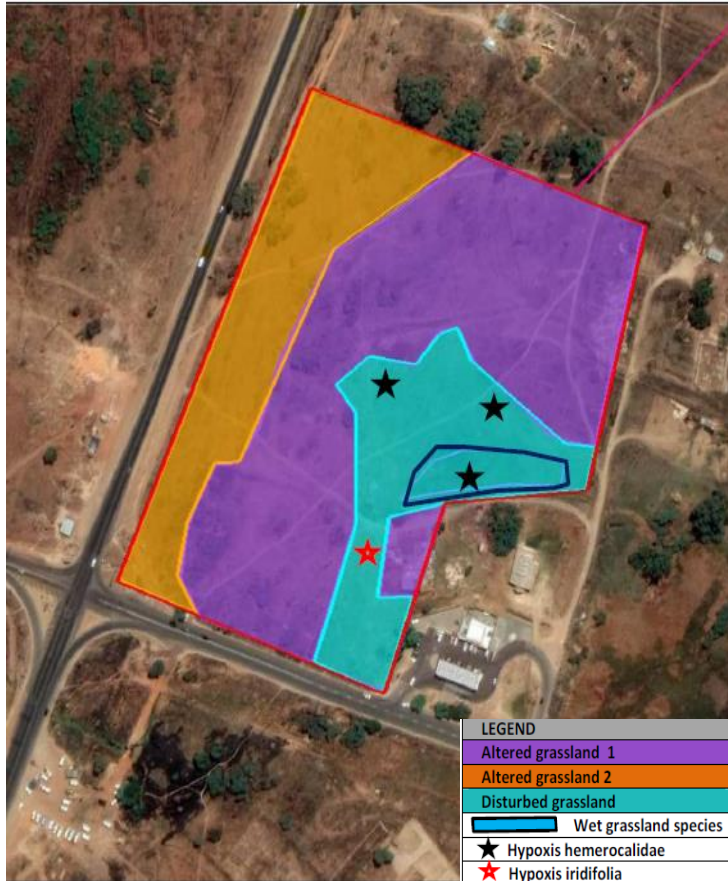
Figure 10: Vegetation unit map

Three Vegetation units were identified within and around the study area:

Disturbed grassland: This grassland was observed towards the centre and south of the site. Mostly natural grassland species were found in the 1.3-hectare piece of grassland but with a moderate to low species richness. The vegetation cover was further found to be low, which has left the soil exposed to raindrop impact and erosion. The dominance of *Stoebe vulgaris* further indicated that the vegetation has been disturbed in the past. This is a hardy, indigenous dwarf-shrub thriving in nutrient deficient soils with a history of poor veld management.

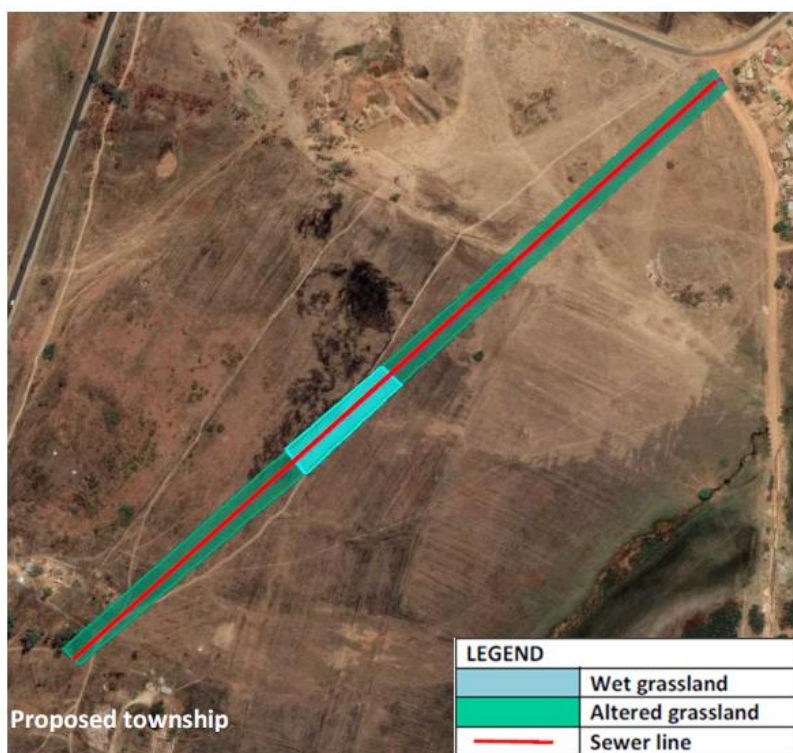
Figure 11: Vegetation map of the sewer line

Along the route, a small wet area was observed where *Berkheya radula* and the grass species *Imperata cylindrica* were observed. The species typically grow in wetter soils. The wet area was not sensitive from a vegetation point of view due to the low species richness observed and small area that was affected.

The conservation status of the vegetation along the pipeline is subsequently considered to be poor due to historic and significant disturbances to the vegetation.

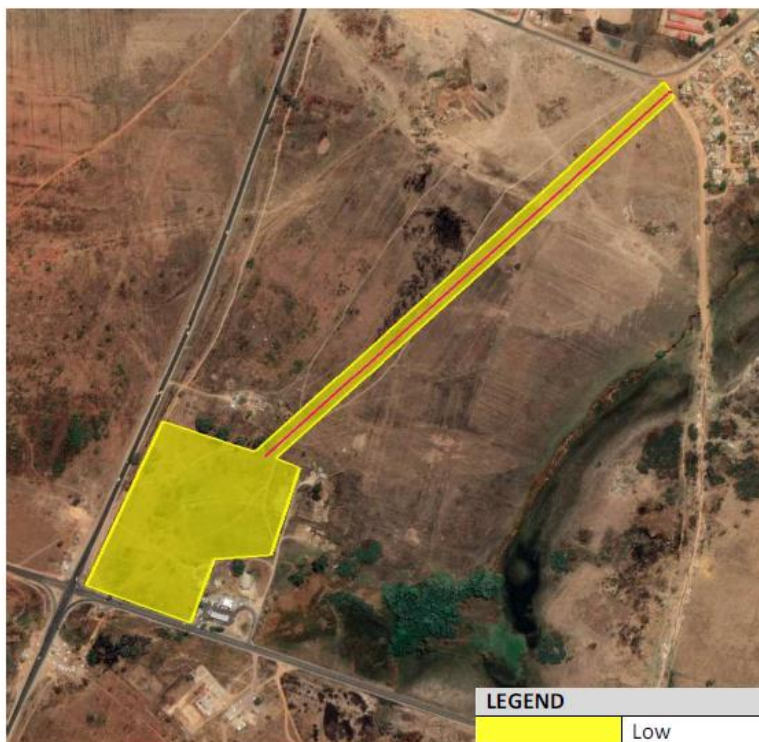
Figure 13: Sensitivity map

The site also does not lie adjacent or in close proximity to a protected area or similar of conservation concern (i.e. ridge or natural habitat). The site does however lie just upslope of a water course,

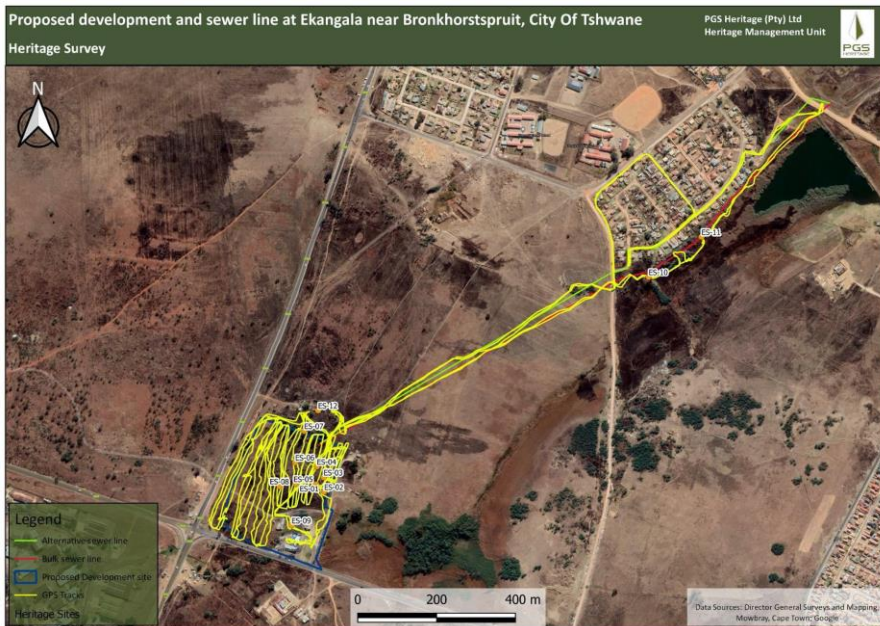
Figure 17: Google Earth image depicting the tracklogs that were recorded in the field (yellow line) and the identified heritage sites.

Throughout the fieldwork, hand-held GPS devices were used to record the tracklogs showing the routes followed by the team. The identified archaeological and heritage sites were numbered from ES-01 to ES-12. The recorded tracklogs and heritage sites in relation to the proposed development footprint areas are depicted in **Figure 17**.

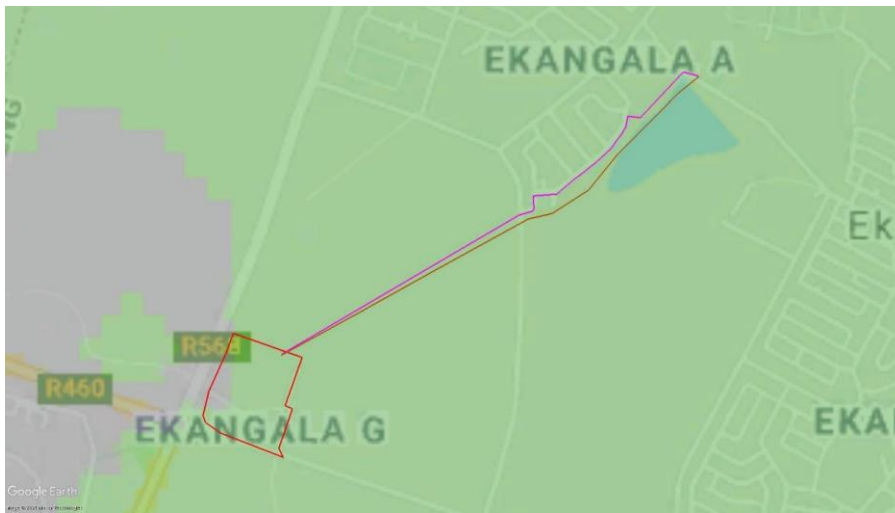
Figure 21: Palaeontological Sensitivity map

According to the PalaeoMap on the SAHRIS database, the Palaeontological Sensitivity of the site is considered to be Moderate. As such, it is recommended that a palaeontological desktop study be undertaken.
