# **Aquatic Ecological**

# **Site Verification Report**

Khauta Solar Photovoltaic (PV)

**Cluster Development, Riebeeckstad,**

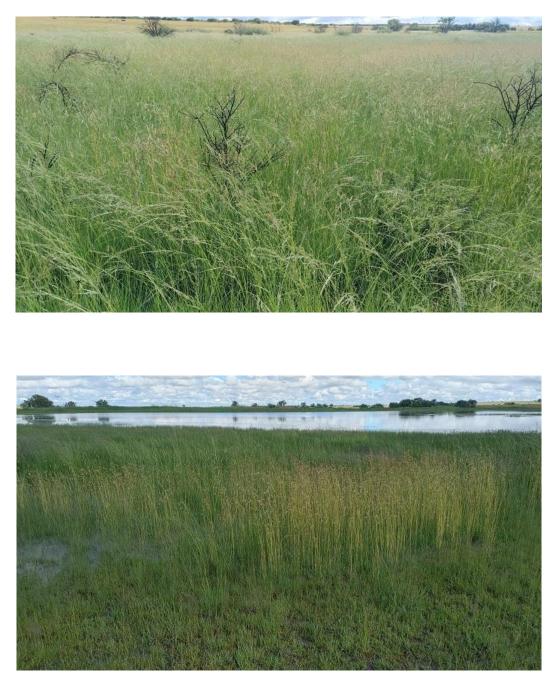
Figure 5: Two images illustrating the presence of the significant first-order seasonal watercourse/tributary associated with the commencement portion of the Sandspruit, which flows past the assessment area, directly adjacent north; the presence of artificially constructed earth dams within the watercourse, is also evident

It is recommended that the watercourse as well as a portion of the surrounding natural undisturbed terrestrial grassland must be adequately buffered out of the proposed development footprint area. By implementing the relevant Department of Water and Sanitation (DWS) Watercourse buffer calculation tool, a minimum water quality buffer distance of approximately 60 m from the watercourse, was determined. Due to the extensive vegetation clearance and associated significantly increased sediment input into the watercourse, it is however highly recommended that the proposed buffer distance should be increased by a further approximately 20 m.

A minimum approximately 80 m water quality buffer distance is therefore recommended to be implemented on both sides of the watercourse edges. No current or future development is allowed to take place within this buffered zone.

From an aquatic ecological perspective, when taking the important aquatic and semi-aquatic habitat into account coupled with the significant visual impacts of a solar power generation facility, a minimum approximately 200 m biodiversity buffer distance is recommended to be implemented on both sides of the watercourse edges. No current or future development is allowed to take place within this buffered zone. It is however recommended that the appointed Avifaunal Specialist must provide final recommendations on suitable aquatic avifaunal species-and habitat buffer zones, after completion of his/her assessment.

This recommended buffer zone and associated recommendations must be implemented to attempt to maintain the hydrological and ecological functionality and -integrity of the watercourse and subsequent downstream waterbodies and their associated semi-aquatic habitats along with the Critical Biodiversity Area one (CBA 1), in order to prevent any significant increase in sediment inputs and contamination and ensure the persistence/livelihood of aquatic and semi-aquatic fauna in the area.

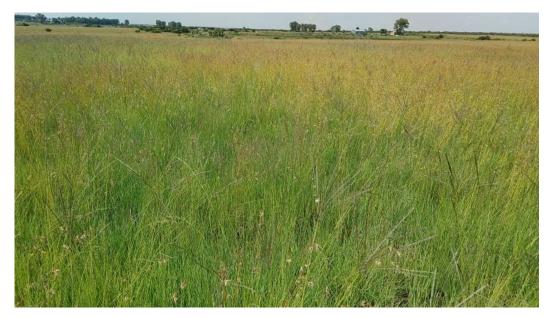
Figure 6: Image illustrating an example of the presence of the three small preferential water flow paths/drainage lines, which traverse the old historically cultivated agricultural lands, associated with the central-northern portion of the assessment area; the overwhelming dominance of the grass species *Digitaria eriantha* is also evident

It is the opinion of the specialist that avoidance of the proposed development through these flow paths/drainage lines, is not necessarily required. It is however recommended that sufficient continued stormwater runoff within- and through the assessment area towards the north, must still be ensured and sufficiently managed. An adequate Stormwater and Erosion Management Plan must be implemented during the construction- and operational phases of the proposed development, in order to assist with this and allow for continued flow within the localised catchment. This must be done to attempt to maintain the ecological functionality and -integrity of the local and broader quaternary surface water catchment- and drainage area, towards the west. A Water Use License Application (WULA) must also be submitted to the Department of Water and Sanitation (DWS), to request authorisation for the proposed development through the flow paths/drainage lines, in accordance with the National Water Act (Act 36 of 1998).

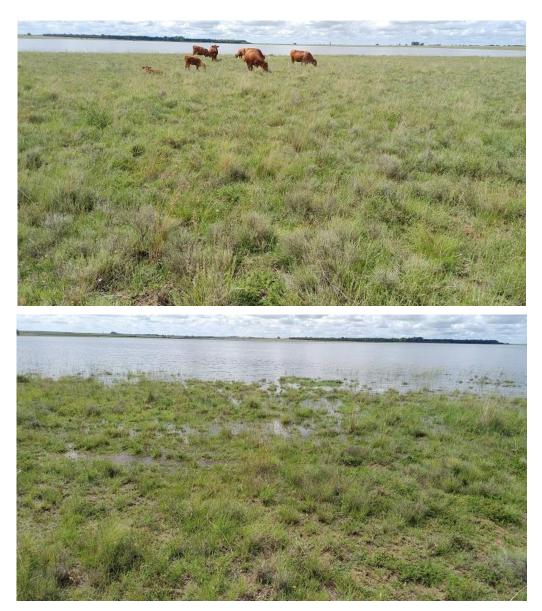
Figure 7: Two images illustrating the presence of the significantly sized naturally occurring Commandants Pan, located approximately 150 m south-east of the assessment area

It is therefore recommended that the pans as well as portions of the surrounding natural undisturbed terrestrial grassland must be adequately buffered out of the proposed development footprint area. By implementing the relevant Department of Water and Sanitation (DWS) Wetland buffer calculation tool, a minimum water quality buffer distance of approximately 60 m from the pans, was determined. Due to the extensive vegetation clearance and associated significantly increased sediment input into the pans, it is however highly recommended that the proposed buffer distance should be increased by a further approximately 20 m. A minimum approximately 80 m water quality buffer distance is therefore recommended to be implemented around the pans. No current or future development is allowed to take place within these buffered zones.

From an aquatic ecological perspective, when taking the important semi-aquatic habitat into account coupled with the significant visual impacts of a solar power generation facility, a minimum approximately 250 m biodiversity buffer distance is recommended to be implemented around the Commandants Pan and a minimum approximately 200 m buffer distance around the second pan. No current or future development is allowed to take place within these buffered zones. It is however recommended that the appointed Avifaunal Specialist must provide final recommendations on suitable aquatic avifaunal species- and habitat buffer zones, after completion of his/her assessment.

It is further recommended that no bright light from any spotlights or perimeter lights should be emitted into the surrounding landscape towards the pans during night time. As little light emissions as practicably/reasonably possible from the proposed development area, should occur during night time as this could lure owl and other nocturnal bird individuals towards the permitter fences and potentially result in collisions and mortality.

These recommended buffer zones and associated recommendations must be implemented to attempt to maintain the hydrological and ecological functionality and -integrity of the pans and their associated semi-aquatic habitats along with the localised surrounding terrestrial grassland landscape, in order to prevent any significant increase in sediment inputs and contamination and ensure the persistence/livelihood of semi-aquatic fauna in the area.

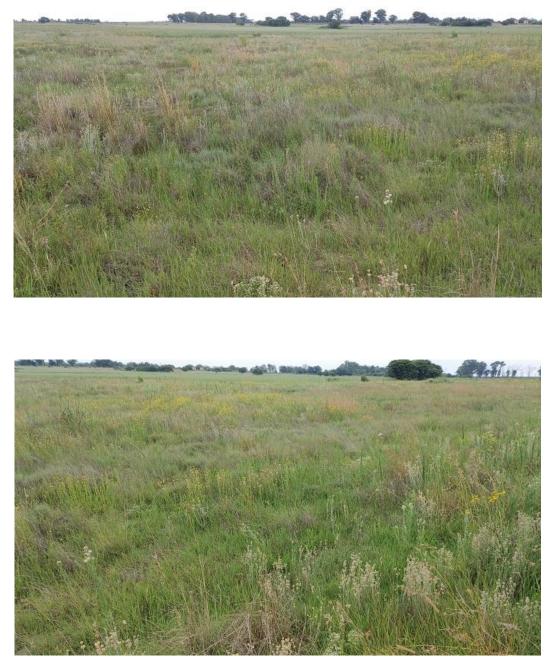
Figure 8: Two images illustrating the presence of the second smaller naturally occurring depression pan, located directly adjacent south-west of the assessment area

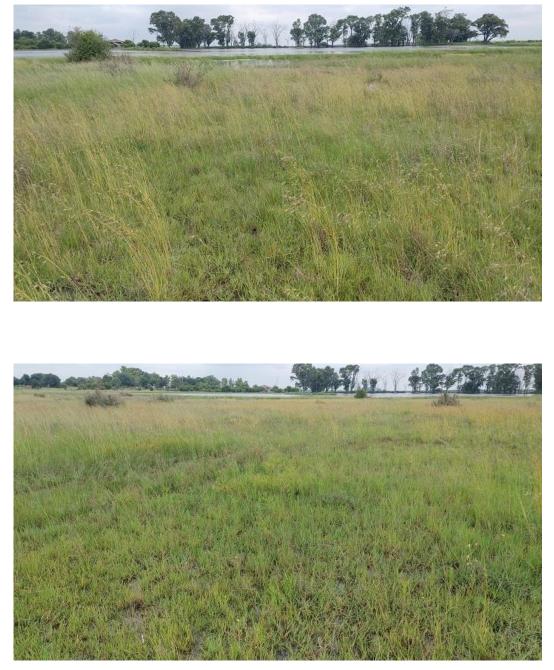
Figure 9: Two images illustrating the presence of the artificially constructed earth dam, located directly adjacent south-west of the assessment area

It is therefore recommended that the dam as well as a portion of the surrounding natural undisturbed terrestrial grassland must be adequately buffered out of the proposed development footprint area. By implementing the relevant Department of Water and Sanitation (DWS) Wetland buffer calculation tool, a minimum water quality buffer distance of approximately 60 m from the dam, was determined. Due to the extensive vegetation clearance and associated significantly increased sediment input into the dam, it is however highly recommended that the proposed buffer distance should be increased by a further approximately 20 m. A minimum approximately 80 m water quality buffer distance is therefore recommended to be implemented around the dam. No current or future development is allowed to take place within this buffered zone.

From an aquatic ecological perspective, when taking the important semi-aquatic habitat into account coupled with the significant visual impacts of a solar power generation facility, a minimum approximately 200 m biodiversity buffer distance is recommended to be implemented around the dam. No current or future development is allowed to take place within this buffered zone. It is however recommended that the appointed Avifaunal Specialist must provide final recommendations on suitable aquatic avifaunal species- and habitat buffer zones, after completion of his/her assessment.

It is further recommended that no bright light from any spotlights or perimeter lights should be emitted into the surrounding landscape towards the dam during night time. As little light emissions as practicably/reasonably possible from the proposed development area, should occur during night time as this could lure owl and other nocturnal bird individuals towards the permitter fences and potentially result in collisions and mortality.

This recommended buffer zone and associated recommendations must be implemented to attempt to maintain the hydrological and ecological functionality and -integrity of the dam and its associated semi-aquatic habitat along with the localised surrounding terrestrial grassland landscape, in order to prevent any significant increase in sediment inputs and contamination and ensure the persistence/livelihood of semi-aquatic fauna in the area.

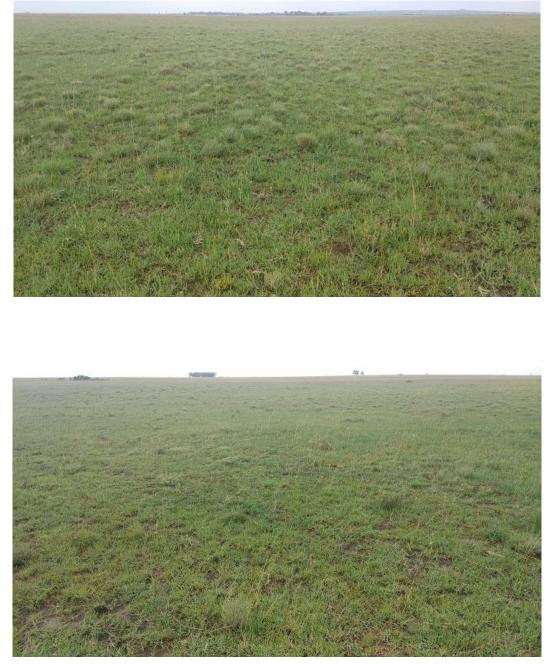
Figure 10: Two images illustrating the presence of the first naturally occurring broad unchanneled valley-bottom wetland, through which surface water runoff from the central and southern portions of the assessment area situated south of the highpoint/ridge apex, mainly channels and drains, towards the south-west

By implementing the relevant Department of Water and Sanitation (DWS) Wetland buffer calculation tool, a minimum water quality and biodiversity buffer distance of approximately 60 m from the first broad wetland as well as the wetland which flows past the assessment area directly adjacent south, was determined. Due to the extensive vegetation clearance and associated significantly increased sediment input into the wetland, it is however highly recommended that the proposed buffer distance should be increased by a further approximately 20 m. A minimum approximately 80 m aquatic ecological buffer distance is therefore recommended to be implemented around the first wetland. No current or future development is allowed to take place within this buffered zone.

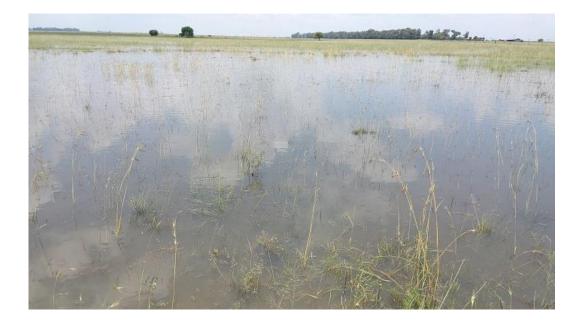
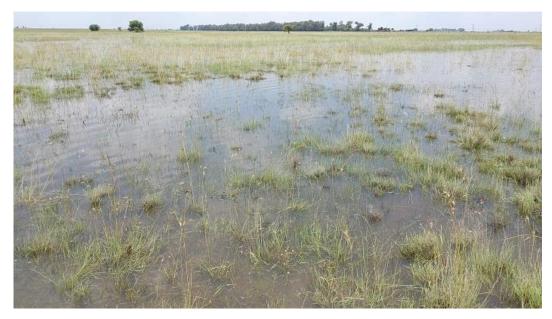
Figure 11: Two images illustrating the presence of the naturally occurring unchanneled valleybottom wetland, which flows past the assessment area directly adjacent south while a portion of the wetland also traverses the south-western corner of the assessment area; the extensive inundation visible in the images was mainly as a result of the abnormally high rainfall received during that time period and a subsequent upstream dam wall failure

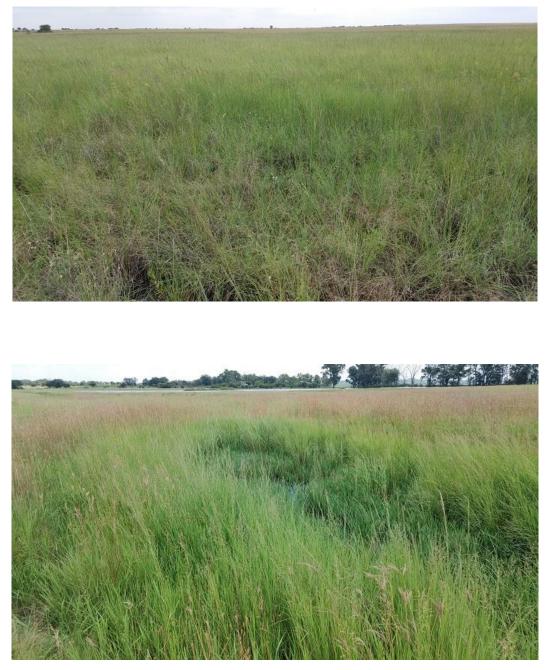
Figure 12: Two images illustrating the presence of the subsequent naturally occurring unchanneled valley-bottom wetland into which the first broad wetland gradually flows, located within the southern portion of the assessment area

It is therefore recommended that the subsequent wetland into which the first broad wetland gradually flows as well as the significantly sized wetland situated approximately 330 m north-east of the assessment area, along with portions of the surrounding natural undisturbed terrestrial grassland must be adequately buffered out of the proposed development footprint area. By implementing the relevant Department of Water and Sanitation (DWS) Wetland buffer calculation tool, a minimum water quality buffer distance of approximately 60 m from the two wetlands, was determined. Due to the extensive vegetation clearance and associated significantly increased sediment input into the wetland, it is however highly recommended that the proposed buffer distance should be increased by a further approximately 20 m. A minimum approximately 80 m water quality buffer distance is therefore recommended to be implemented around the two wetlands. No current or future development is allowed to take place within this buffered zone.

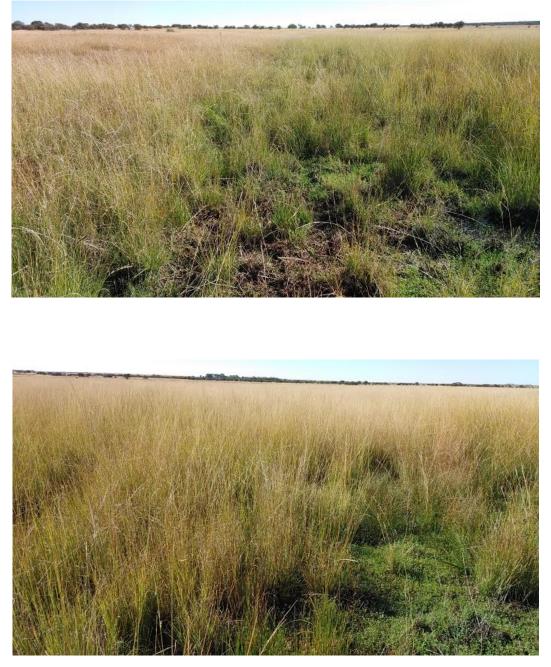
Figure 13: Two images illustrating the presence of the significantly sized naturally occurring unchanneled valley-bottom wetland situated approximately 330 m north-east of the assessment area, which constitutes the main inflow of the Commandants Pan

After consultation with well-known and recognized avifaunal specialists and due to the actual confirmed presence of the owl species, it is however recommended that a minimum approximately 300 m biodiversity buffer distance be implemented around the two wetlands. No current or future development is allowed to take place within these buffered zones. It is however recommended that the appointed Avifaunal Specialist must provide final recommendations on suitable aquatic avifaunal species- and habitat buffer zones, after completion of his/her assessment.

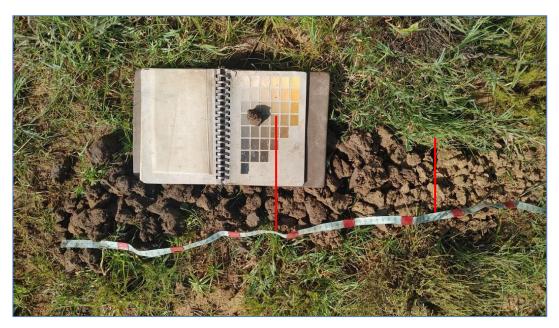
Figure 14: Image illustrating from left to right, the Melanic A horizon, followed by the G 1 and G2 horizons of the wetland soils

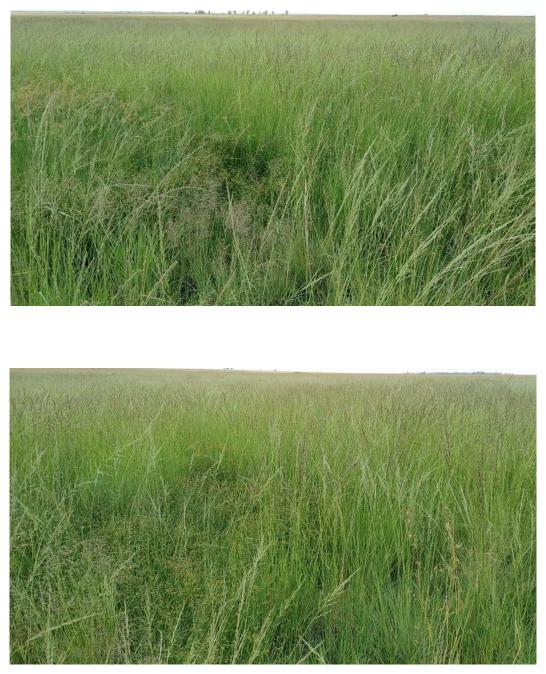
Figure 15: Two images illustrating the presence of the naturally occurring depression wetland, located within the central portion of the assessment area

It is therefore recommended that the three depression wetlands as well as portions of the surrounding natural undisturbed terrestrial grassland must be adequately buffered out of the proposed development footprint area. By implementing the relevant Department of Water and Sanitation (DWS) Wetland buffer calculation tool, a minimum water quality buffer distance of approximately 60 m from the wetlands, was determined. Due to the extensive vegetation clearance and associated significantly increased sediment input into the wetlands, it is however highly recommended that the proposed buffer distance should be increased by a further approximately 20 m. A minimum approximately 80 m water quality buffer distance is therefore recommended to be implemented around the wetlands. No current or future development is allowed to take place within these buffered zones.

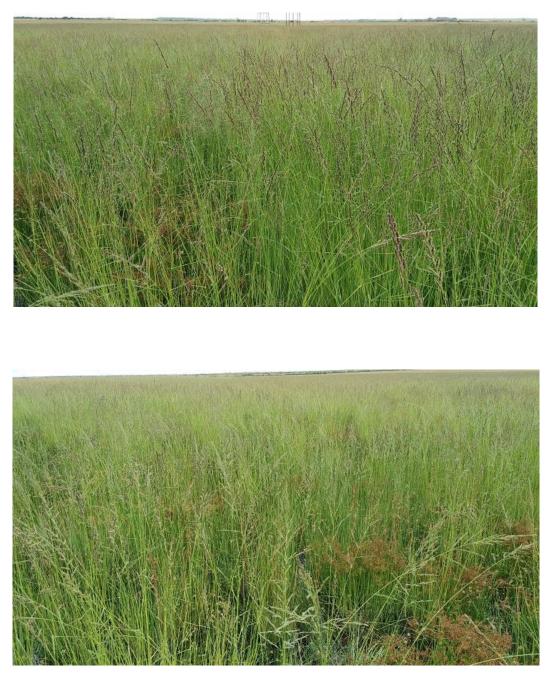
Figure 16: Two images illustrating the presence of the naturally occurring depression wetland, situated approximately 200 m east of the assessment area

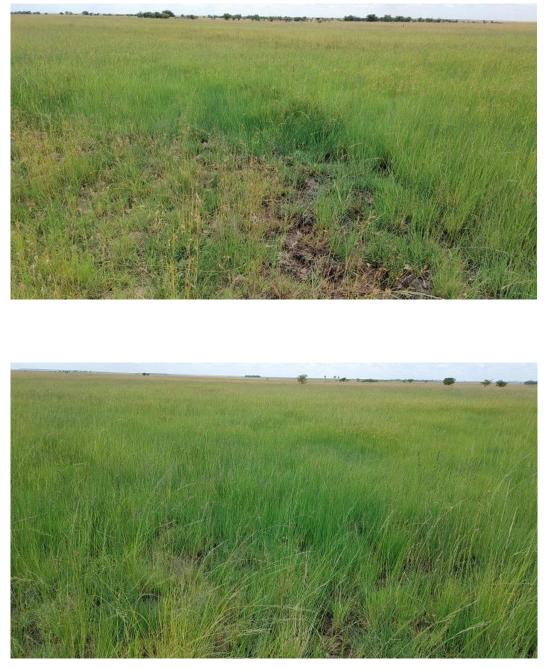
Figure 17: Two images illustrating the presence of the naturally occurring depression wetland, situated approximately 160 m west of the assessment area

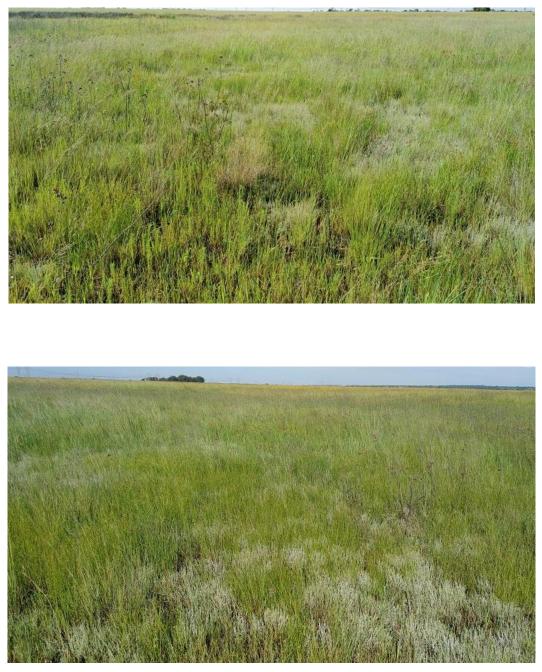
Figure 18: Two images illustrating the presence of the naturally occurring depression wetland, located along the proposed route directly south of the split between the proposed Transmission line route options 1 & 2

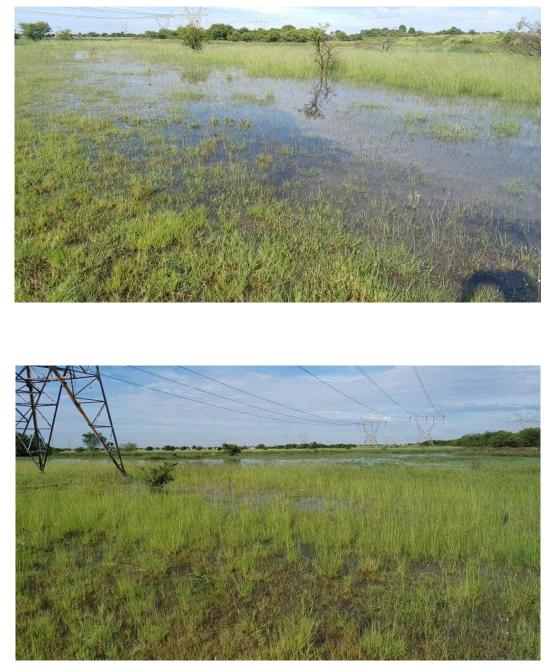
Figure 19: Two images illustrating the presence of the two adjacently located first-order seasonal watercourses and associated small channelled valley-bottom wetlands, located within the central portion of the proposed Transmission line route option 2; the presence of numerous existing high voltage transmission lines in the same area, is also evident

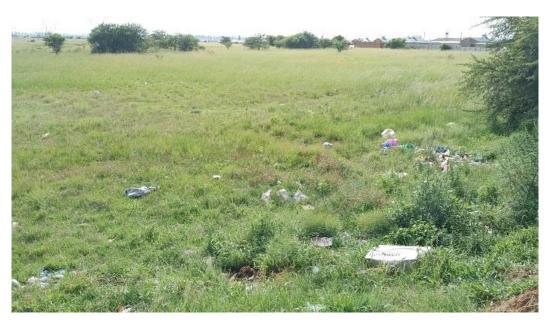
The western portion of the proposed route which runs through the existing township, also traverses a small remaining portion of what likely used to form part of a valley-bottom wetland. The assumed historic wetland has however virtually been completely fragmented and transformed by the presence of the township. The small remaining wetland portion is isolated and completely degraded and is therefore not viewed as being of any conversational significance for habitat preservation and ecological functionality persistence in support of the surrounding aquatic ecosystem or the local and broader quaternary surface water catchment- and drainage area, towards the west.

Figure 20: Image illustrating the presence of the small remaining portion of what likely used to form part of a valley-bottom wetland, which is traversed by the western portion of the proposed Transmission line route option 2

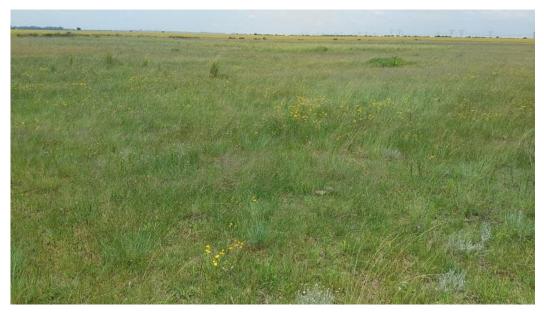
Figure 21: Image illustrating the presence of the naturally occurring depression wetland, along the proposed route directly west of the split between the proposed Transmission line route options 1 & 2

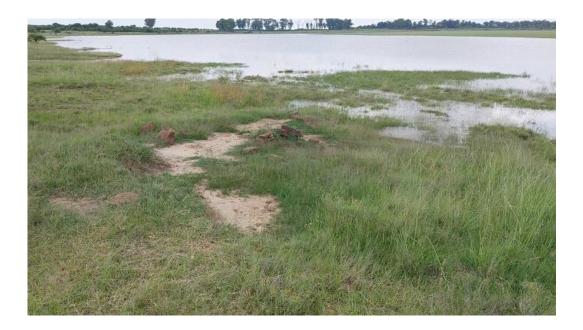
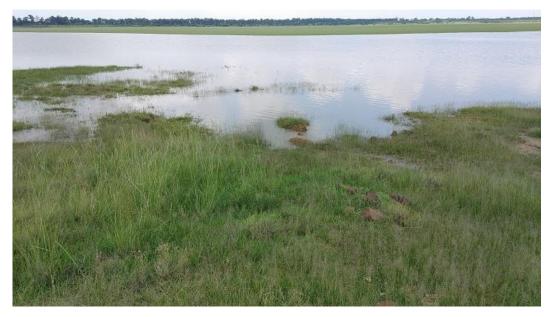
Figure 22: Two images illustrating the presence of the significantly sized naturally occurring depression pan, which is located approximately 700 m south-west of the assessment area and is situated to the east of a very small section of the proposed route located to the south of the proposed Transmission line route – 44 kV

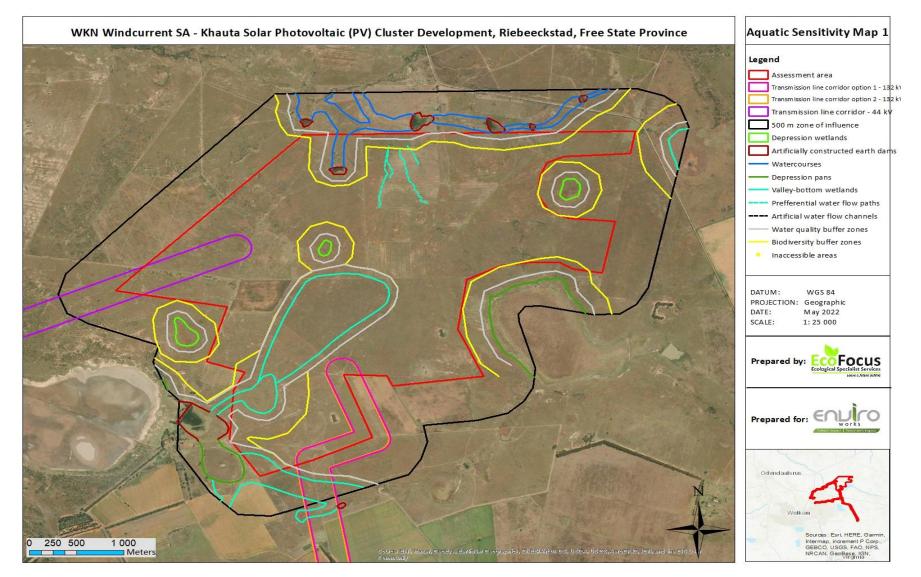
Figure 23: Aquatic site sensitivity map 1 illustrating the approximate delineations of the identified significant watercourses, wetlands and pans which are present throughout the assessment area; the recommended buffer zones to be implemented around the various aquatic features, are also illustrated

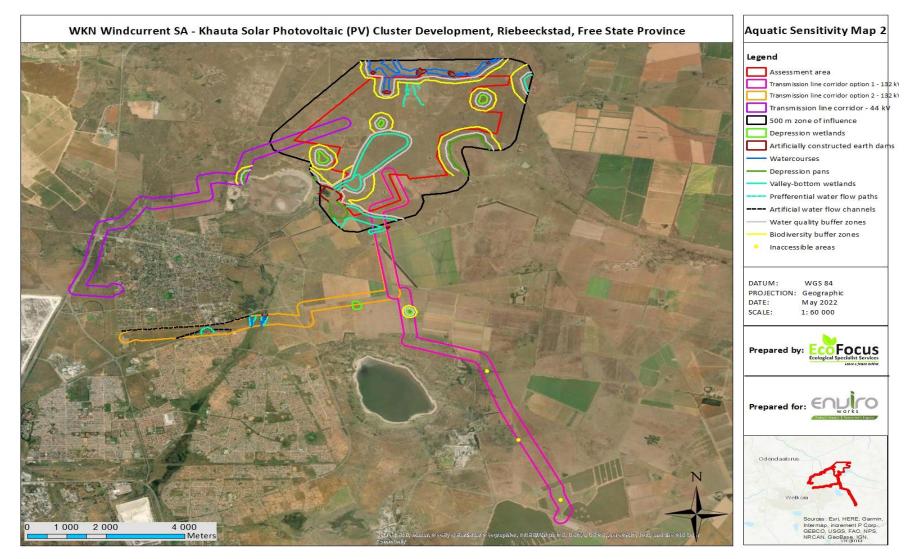
Figure 24: Aquatic site sensitivity map 2 illustrating the approximate delineations of the identified significant watercourses, wetlands and pans which are present throughout the assessment area and along the proposed three transmission line route alternatives; the recommended buffer zones to be implemented around the various aquatic features, are also illustrated
