## HERITAGE SIGNIFICANCE

to accompany an application in terms of Section 37(1)(a) of the KwaZulu-Natal Amafa and Research Institute Act (5/2018) for a Permit to demolish, alter or add to a structure which is, or which may reasonably be expected to be older than 60 years.

Erf 60 Bothas Hill  
21 Old Main Road, Bothas Hill

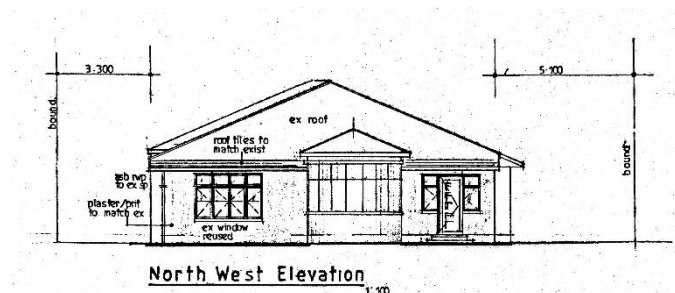
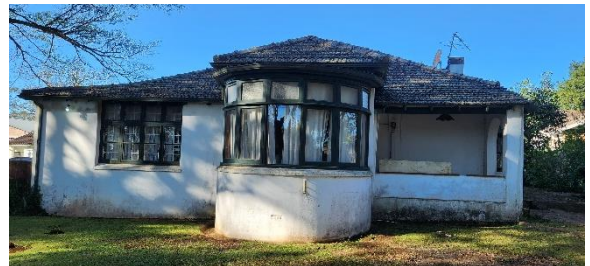
### 2.2.2 North West elevation

By extending the 17 degree veranda section of the roof and continuing the pitch, the external walls on the TV lounge are considerably lower than the sun lounge roof, further emphasising the extent to which the sun room protrudes and is off centre to the ridge line. The elevation is not accurate as the veranda roof that wraps around on the east side is not drawn correctly.

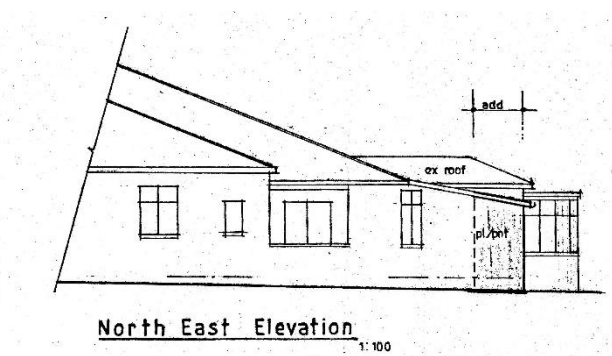
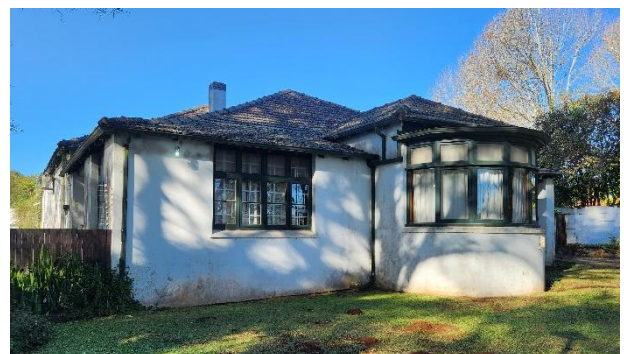
### 2.2.3 North East elevation

The 17 degree section of roof wraps around on the north east façade. By extending the roof pitch line, it no longer connects with the hipped roof on the east side. This is a crude detail and is also not drawn correctly.

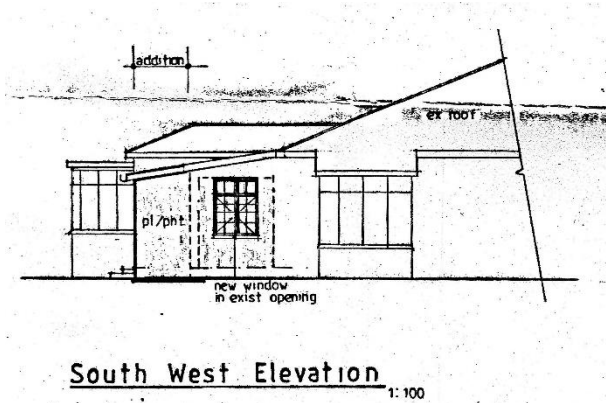
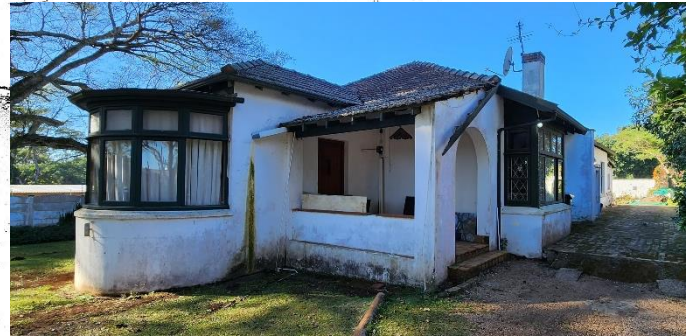
### 2.2.4 South West elevation

This elevation illustrates the disjointed composition of the building. There are arched or curved forms to the entrance porch and sun lounge but a rectangular bay window next to the porch entrance. The most disturbing element is the protruding sun lounge.
