DRAFT BASIC ASSESSMENT REPORT

NBC Colliery, Universal Coal D2809 Road Realignment Wetland Risk Assessment

NBC Colliery, Universal Coal: D2809 Road Realignment Wetland Risk Assessment

Ecology International Ref. No. 210057

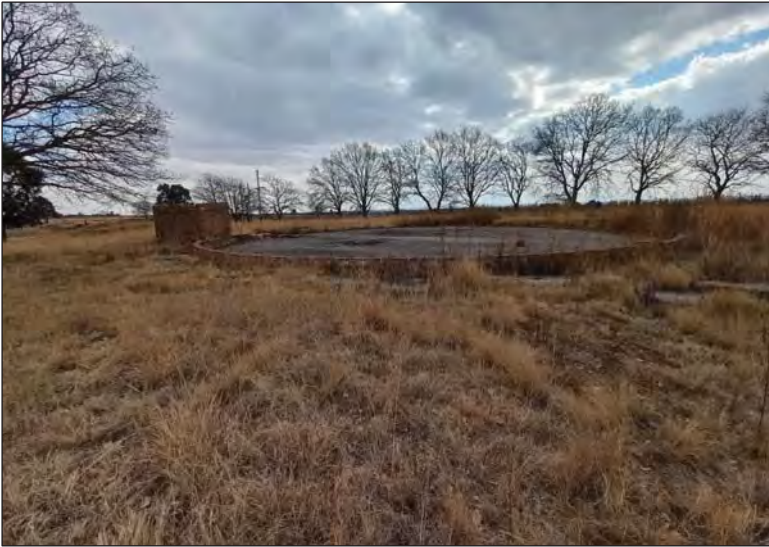
Figure 6 – General view of the reservoir and associated structural remains at site PP 38. This photograph was taken on 16 July 2021.

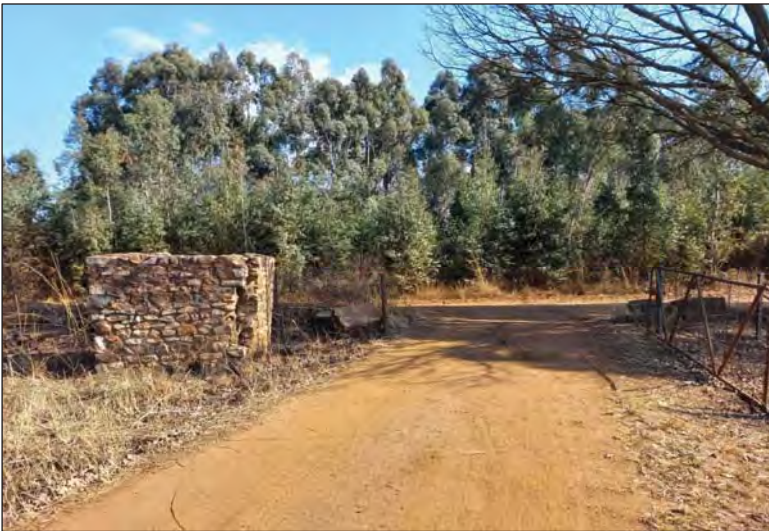
Figure 7 - View of the remains of the stone structure at PP 41 as taken on 16 July 2021.

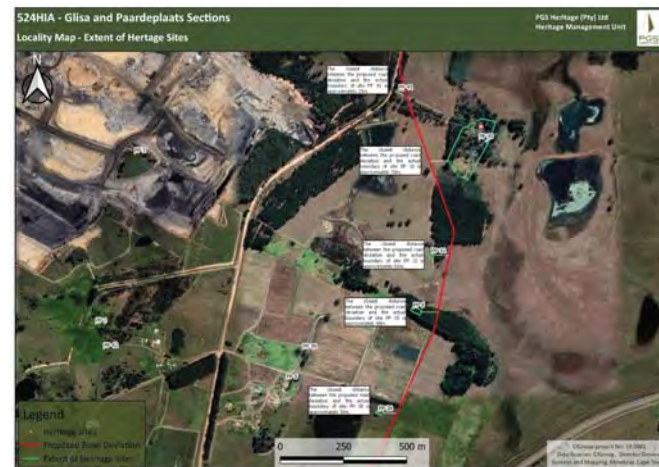
Figure 11 - Map showing the actual boundaries of the heritage sites in green line. The measured distances between these site boundaries and the proposed road realignment are also shown.

Site	GPS	Distance from Road Deviation Footprint
PP 05 - Cemetery	S 25.725210 E 30.015134	The closest distance between the proposed road realignment and the actual boundary of site PP 05 is approximately 68m.
PP 30 – Historic Homestead	S 25.718530 E 30.017220	The closest distance between the proposed road realignment and the actual boundary of site PP 30 is approximately 70m.
PP 32 – Remains of Historic Homesteads with the Risk for Unmarked Graves	S 25.723070 E 30.015850	The closest distance between the proposed road realignment and the actual boundary of site PP 32 is approximately 61m.
PP 38 - Reservoir with Associated Structures	S 25.729260 E 30.013751	The closest distance between the proposed road realignment and the actual boundary of site PP 38 is approximately 50m.
PP 41 – Small Stone Structure	S 25.716593 E 30.014553	The closest distance between the proposed road realignment and the actual boundary of site PP 41 is approximately 25m.

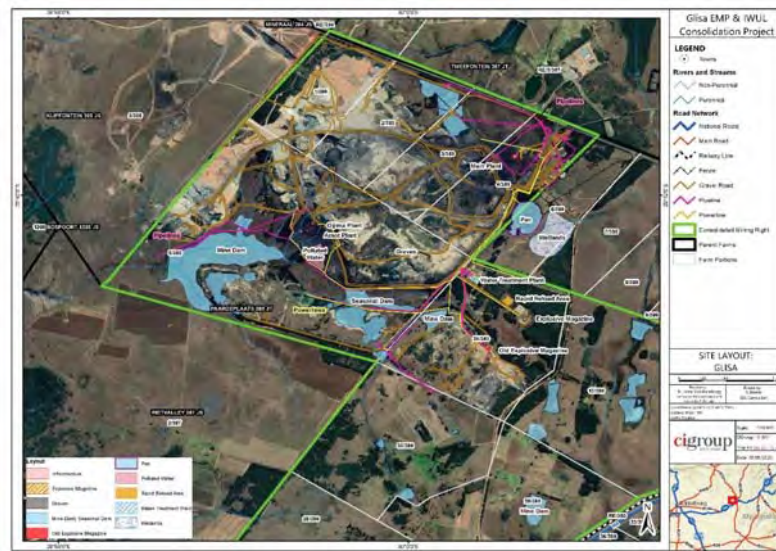
Figure 6: Existing Infrastructure Layout at the Glisa Section.

Existing infrastructure at the WTP in the Glisa Section is licensed in terms of the MPRDA and the NEMA and all of the existing infrastructure for the WTP will continue to be used in support of the Paardeplaats Section mining activities. The infrastructure that will continue to be used and which does not require licensing in terms of this application includes, the following (Figure 9):

- WTP and pipeline reticulation system, including discharge pipeline and electrical supply through a 500 Kilovolt Ampere (kVA) mini-substation;
- Gypsum storage areas at the WTP; and
- Waste management areas.

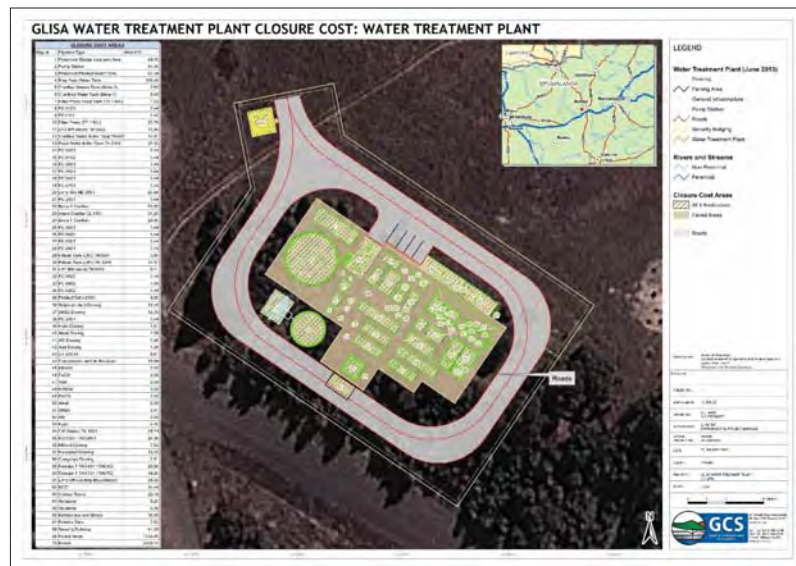
Figure 9: Existing Infrastructure Layout for the WTP (GCS, 2014).

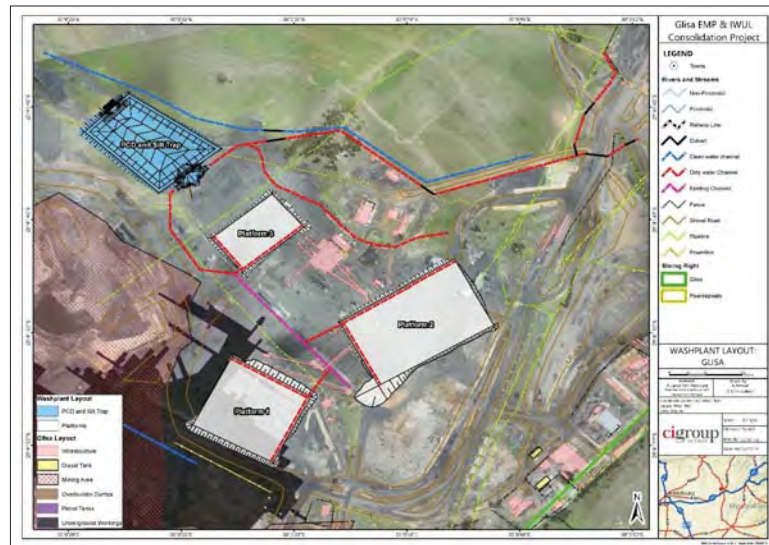
Figure 14: Proposed Site Layout around the Glisa Section CSWP.

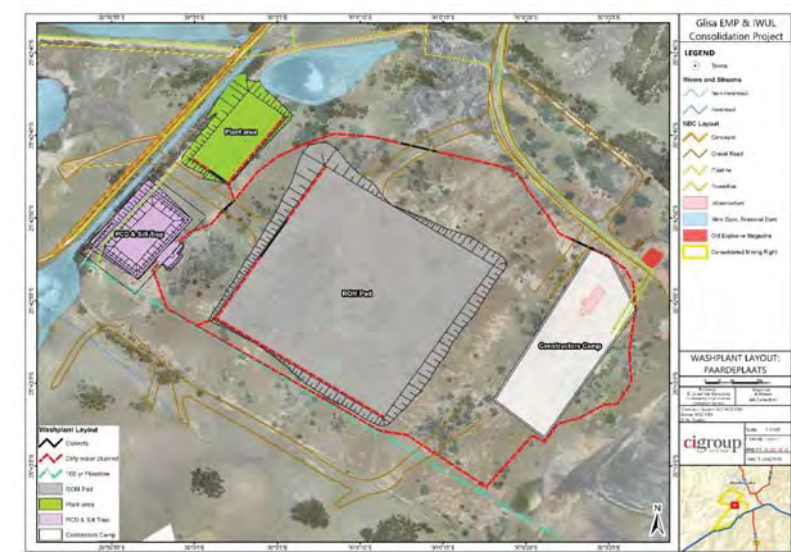
Figure 15: Proposed Site Layout on Portion 24 of the Farm Paardeplaats 380 JT.

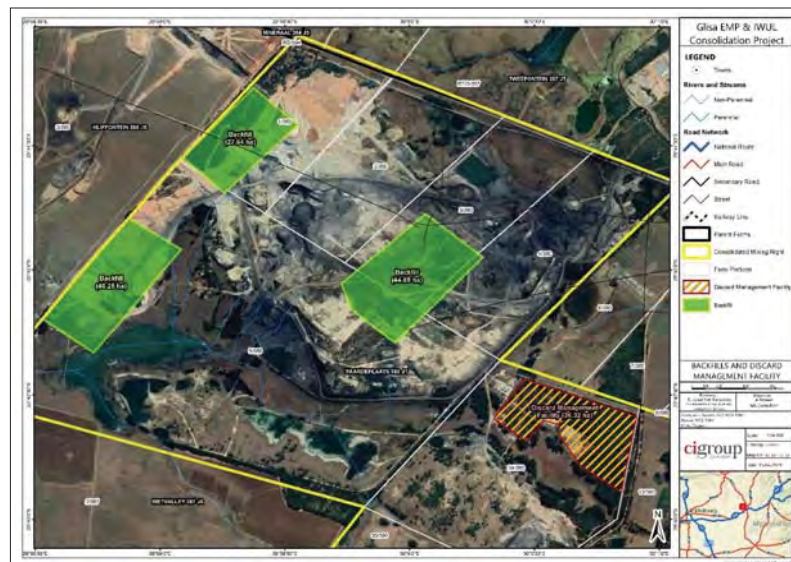
Figure 16: Proposed Backfill Areas in the Glisa Section and DMF on Portion 24.

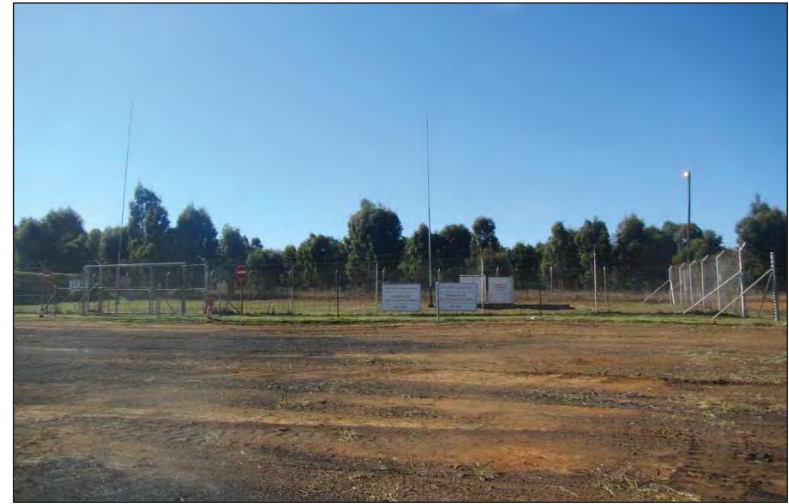
Figure 11 - The explosives magazine of the mine is located in the north-western section of the study area.

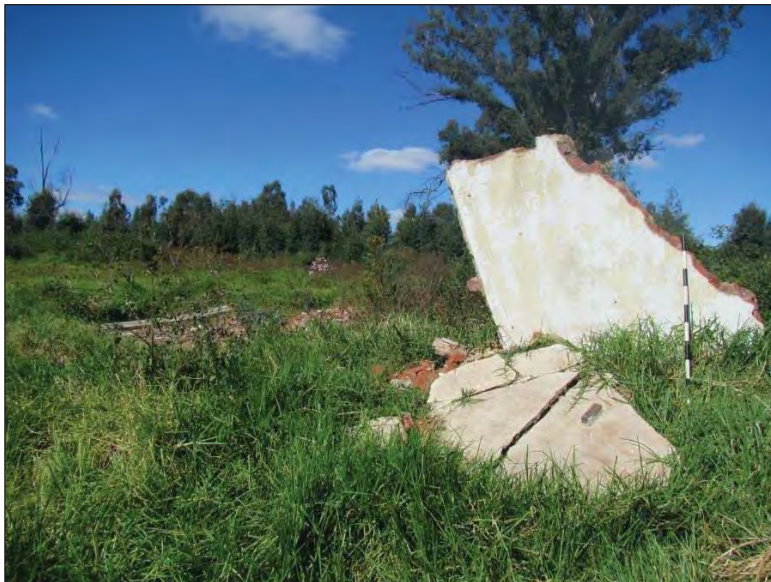
Currently, the structures that were identified at site PP 01 in 2012 have been demolished. Only the ruins of the foundations remain. The site is overgrown and abandoned.

Figure 27 - General view of site PP 01 as recorded during the 2021 fieldwork.

See Chapter 7 for impact assessment calculations and Chapter 8 for required mitigation measures

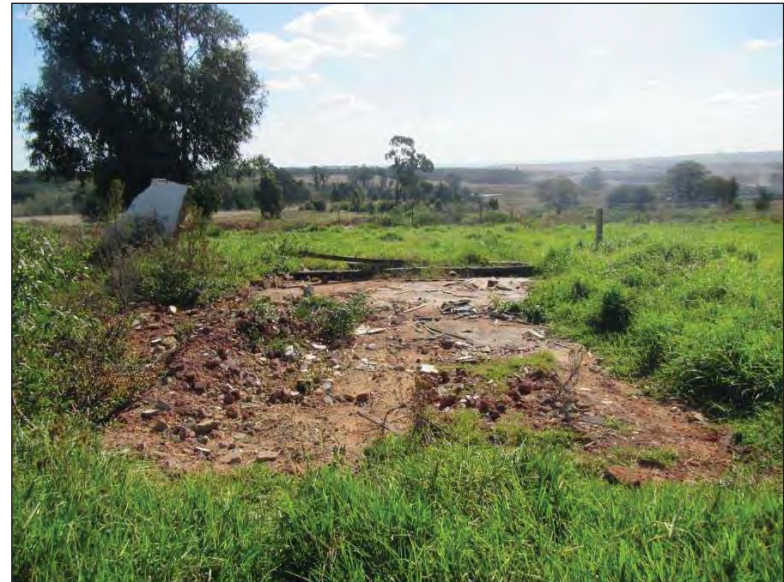
Figure 28 – Another view of site PP 01 as recorded during the 2021 fieldwork.

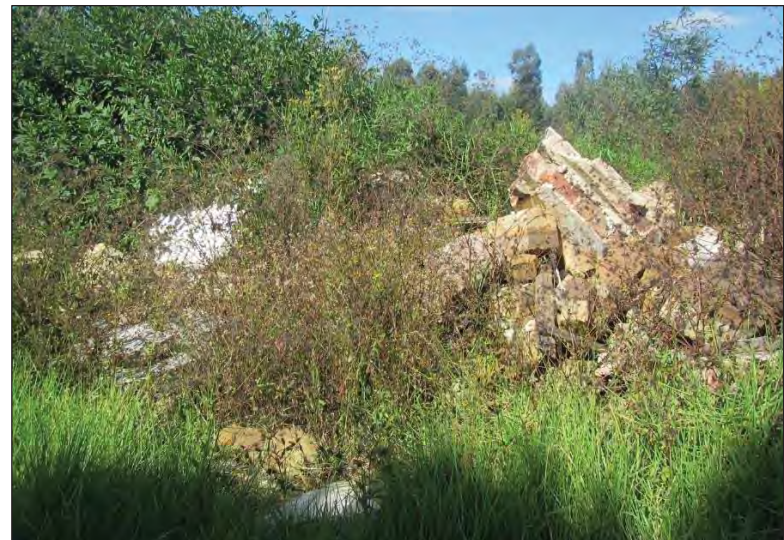
Figure 29 - View of building rubble from the demolished remains of structures from site PP 01.

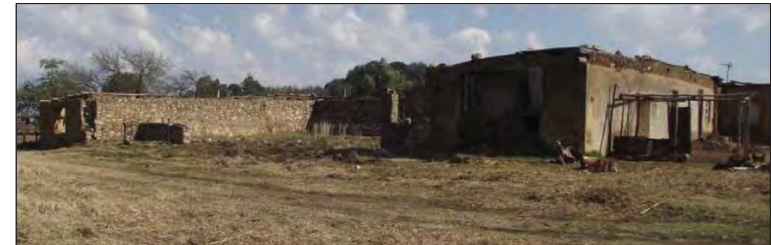
The remains of an old cattle kraal were identified at this location. The structure was built with stone and mortar and measures approximately 20m x 25m in size. The walls of the kraal are thick and measure approximately 0.75m thick and 2.2m high. The kraal has a storeroom attached to one side and feeding troughs are placed along another wall. The storeroom is a later addition and is brick-built with a sloping corrugated iron roof. Three families had used parts of the old kraal structure to build their own homesteads. These families were working on the farm. The age of the kraal is not known.

Figure 47 - View of the kraal with dwelling additions as recorded in 2012 (Photo: Kitto & Fourie, 2012).

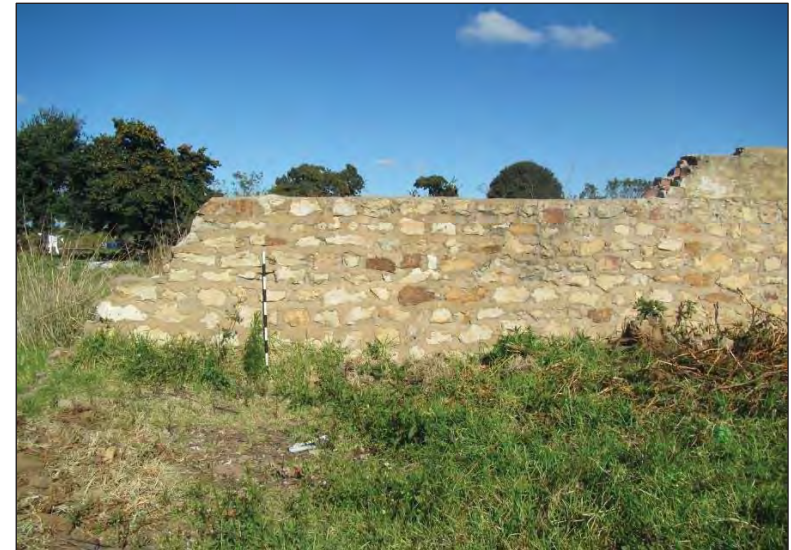
Figure 50 – Closer view of a section of walling from the kraal. The scale is in 10cm increments.

See Chapter 7 for impact assessment calculations and Chapter 8 for required mitigation measures

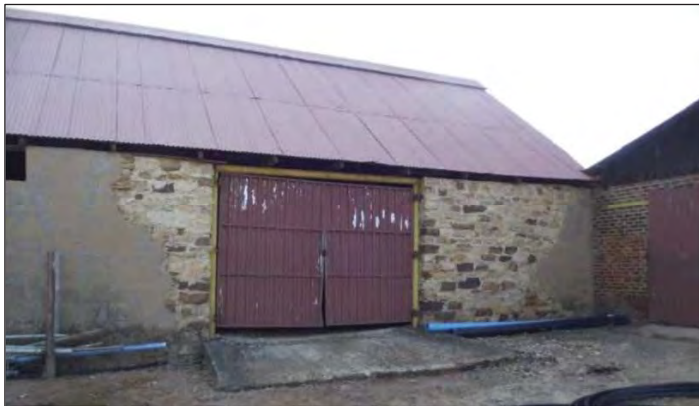
A large storeroom or shed was identified at this location. The storeroom measures approximately 20m x 12m in size and has a high pitched corrugated iron roof. It has large metal doors with metal door frames. These are most likely a later addition. The high windows have wooden frames and are open. The building also has an external electrical system. It has a cement floor and the building is still in use. A small, square sandstone-built structure is situated next to the larger storeroom. This structure measures approximately 5m x 5m in size and also has a pitched corrugated iron roof. It is built with sandstone blocks and mortar and is in a rather weathered state. It does not have a door or door frame and a wooden lintel is used in the door opening. It has wooden window frames. The building has a dirt floor and does not have any water or electrical systems. The age of these buildings is not known.

Figure 52 – General view of the large storeroom as recorded in 2012 (Photo: Kitto & Fourie, 2012).

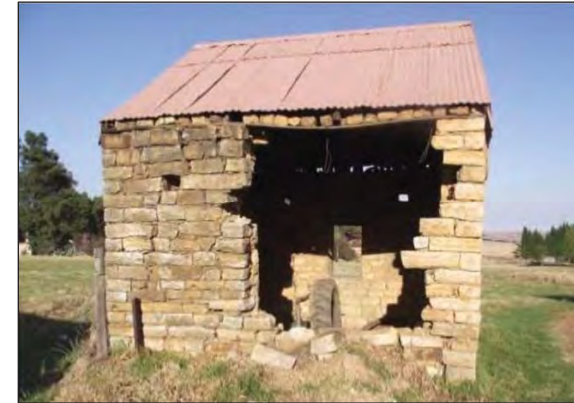
Figure 53 – The dilapidated square structure as recorded in 2012. This building was constructed of sandstone (Photo: Kitto & Fourie, 2012).

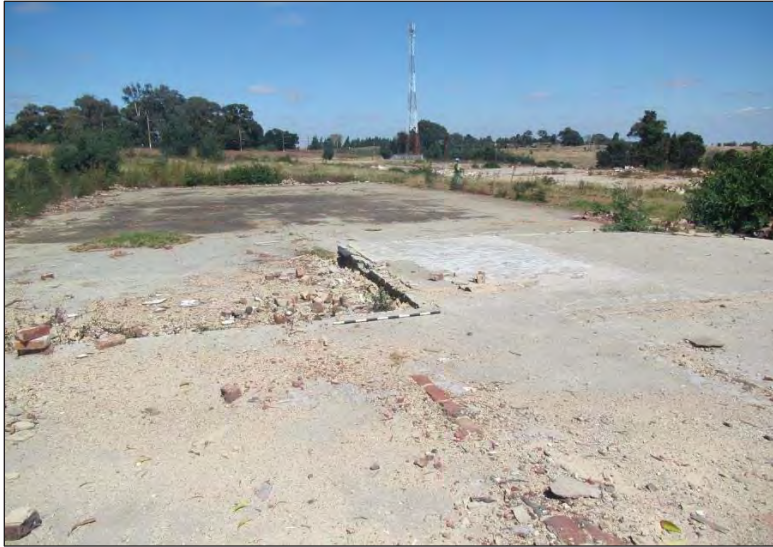
All the structures and buildings that were located at site PP 07 have been demolished. Only the remains of the foundations are visible on site.

Figure 54 - General view of site PP 07 as recorded during the 2021 fieldwork.

See Chapter 7 for impact assessment calculations and Chapter 8 for required mitigation measures

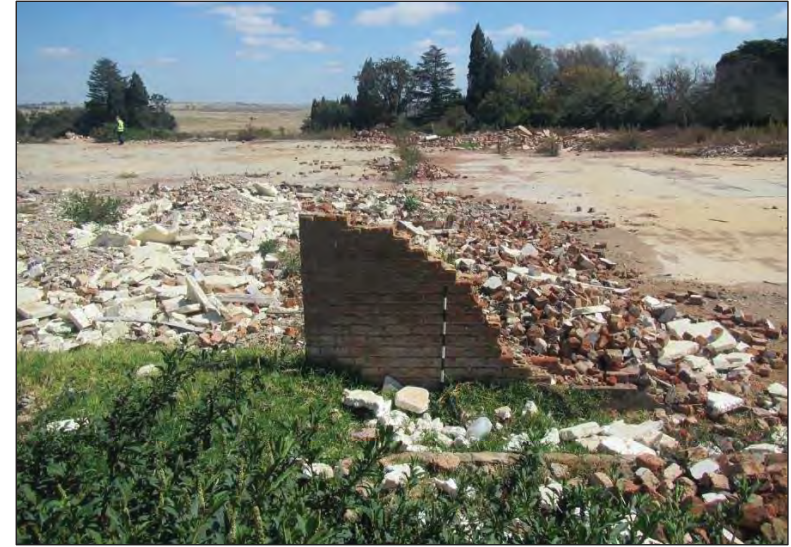
Figure 56 – Another view of the state of site PP 07 as recorded during the 2021 fieldwork. The scale is in 10cm increments.

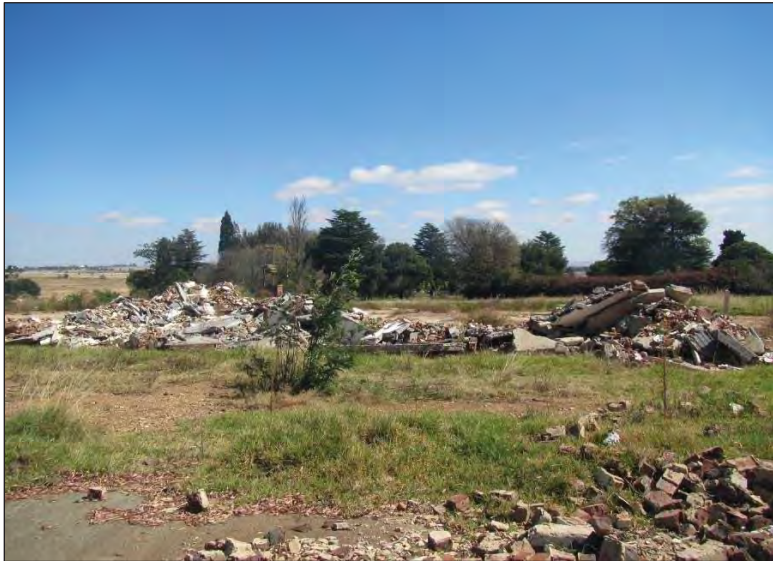
Figure 55 - General view of the demolished remains observed at site PP 07.

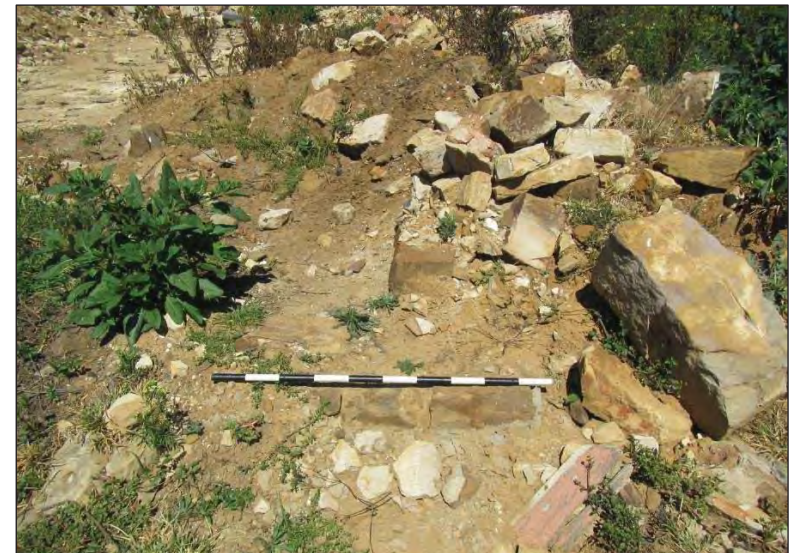
Figure 57 - Remains of the sandstone-built structure as recorded during the 2021 fieldwork at site PP 07. The scale is in 10cm increments.

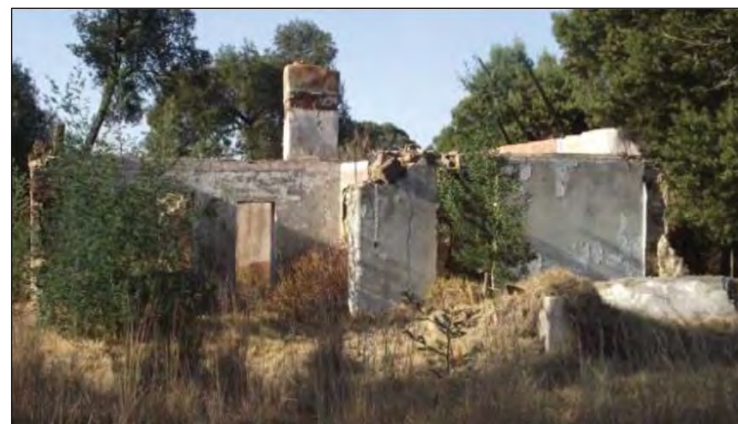
The remains of a farmhouse and its associated buildings were identified at this location. The remains of the multi-roomed farm house measure approximately 20m x 20m in size. The building was constructed with sandstone blocks and mortar and later additions are brick-built. The walls of the building are thick and are mostly constructed with sandstone blocks and mortar. Some other sections had been constructed or repaired with mud-bricks. Most of the building is plastered with cement and is painted over. A wrought iron fireplace with red tile surround was still in situ, which could date the building to approximately the 1910s to 1930s [Edwardian period, <http://www.c20fireplaces.co.uk/information/history-twentieth-century-fireplaces-1905-1939>].

Figure 58 – General view of the farmhouse as recorded in 2012 (Photo: Kitto & Fourie, 2012).

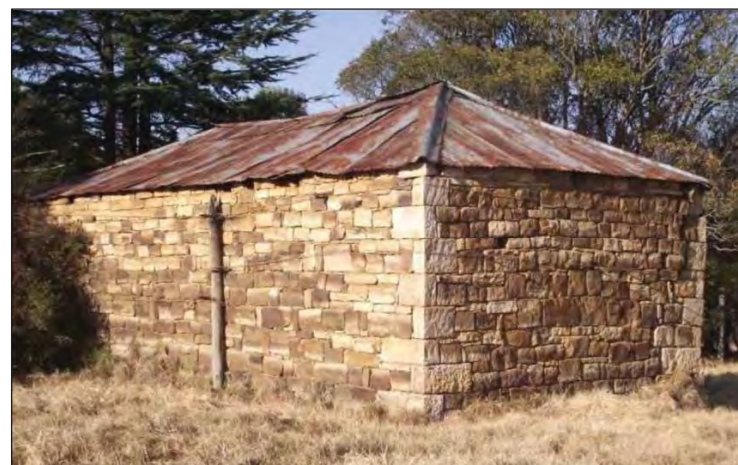
Figure 59 – The sandstone storeroom as recorded during 2012 (Photo: Kitto & Fourie, 2012).

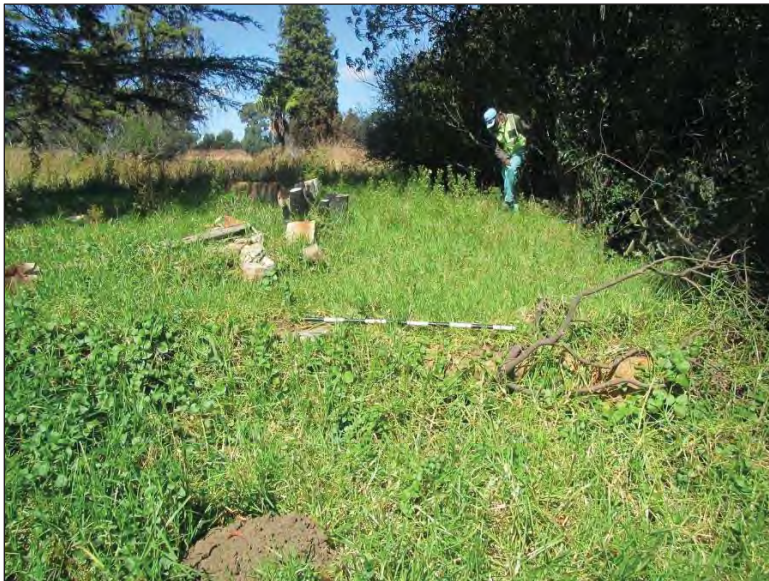
The structures that were identified in 2012 have all been demolished. Only the remains of the structures and foundations were found during the 2021 fieldwork.

Figure 60 - View of the foundation of a structure as seen during 2021. The scale is in 10cm increments.

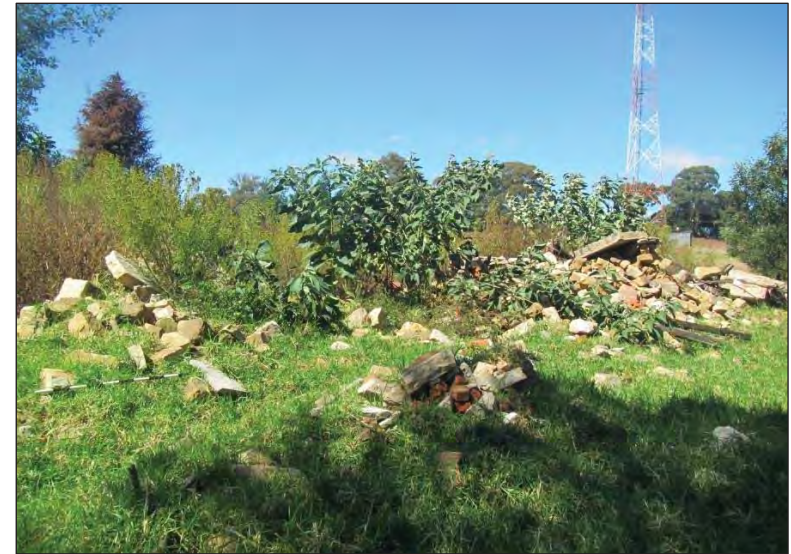
Figure 61 – Building rubble from a demolished structure at site PP 08. The scale is in 10cm increments.

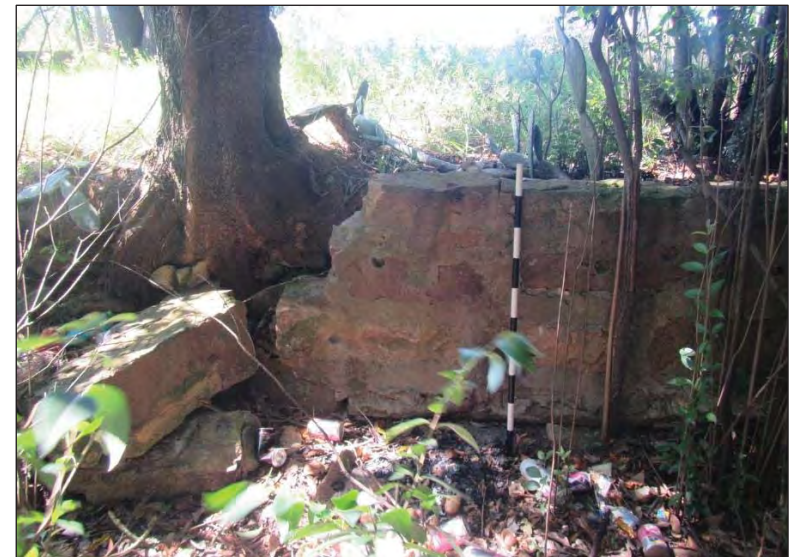
Figure 62 – More structural remains observed at site PP 08. The scale is in 10cm increments.

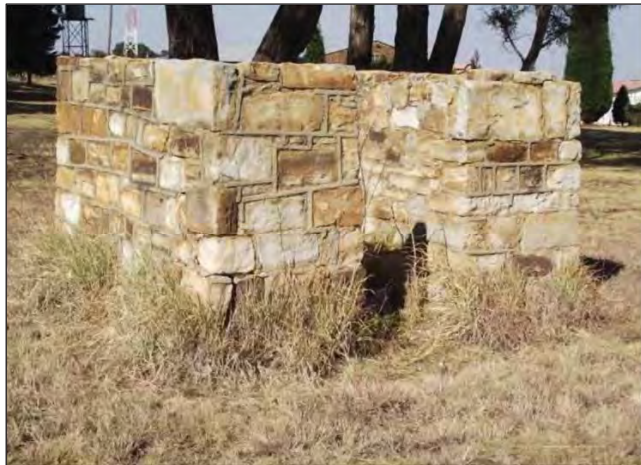
The remains of a small, square structure were identified at this location. The structure is built with sandstone blocks and cement and measures approximately 4m x 4m in size. The structure has no roof and has only one entrance with no windows. It also has a gravel floor. The function and age of this structure is unknown.

Figure 63 - Square sandstone structure as recorded in 2012 (Photo: Kitto & Fourie, 2012).

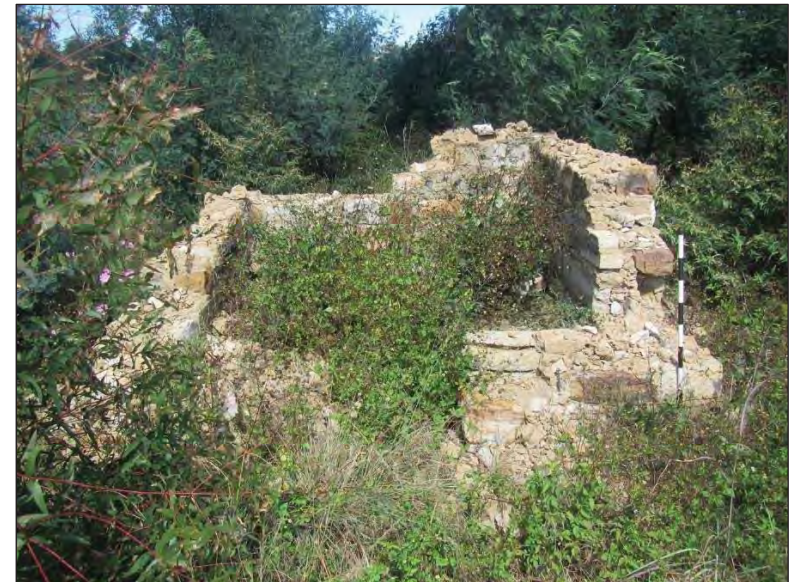
The remains of the same square structure were identified during the 2021 fieldwork. However, the condition of the structure has deteriorated significantly in the nine years since the previous assessment

During the 2012 study, the site was assessed to be of **Medium Significance** or **Generally Protected B (GP. B)**. Due to the fact that the site has now deteriorated significantly, the current significance of the site is deemed to be of **Low Significance** or **Generally Protected C (GP.C)**.

Figure 64 - View of the front of the structure as recorded in 2021. This view of the structure shows the same façade as the one that was taken in 2012 above. A comparison of the two photographs clearly show the level of deterioration at the site. The scale is in 10cm increments.

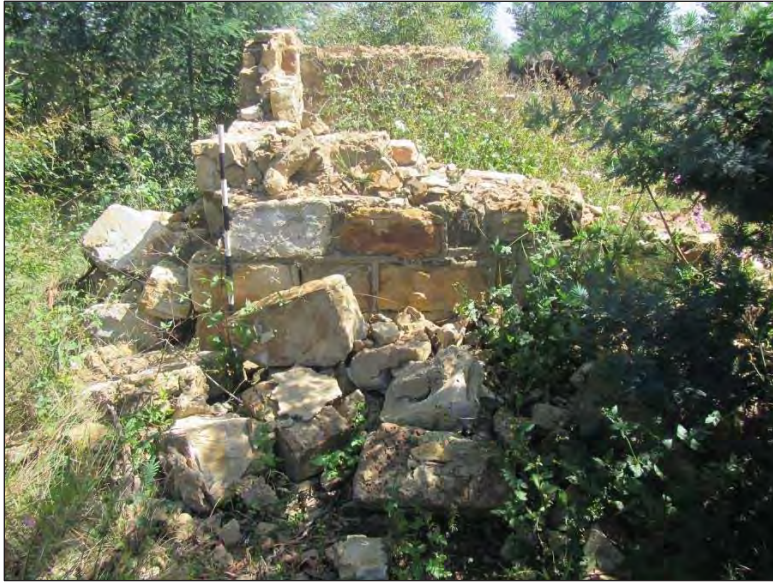
Figure 65 – Another view of the structure as recorded in 2021. The scale is in 10cm increments.

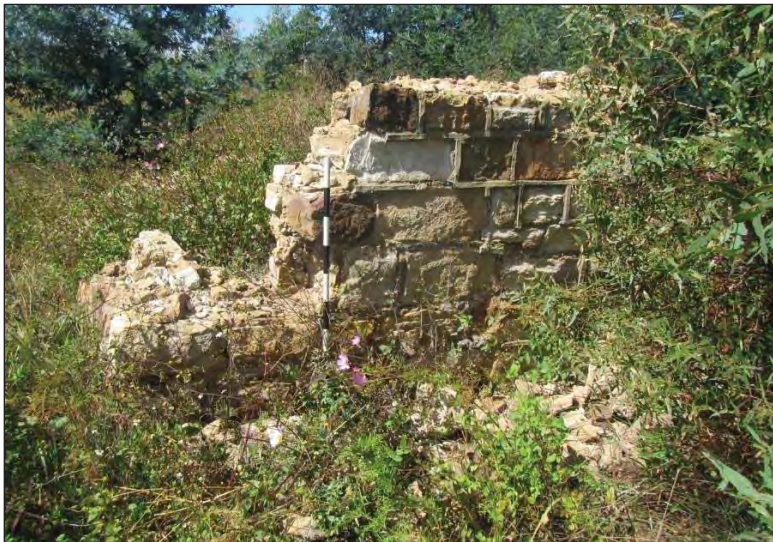
Figure 66 – Another view of the structure as recorded in 2021. The scale is in 10cm increments.

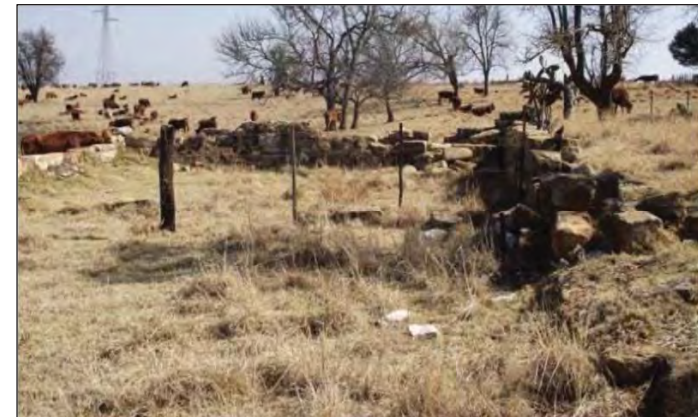
The remains of a cattle kraal were also identified near the houses. The kraal was built with sandstone blocks and mortar and measures approximately 25m x 8m in size. The kraal is in a ruined state and the walls had been replaced by fencing.

Figure 73 - Remains of the cattle kraal as recorded in 2012 (Photo: Kitto & Fourie, 2012).

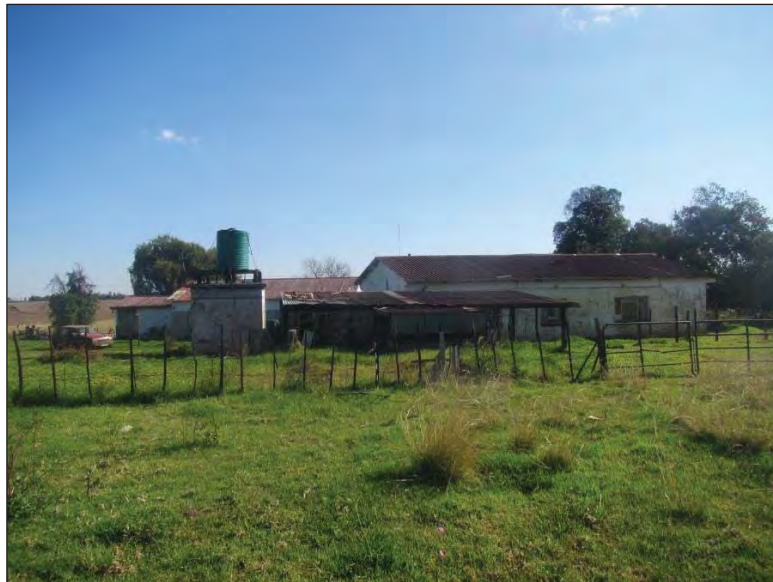
The farmstead was visited during the current fieldwork. The main farmhouse appears to be a bit dilapidated from the building that was recorded in 2012. However, all the other structures are still intact and appear to be in a similar condition as when they were identified in 2012. The site is currently occupied by the Joubert family.

Figure 74 - View of the main farm house as recorded during the recent fieldwork.

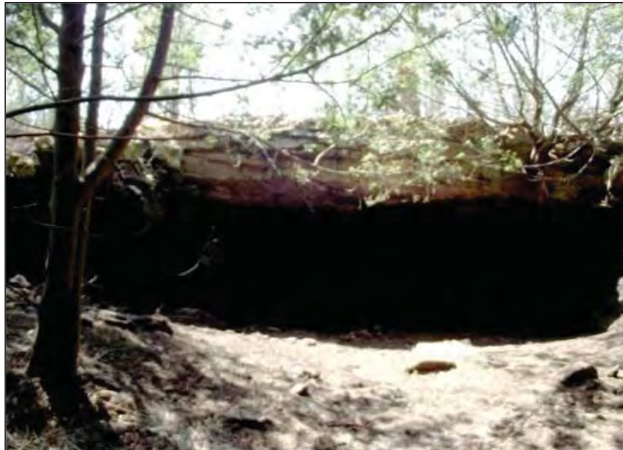
An abandoned coal mine shaft was identified at this location. The shaft measures approximately 2m x 5m and extends approximately 25m into the side of the hill. A second tunnel/shaft extended from the main shaft and its roof had collapsed at the end of this shaft/tunnel. Most of the shaft is flooded with water. Wooden supports to keep the roof of the shaft from collapsing are still in place. A ventilation hole had been dug in the roof which is visible on the surface of the rock outcrop. The age of this abandoned mine is not known. However, it is likely that it dates to over 100 years. Van der Merwe's book on the town of Belfast states that coal mining occurred in this area in historical times and was associated with Sammy Marks (1952).

Figure 77 – The entrance to the old mine shaft as recorded in 2012 (Photo: Kitto & Fourie, 2012).

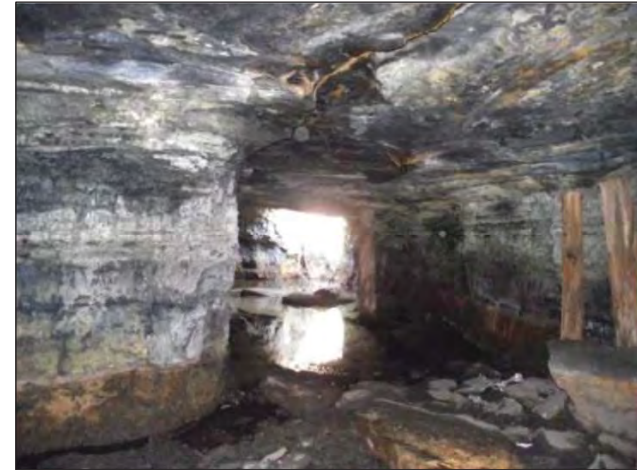
Figure 78 - Interior view of mine shaft as recorded in 2012 (Photo: Kitto & Fourie, 2012).

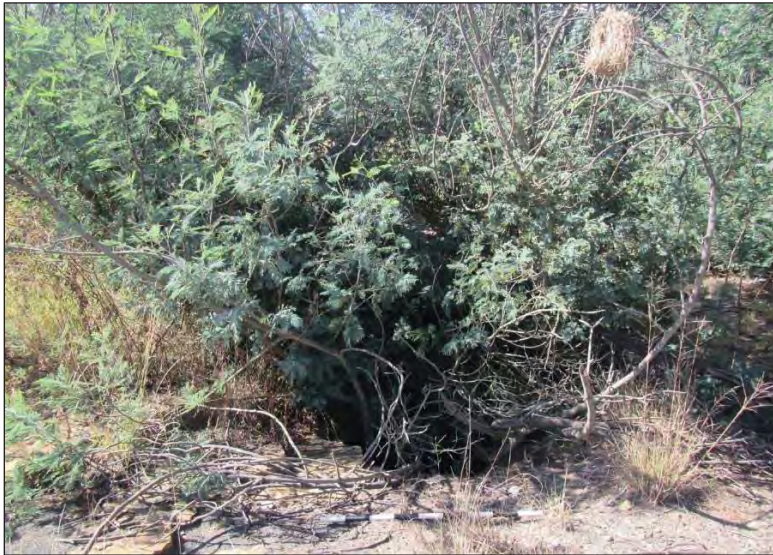
Figure 80 – Closer view of the entrance to the shaft as recorded during the recent fieldwork. As can be seen, the shaft entrance is completely overgrown. The scale is in 10cm increments.

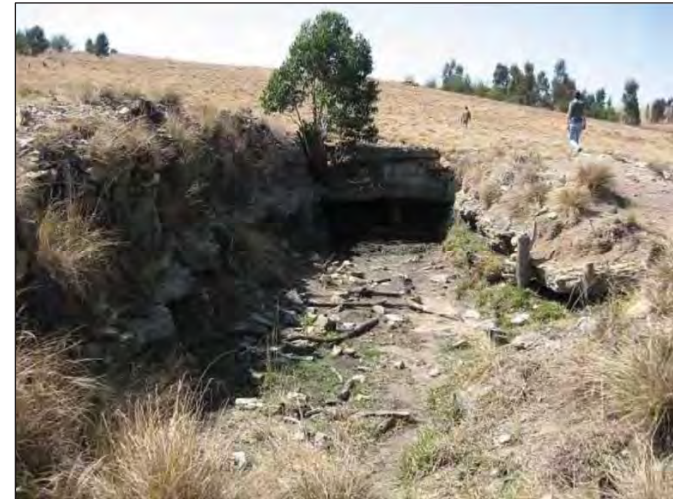
Another abandoned mine shaft was identified at this location. The shaft also measures approximately 2m x 5m and extends approximately 25m into the side of the hill. Most of the shaft is flooded with water. Wooden supports to keep the roof of the shaft from collapsing are still in place. The age of this abandoned mine was not known. However, as noted above, it probably dates to the historical period. The coal spoil heap is also still present close to the entrance of the shaft

Figure 81 - General view of mine shaft at site PP 13 as recorded in 2012 (Photo: Kitto & Fourie, 2012).

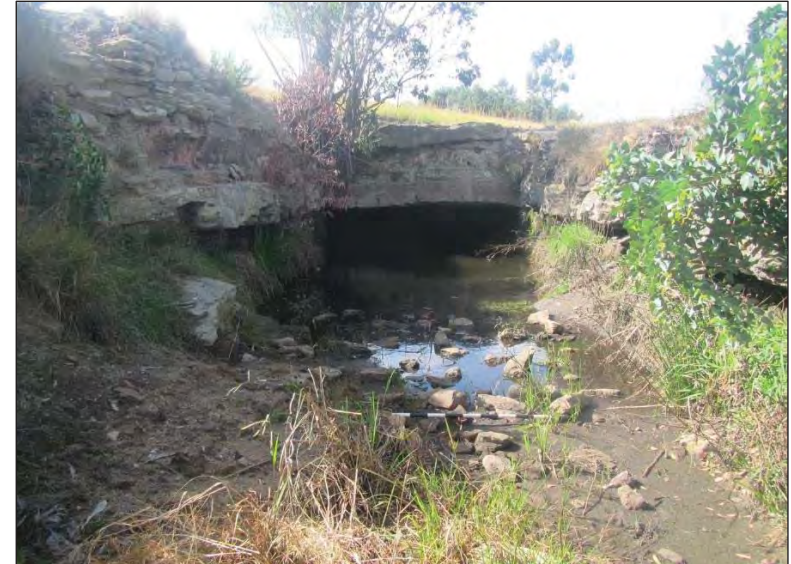
The shaft appears to be in the same condition as when it was identified in 2012.

Figure 83 – General view of the shaft entrance at PP 13 as recorded during the recent fieldwork. The scale is in 10cm increments.

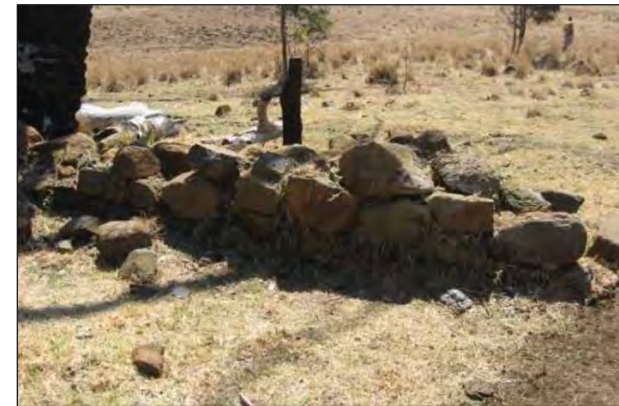
The ruined stone walled cattle kraal was situated approximately 35m to the west of the homestead. The kraal measures approximately 10m x 10m in size and the walls measure approximately 0.5m wide and 0.75m high.

Figure 89 - Remains of the cattle kraal as recorded in 2012 (Photo: Kitto & Fourie, 2012).

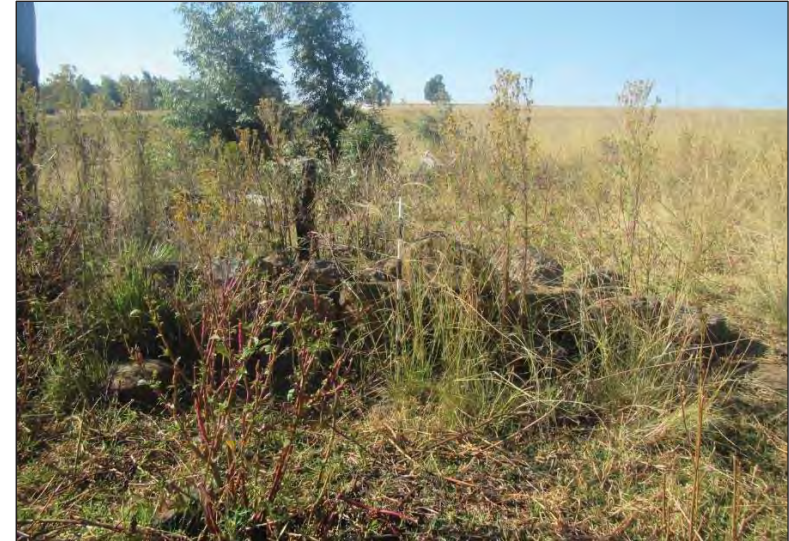
Figure 91 - View of the stone kraal as recorded during the 2021 fieldwork. The site is currently overgrown and it appears as if sections of its walls have collapsed since the 2012 fieldwork. The scale is in 10cm increments.

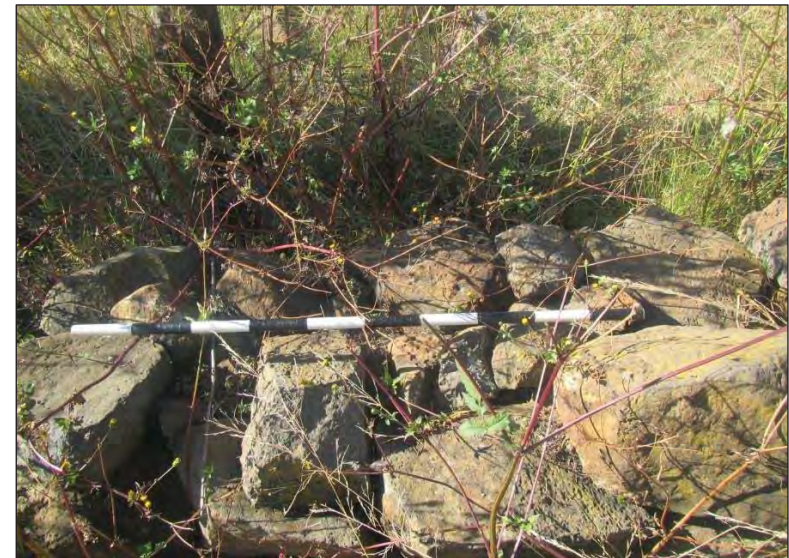
Figure 92 - Closer view of a section of walling from the kraal. The scale is in 10cm increments.

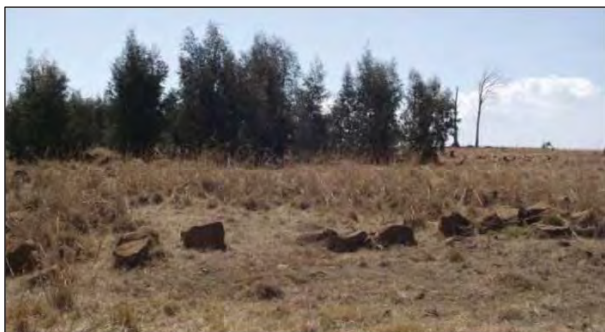
The ruin of a stone-walled cattle kraal is situated approximately 30m to the east of the homestead. The kraal measures approximately 10m x 12m in size but the walls had been robbed and the size of the walls could not be determined. Two informal graves were also identified next to the kraal. They are placed next to each other and are orientated from west to east. The graves have oval-shaped mounds of packed rocks as dressing. The graves have no headstones and their age could not be determined.

Figure 93 – The remains of kraal walling as recorded in 2012 (Photo: Kitto & Fourie, 2012).

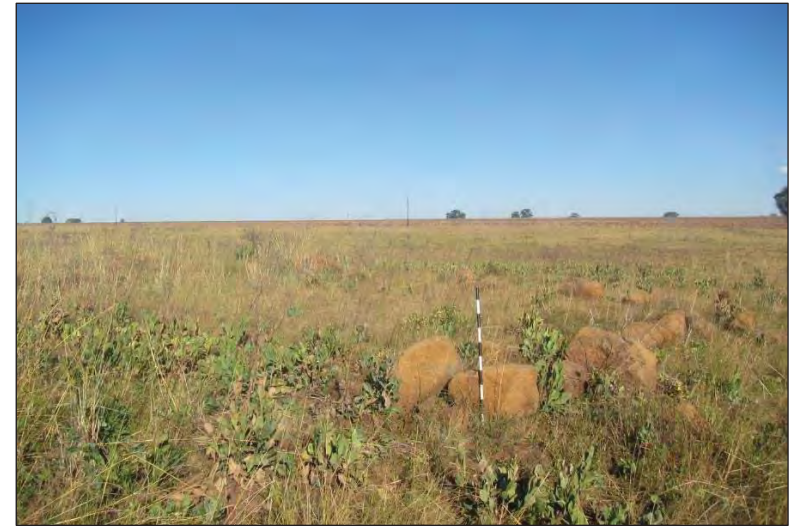
Figure 96 - View of the stone wall observed at the site during the 2021 fieldwork. The scale is in 10cm increments.

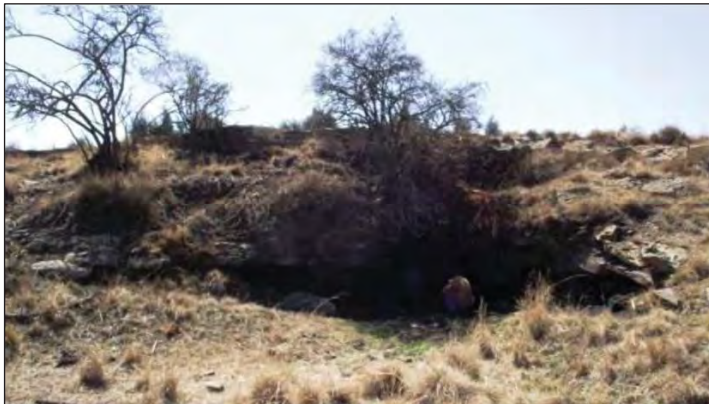
An abandoned coal mine shaft was identified at this location. The shaft measures approximately 2m x 4m and extends approximately 15m into the side of the hill. Most of the shaft is flooded with water. The age of this abandoned mine is not known but it is likely to be of historical date (as discussed above).

Figure 98 – Entrance to the mine shaft at site PP17 as recorded in 2012 (Photo: Kitto & Fourie, 2012).

The site was visited during the recent fieldwork. The mine shaft appears to be relatively intact and in a similar condition as when it was recorded in 2012. The shaft is still flooded with water.

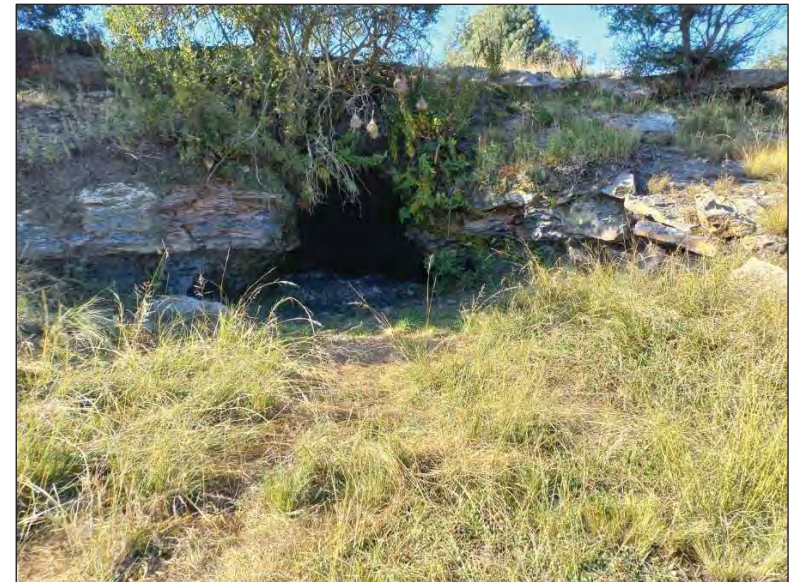
Figure 99 – General view of site PP 17 as recorded during the recent fieldwork. The entrance to the mine shaft can be seen below the weaver-nests hanging from the tree.

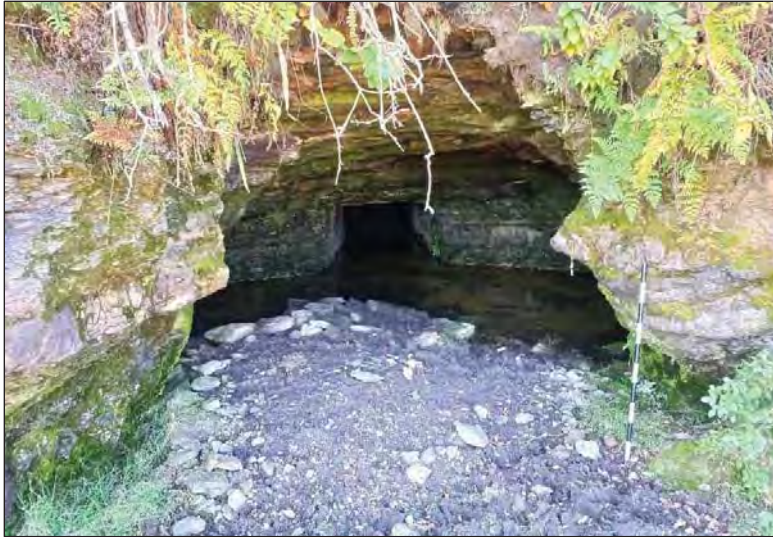
Figure 100 – General view of the entrance to the shaft at site PP 17 as recorded during the recent fieldwork. The scale is in 10cm increments.

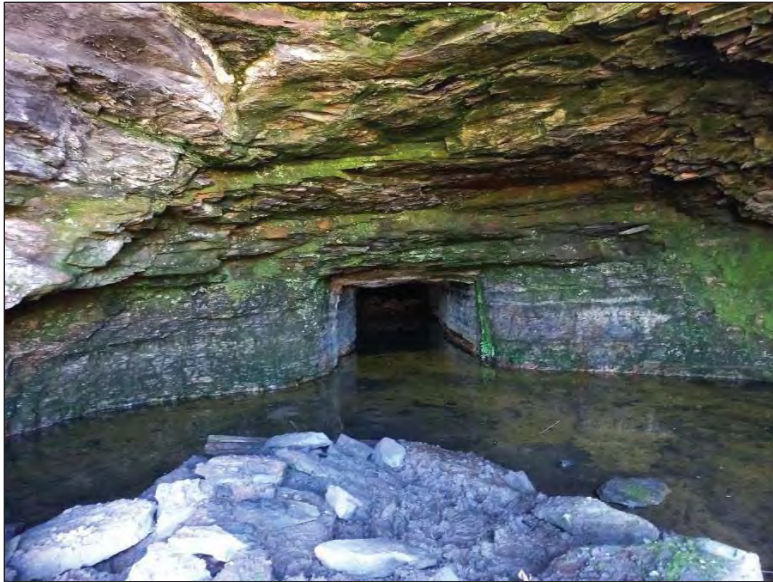
Figure 101 - Interior view of the shaft as recorded during the recent fieldwork.

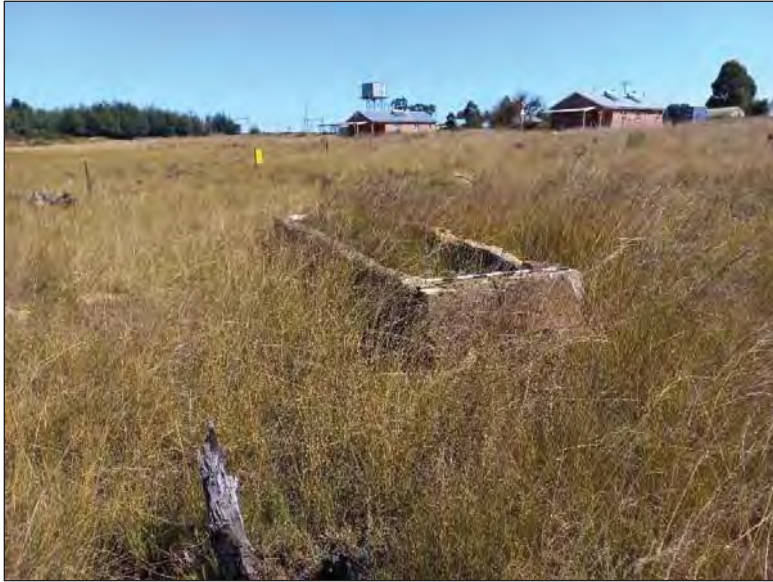
The site was visited during the recent fieldwork. The trough appears to be in the same condition as when it was recorded in 2012. The site is overgrown with vegetation and it would appear that the trough is not currently used.

Figure 102 - General view of the animal drinking trough at site PP 18 as recorded during the recent fieldwork. The scale is in 10cm increments.

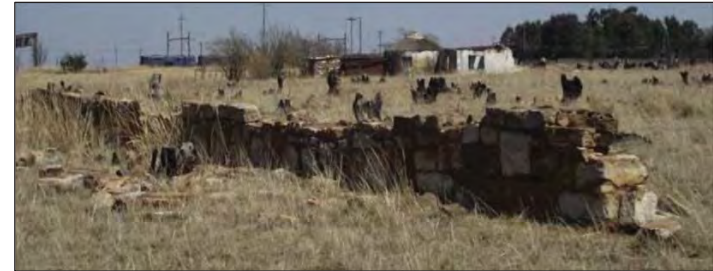
A ruined stone-walled cattle kraal was identified at this location. The kraal measures approximately 20m x 10m in size and the walls measure approximately 0.5m wide and 1m high. Most of the sandstone blocks used in the walls of the kraal have been robbed (used somewhere else) and the original kraal is in a very dilapidated state.

Figure 103 - Remains of stone kraal as recorded in 2012 (Photo: Kitto & Fourie, 2012).

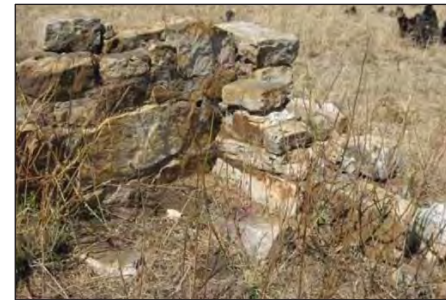
Figure 104 - Close-up view of a section of walling from the kraal (Photo: Kitto & Fourie, 2012).

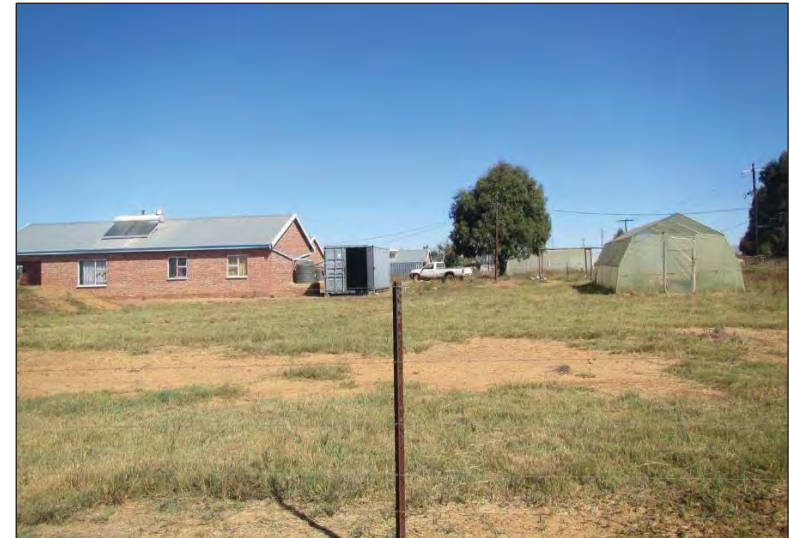
Figure 105 - General view of PP 19 as recording during the recent fieldwork. The kraal is no longer located on-site, as the area has since been used for the site of the Phumulani Agri-Village.
