DRAFT BASIC ASSESSMENT REPORT

NBC Colliery, Universal Coal D2809 Road Realignment Wetland Risk Assessment

NBC Colliery, Universal Coal: D2809 Road Realignment Wetland Risk Assessment

Ecology International Ref. No. 210057

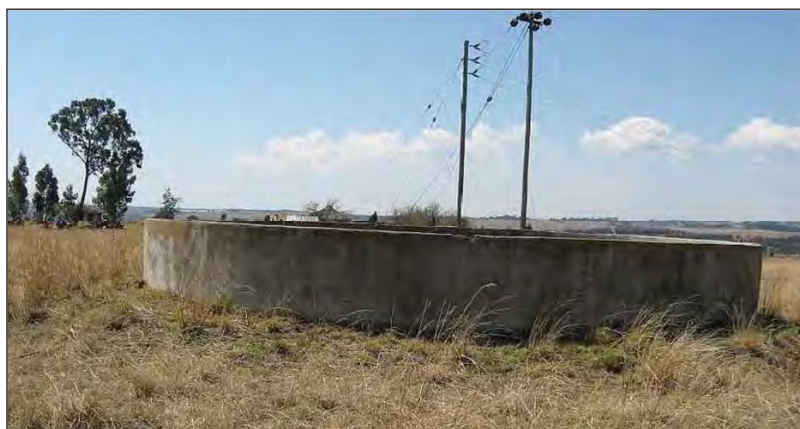
Figure 107 – General view of the brick and cement dam as recorded during the fieldwork undertaken in 2012 (Photo: Kitto & Fourie, 2012).

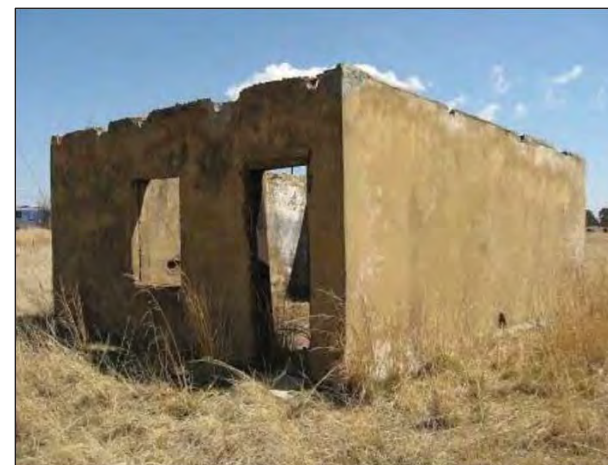
A 6m x 6m square brick-built building is situated next to the cement dam. The building is plastered and has a wooden door frame. The building's roof, windows and doors had been removed.

Figure 108 - Brick structure as recorded during the fieldwork undertaken in 2012 (Photo: Kitto & Fourie, 2012).

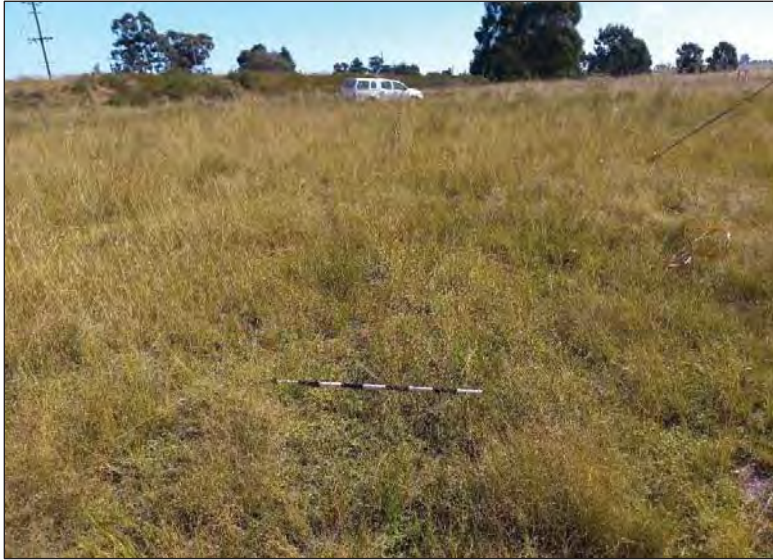
During the recent fieldwork undertaken in 2021, the site was also visited. No evidence for the structures that were recorded in 2012 could be observed during the recent fieldwork. It would appear that the structures were most likely demolished during the construction of the Phumulani Agri-village. A newer steel reservoir is located close to the original position of the cement dam.

Figure 109 - General view of the site as recorded in 2021. As can be seen from this image, no evidence for the dam or associated structure could be found. The scale is in 10cm increments

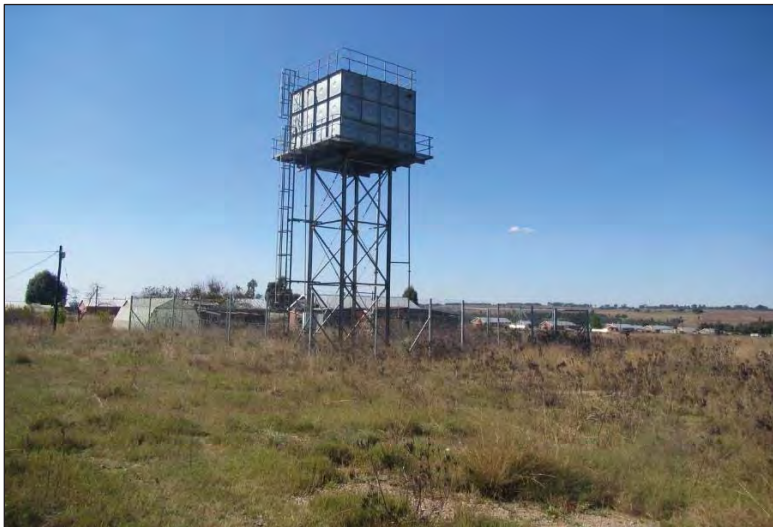
Figure 110 – The new steel reservoir that was built near site PP 20. This steel reservoir is associated with the Phumulani Agri-Village.

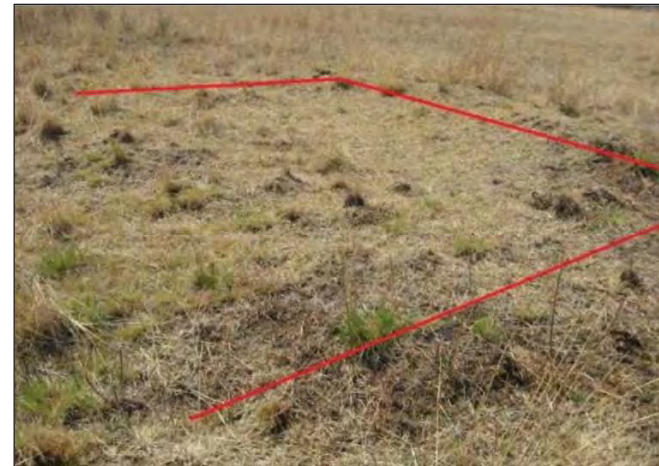
The remains of a mud-brick homestead were identified at this location. The remains of the mud-brick homestead consist of the foundations of one rectangular structure, which measure approximately 7m x 4m in size, and a multi-roomed l-shaped structure, which measures 8m x 12. A further circular structure measures approximately 4m in diameter. This structure was most probably the cooking hut. Rocks were used in the foundations to support the mud-brick walls of the structures. A lower grinding stone was also identified with the remains of the structures. Several modern metal artefacts such as wire, corrugated iron and cans were found scattered around the site.

Figure 111 - Foundations of rectangular structure as recorded in 2012 (Photo: Kitto & Fourie, 2012).

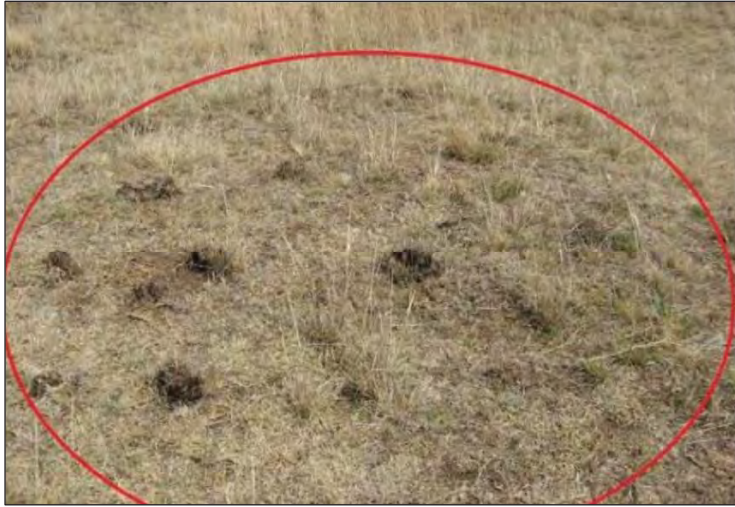
Figure 112 - Remains of circular structure as recorded in 2012 (Photo: Kitto & Fourie, 2012).

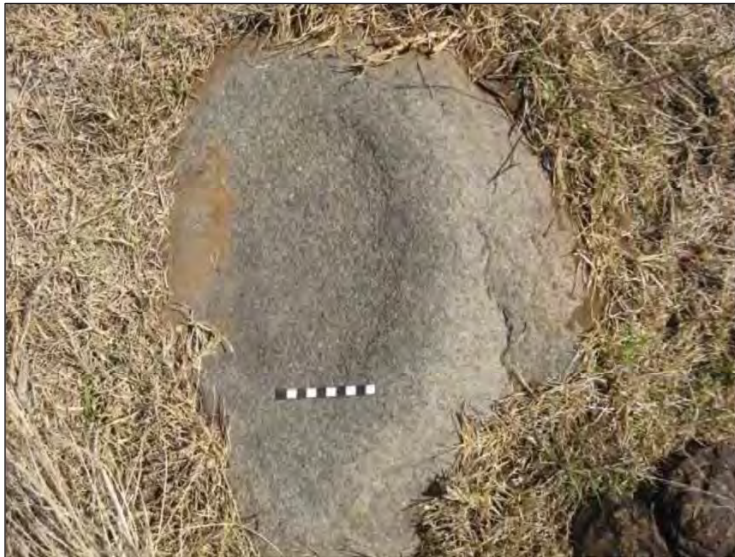
Figure 113 - Lower grinding stone as recorded in 2012 (Photo: Kitto & Fourie, 2012).

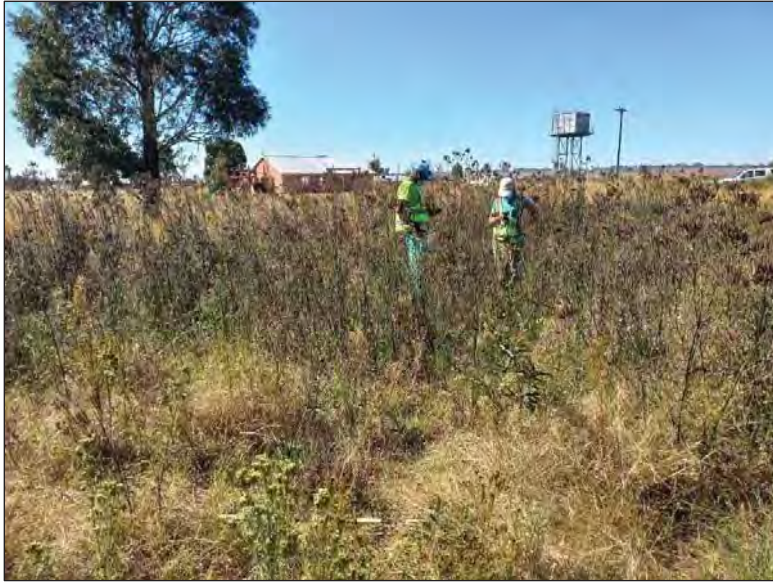
During the recent fieldwork undertaken in 2021, the site was also visited. No remains of a mud-brick homestead were identified at this location. The site is overgrown with grassy vegetation. No other cultural material including remains of foundations of a grinding stone was observed at the site. The site has been disturbed by illegal dumping activities.

Figure 114 - General view of the site as recorded during the recent site visit. Note the dense vegetation found across the surface of the site, which may explain why the remains of the structures could not be found.

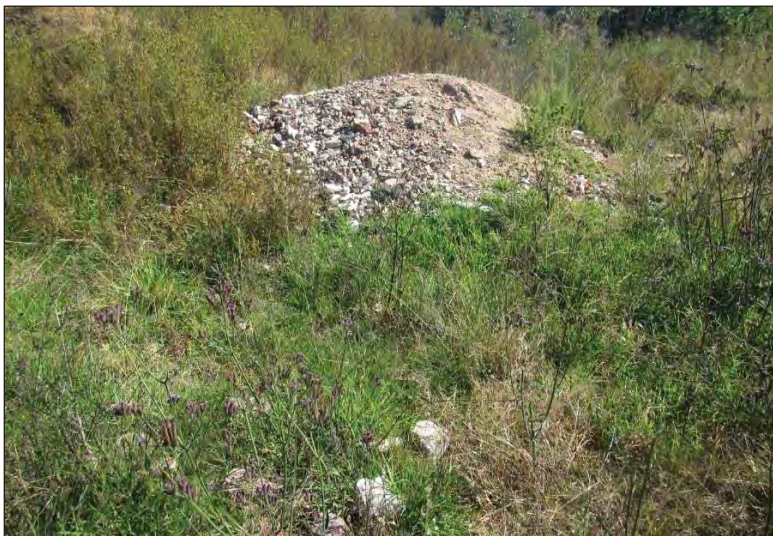
Figure 115 – Evidence for illegal dumping activities was noticed around the site.

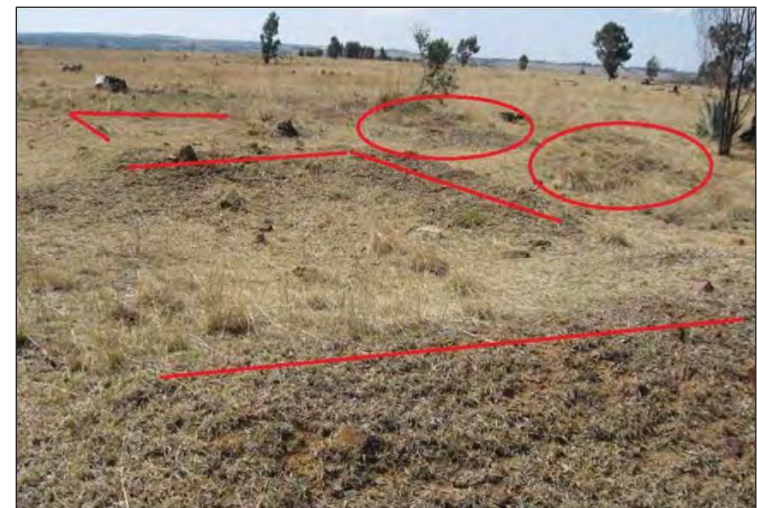
The remains of a mud-brick homestead were identified at this location. The remains of the mud-brick homestead consist of the foundations of one rectangular multi-roomed structure, which measures approximately 10m x 15m in size; two rectangular-shaped structures, which measure 4m x 6m each; and a square room, which measures 4m x 4m. There was also a circular structure, which measures approximately 4m in diameter. This structure was most probably the cooking hut. The structures are arranged in an open square which formed a central Lapa area. Rocks were used in the foundations to support the mud-brick walls of the structures. Several modern metal artefacts such as wire, corrugated iron and cans were found scattered around the site.

Figure 116 - Foundations of a multi-roomed structure recorded in 2012 (Photo: Kitto & Fourie, 2012).

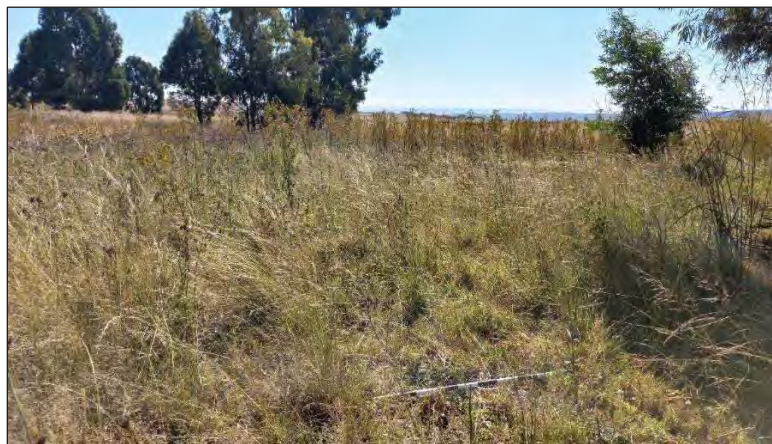
The site was visited during the recent fieldwork. A small section of the remains of the foundation of the mud-brick homestead could be identified. The outlines of the structure were barely visible underneath the grassy vegetation. No other cultural material including remains were observed at the site.

Figure 117 - General view of site PP 22 as recorded during the recent site visit. The remains of the mudbrick homestead could barely be seen in the dense vegetation. The scale is in 10cm increments.
6.2.23 PP 23

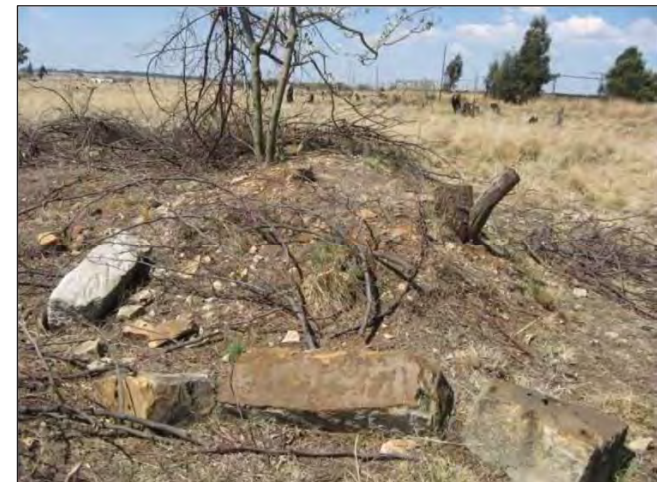
The remains of an old sandstone building were identified at this location. Most of the remains of the building had been removed and only the sandstone blocks which formed the foundations of the building are left. Several bricks were also found scattered across the site. There were no other features such as windows, doors or any floors to identify the structure with. These remains are most probably parts of an old farmhouse, which were broken down and removed from this site in the past. The structure measures approximately 18m x 20m in size. The exact function and age of this structure are not known.

Figure 118 – General view of the site as recorded in 2012. The poorly preserved state of the structure can be seen (Photo: Kitto & Fourie, 2012).

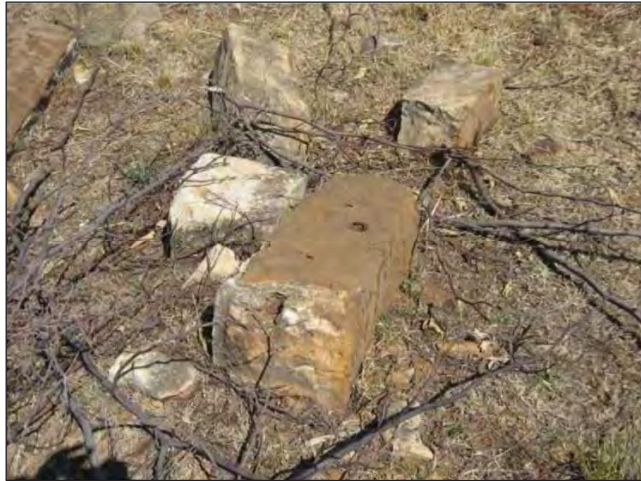
Figure 119 – Another photograph of the site that was taken in 2012. A few of the sandstone blocks can be seen (Photo: Kitto & Fourie, 2012).

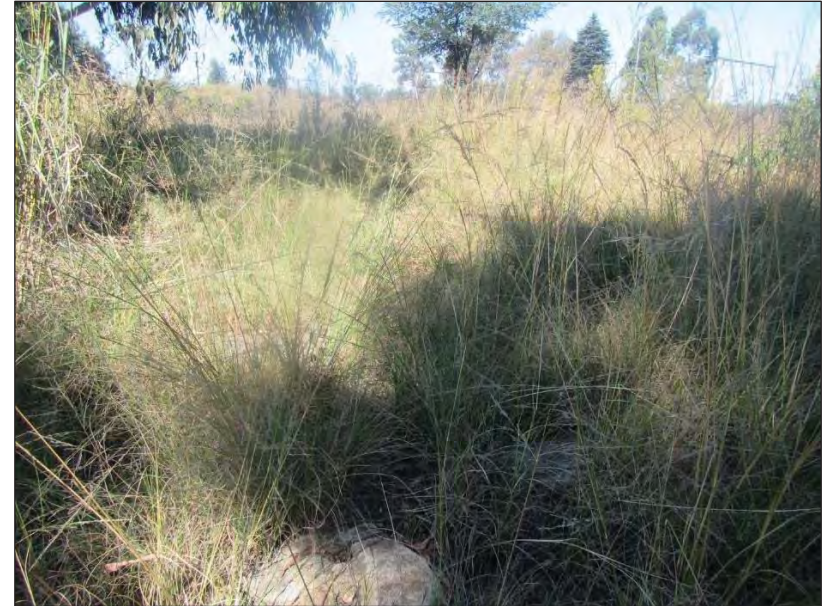
The site was visited during the recent fieldwork. The scattered remains of an old sandstone building were identified at this location. Most of the remains of the building had been removed and only the sandstone blocks which formed the foundations of the building were left. The site is overgrown.

Figure 120 - General view of site PP 23 as recorded during the recent fieldwork. The dense vegetation covering the surface of the site can be seen.

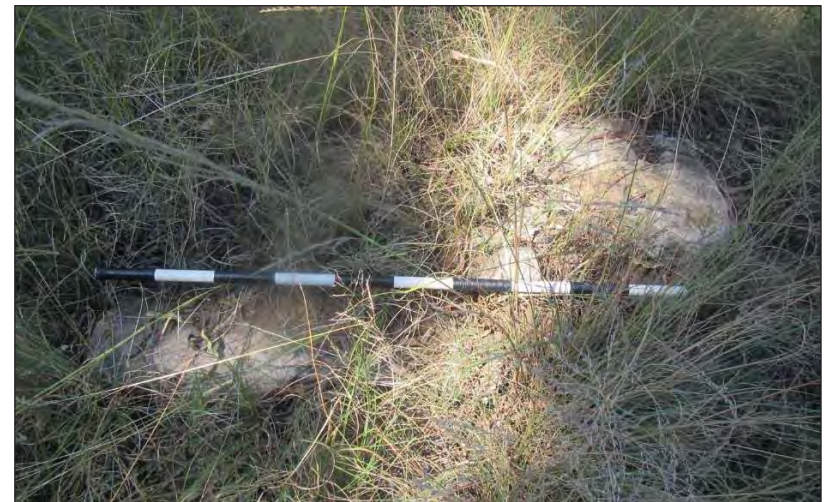
Figure 121 - Only the scattered remains of the sandstone blocks of the structure were observed on site. The site is poorly preserved and overgrown. The scale is in 10cm increments.

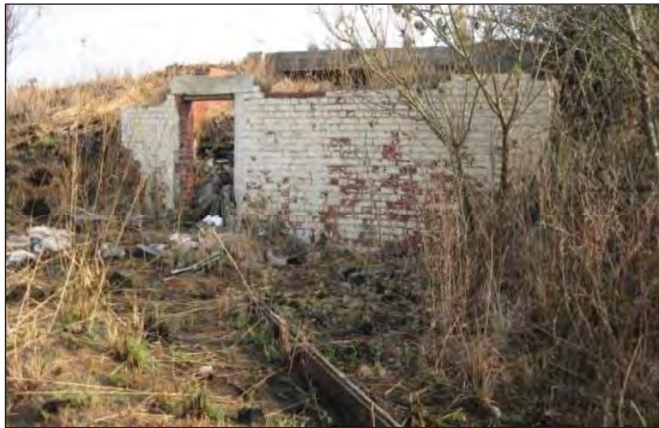
The ruined remains of the Sunbury Railway Station were identified at this location. The structure is constructed of red brick that was plastered and painted. The structure has been stripped of its roof, doors, windows and all other features. Only a few of its walls remain. The structure is in ruins and is overgrown with vegetation. The age of the station is not known.

Figure 122 - Remains of the building at the Sunbury Railway Station as recorded in 2012 (Photo: Kitto & Fourie, 2012).

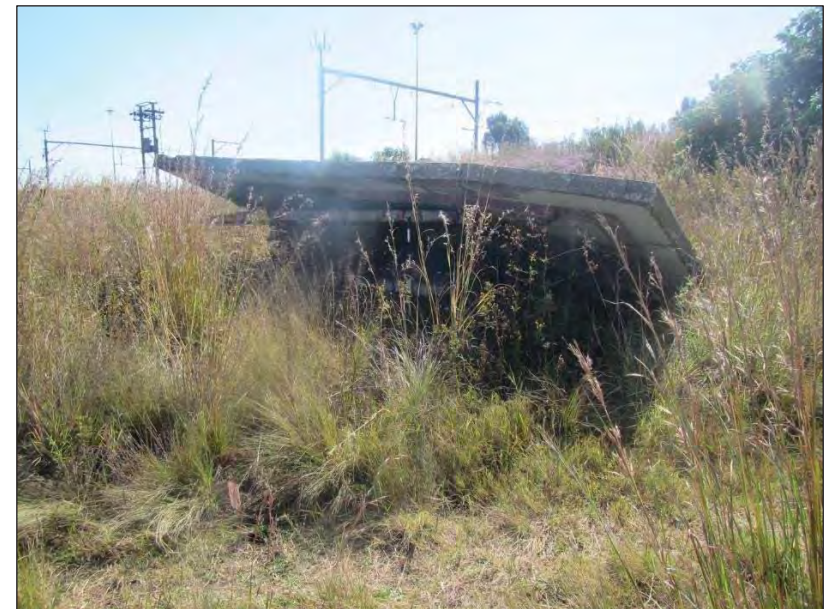
Figure 123 - The collapsed remains of the building associated with the Sunbury Railway Station as recorded during the recent fieldwork.

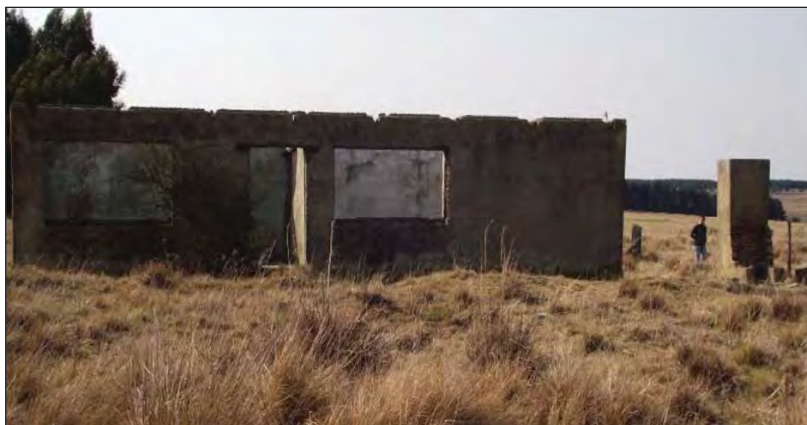
The remains of farm labourer quarters were identified at this location. The structure is brick-built and plastered and measures approximately 10m x 5m in size. The roof, doors, windows and frames have been removed from the building. The building consisted of two rooms and a bathroom. A warm water system (donkey) is situated next to the bathroom of the building. A midden was also identified approximately 20m from the structure.

Figure 124 - Ruins of farmworker dwelling and "donkey" structure as recorded during the fieldwork undertaken in 2012 (Photo: Kitto & Fourie, 2012).

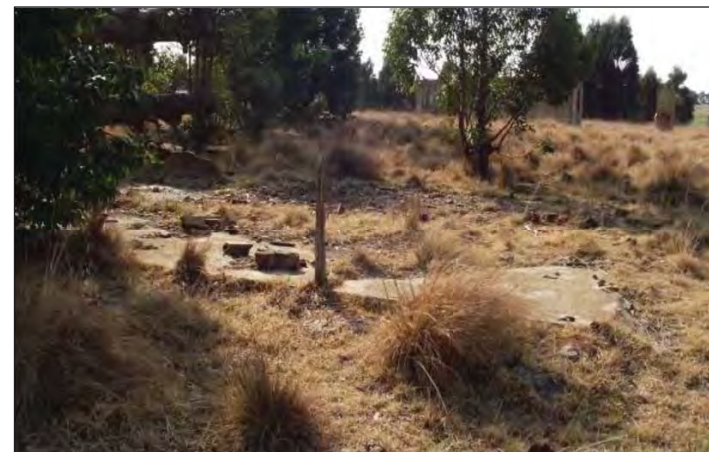
The remains of a cattle or pig shed were also identified approximately 50m to the west of the labourer quarters. A brick and cement drinking trough was identified near the remains of the cattle/pig shed.

Figure 125 - Remains of shed as recorded in 2012 (Photo: Kitto & Fourie, 2012).

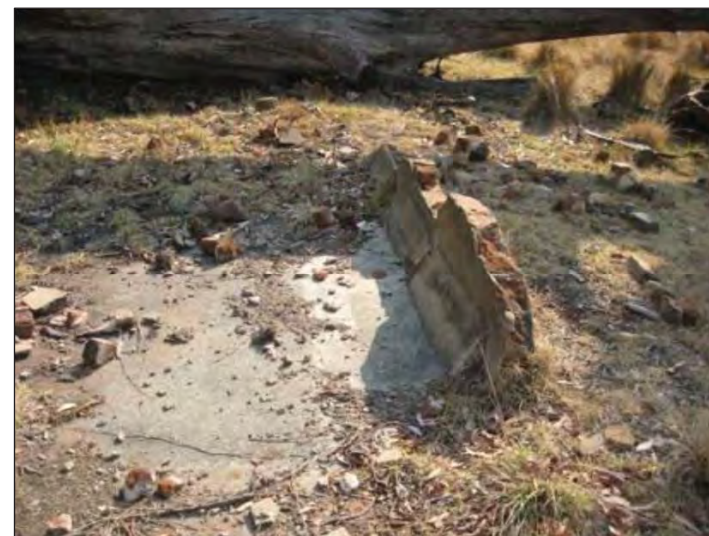
Figure 126 - Close-up view of a section of walling from the shed. This photograph was also taken during the site visit of 2012 (Photo: Kitto & Fourie, 2012).

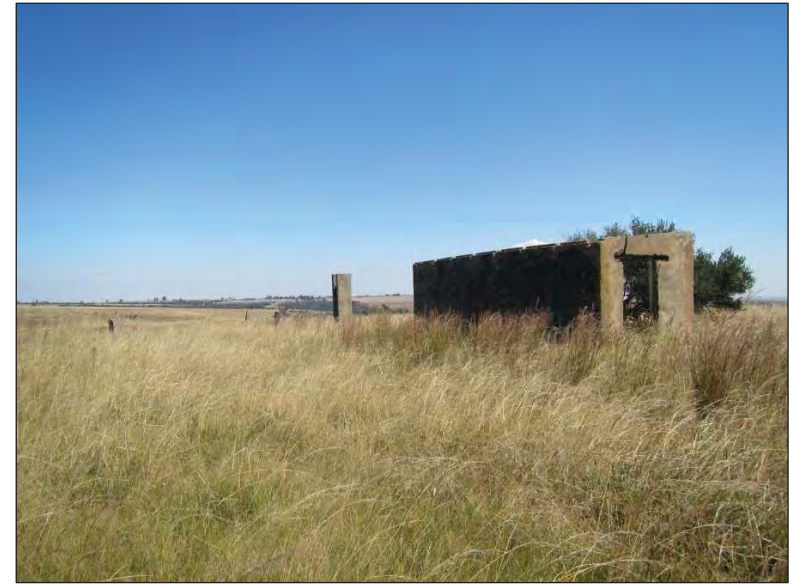
During the site visit undertaken recently, the remains of collapsed dwellings were observed. A single animal drinking trough was also found near the houses.

Figure 127 - General view of site PP 25 as recorded during the recent site visit.

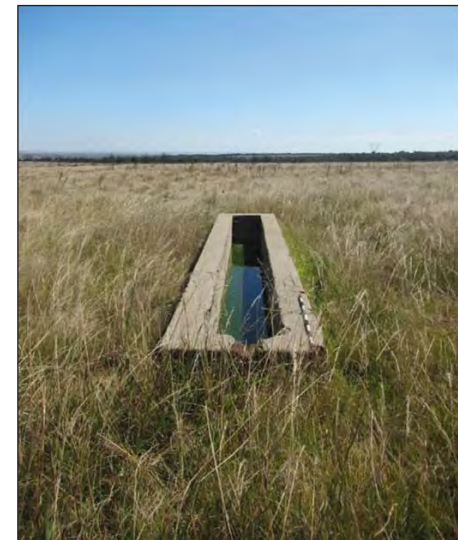
Figure 128 - The drinking trough was also observed during the recent fieldwork.

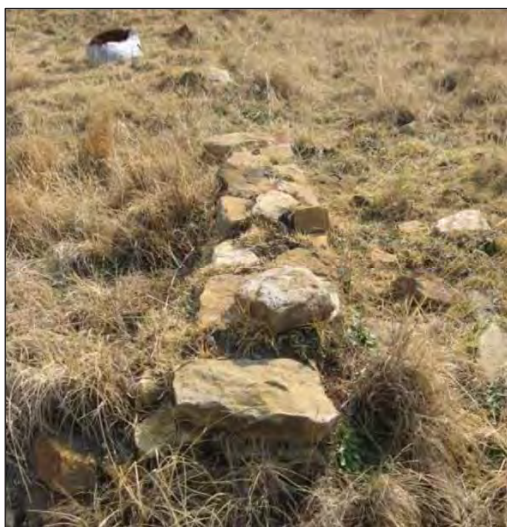
The remains of a mud-brick homestead were identified at this location. The mud-brick homestead consists of the foundations of two square structures, which measure approximately 4m x 4m in size each, and a multi-roomed rectangular structure, which measures 8m x 15m. Another circular structure measures approximately 4m in diameter. This structure was most probably the cooking hut. Rocks were used in the foundations to support the mud-brick walls of the structures. Several modern metal artefacts such as wire, corrugated iron and cans were found scattered around the site.

Figure 129 - Foundation of the homestead as recorded in 2012 (Photo: Kitto & Fourie, 2012).

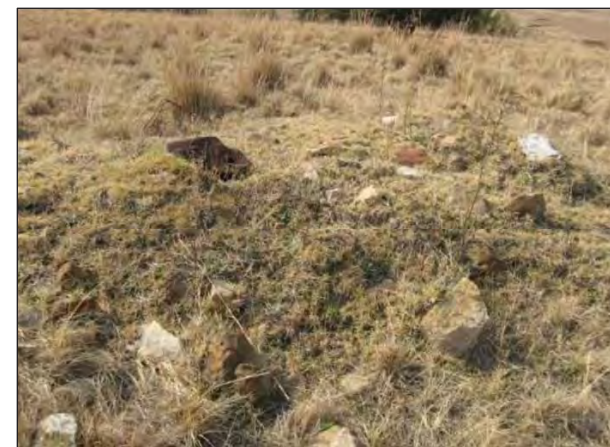
Figure 130 - Remains of a circular structure recorded in 2012 (Photo: Kitto & Fourie, 2012).

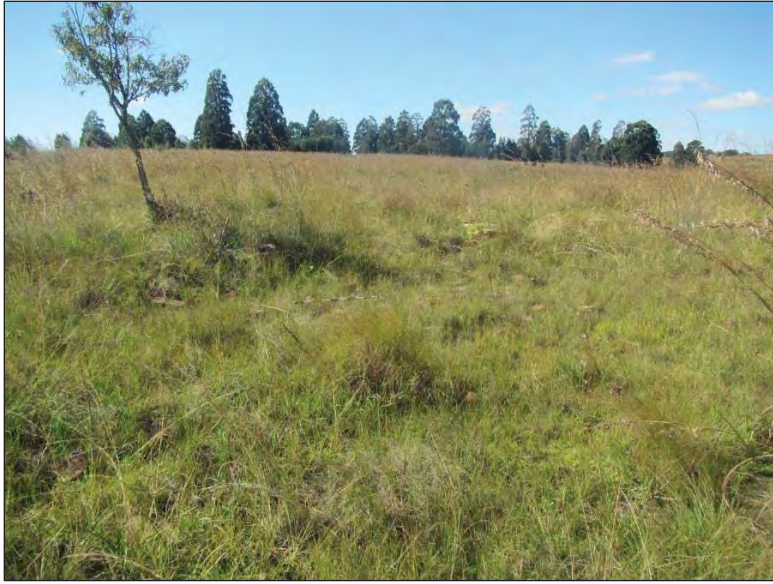
During the site visit undertaken recently, the site was found to consist of the remains of a barely visible foundation of a mudbrick house. The site was found to be very overgrown.

Figure 131 - General view of the site as recorded during the recent fieldwork.

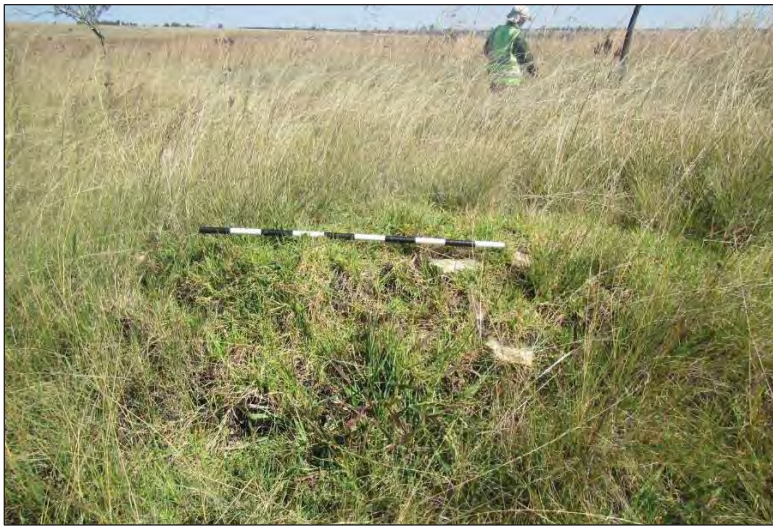
Figure 132 – Another view of the site that was recorded during the recent visit. This image depicts an elevated soil heap containing scattered bricks and stones. The scale is in 10cm increments.

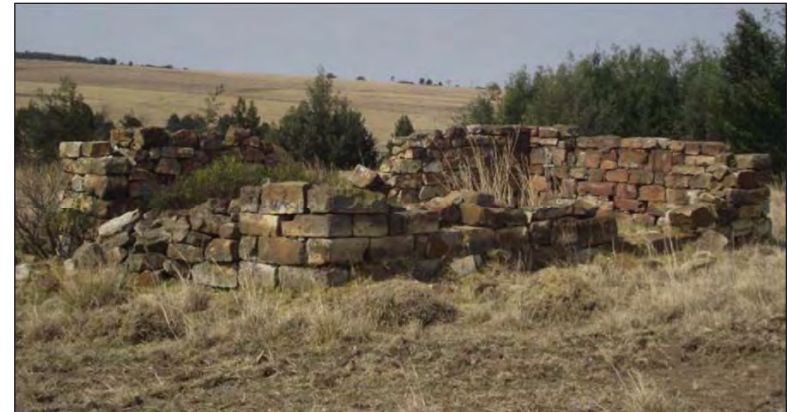
The remains of a sandstone building were identified at this location. The structure measures approximately 12m x 5m and is constructed with sandstone blocks without mortar or cement. The original entrance to the structure has been filled up with other sandstone blocks. The walls of this structure measure approximately 0.5m wide and approximately 2m high. The structure was most probably a shed or a storeroom.

Figure 133 - Ruin of the sandstone building as recorded during the fieldwork undertaken in 2012 (Photo: Kitto & Fourie, 2012).

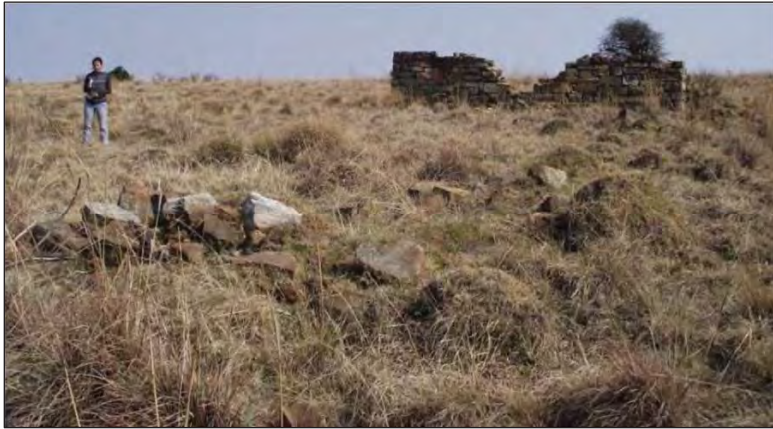
The remains of a stone-walled kraal were identified next to the sandstone structure. Most of the walling for the kraal has been removed and only some sandstone blocks from the foundations are left. The kraal measures approximately 10m x 25m.

Figure 134 – Another view of the site as recorded in 2012. This image depicts the remains of walls associated with the building (Photo: Kitto & Fourie, 2012).

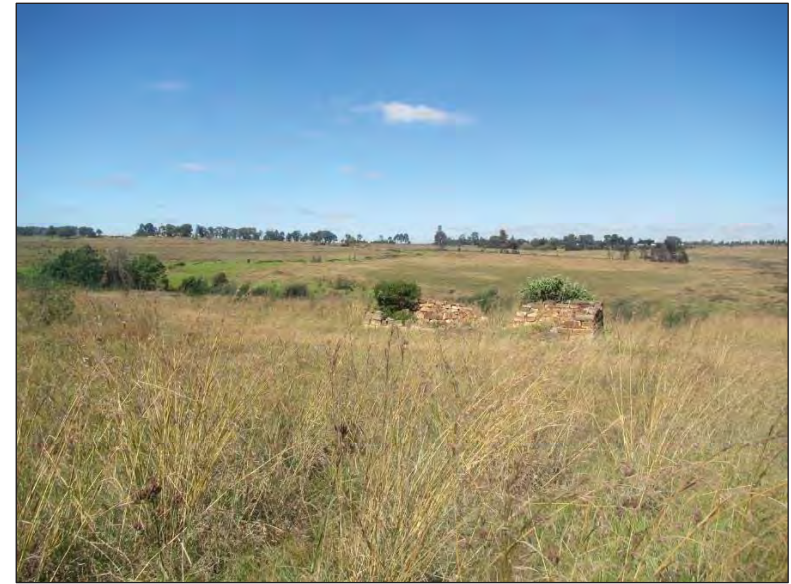
During the site visit undertaken recently, the site was found to consist of a collapsed sandstone building and wall. The site is abandoned and poorly preserved. This said, the site appears to be in a similar condition as what was recorded in 2012.

Figure 135 - General view of the site as recorded during the recent fieldwork. The sandstone building can clearly be seen.

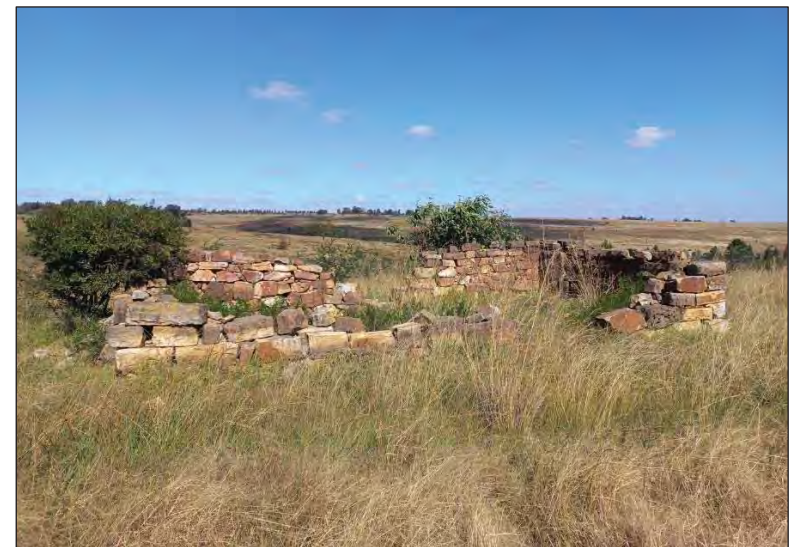
Figure 136 – Closer view of the sandstone building as recorded during the recent fieldwork.

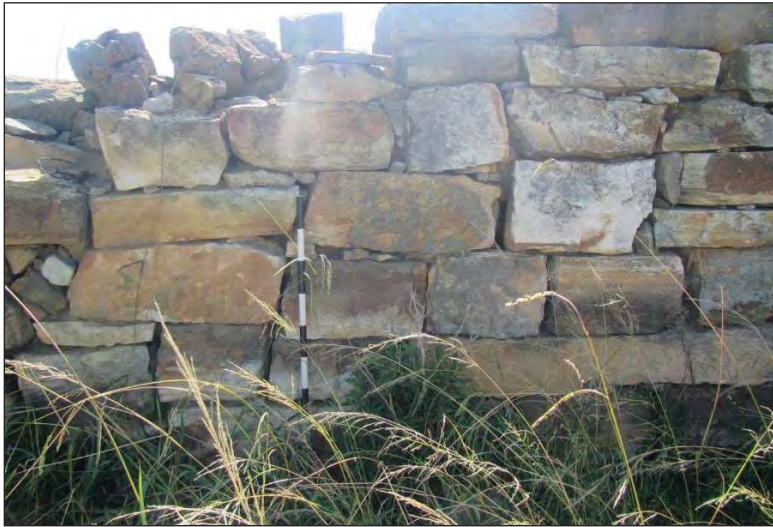
Figure 137 – Side view of a section of walling from the building. The scale is in 10cm increments.

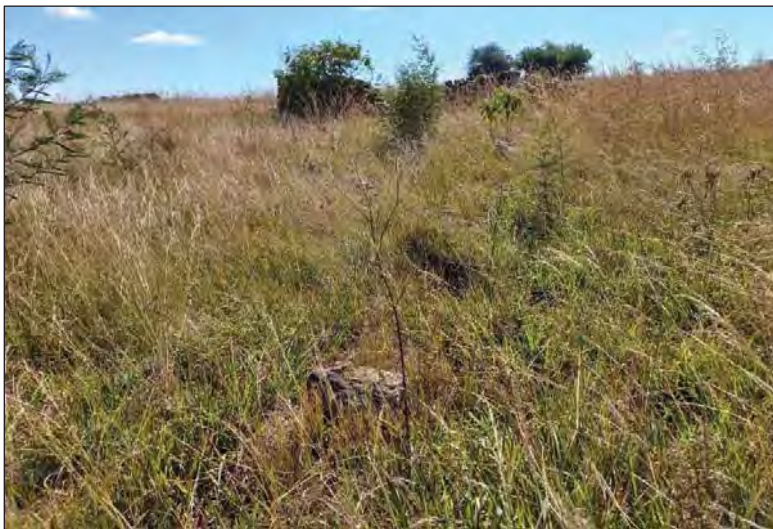
Figure 138 – A section of the stone wall associated with the sandstone building (visible in the back) can be seen in the foreground.

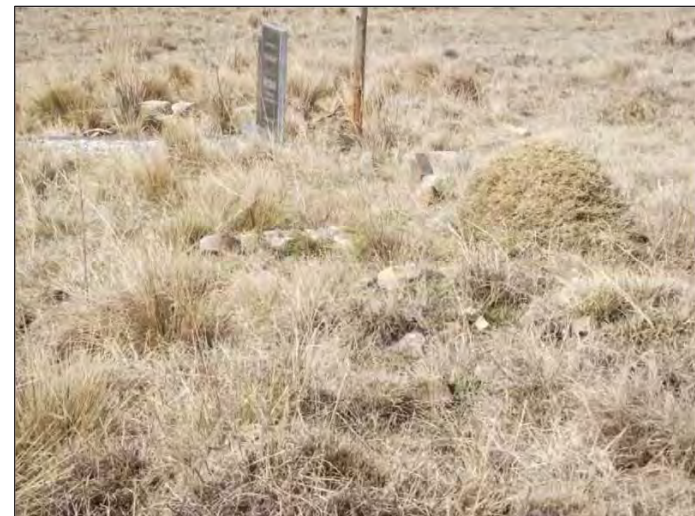
A small informal cemetery with eight graves was identified at this location. The cemetery is fenced and is situated in the open veld. The graves are placed in one line next to each other and all are orientated from west to east. Seven of the graves have informal, oval-shaped outlines of packed rocks which are filled with soil. Rocks are placed upright at the western ends to serve as headstones. One grave has a formal granite dressing and an inscribed granite headstone. This grave dates from the early 1960's and belongs to the Skhosana family. Most of the graves are overgrown with grass and other vegetation. No grave goods were found with these graves.

Figure 139 – General view of the cemetery as recorded in 2012 (Photo: Kitto & Fourie, 2012).

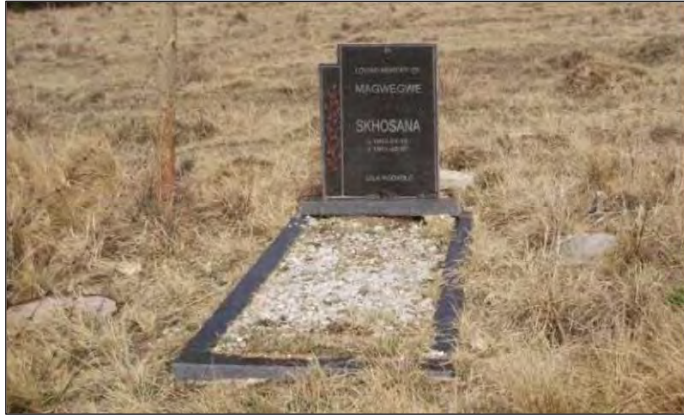
Figure 140 - Close-up view of one of the graves from site PP 28 as recorded in 2012 (Photo: Kitto & Fourie, 2012).

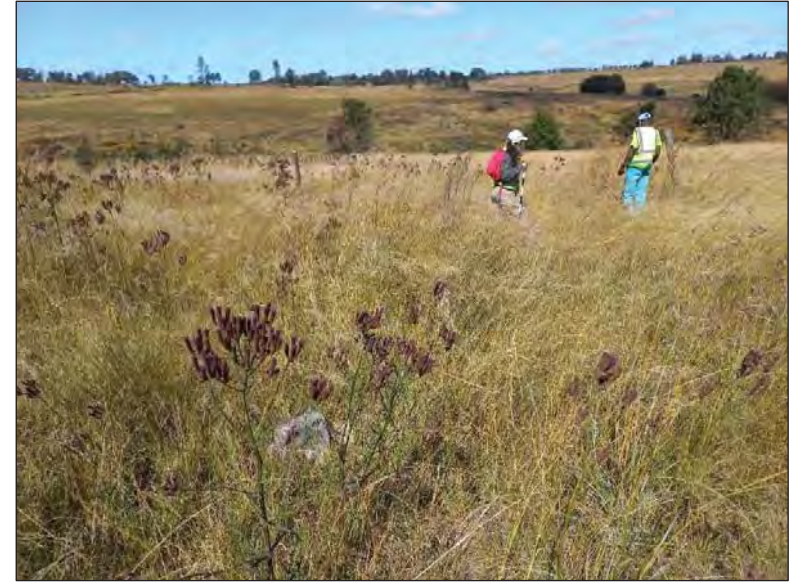
All eight graves were observed during the site visit undertaken recently. One of the graves contained a headstone, which is in a poor state of preservation and has fallen over. The graves are overgrown but clearly visible.

Figure 141 - General view of the site as recorded during the recent site visit. The dense vegetation can still be seen.

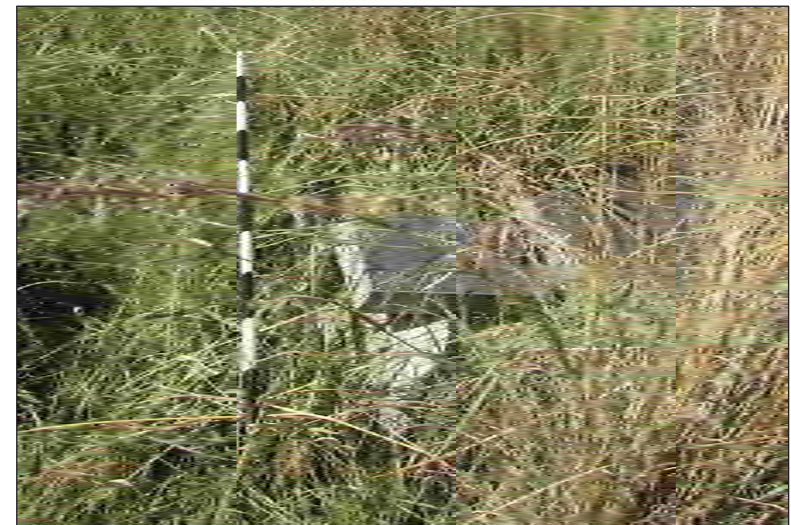
Figure 142 - View of the headstone on the grave of Magwegwe Skhosana, which has fallen over. The scale is in 10cm increments.

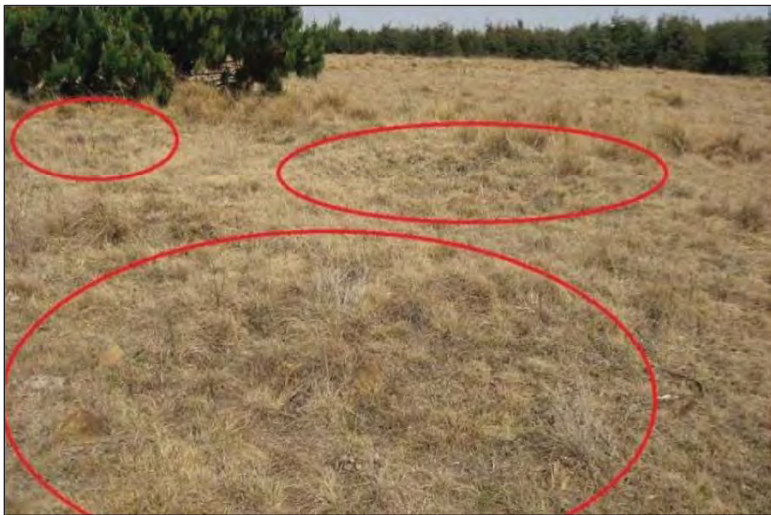
The remains of an extended mud-brick settlement were identified at this location. The remains of this mud-brick settlement cover an area of approximately 200m x 200 and consist of at least nine different homesteads or structures that formed part of the larger settlement. Most of the structures are ruined and were very difficult to identify. The numbers, sizes and shapes of these structures of this settlement are not clearly identifiable. Rocks were used in the foundations to support the mud-brick walls of the structures. Several modern metal artefacts such as wire, corrugated iron and cans were found scattered around the site.

Figure 143 - General view of some of the foundation remains as recorded in 2012 (Photo: Kitto & Fourie, 2012).

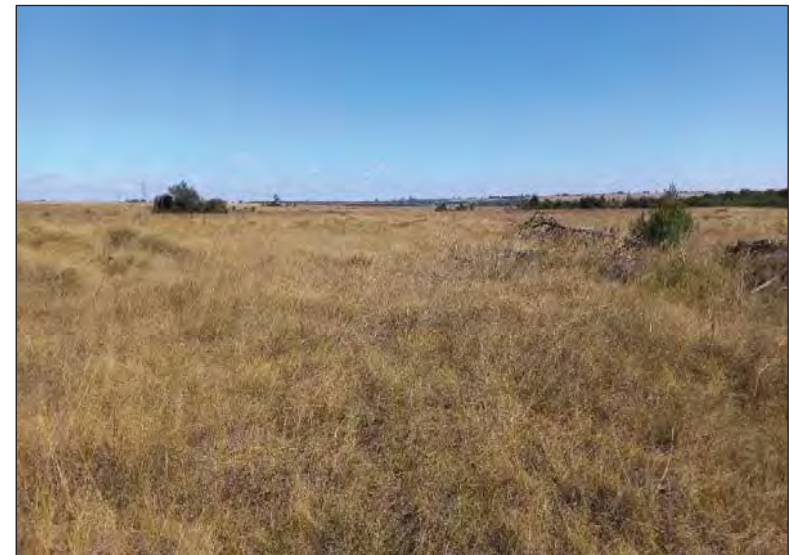
The site was visited during the recent fieldwork. It was found to consist of the foundation remains of several mudbrick homesteads spread across the site. Only the raised foundations are visible on the surface. The site is overgrown. No other cultural remains were found.

Figure 144 - General view of site PP 29 as recorded during the recent fieldwork.

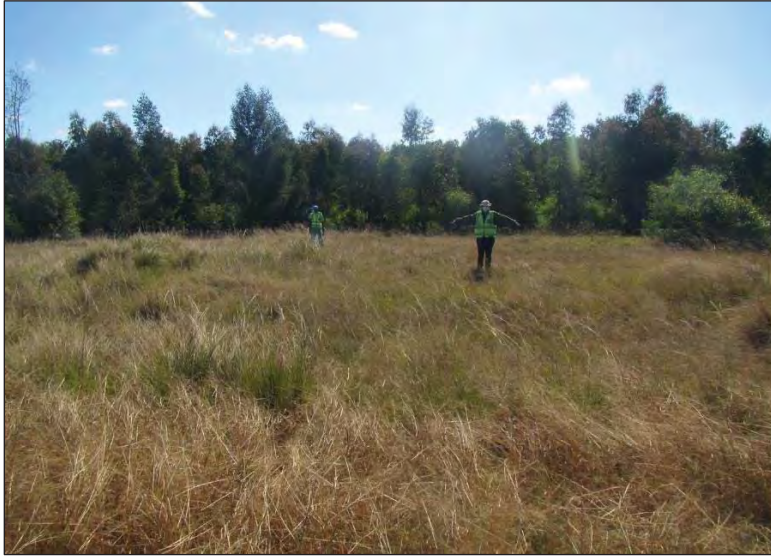
Figure 145 - View of the remains of the foundations of two mudbrick homesteads. The scale is not visible due to the dense grass covering the surface of the site.

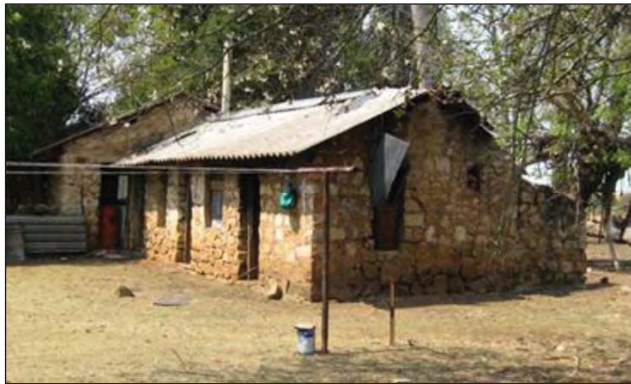
A storeroom or shed with farm implements was also identified. This storeroom measures approximately 12m x 8m and has a low pitched corrugated iron roof. The building is built with sandstone blocks and mortar and has wooden window frames and wooden door frames with homemade doors. It has an external electrical system.

Another storeroom or shed is situated next to the first shed. It measures approximately 10m x 5m and is also constructed with sandstone blocks and mortar, with a low pitched corrugated iron roof. This building is in a rather poor state and more recent brick and cement supports had been placed there to extend the life of the building. The building has wooden window frames and wooden doors and door frames.

Figure 149 - Two sandstone sheds (Photo: Kitto & Fourie, 2012).

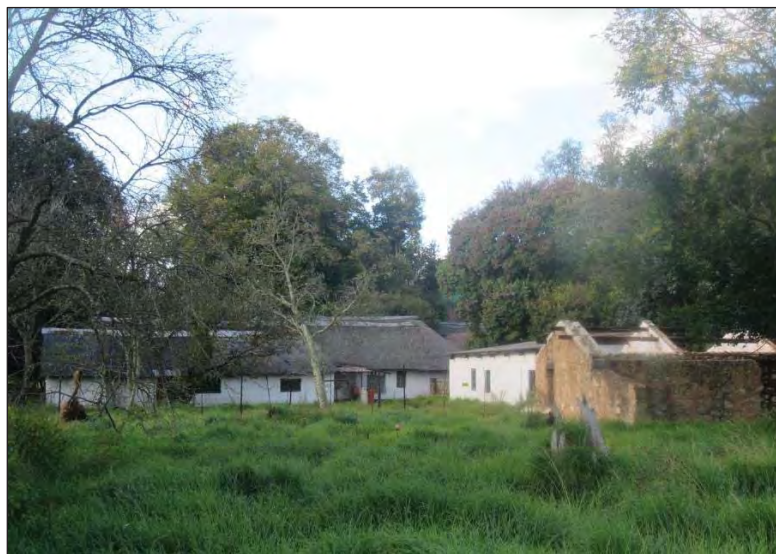
The site was visited during the recent fieldwork. It was found to consist of the remains of an abandoned farmstead with several buildings and a stone kraal. It appears as if the site has been abandoned for some period as the site is overgrown with vegetation.

Figure 152 - General view of the farmstead at site PP 30 as recorded during the recent visit to the site. The thatched-roof farmhouse can be seen in the background on the left.

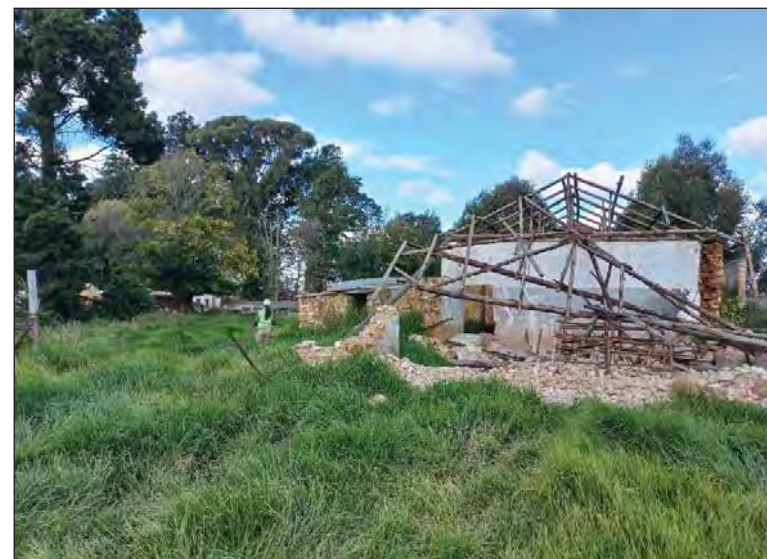
Figure 153 - View of the stone building with collapsed roof. The scale is in 10cm increments.

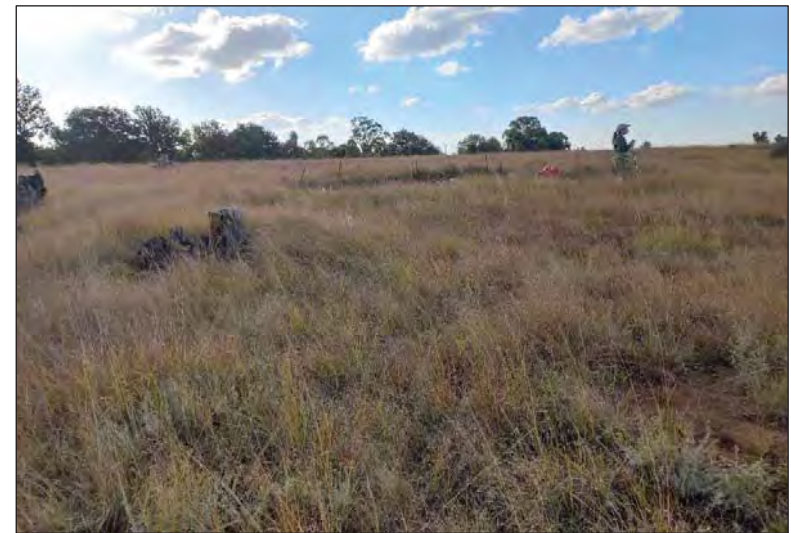
The site was visited during the recent fieldwork. It was found to consist of a cemetery containing a total of approximately 40 graves located in an agricultural field. Many of the graves have stone-lined dressings whereas some graves have formal dressings and inscribed headstones. The graves are clearly visibly. The cemetery is not fenced.

Figure 156 - General view of the cemetery at site PP 31 as recorded during the recent site visit.

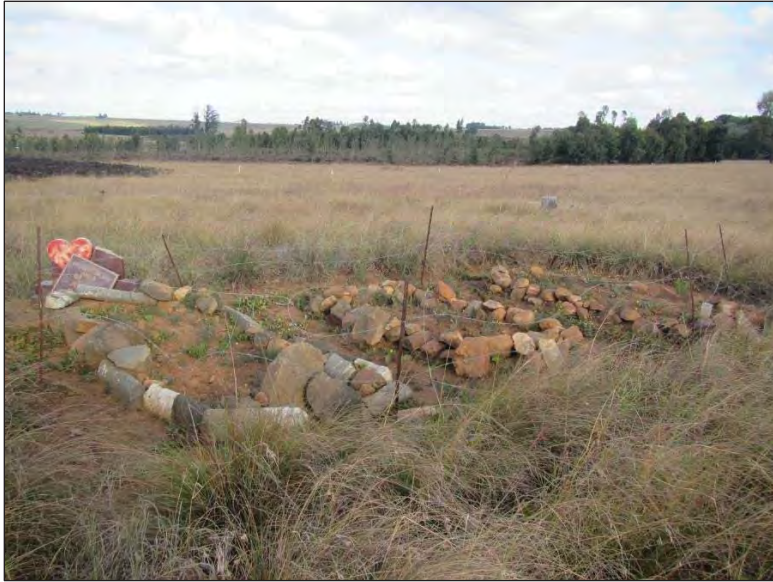
Figure 157 - View of some of the graves consisting of formal dressings, headstones and packed graves. Not the small fence surrounds three stone-lined graves.

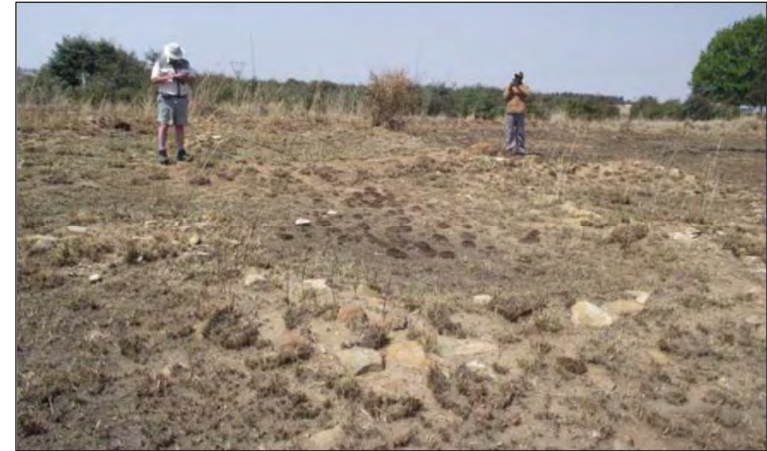
The remains of another mud-brick homestead were identified at this location. The remains of the mud-brick homestead consist of the foundations of four square structures, which each measure approximately 4m x 4m in size, and a circular structure that measured approximately 4m in diameter. This structure was most probably the cooking hut. The structures are all placed around a central Lapa area. Rocks were used in the foundations to support the mud-brick walls of the structures. Several modern metal artefacts such as wire, corrugated iron and cans were found scattered around the site.

Figure 158 – General view of site PP 32 as recorded during the fieldwork undertaken in 2012. The foundation remains of the homestead can be seen on this photograph (Photo: Kitto & Fourie, 2012).

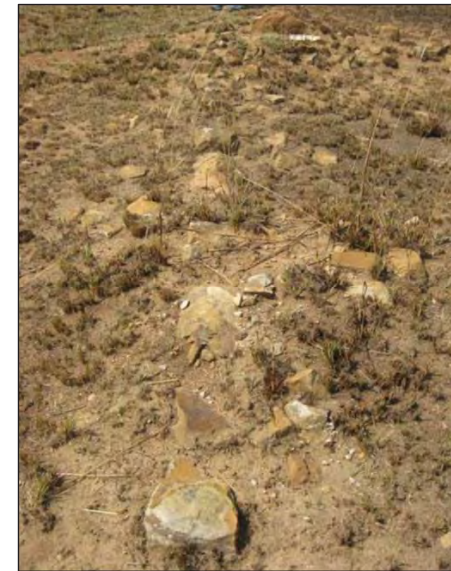
Figure 159 - Close-up view of one of the wall foundations. This photograph was also taken during the 2012 fieldwork (Photo: Kitto & Fourie, 2012).

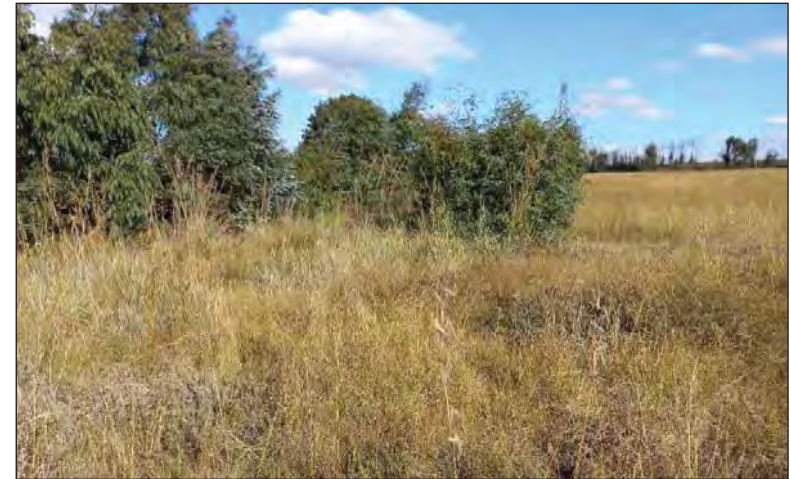
The site was visited during the recent fieldwork. It was found to consist of the remains of a mudbrick homestead, with only some of the foundations visible on site. The site is overgrown with vegetation.

Figure 160 - General view of site PP 32 as recorded during the recent fieldwork. Note the dense vegetation found at the site.

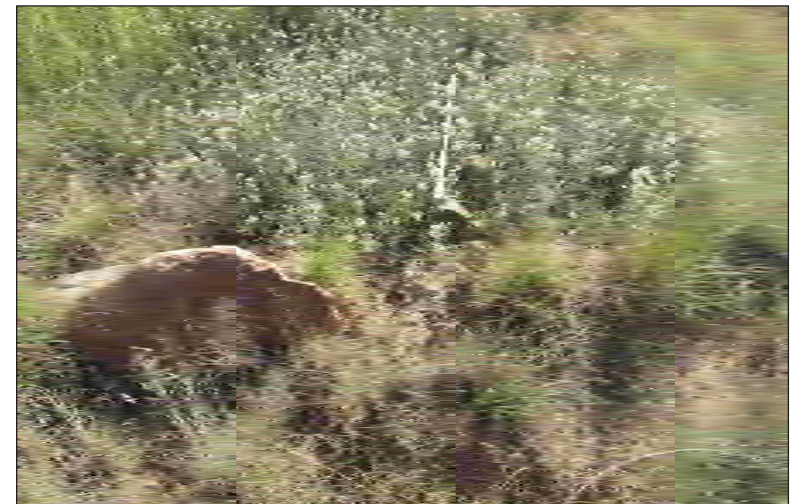
Figure 161 - View of some of the stone foundations observed at the site.
