DRAFT BASIC ASSESSMENT REPORT

NBC Colliery, Universal Coal D2809 Road Realignment Wetland Risk Assessment

NBC Colliery, Universal Coal: D2809 Road Realignment Wetland Risk Assessment

Ecology International Ref. No. 210057

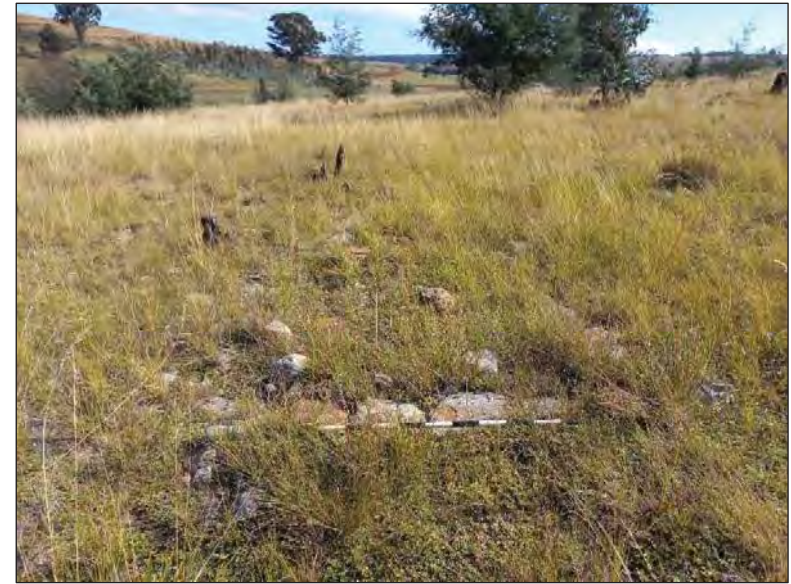
Figure 162 - General view of the stone foundations of a mining structure found at site PP 33. The scale is in 10cm increments.

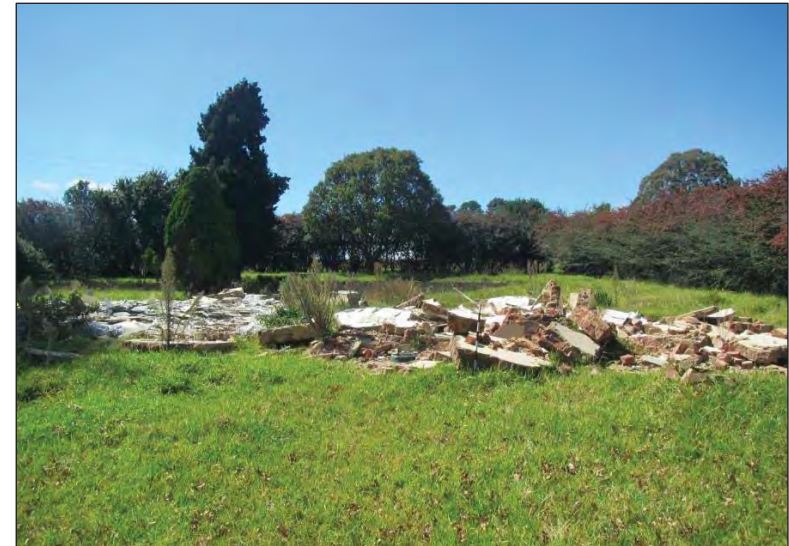
Figure 163 - General view of the demolished structure at PP 34.

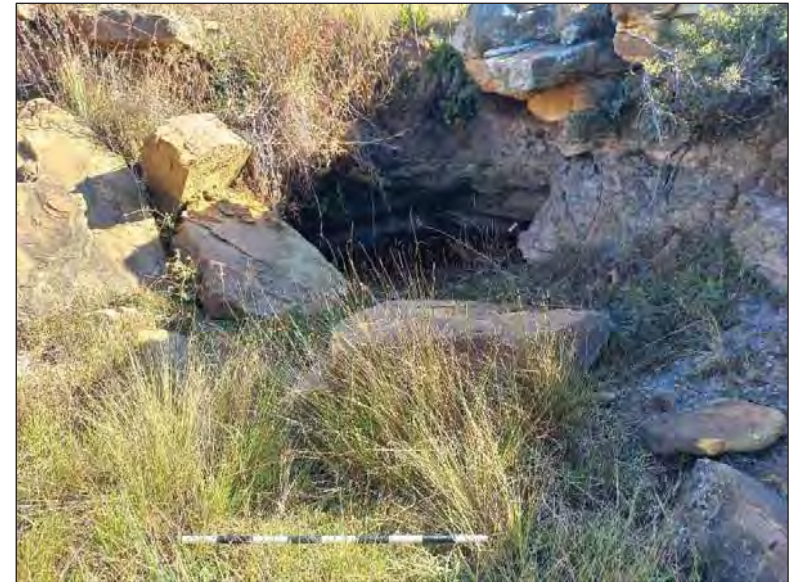
Figure 167 - View of the entrance to the abandoned coal mine shaft at PP 36. The scale is in 10cm increments.

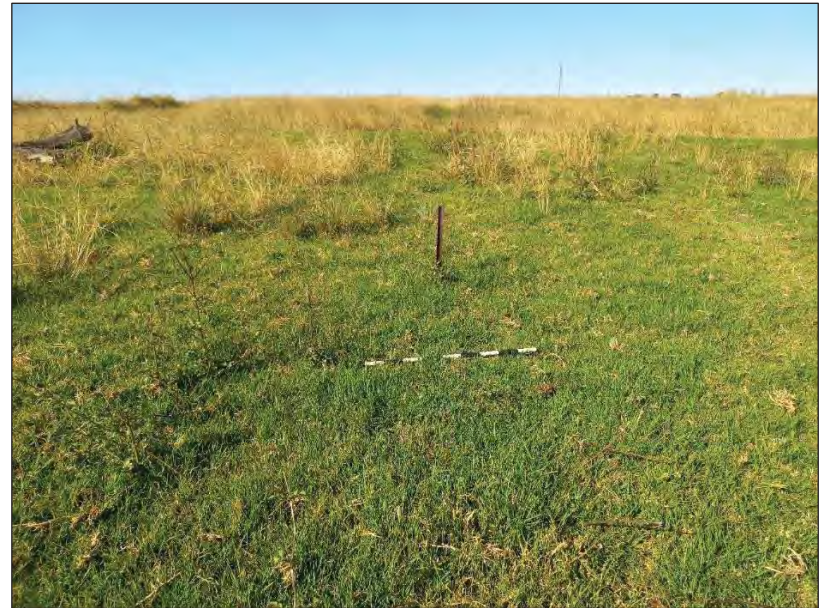
Figure 168 - General view of the single grave at site PP 37. The metal rod marking the position of the grave can be seen. The scale is in 10cm increments.

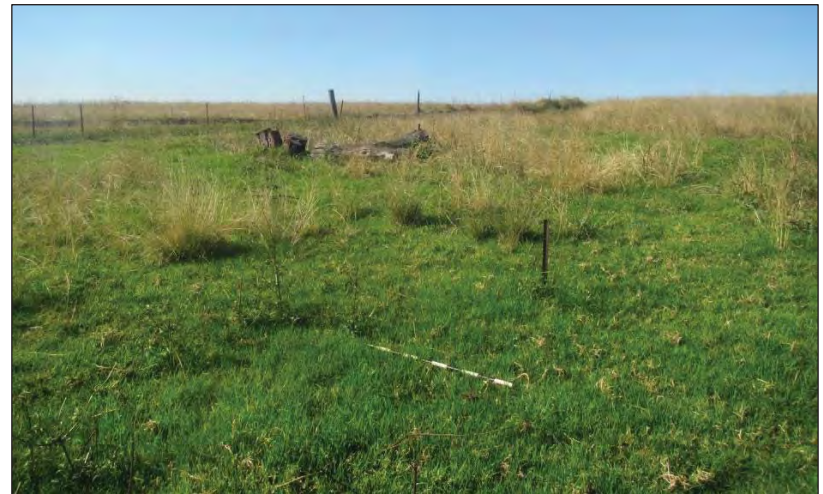
Figure 169 - Another view of the single grave at site PP 37. The metal rod marking the position of the grave can again be seen. The scale is in 10cm increments.

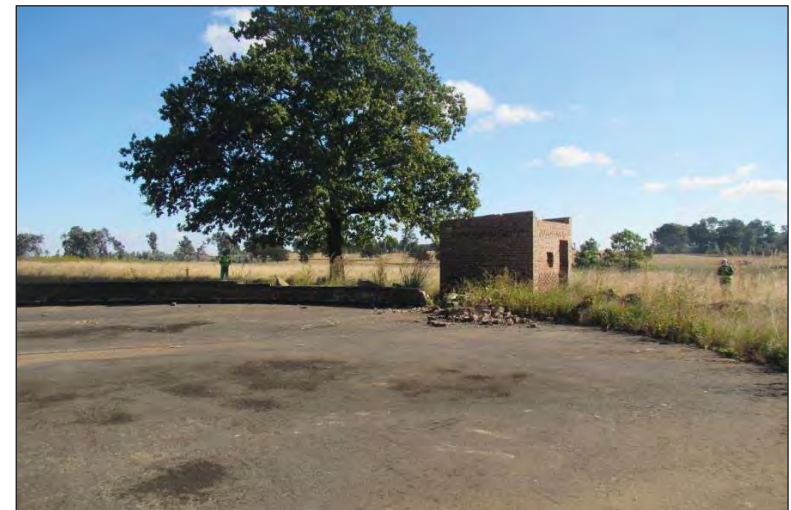
Figure 171 – Another view of the site showing a section of the reservoir in the foreground with the brick building in the back.

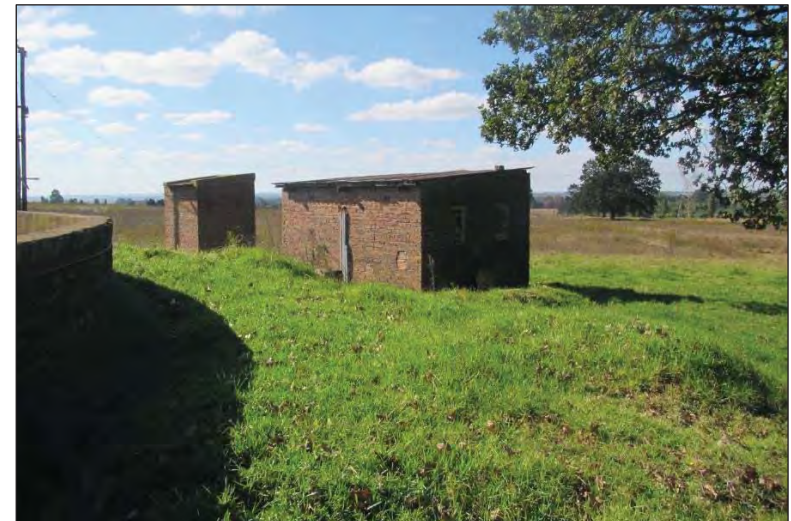
Figure 173 – A section of the reservoir is visible on the left, with the two associated brick structures located in the back.

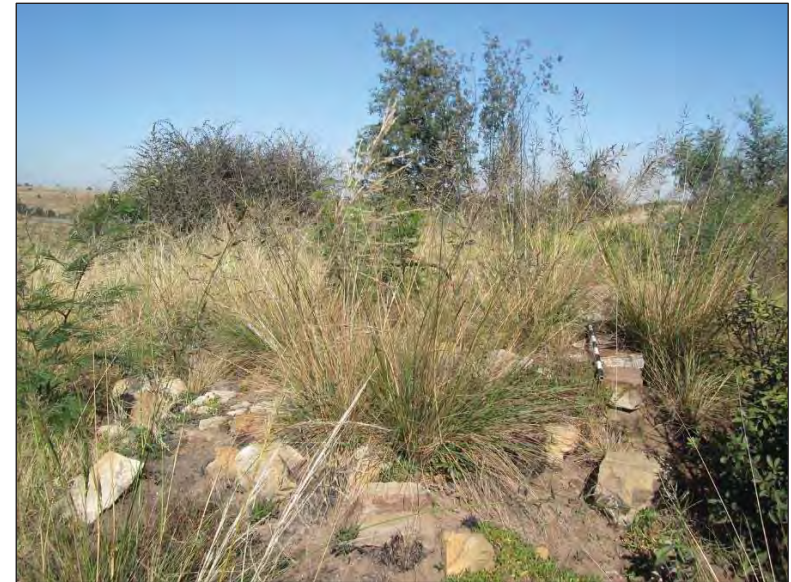
The site consists of the stone foundations of a rectangular structure. The structure is located approximately 252m north-west of the mudbrick homestead at site PP 26 and approximately 180m west of the stone structure at site PP27. It is most likely that the structure was a dwelling and can likely be associated with sites PP 26 and PP 27.

Figure 174 – General view of the stone foundations of a rectangular structure. The scale is in 10cm increments.

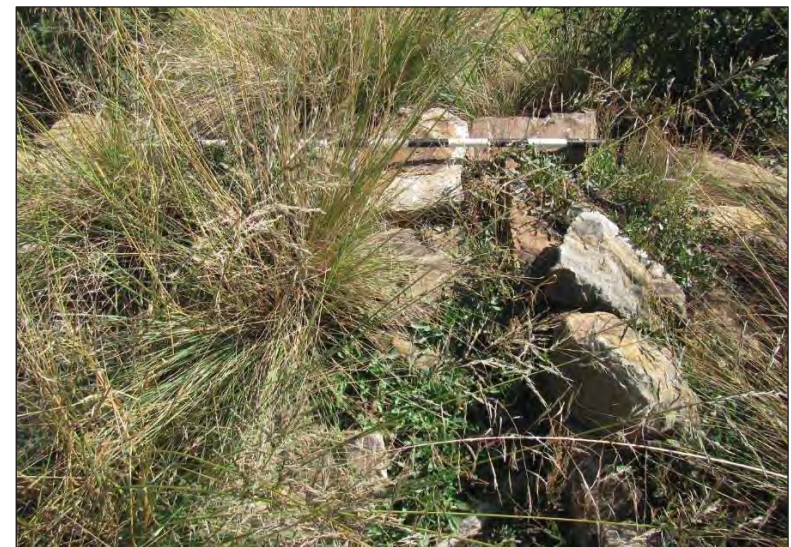
Figure 175 - Closer view of a section of the foundations at site PP 40.

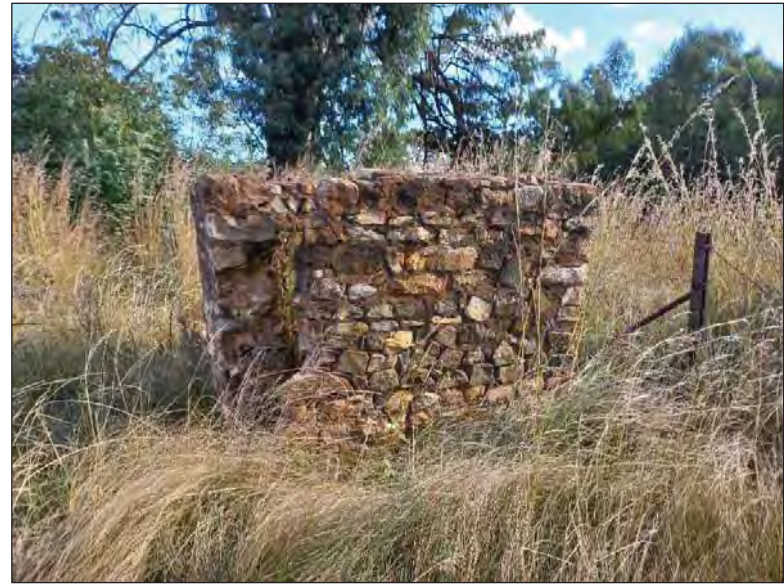
The remains of a small, square structure were identified at this location. The structure was built with stone and cement and measures approximately 4m x 4m in size. It has no roof and has only one entrance with no windows. The function and age of this structure are unknown. A section of one wall has broken away.

Figure 176 – General view of the stone structure at site PP 41.

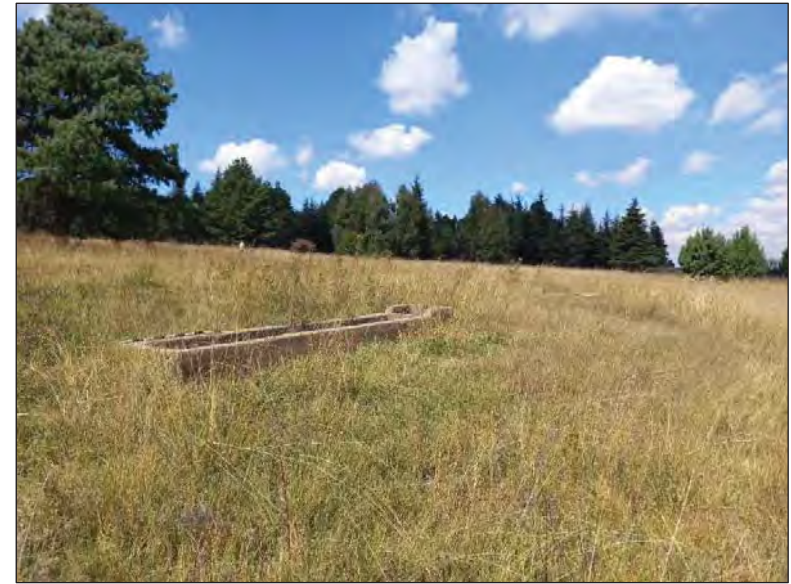
Figure 177 - View of the animal drinking trough. The scale is in 10cm increments.

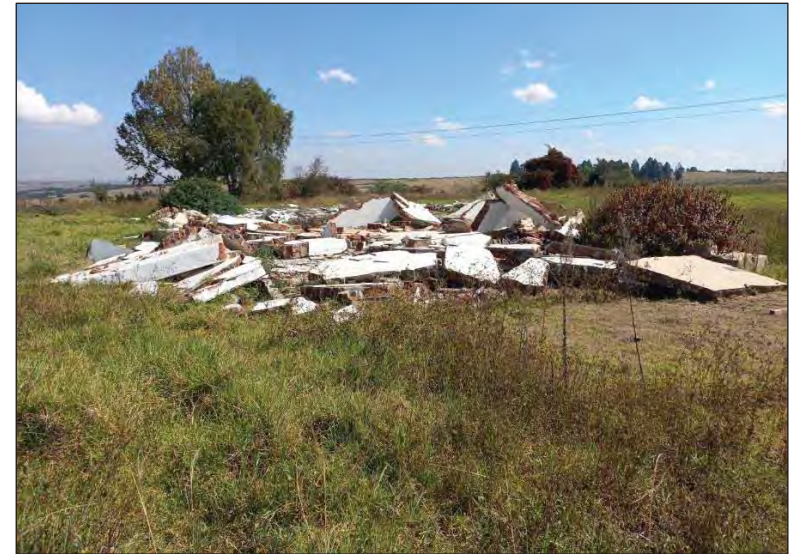
The site consists of the remains of a demolished brick and plaster structure. The collapsed walls and foundations of the structure were found on site.

Figure 178 - General view of the demolished structure at site PP 43.

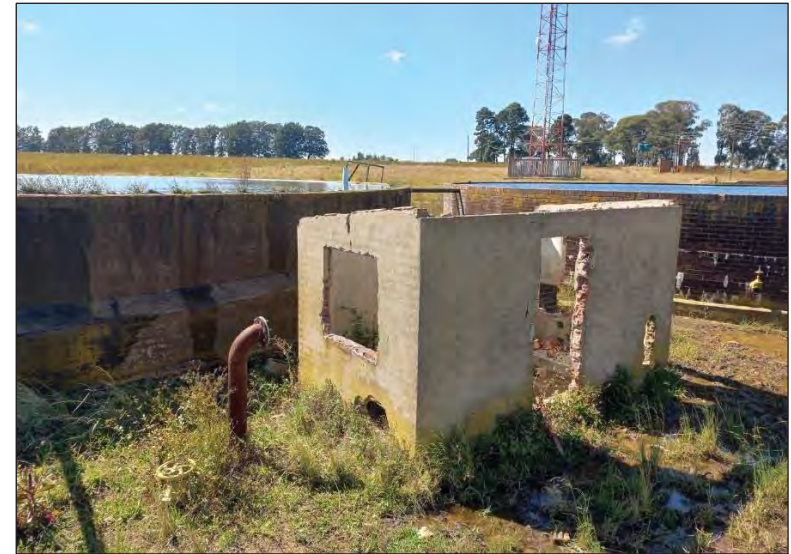
Figure 180 - General view of the site showing sections of the two reservoirs in the back with one of the associated brick buildings visible in the foreground.

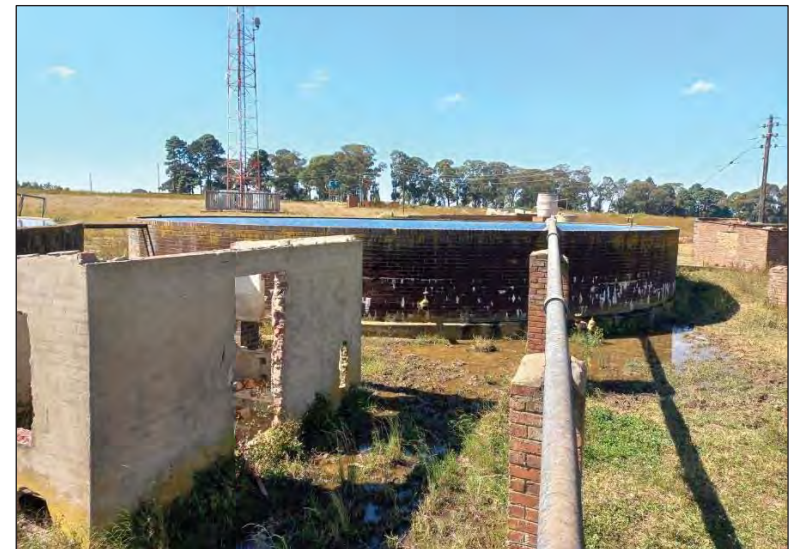
Figure 181 – Another view of the site showing a reservoir and its associated buildings and structures.
6.2.45 PP 45

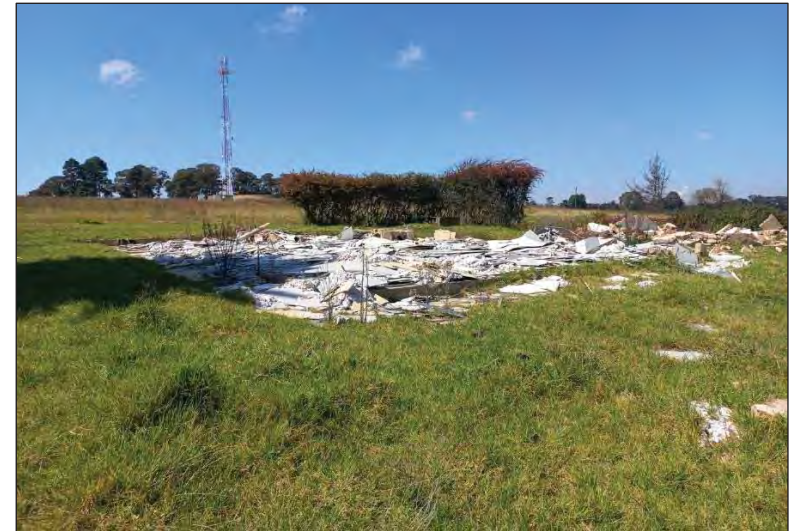
Figure 182 - General view of the demolished structure at site PP 45.

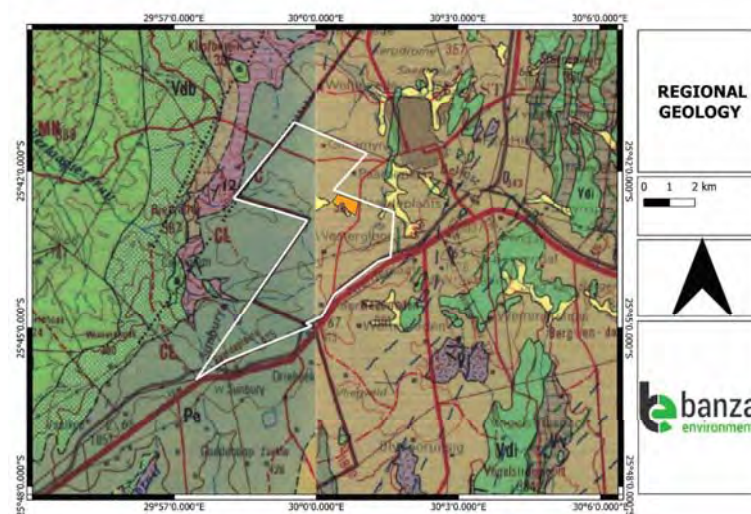
Figure 184 - Extract of the 2528 (Pretoria) and 2530 (Baberton) Geological Map (Council of Geoscience) indicating the surface geology of the proposed development in white and orange (Butler, 2021:12).

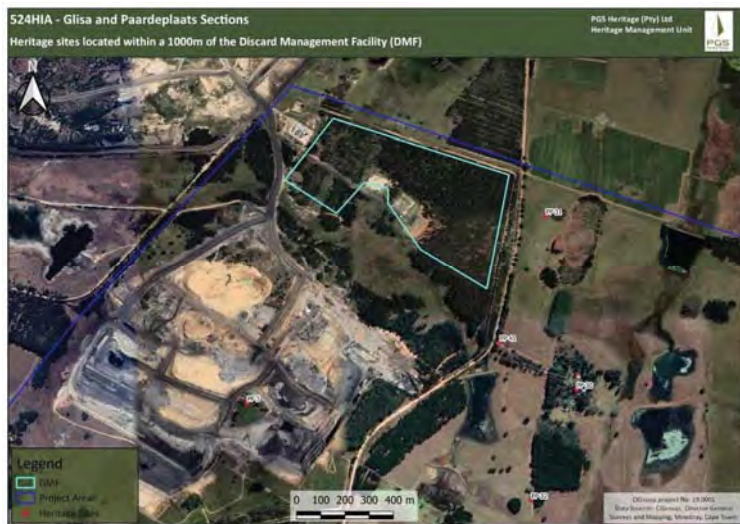
Figure 189 – This image provides an overlay of the identified heritage sites over the proposed development footprint area of the DMF. As can be seen, none of the identified heritage sites are located within, or in close proximity to, this development footprint.

- Site PP 31 (Burial Ground) – 158m east of the proposed development;
- Site PP 41 (Structure) – 199m south by south-east of the proposed development;
- Site PP 30 (Historic Farmstead) – 549m south-east of the proposed development;
- Site PP 3 (Burial Ground) – 930m south-west of the proposed development; and
- Site PP 32 (Historic Homestead with Possible Risk for Unmarked Graves) – 937m south-east of the proposed development.

From these distances it is evident that the construction of the proposed DMF will have no impact on any of the identified heritage sites.

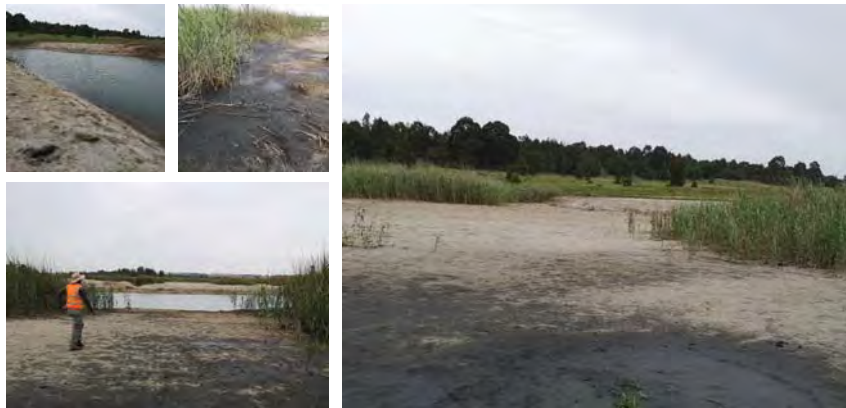
Figure 6-13: Possible sedimentation observed within the Transformed areas

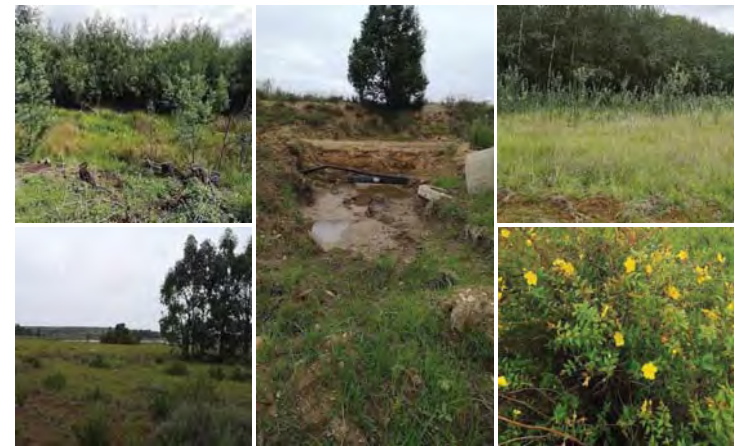
Figure 6-14: AIPs observed in the Transformed areas

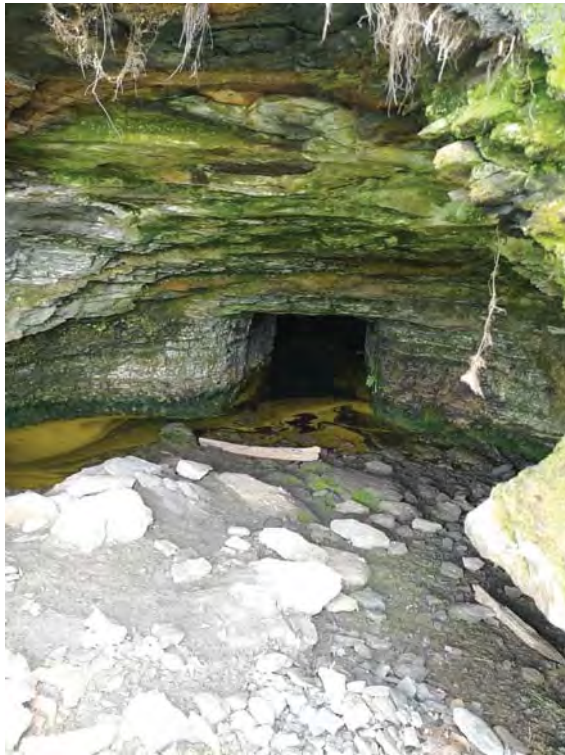
Figure 6-15: Cave with tunnel

It should be noted that a potential cave with a manmade tunnel was encountered within the rocky outcrop habitats. This potential cave may have cultural or heritage significance and may require further investigation for clarification. The location of the tunnel is represented in Figure 6-9 and an image of the cave can be seen in Figure 6-15 below. The potential cave may support cave dwelling dependent species and have significant ecological importance. Cave-formations are also protected under the MNCA (1998) and any alterations will require permit applications. Therefore, further investigations are required in the instance of mining.

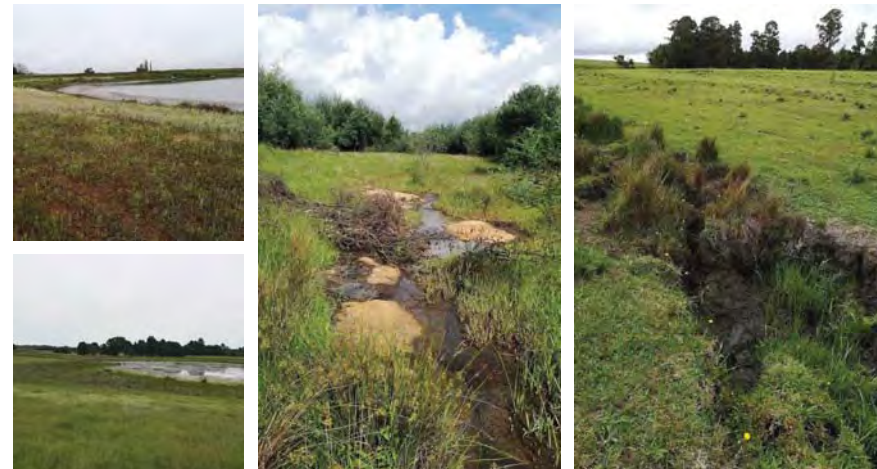
Figure 6-17: Various wetlands encountered within the Project area

Numerous wetlands have been previously recorded, delineated and monitored within the Project area (Paardeplaats and EFN) (Tony de Castro, 2020) (Wetland Consulting Services (Pty) Ltd, 2020). The monitoring results claimed some deterioration of the wetlands since the studies commenced in 2017. The decline in condition was caused by factors such as limited vegetation clearing, soil disturbances along temporary access roads, increased mining in the catchments and an increase in AIP proliferation. The slow sprawl of alien invasive species, such as *Eucalyptus* sp., and *Acacia* sp., threatens both the vegetation integrity of the wetlands, and the hydrology due to their high-water uptakes. Other AIP observed within most of the wetlands included, *Verbena brasiliensis*, *Centella asiatica*, *Amaranthus viridus*, *Salix babylonica*, *Populus x canescens* and *Cirsium vulgare*. The AIP NEM:BA Category for listed species is presented in Section 6.3.1.1. Ongoing sedimentation (viewed and discussed in Section 6.3.1.1) is having negative effects on the wetland functioning by burying the wetland and decelerating vegetation growth. Within a number of wetlands, the presence of large pollution control dams were observed. No measures for low flows were accounted for and thus are having a negative impact of the wetland integrity. The dams alter the wetness regime and reduce flow to the downstream reaches. As recorded by the previous wetland studies, most of the wetland habitats have been seriously impacted within the Glisa mining operation area. Nonetheless, various floral SCC were encountered and recorded at varying wetland locations within the Project area. *Brunsvigia radulosa*, *Gladiolus crassifolius*, *Eucomis autumnalis* and *Watsonia lepida* were located along the southern border adjacent to the R33 within the EFN farm portion. Numerous wetland indicating species and sedges were recorded, such as *Chironia krebssii*, *Berkheya setifera*, numerous *Cyperus* sp., *Eleocharis dregeana*, *Fimbristylis ferruginea*, *Leersia hexandra*, *Isolepis sepulcralis*, *Juncus* sp., *Oropetium capense*, *Xyris capensis* and *Gomphostigma virgatum*. Figure 6-17 depicts some of the wetlands encountered during the field assessment. Most of the wetlands are negatively impacted by artificial dams, AIP sprawl, agricultural disturbances and the current mining activities.

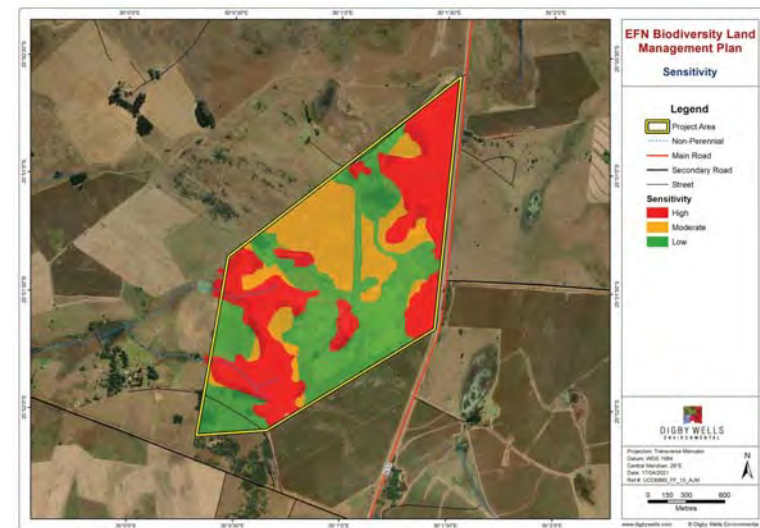
Figure 7-2: Sensitive areas associated with Eerstelingfontein 406 JT

As EFN has previously been subjected to mining activities, several areas have consequently succumbed to habitat modifications and have resulted in low sensitivities. Areas of high sensitivity within the portion were based on the remaining intactness of the natural areas and presence of SCC. The remaining natural systems in the Project area provide habitat for faunal SCC, particularly the Grey Crowned Crane (see Section 6.4.2). These sensitive areas can be observed in Figure 7-2 below.
