Specialist Reports

Report on the ecological assessment for the proposed borrow pit along the R58 Provincial Road between Aliwal North and Lady Grey, Eastern Cape Province.

January 2021

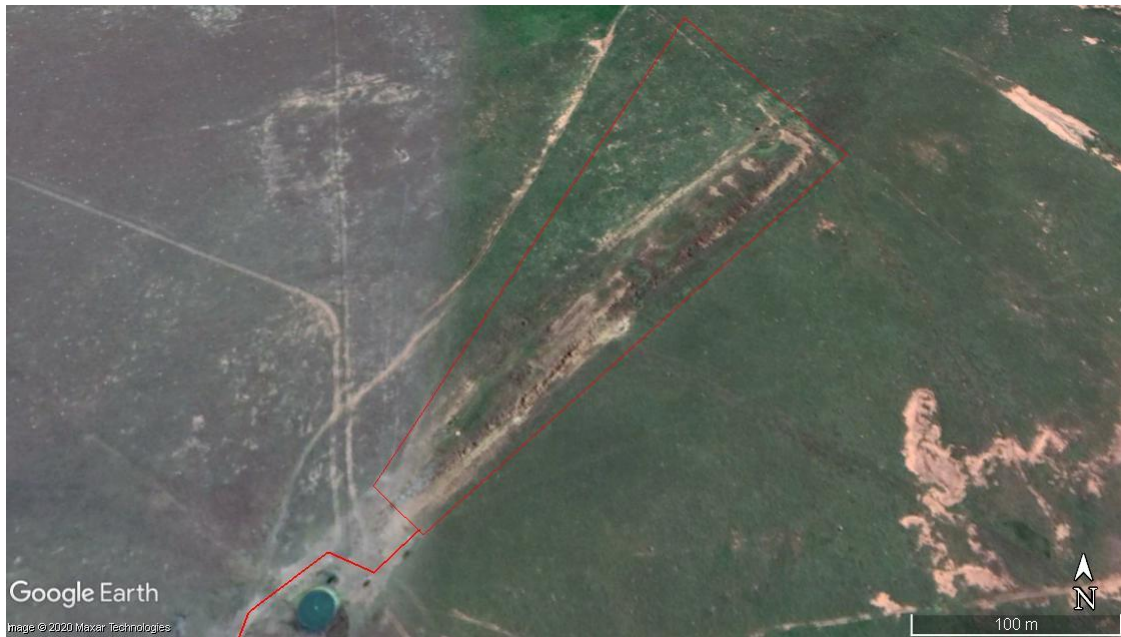
Figure 1: Aerial view of the proposed site (Google Earth 2020). Note the historical borrow pit on the site is clearly visible which causes transformation of the natural vegetation. Though not clearly apparent previous disturbance has also affected the immediately adjacent grassland.

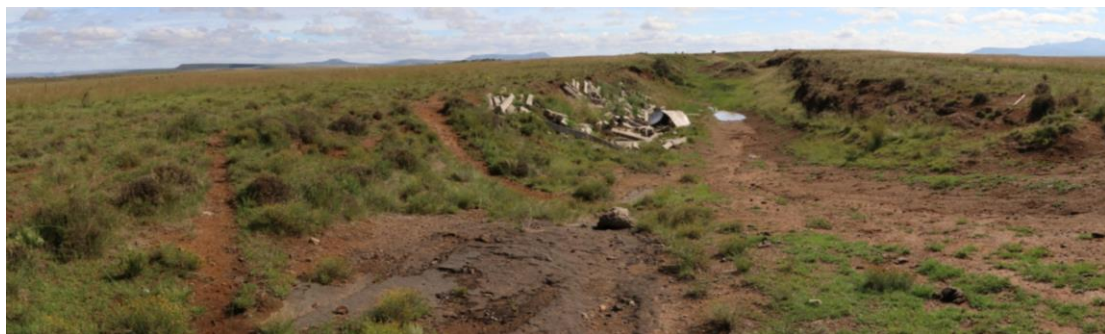
Figure 2: Panorama of the existing borrow pit on the site which has clearly caused transformation of the natural vegetation.

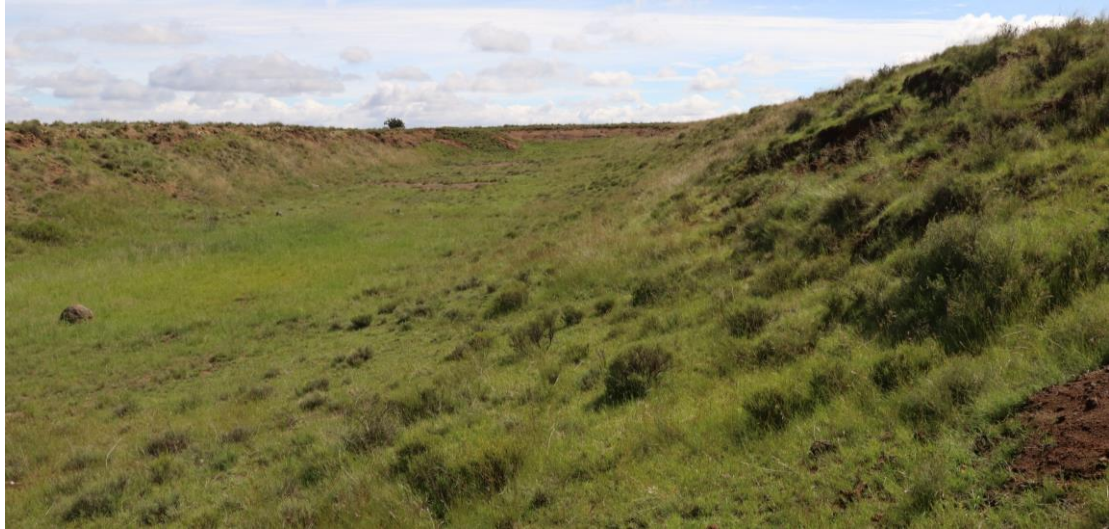
Figure 3: Another view of the existing borrow pit. Although the natural vegetation has clearly been transformed, a significant pioneer vegetation layer has subsequently been able to re-establish.

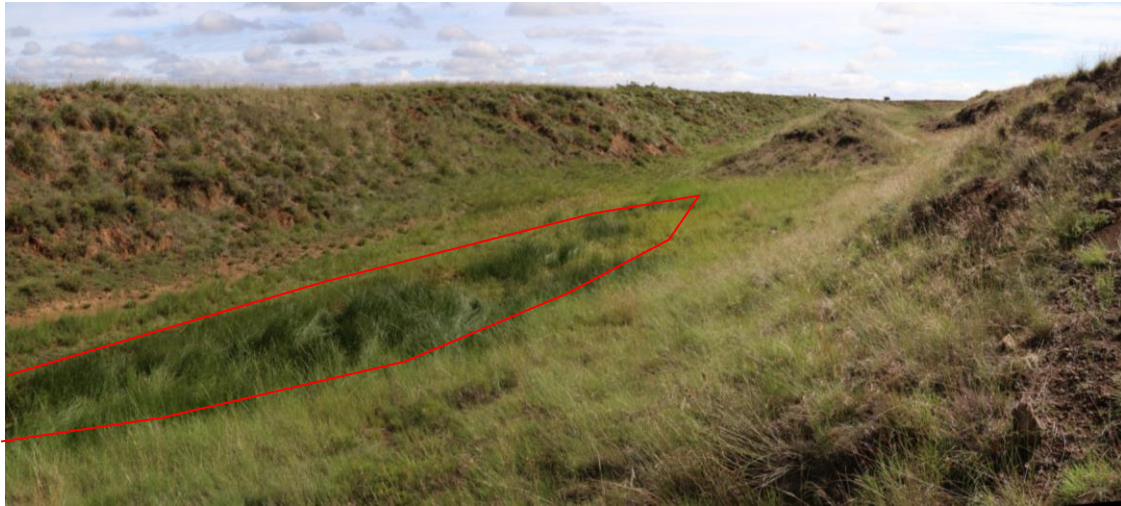
Figure 4: The existing borrow pit is not completely free draining and where inundation occurs, artificial wetland patches has formed (red).

The site does not contain any watercourses, including drainage lines or wetlands and the impact on these would therefore be negligible (Map 1 & 2). The existing borrow pit excavation does form small patches which become inundated and form wetland conditions though these are completely artificial and perform no significant ecological function. The impact of the removal of these would not result in any significant impact and it is also likely that after mining has completed such inundated patches will again be formed. The excavations formed by borrow pit are seldom able to be free draining and almost all rehabilitated borrow pits will contain some water or saturated soils. The nearest watercourse is a small but distinct drainage line to the south (approximately 250 meters) (Map 1). This drainage line flows to the south of the site and is highly unlikely that it will be affected by the development. Furthermore, since the site slopes generally in a north western direction, runoff generated on the site will also drain away from the drainage line and will therefore clearly not have an influence on it. However, runoff from the surroundings should still be kept separate from the proposed borrow pit and will need to divert clean runoff around the site which should be easily attainable by implementing a low berm around the perimeter.

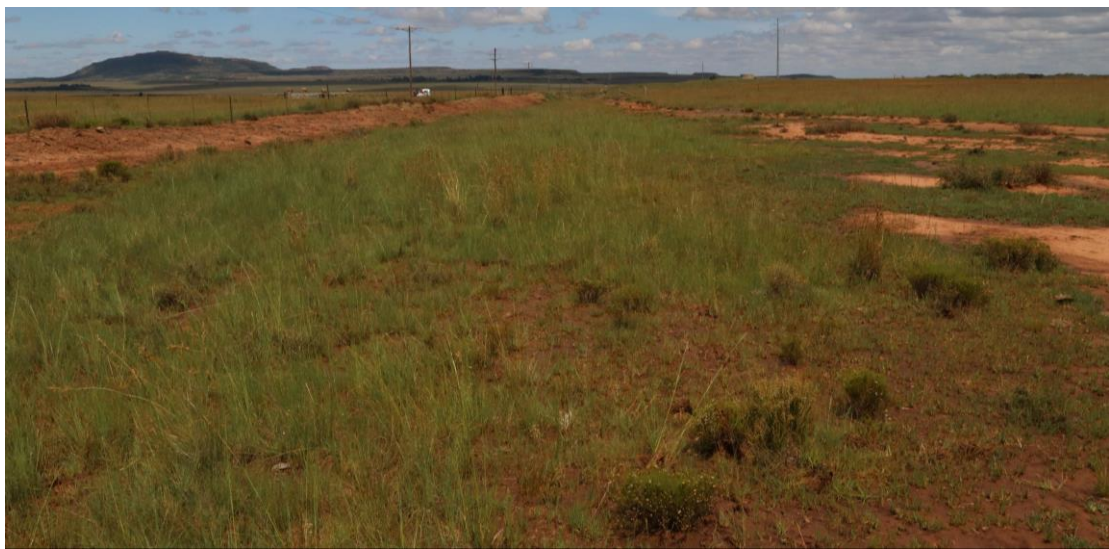
Figure 5: The drainage line to the south of the site is clearly quite small, not located near the site or fed by runoff from it and should therefore remain unaffected.

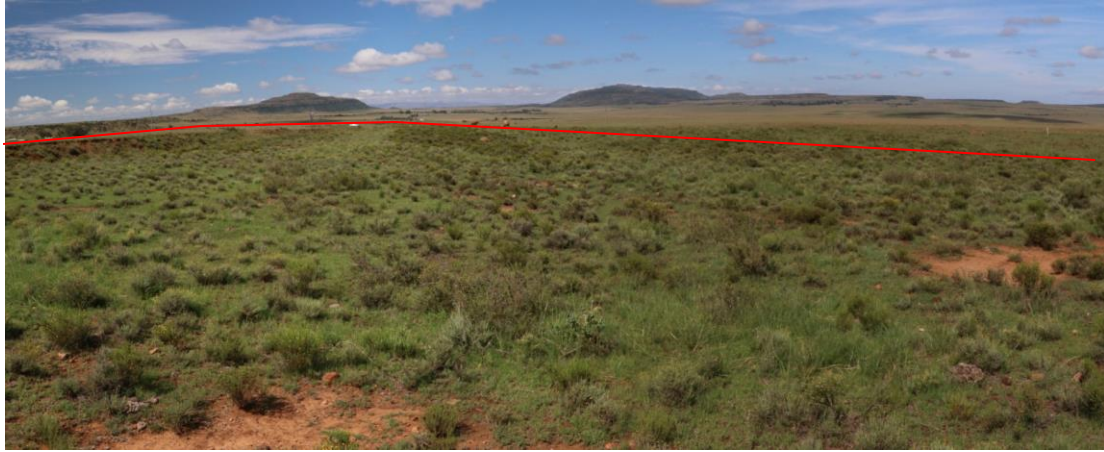
Figure 6: Although the existing borrow pit entails the highest impact on the site, the adjacent portions had clearly also been transformed by previous mining activities. These areas are clearly visible where dwarf karroid shrubs dominate and grasses are sparse and short.

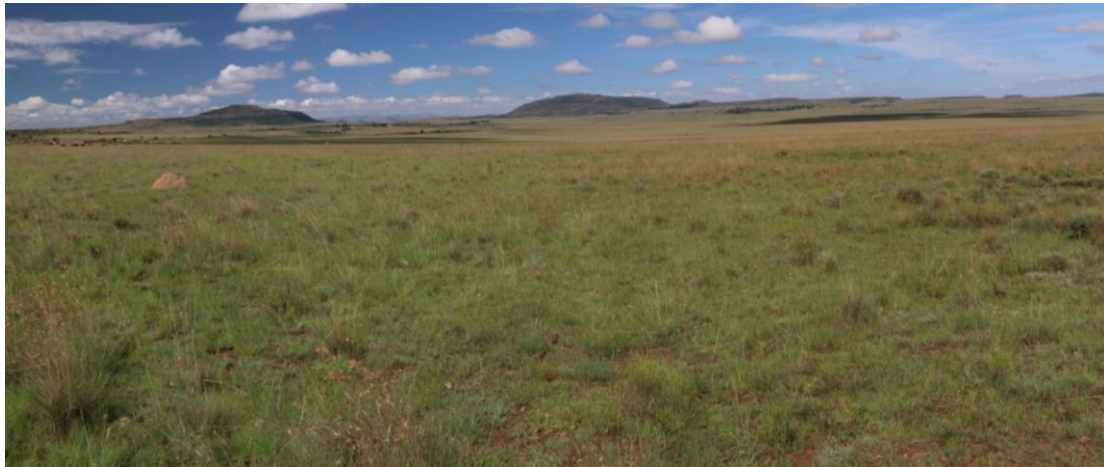
Figure 7: When compared to those portions affected by previous mining activities, the surrounding natural grassland is clearly different, being dominated by a dense grass layer with dwarf karroid shrubs being largely absent.

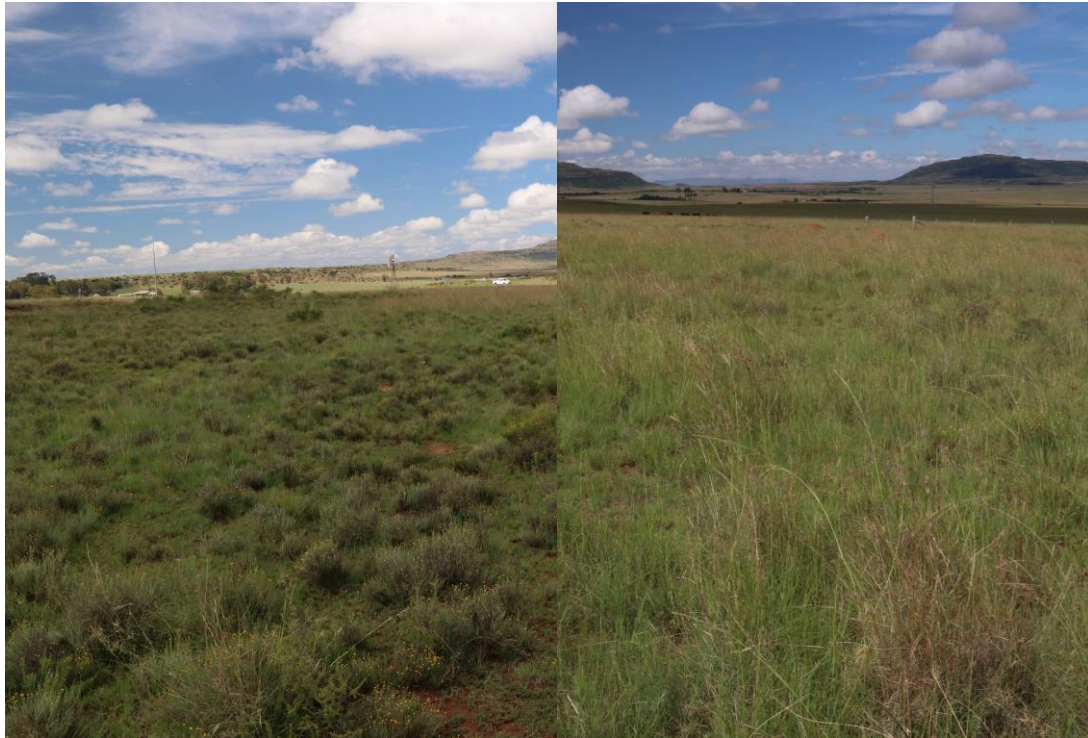
Figure 8: When viewed side-by-side the previously disturbed and surrounding natural areas are quite clearly discernible. The proposed development footprint was therefore confirmed to be largely confined to those areas previously being transformed. This will significantly reduce the anticipated impacts of the development.

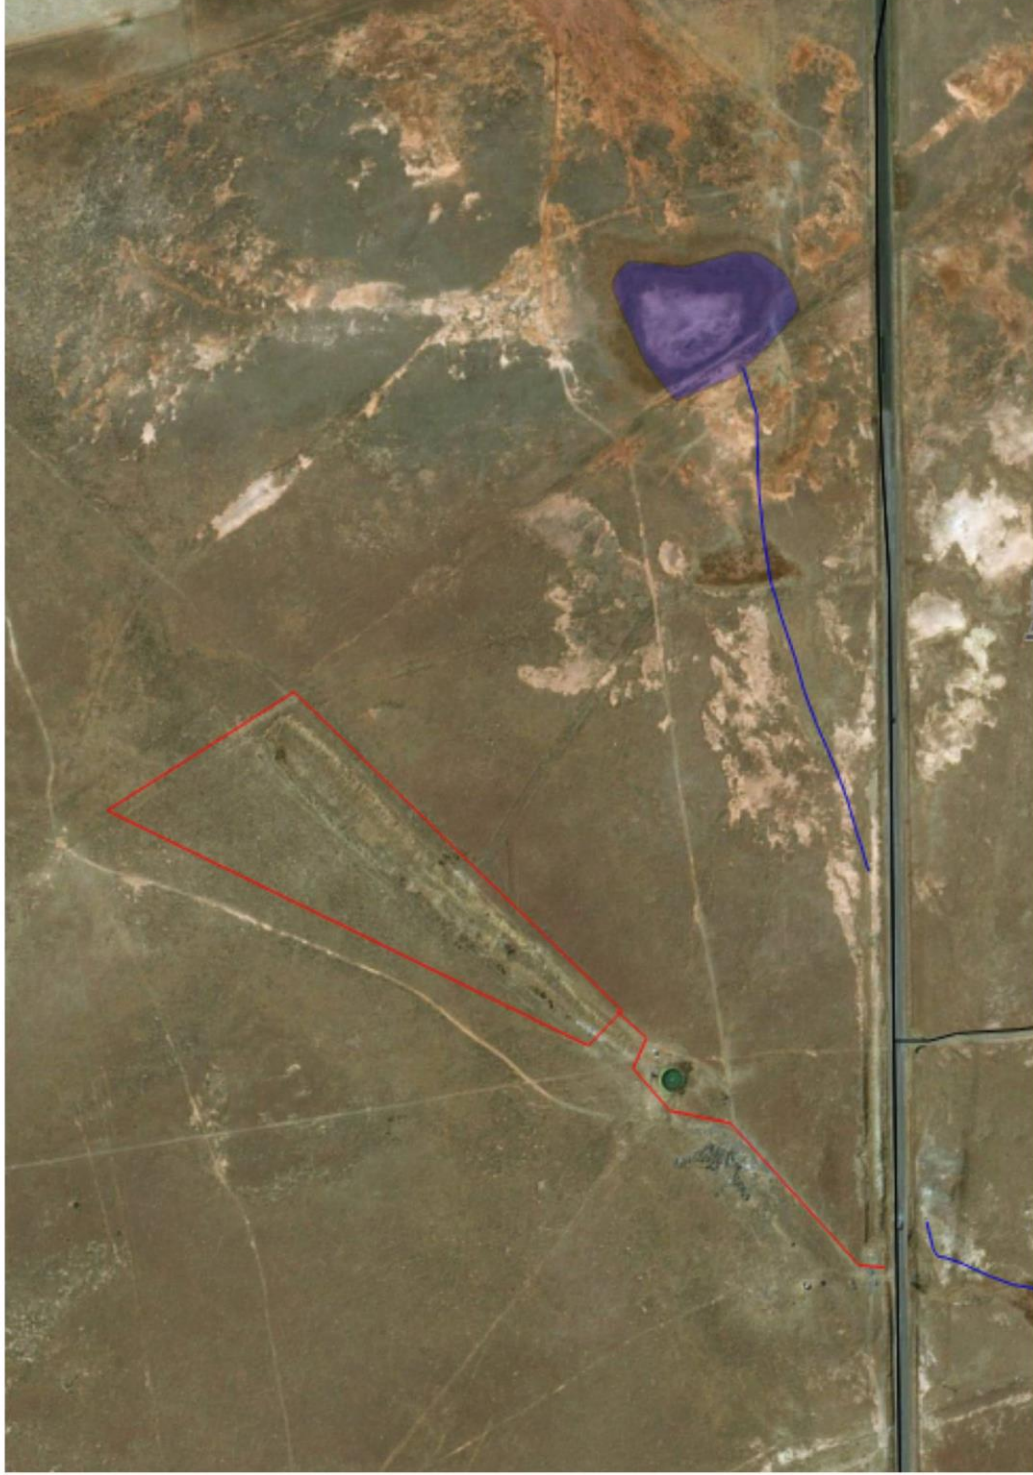
Layout map of a proposed borrow pit along the R58 Provincial Roads between Aliwal North and Lady Grey, Eastern Cape Province.

Map 1: Layout map of the proposed borrow pit adjacent to the R58 Provincial Road. The proposed development footprint and access road is indicated. Note that an existing road will be utilised. The existing borrow pit excavation is clearly visible. The surrounding area consists of extensive natural grassland. Note the small drainage line to the south of the proposed borrow pit. It is however not located near the site and prevalent runoff patterns should prevent the development from having any significant impacts on it.

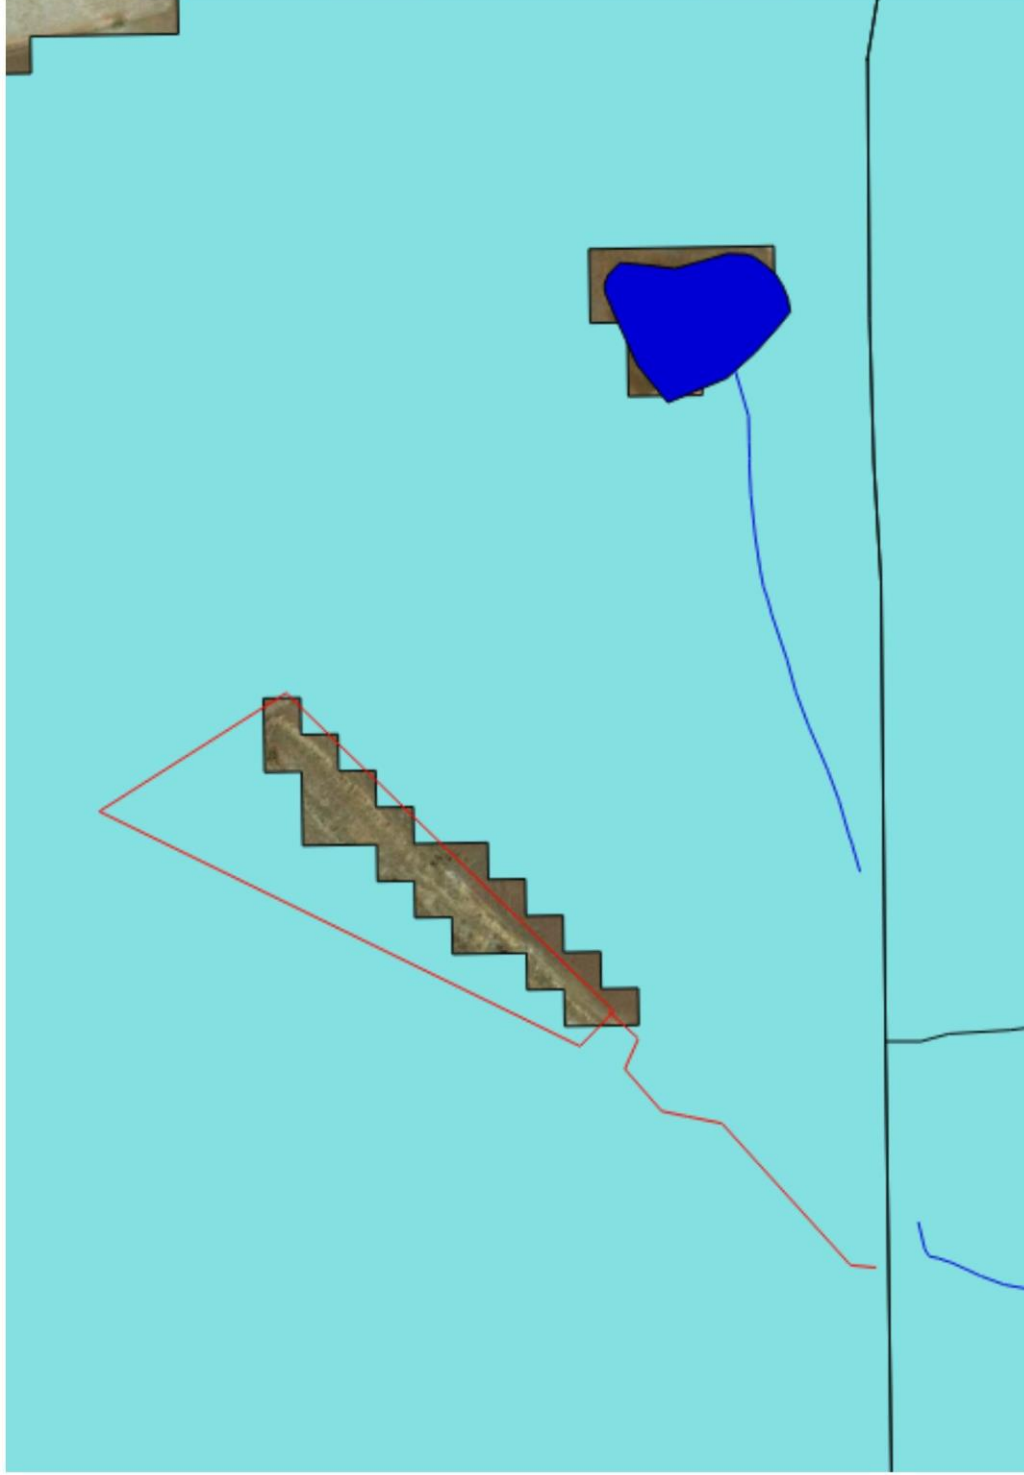
General ecology map of a proposed borrow pit along the R58 Provincial Roas between Aliwal North and Lady Grey, Eastern Cape Province.

Map 2: General ecology map of the proposed borrow pit adjacent to the R58 Provincial Road. The area consists exclusively of Aliwal North Dry Grassland which is neither listed as a Threatened Ecosystem, Critical Biodiversity Area or National Protected Areas Expansion Strategy (NPAES) Focus Area. The National Biodiversity Assessment (NBA 2018) also indicates a portion of the site no longer consists of natural vegetation, note however that this is coarsely delineated with the on-site survey confirming that the borrow pit and surroundings are no longer representative of the natural vegetation type.

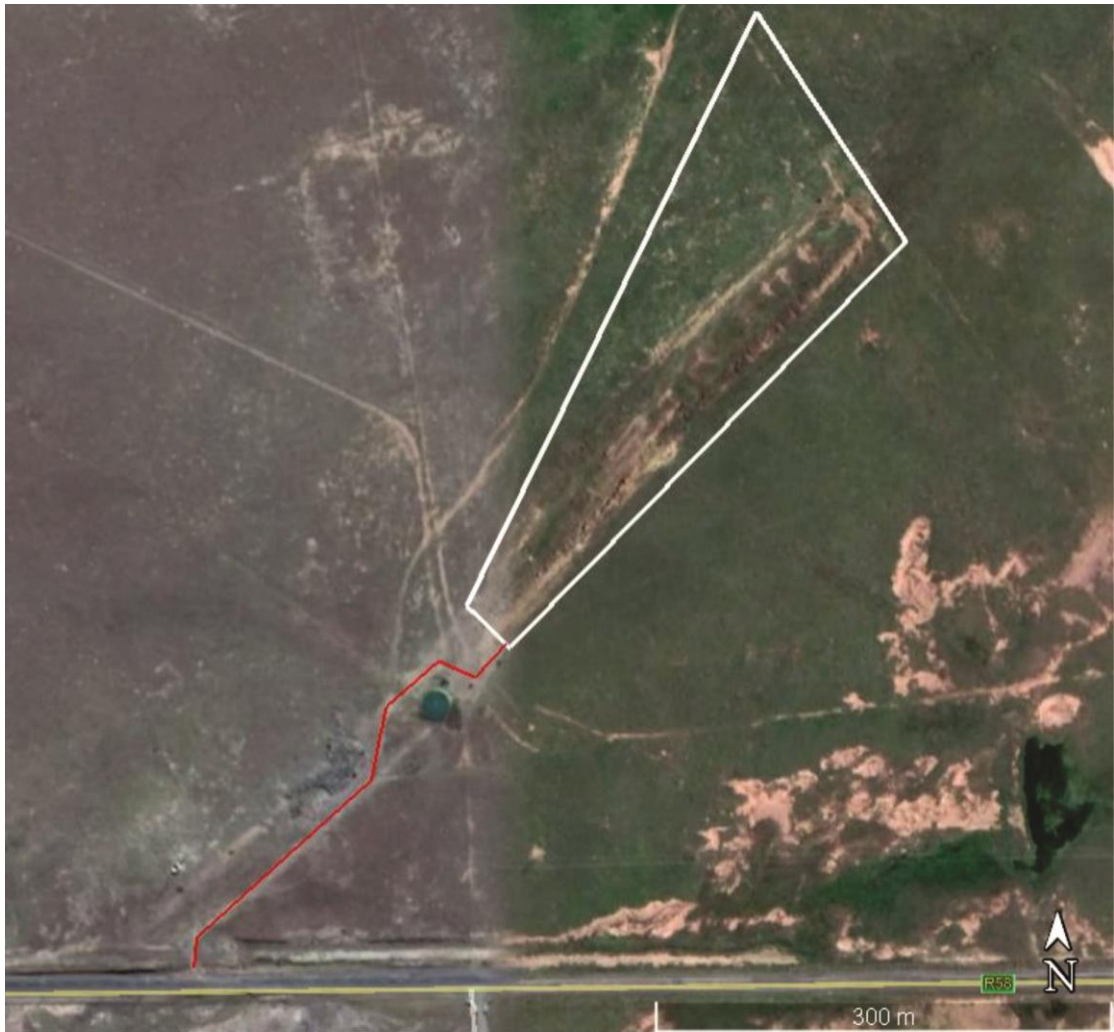
Figure 2. Aerial view of the proposed footprint area. Existing access road indicated by red line.

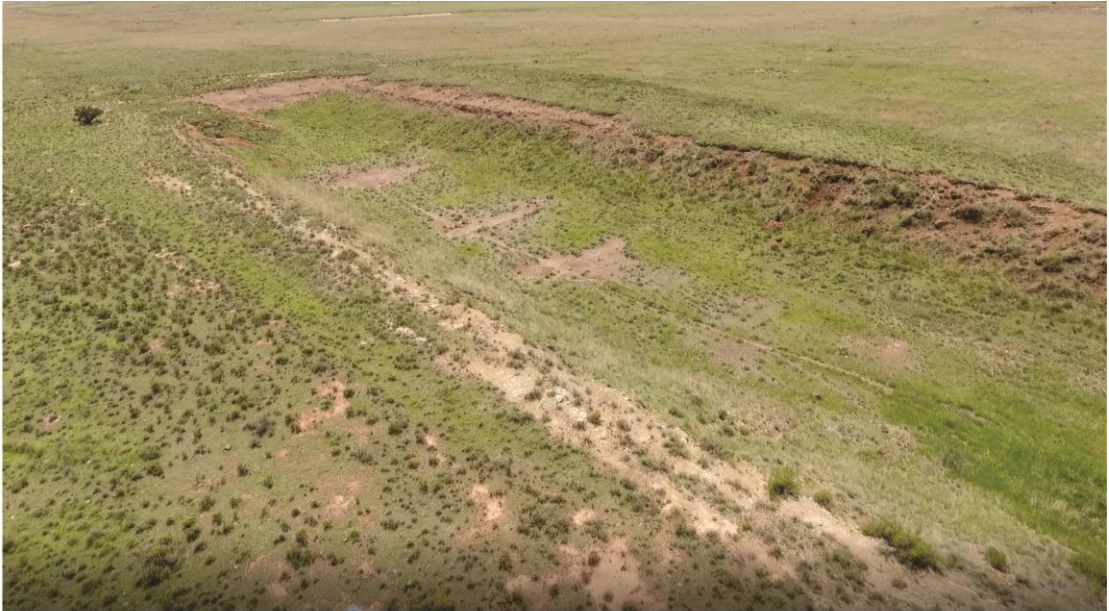
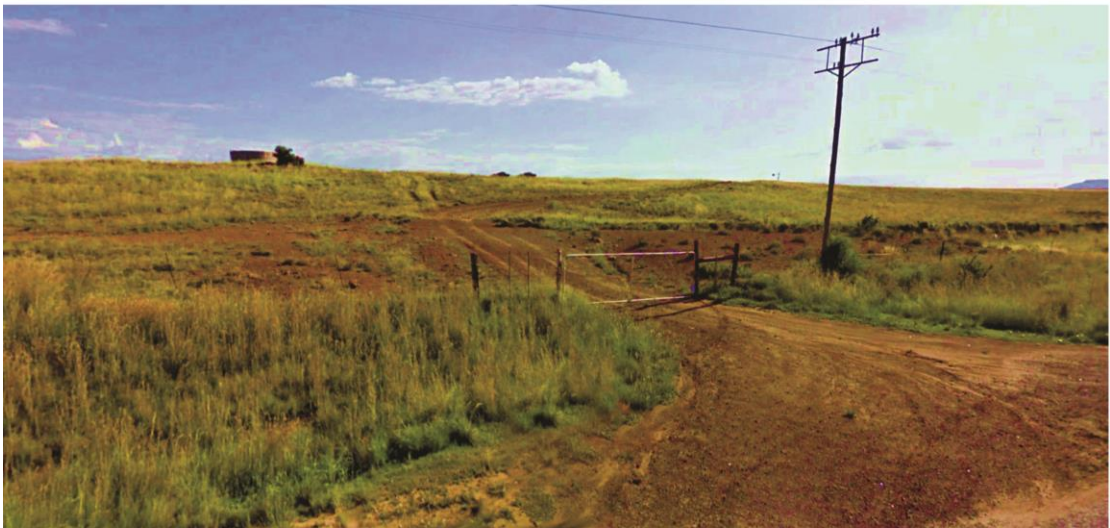
Figure 3. General view of the existing borrow pit area, looking west (above) and access road entrance (below).

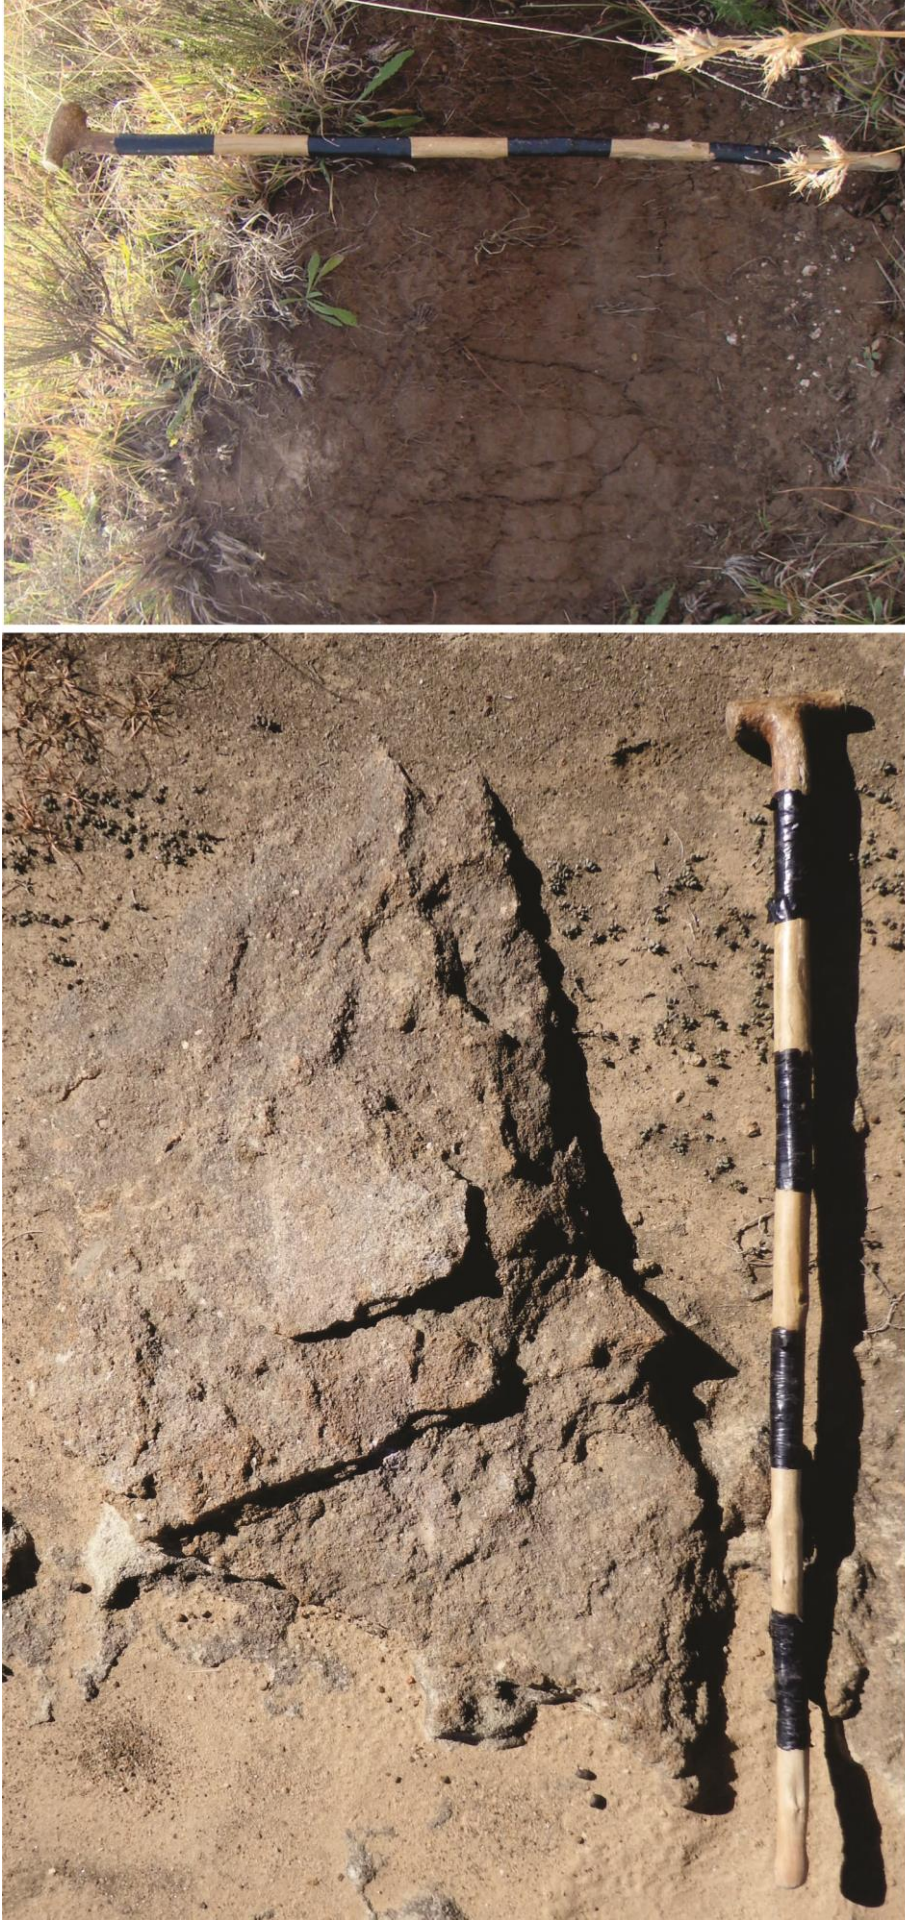
Figure 5. Course to medium-grained sandstones of the Molteno Formation exposed by previous excavations (left) and overlying residual soils (right).
Scale 1 = 10 cm

The footprint is located on weathered Molteno Formation outcrop, buffered by overlying residual soils resting on low relief terrain (**Fig. 5 & 6**). No fossils or potential fossil exposures were observed within the existing borrow pit. There is no above-ground evidence of building structures older than 60 years, Stone Age archaeological remains, Iron Age structures, graves or material of cultural significance within the confines of the borrow pit footprint.

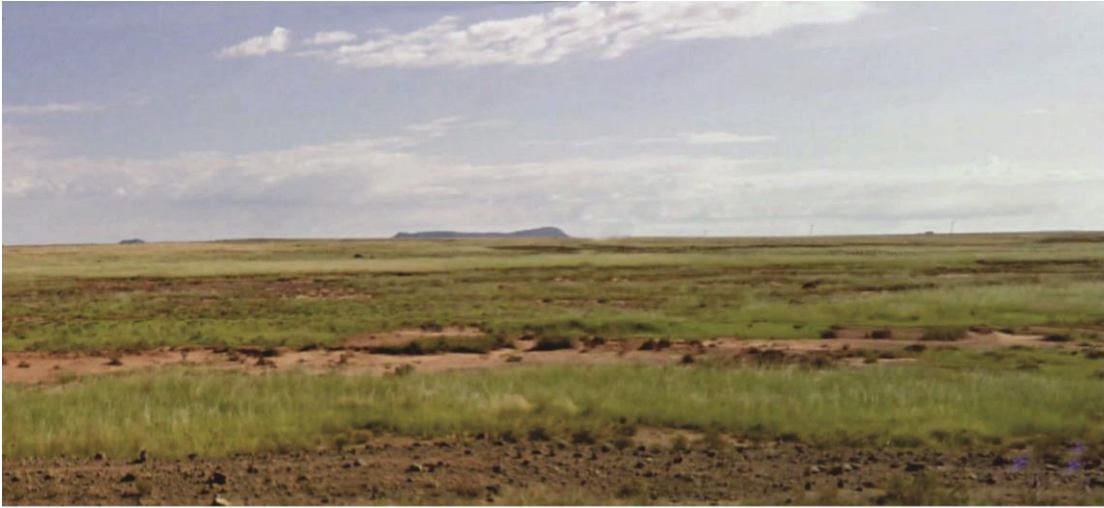
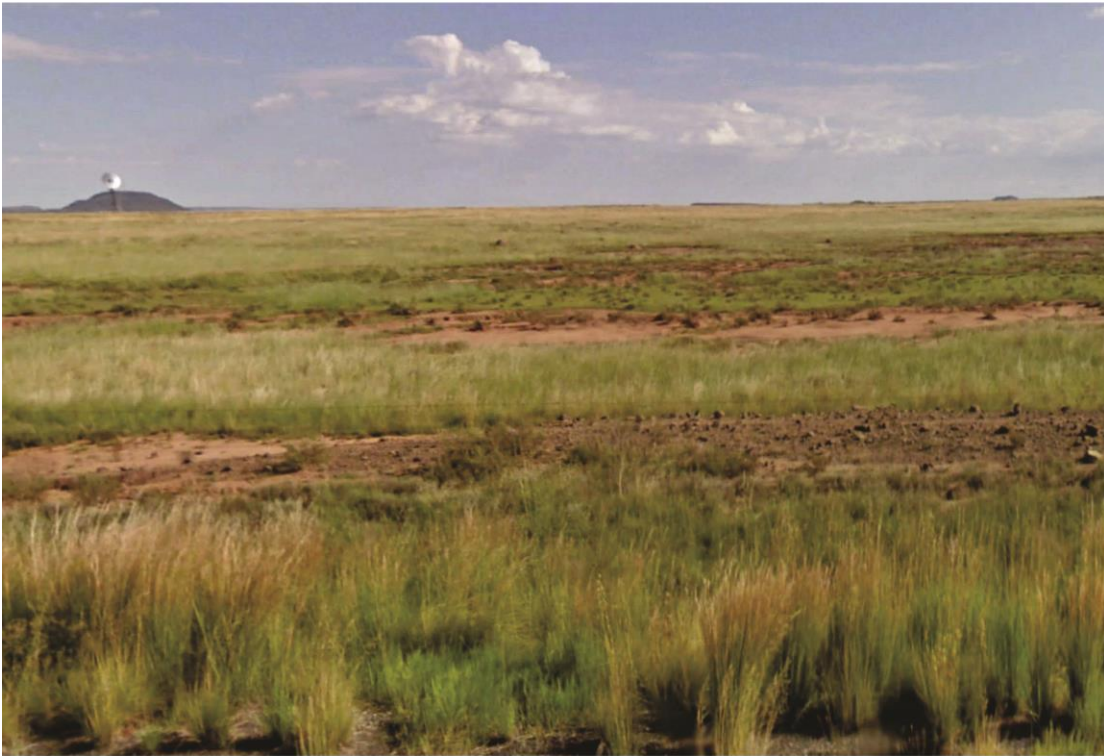
Figure 6. General view of the site showing low relief of the terrain, looking north and northeast.
