Appendix H.13

GEOTECHNICAL ASSESSMENT

**Dalmanutha Wind Energy Facility
Geotechnical Desktop Assessment**
WSP Africa

21500715-352637-3_Rev2

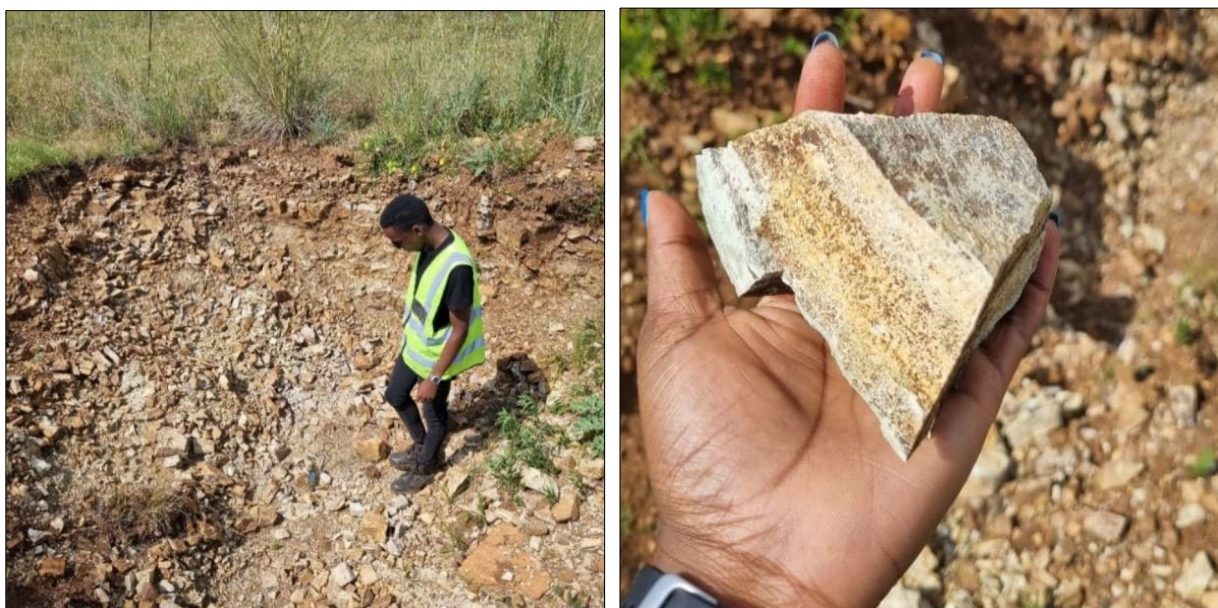
Figure 9: Small Vryheid Shale Borrow Pit Observed on Site Close to WTG37 on the Northern Portion

On site, shale of the Vryheid Formation was observed in a small borrow pit situated close to WTG37. The profile in the pit comprised a thin layer of transported and residual soil underlain by shale as illustrated in Figure 9.

Vryheid shale generally weathers to a clayey residual soil which is often compressible and potentially expansive. Expansive soils are those materials that exhibit volume change with a change in moisture content. These materials “shrink” when the moisture content decreases and “heave” or “expand” when the moisture content increases. Where the residual shale profile is thinly developed, it is recommended that the material should be stripped. Where thickly developed, the structural design needs to take cognizance of the potential expansiveness.

Some shale breaks down rapidly after exposure to the elements with micro-cracks developing as a result of moisture loss or stress relief. Mudrocks such as shale, are generally not considered suitable for use as construction materials. This is due to their potential expansiveness, excessive absorption of water, poor engineering performance and lack of durability. However, some shale material is considered suitable for use as selected layers in road construction (wearing coarse for gravel roads). However, the durability and potential expansiveness should be ascertained beforehand.

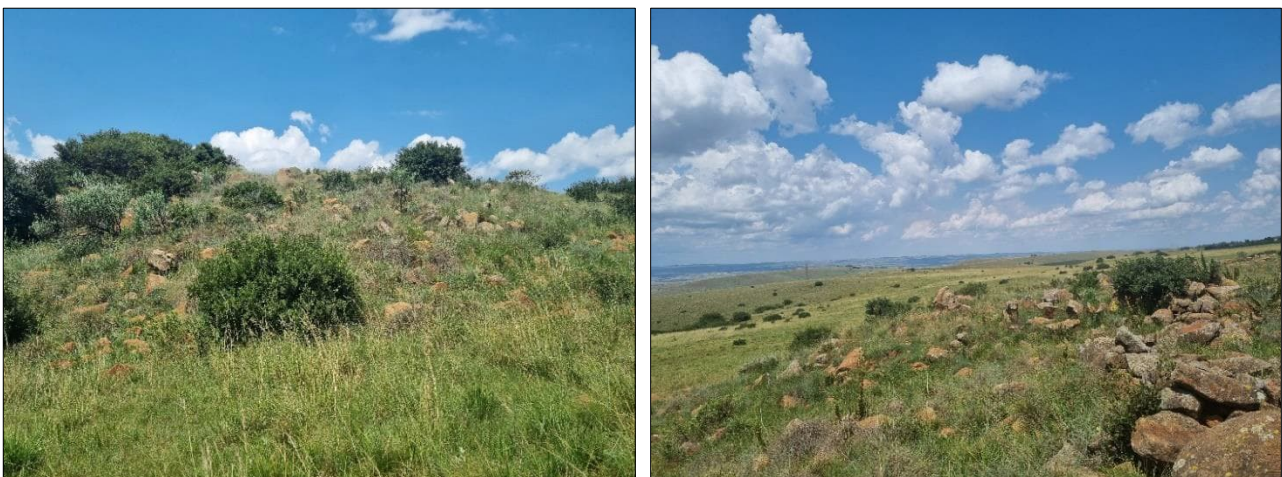
Figure 10: Diabase Hill with Boulders, Located Close to WTG49, Side Profile (Left) and Top (Right)

Diabase was not observed in outcrop across the site during the site reconnaissance. A hill with diabase boulders was observed approximately 0.35m south-west of WTG49, Figure 10. According to the published geological map, WTG54 is underlain by diabase. According to the Google Earth image, diabase boulders may be present in the area of WTG54.

Residual clay is generally compressible and potentially expansive in the “medium to high” range. Where a structure straddle residual diabase and a different soil type, the structure should be moved to avoid differential settlement or designed accordingly.

Diabase rock, cobbles, boulders, gravel and sand are generally durable and are suitable for a variety of purposes. It is commonly quarried and used as a construction material such as for concrete aggregate and road construction material.

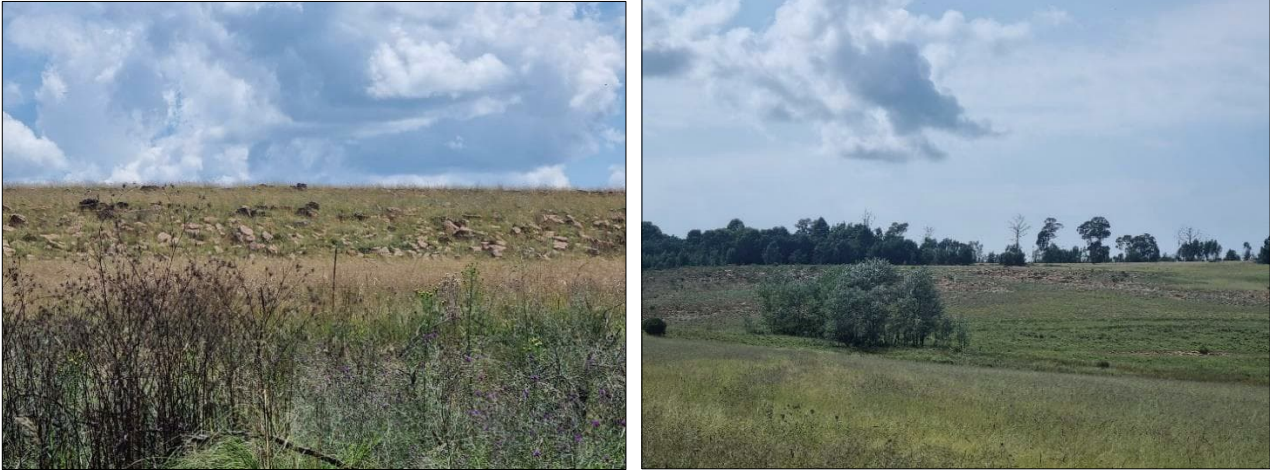
Figure 11: Quartzite on Surface, Photo Taken Facing WTG45 (Left) and Facing WTG16 (Right)

Quartzite outcrop was observed on surface across the center of the WEF on the flat hilltop. The sides of the slopes are characterized by quartzite boulders as shown in Figure 11 and Figure 12. The quartzite encountered is cream white, moderately weathered, medium to coarse grained, medium hard to hard rock. Where present, residual soils are likely to be thinly developed.

Although not observed on site, the residual soil tends to comprise loose silty sand or clayey sand with a thickness of less than 2m. The residual quartzitic clayey/silty sand may be potentially collapsible.

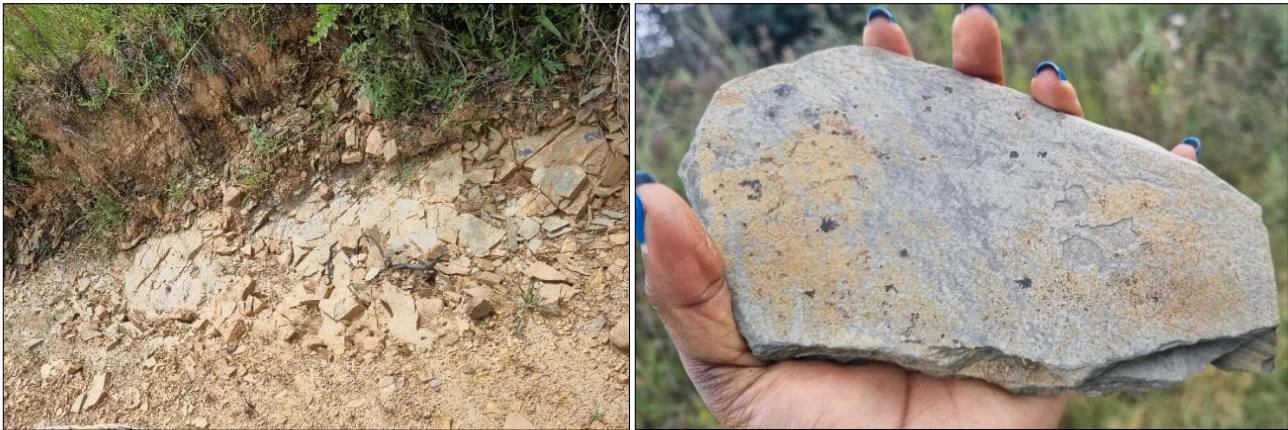
Figure 13: Silverton Shale

Silverton shale underlies the majority of the eastern side of the site. Shale outcrop was encountered on a road near to WTG25 (Figure 13). The rock is light grey, moderately weathered, fine grained, thinly laminated, with light yellow silty sand infill along the bedding planes, soft rock shale. The rock was overlain by a thin (0.30m) layer of residual shale profiled as slightly moist, light brown to beige, soft, intact, sandy silt. A slightly moist, light greyish brown, loose, silty sand topsoil blanketed the area.

The residual profile is generally thinly developed above the Silverton shale, less than 2m thick, and is expected to comprise a clay/silt material. The residual clay is generally potentially expansive and compressible.
