**REPORT TO TGC ENGINEERS CC. ON A GEOTECHNICAL
INVESTIGATION FOR A PROPOSED NEW LANDFILL, CANDIDATE SITE 1
KRANTZ FONTEIN FARM KOKSTAD**

1. INTRODUCTION

Drennan, Maud and Partners was requested by Mr Graham Payne of TGC Engineers cc. to undertake a geotechnical investigation of candidate Site 1 Krantz Fontein Farm for the proposed new landfill to service Kokstad. The aim of the investigation was to determine:

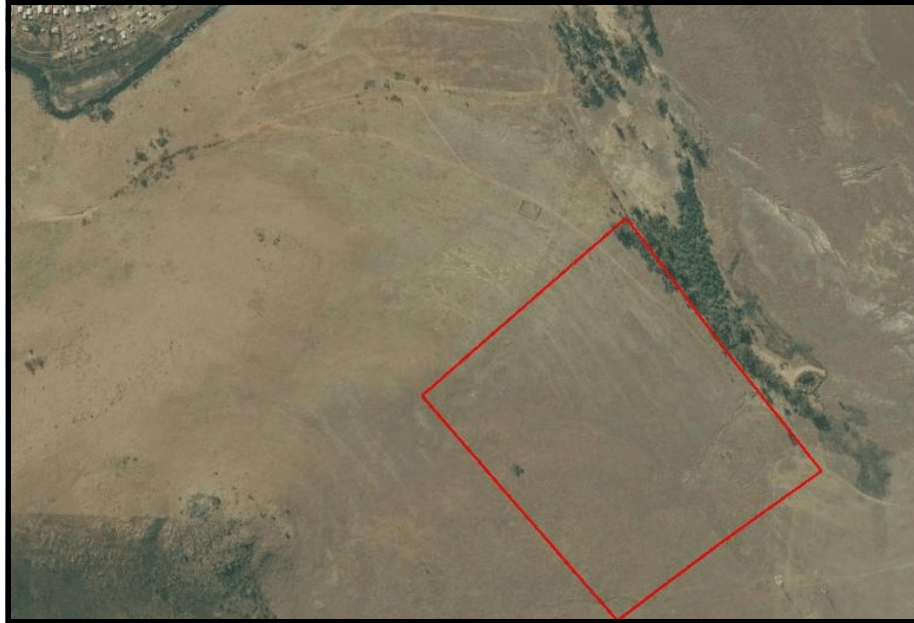
Plate 1. Approximate Extent of Original Landfill Development Footprint (North ↑). Courtesy of Google Earth.

The proposed development area, as indicated by TGC Engineers cc (Plate 1 above), was investigated on the 20th June 2012 by means of inspection pitting using an Bell HD 820R track mounted excavator, as well as excavation of auger holes along the valley line, seismic testing, Dynamic Cone Penetrometer (DCP) testing and selection of soil and water samples for laboratory analysis.
