**CONSULTATION IN TERMS OF SECTION 40 OF THE MPRDA OF 2002:
ENVIRONMENTAL MANAGEMENT PLAN, GRAVEL MINING ON THE
REMAINDER OF FARM ROODEKRANTZ NO. 203, DIVISION OF QUEENSTOWN,
EASTERN CAPE**

Environmental Management Plan

Submitted in support of an application for a mining permit.

ON THE REMAINDER OF FARM ROODE KRANTZ NO. 203,

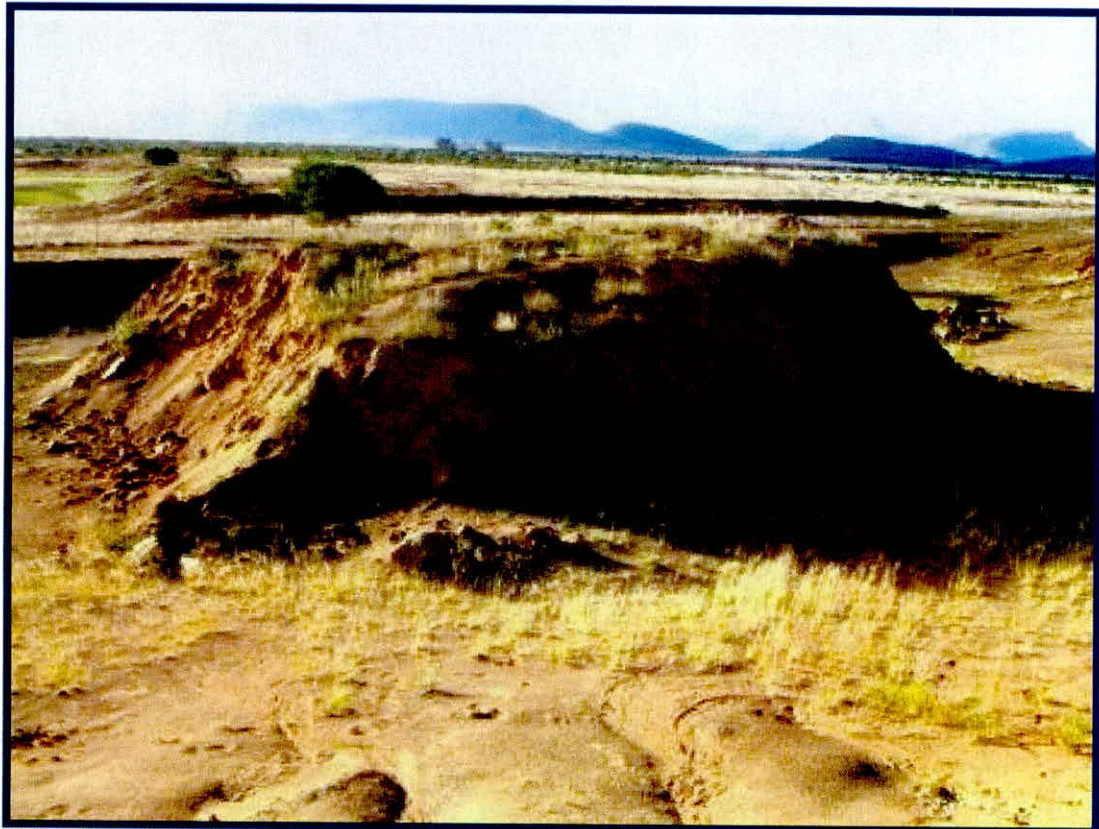
The mine on the farm Roode Krantz 203, generally referred to as the farm Vlakfontein, is situated in, and alongside the over flow of an earth dam which was built about 60 years ago. During the building of the dam topsoil was removed from this area to build the wall and in the process the underlying gravel, or sabunga as it is commonly referred to, became exposed. The locality of the mine in relation to the dam can be seen in this picture showing the main dam wall in the top left and the overflow retaining wall across the picture above the stock pile of sabunga:

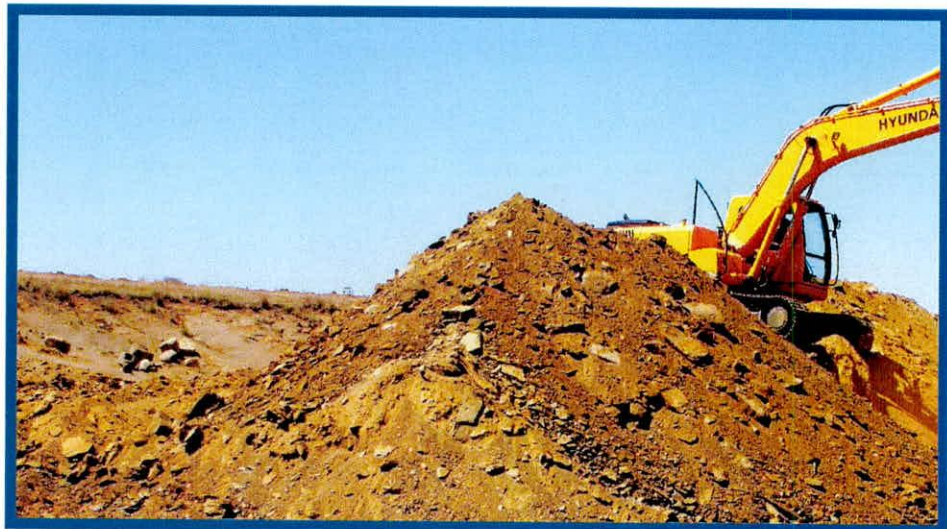
The thin layer of topsoil, which is no thicker than 300mm (as can be seen in the picture below), is removed with conventional heavy machinery, stock piled away from the mining face or loaded onto trucks and stockpiled outside and away from the active mining area, but within the surveyed and demarcated area applied for in this application as depicted in the site survey map in par. 1.

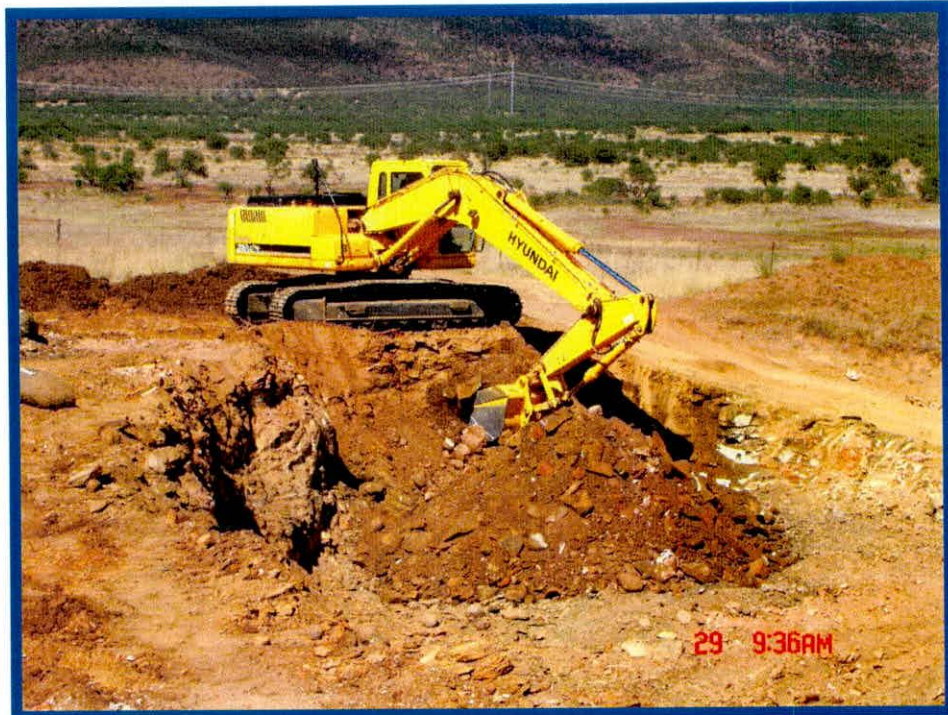
Some of the topsoil can be seen in the next picture where newly removed topsoil can be seen to the left of the excavator and topsoil previously stored, to the right. This picture was taken on 29 January 2009. This however shows only a small portion of the total volume of topsoil that is retained.

The excavation of the gravel is done, as depicted above, by means of an excavator and stock piled inside the excavated area.

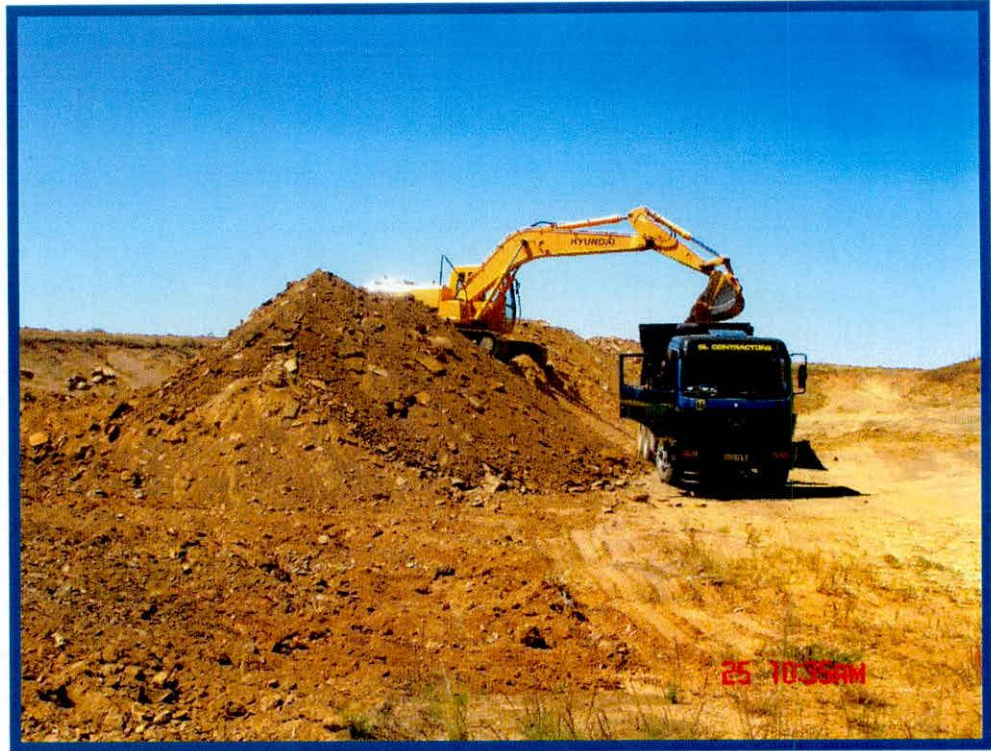
The removal of material is done by trucks, loaded by mechanical means, by the purchaser of the material or somebody contracted by himself and for his account as illustrated in the next picture:

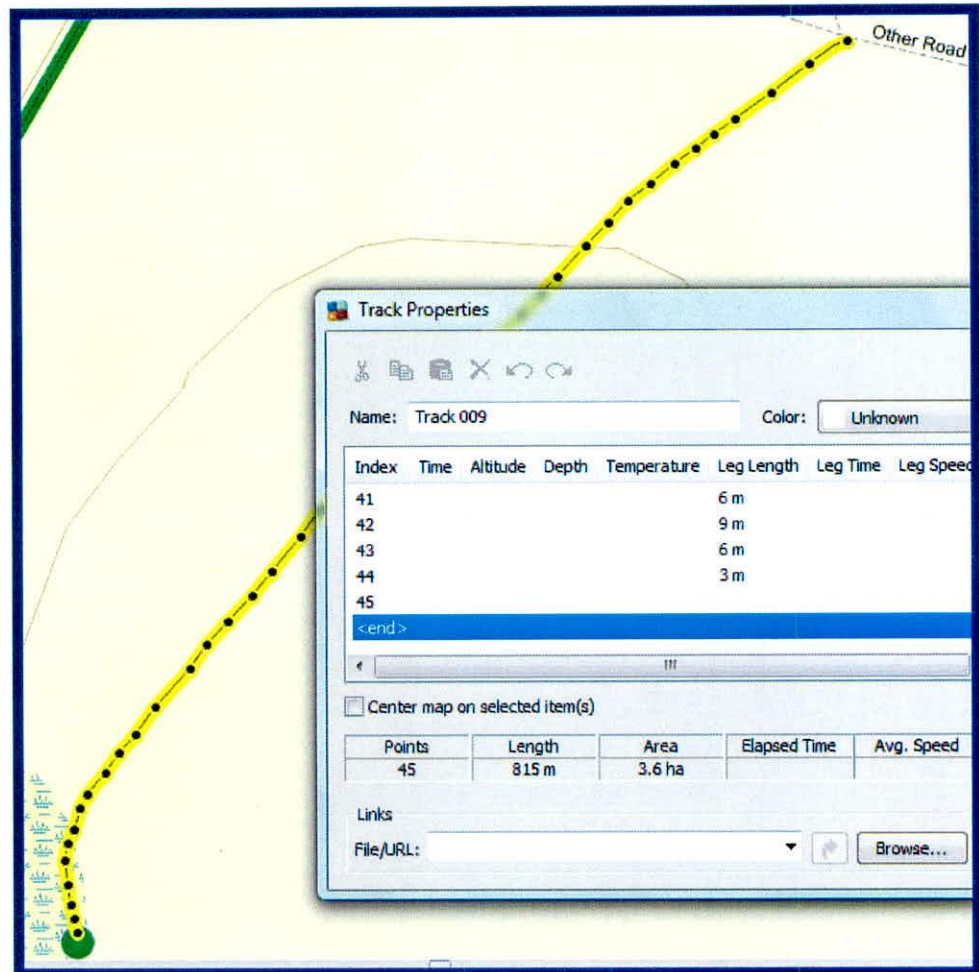
There is an access road from the public road, DR02566 to the mine (see diagram below). The length of road is 815m. It is built with material from the mine to a thickness of about 250mm and compacted to carry the loads.

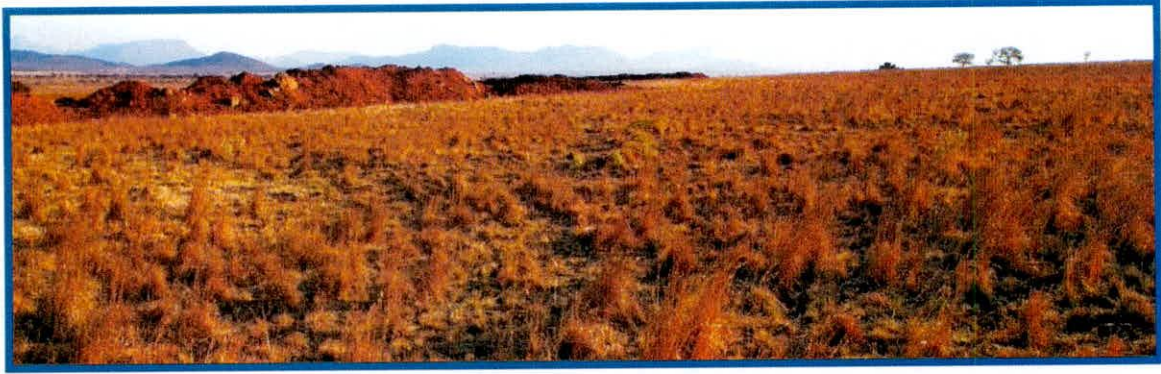
The surrounding vegetation is unaffected by the operation and is still in very good condition despite the current drought and the recent announcement by Government whereby the area is declared a drought disaster area. The picture below was taken on 7 September 2009 under these extreme drought conditions and still shows excellent grass cover. The pit is situated just behind the topsoil in the top-left of the picture.

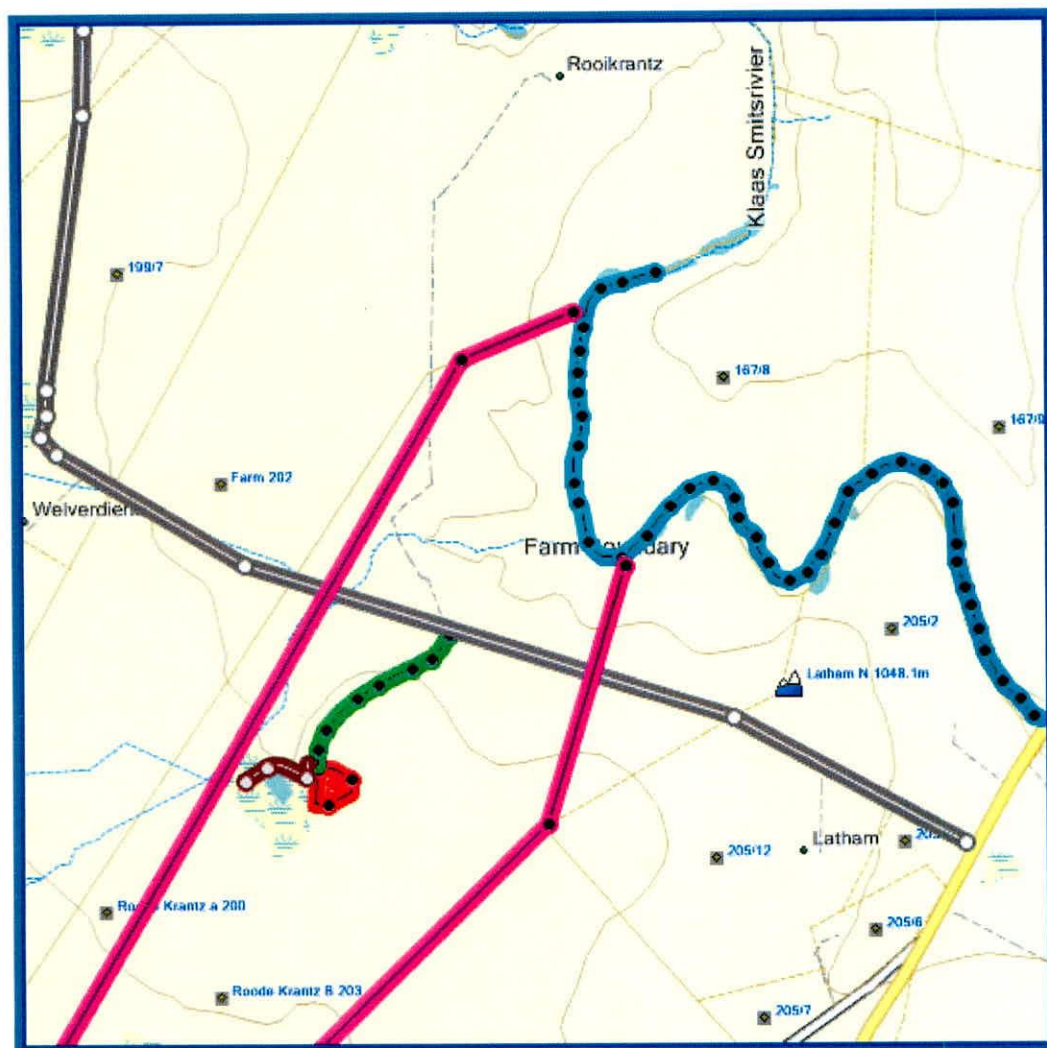
The area map below indicates the following elements:

| The demarcated mining area – RED | The adjacent earth dam – BROWN |
| The access road – GREEN | The Klaas Smits river – BLUE |
| Public road DR 02566– GREY | Public Road R67 – YELLOW |
| Farm boundaries of farm Roodekrantz 203 - MAGENTA | |

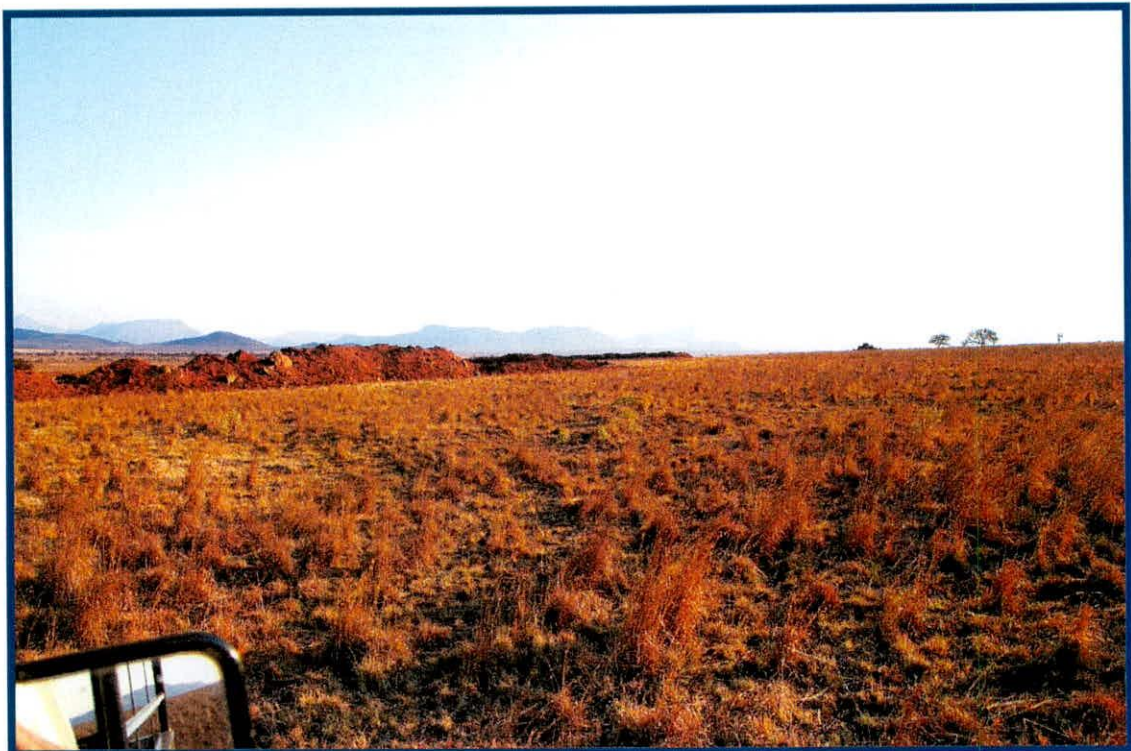
The mine is situated on land with a very even and low gradient of less than 5%. See picture below. There is no risk of erosion. Because of the shallow depth of the pit, and the small area of the mine, the impact is insignificant.

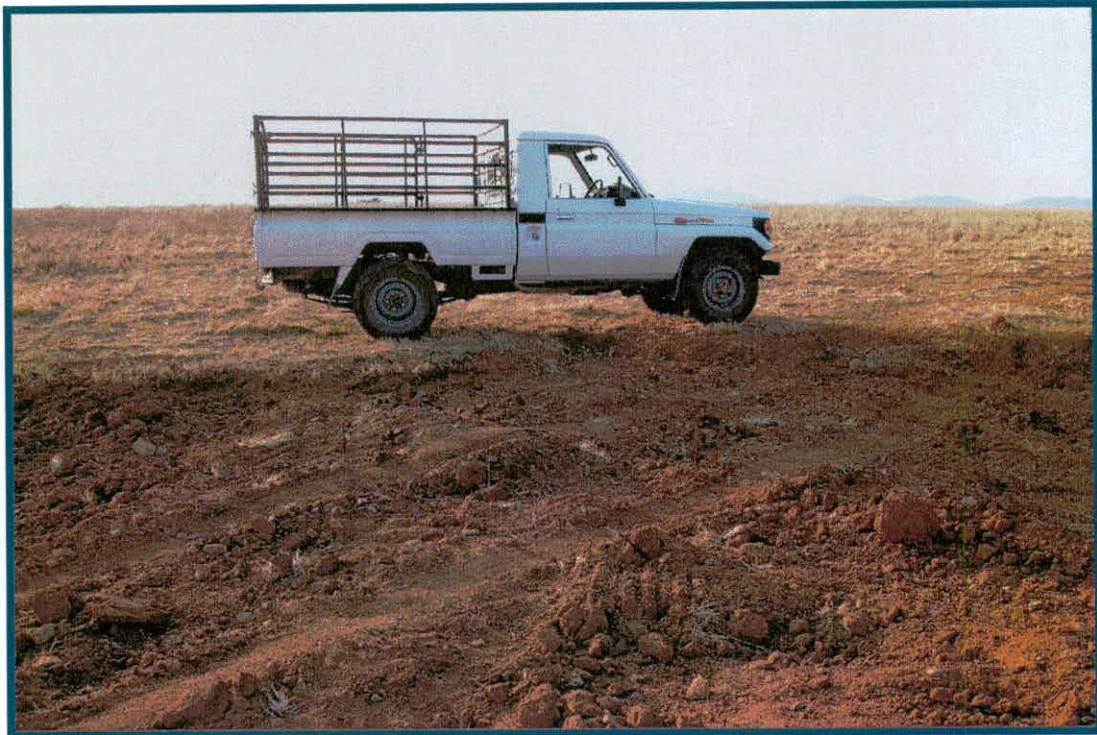
The topsoil is between 200 and 300mm deep and well covered with grass. See picture below depicting an area where the topsoil is removed.

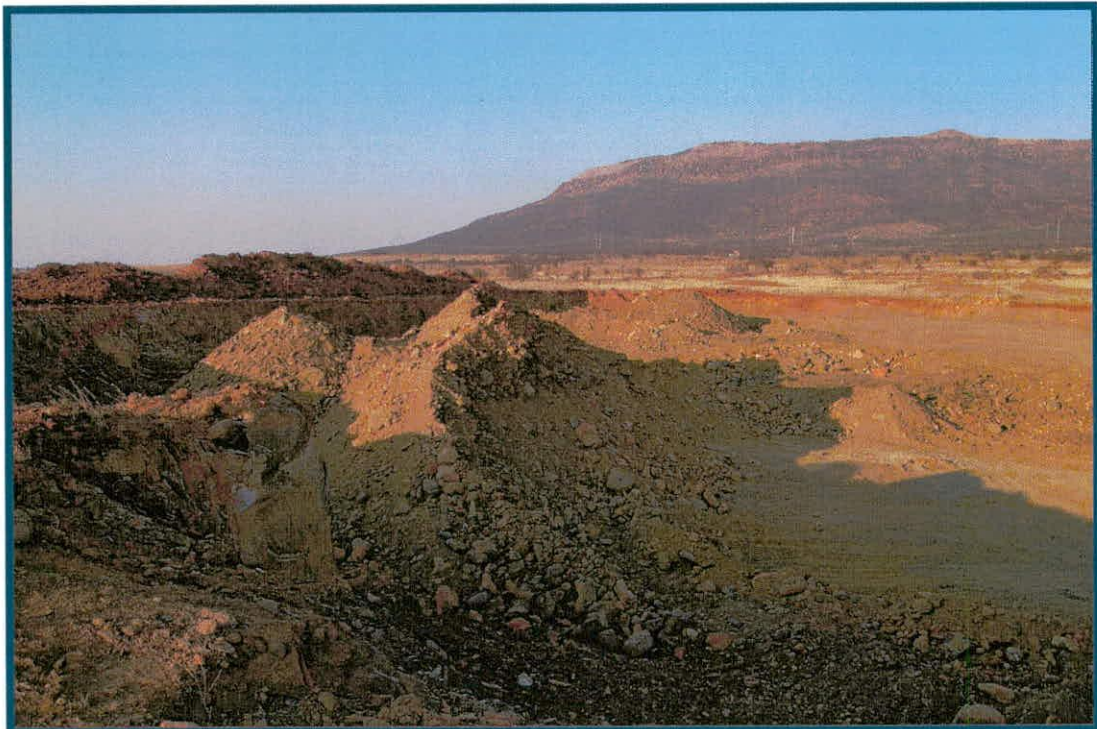
The substrate is dolerite, mined to a depth of between 1 and 3 meters.

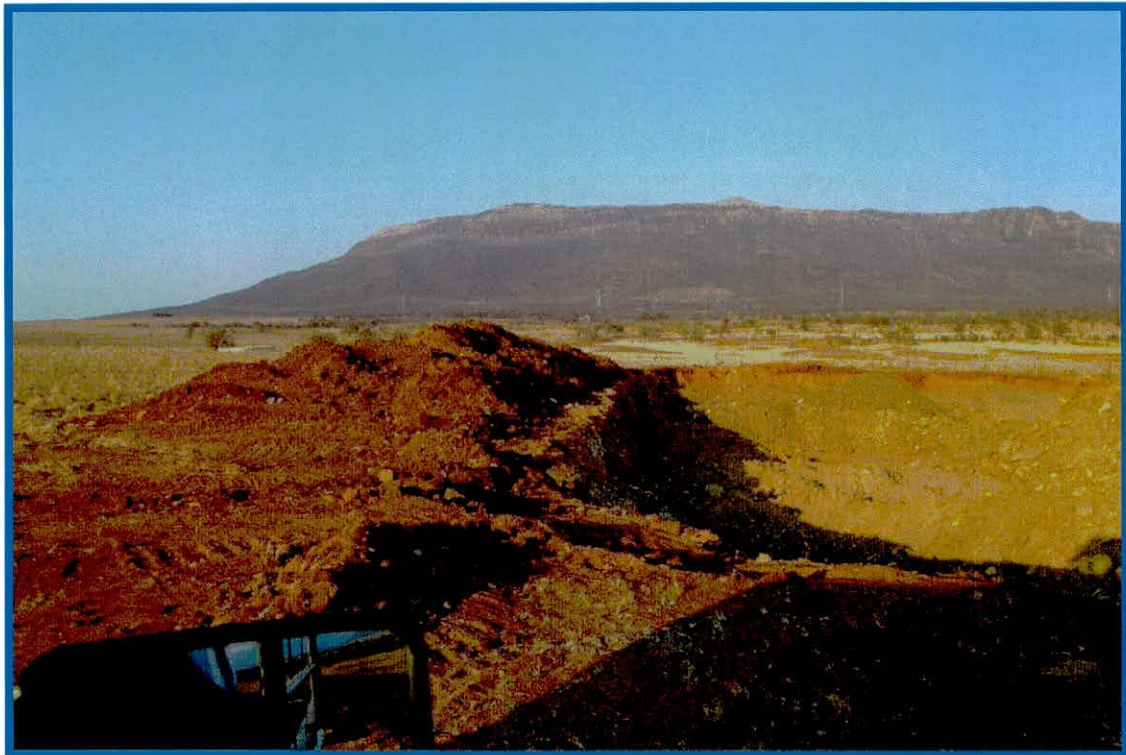
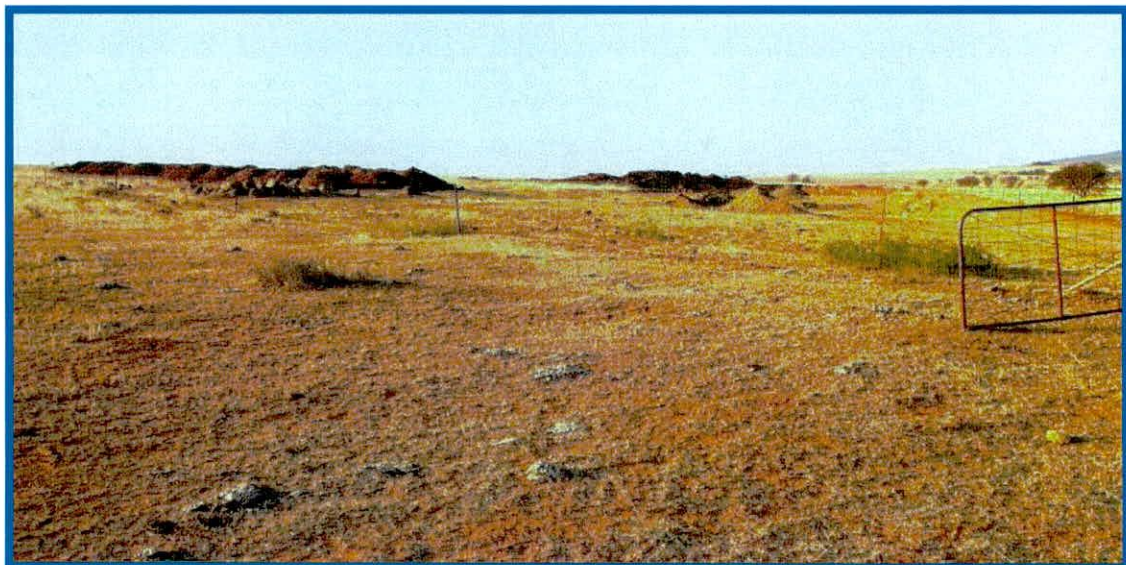
All topsoil is removed and kept next to or close to the pit and is available for replacement and rehabilitation.

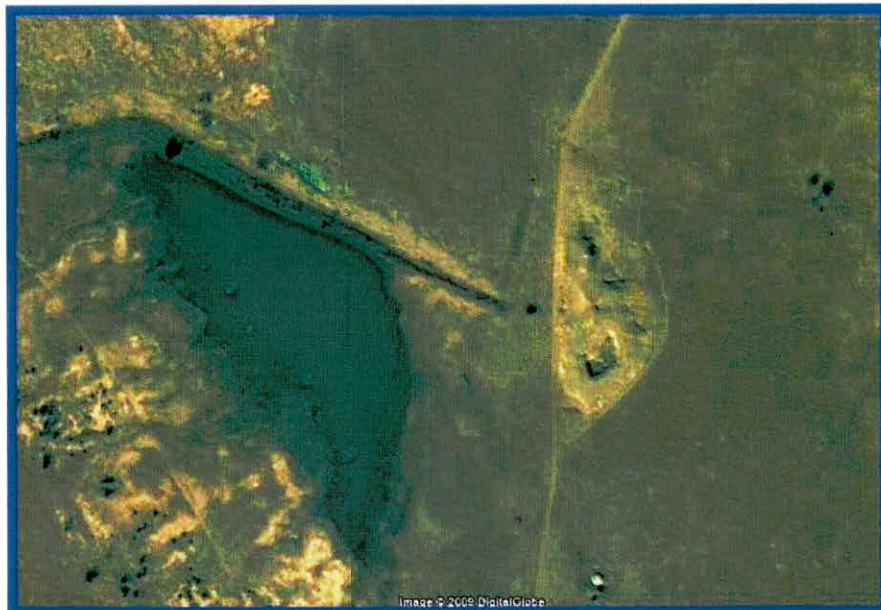
The well established natural vegetation in the area around the mine can also be seen on the Google image below. (The mine is the disturbed area to the tight of the dam)

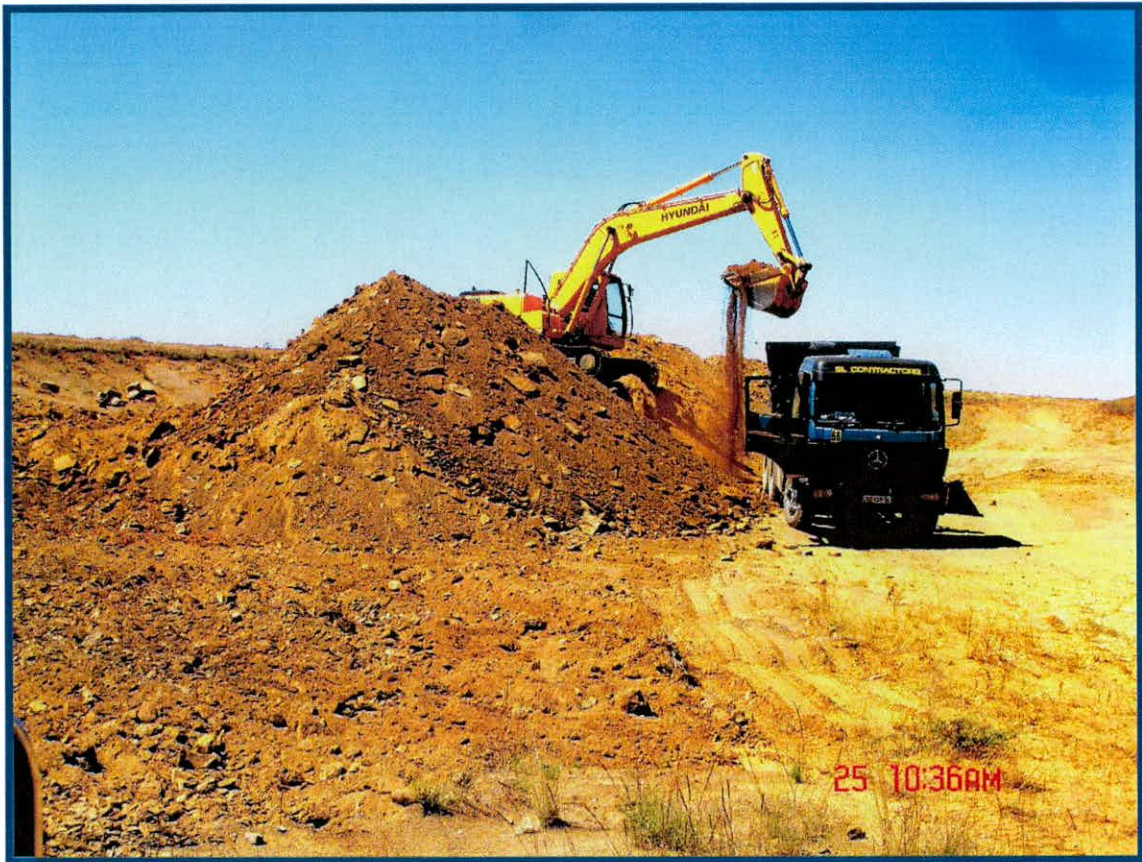
Excavated Dolerite is a coarse mineral and does not contain or produce significant amounts of dust, as demonstrated by the picture below.

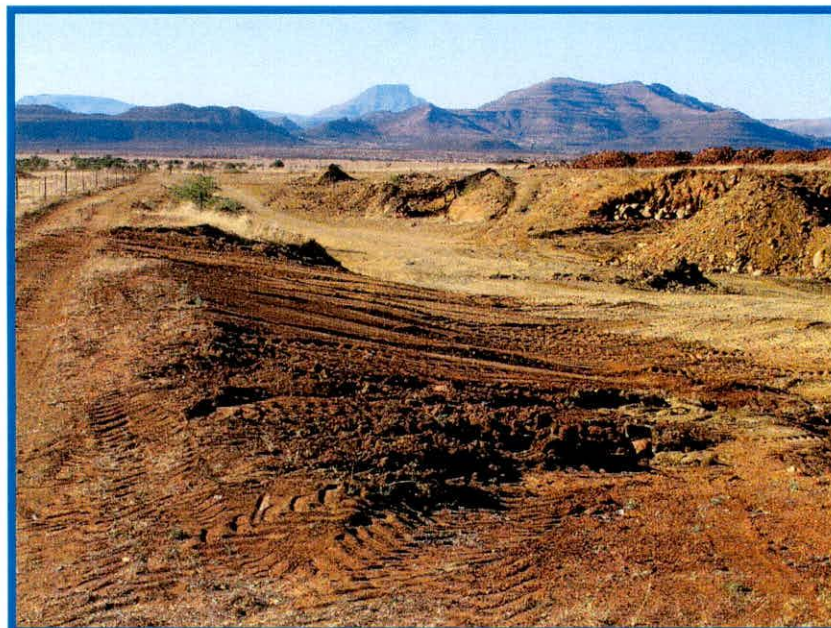
Below is the first phase of rehabilitation done on 24 September 2009 as an example:

Rehabilitation will consist of sloping the edges to a 1:3 gradient for any depth shallower than 1,5 m and to gradients no steeper than 1:2 for depths more than 1,5 m. Once excavations have been profiled with acceptable contours and erosion control measures, the topsoil previously stored, shall be returned and the whole area be covered to its original depth over the area.

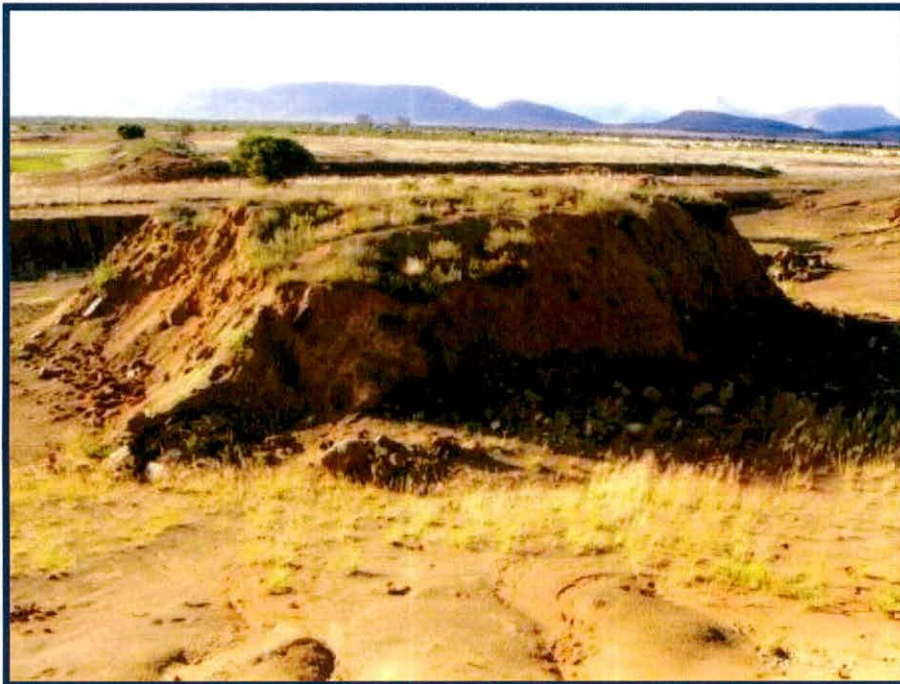
Picture 4

Taken in a North-Western direction

The mine on the farm Roodekrantz is situated in, and alongside the over flow of an earth dam, (as can be seen in **Picture 4**, below), which was built about 60 years ago. During the building of the dam topsoil was removed from this area to build the wall and in the process the underlying gravel or sabunga was exposed. Over the years material was removed from the site, mainly for maintenance of roads on the farm.
