Basic assessment report in terms of the Environmental Impact Assessment Regulations, 2010, promulgated in terms of the National Environmental Management Act, 1998 (Act No. 107 of 1998), as amended.

Anglo American Limited: Rustenburg Platinum Mines Limited (RPM) has four existing empty Tar Dams within their mine lease area near Rustenburg, North West Province. The empty Tar Dams contained legacy residues that were generated from the gas fired smelter at Klipfontein, which existed more than 60 years ago. The tar residue from the smelter was stored in four separate clay-lined, soil compartments. Each empty tar dam is approximately 1600m<sup>2</sup> in size and contained an estimated 3200m<sup>3</sup> of tar residue. Tar Dam footprints A and B (referred to as the Bleskop Tar Dams) are located between the Bleskop Stadium and the RPM Hospital, while Tar Dam footprints C and D (referred to as the TEMSO Tar Dams) are located north of the Klipfontein Concentrator, adjacent to the road to TEMSO. Locality maps are included in Appendix A.

# **Rustenburg Tar dams**

**The Status of Soil, Surface Water and Groundwater at the Tar  
Dam (August 2011)**

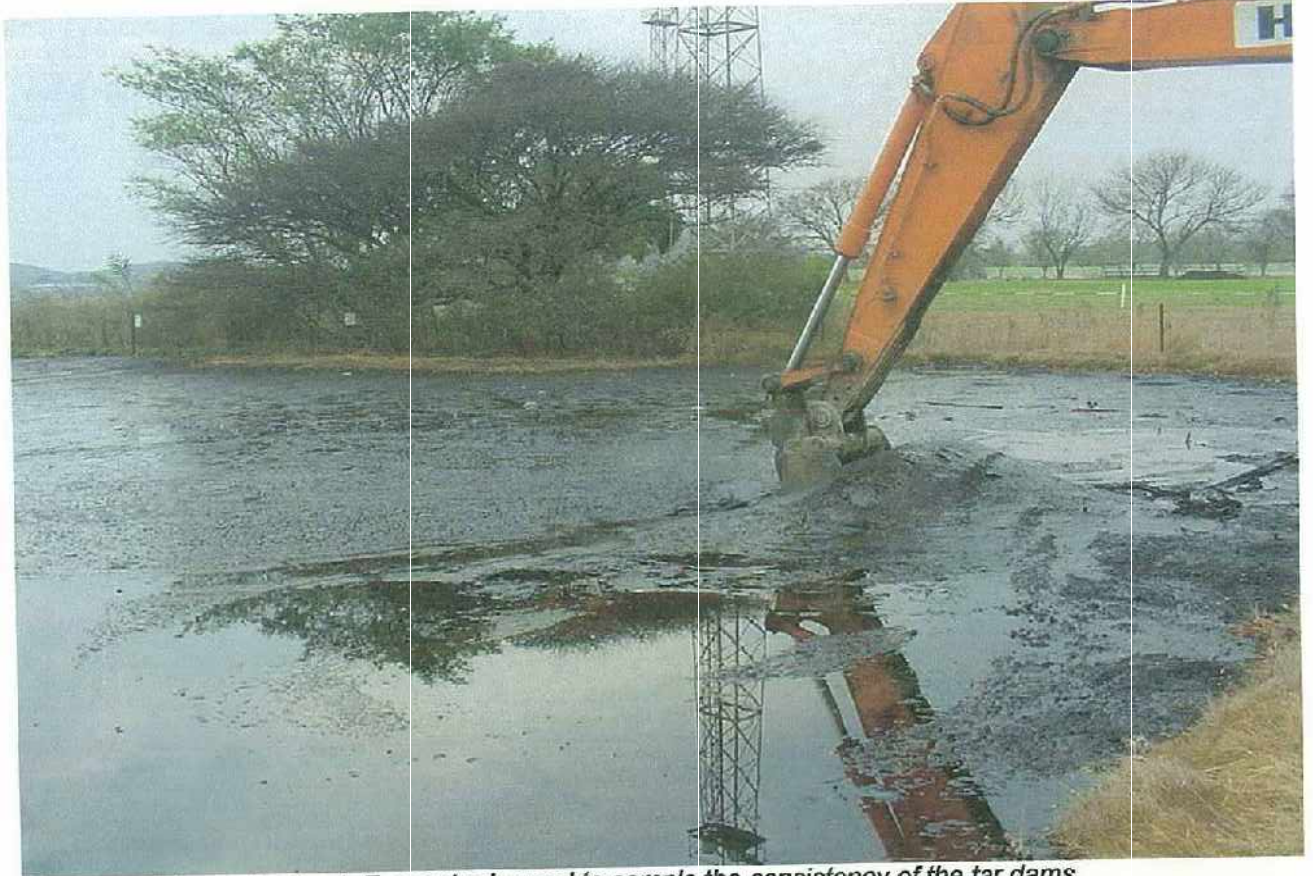
*Photographs 1 – 4: Excavator is used to sample the consistency of the tar dams*

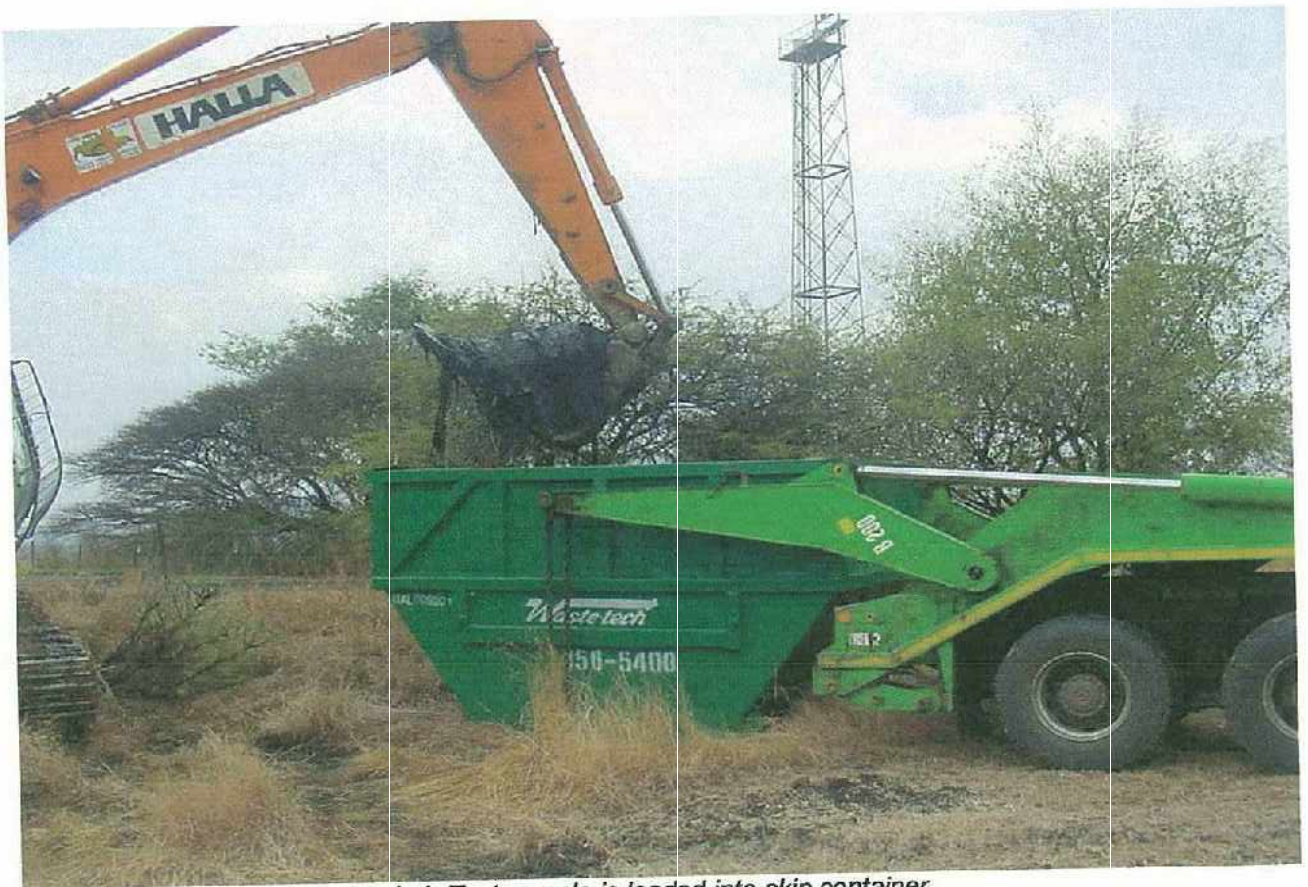
*Photograph 4: Test sample is loaded into skip container*

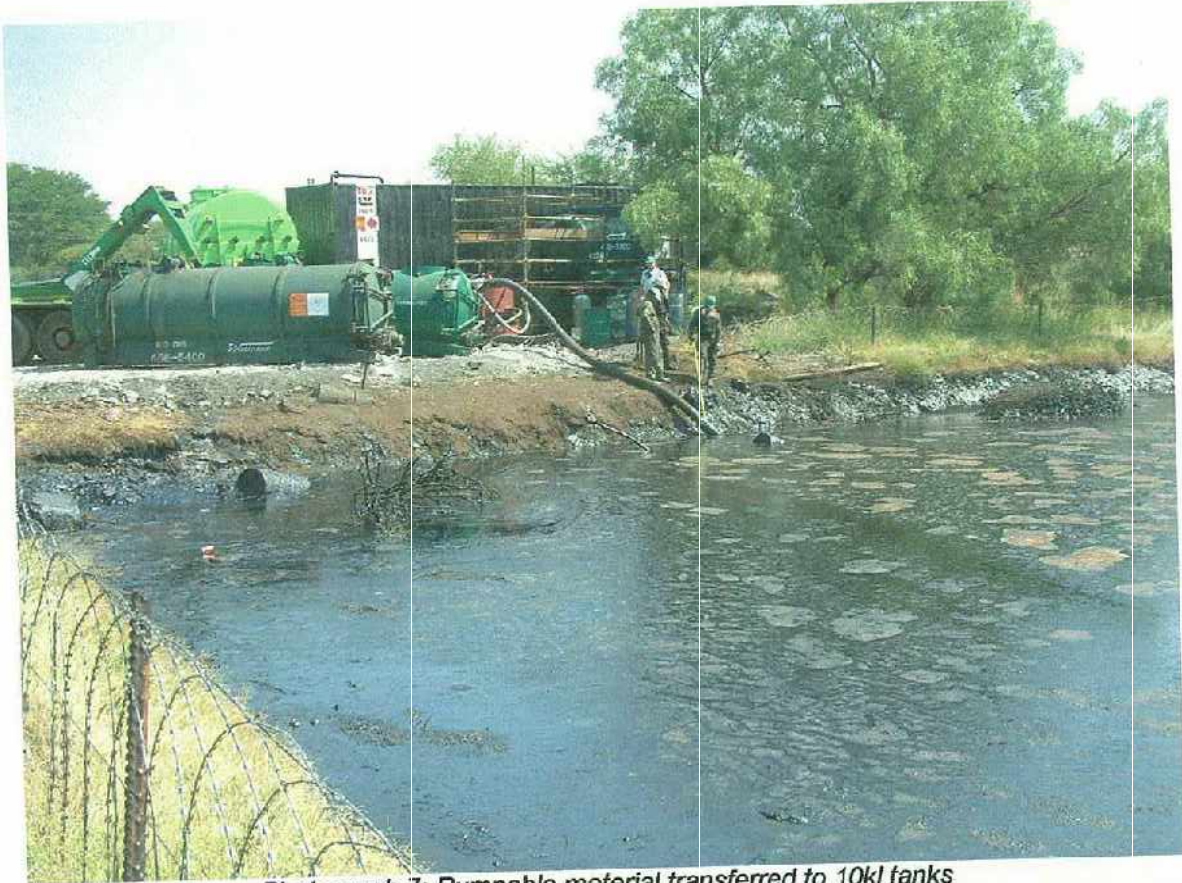
***Photograph 7: Pumpable material transferred to 10kl tanks***

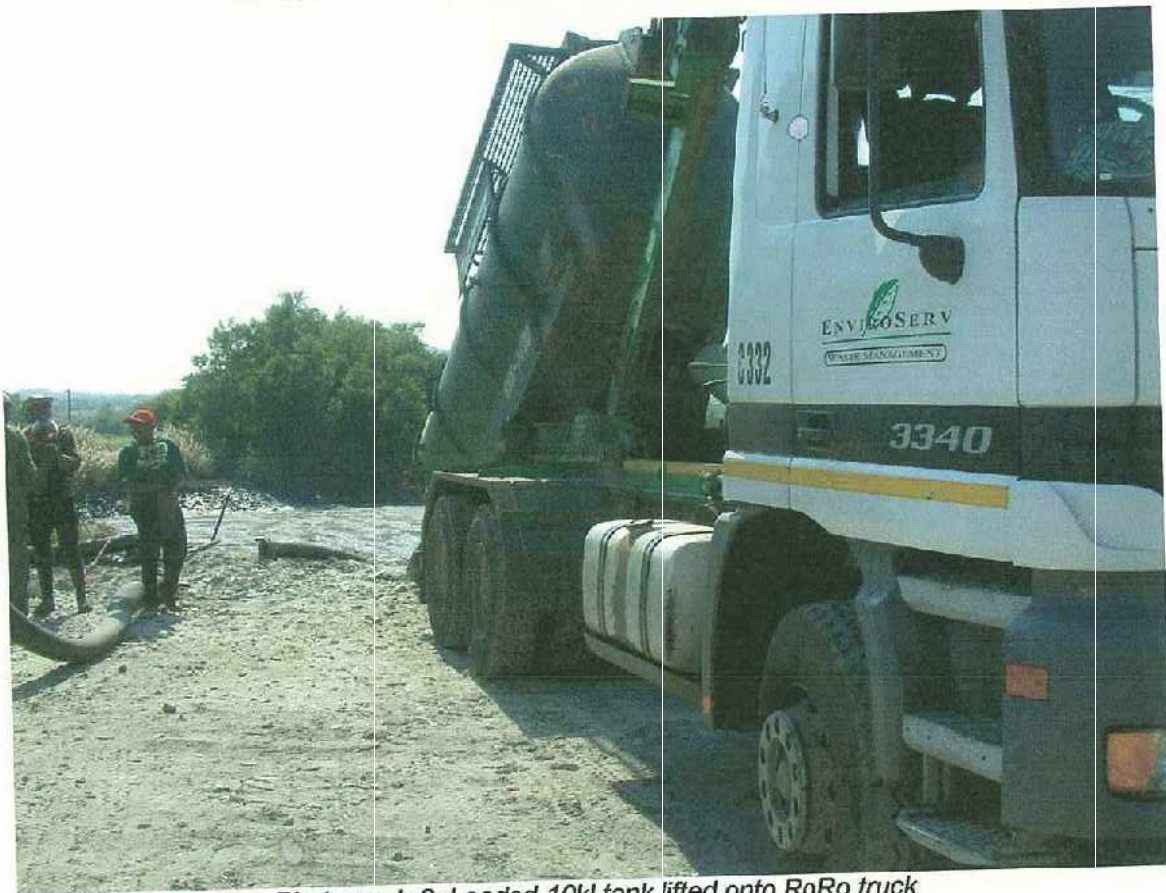
***Photograph 8: Loaded 10kl tank lifted onto RoRo truck***

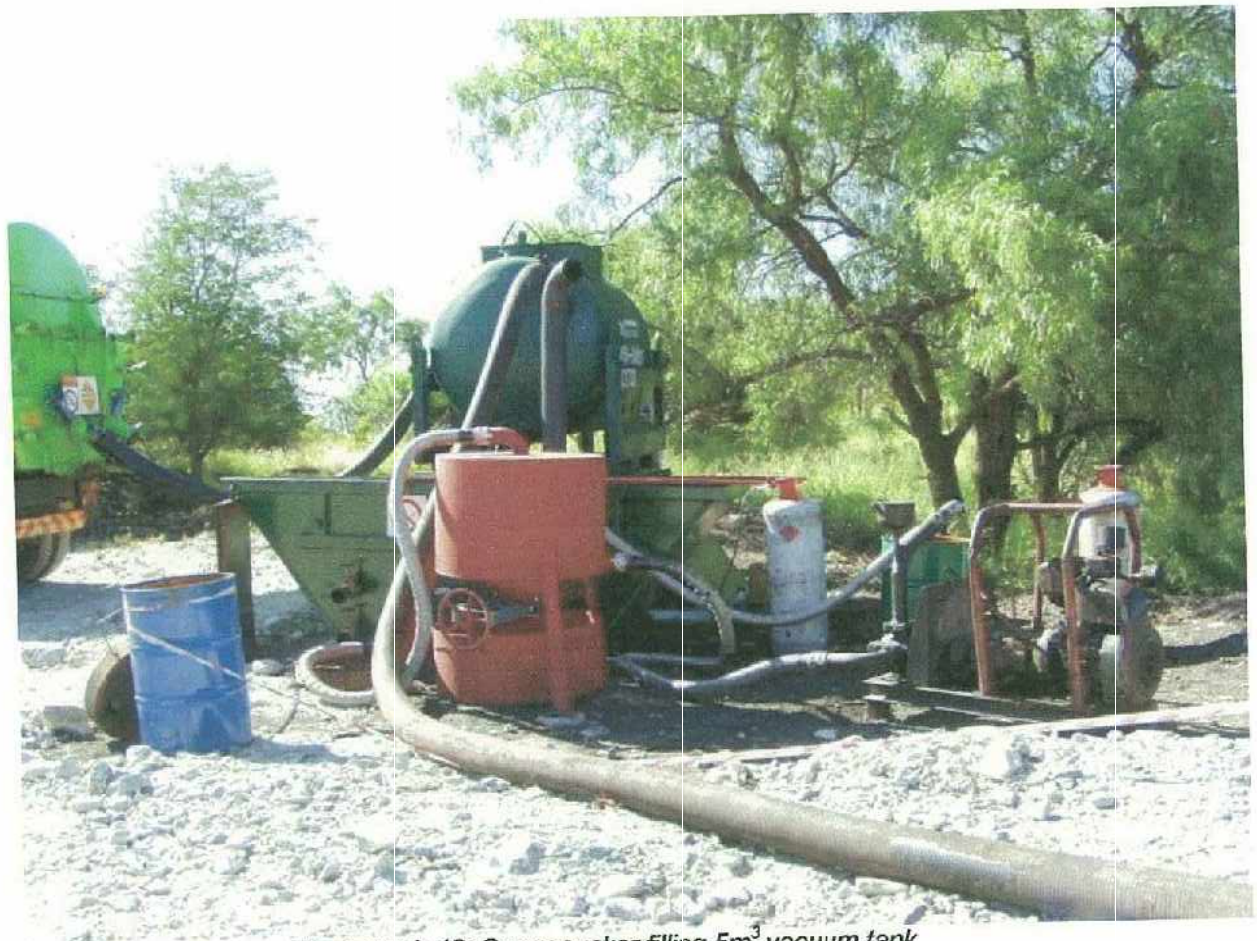
*Photograph 12: Super sucker filling 5m<sup>3</sup> vacuum tank*

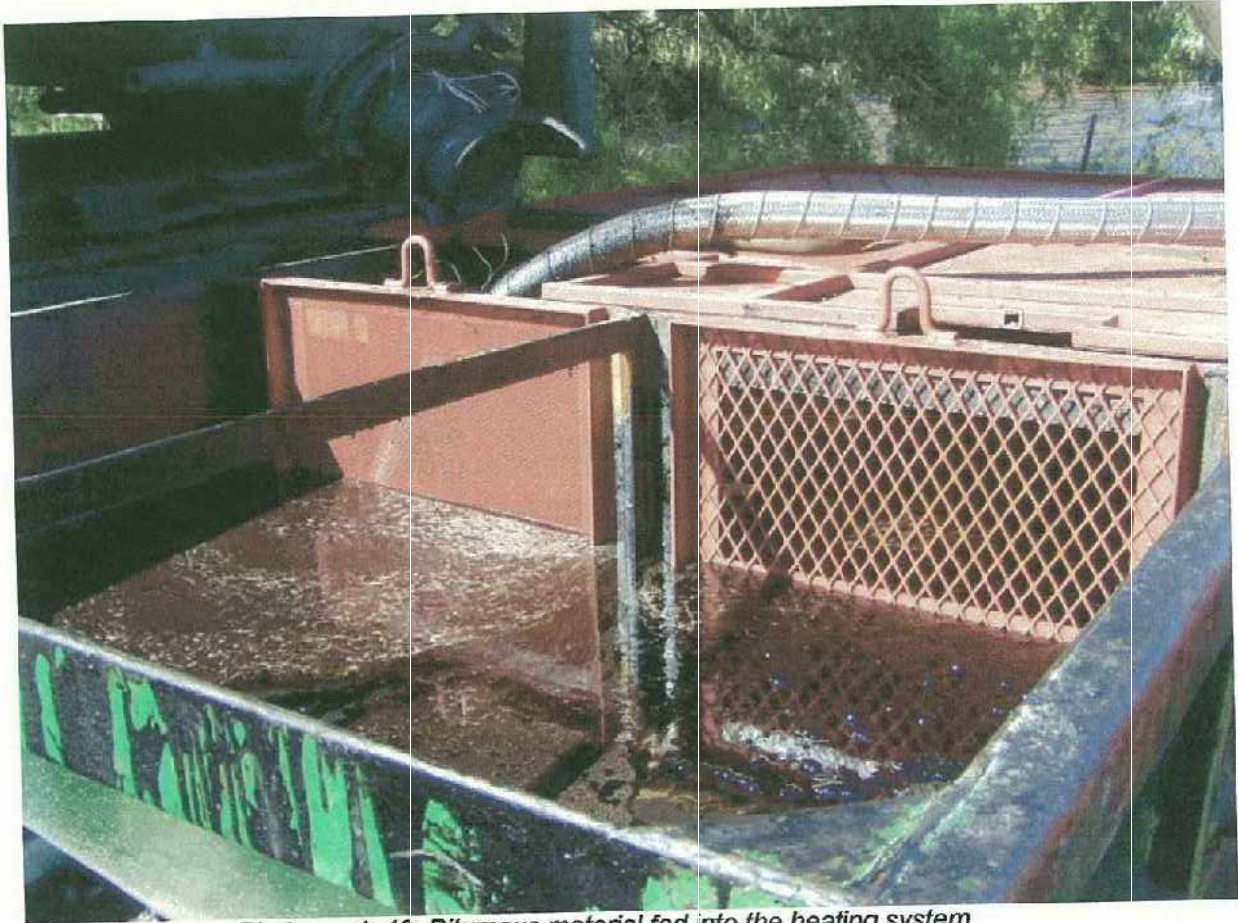
***Photograph 13: Bitumous material fed into the heating system***

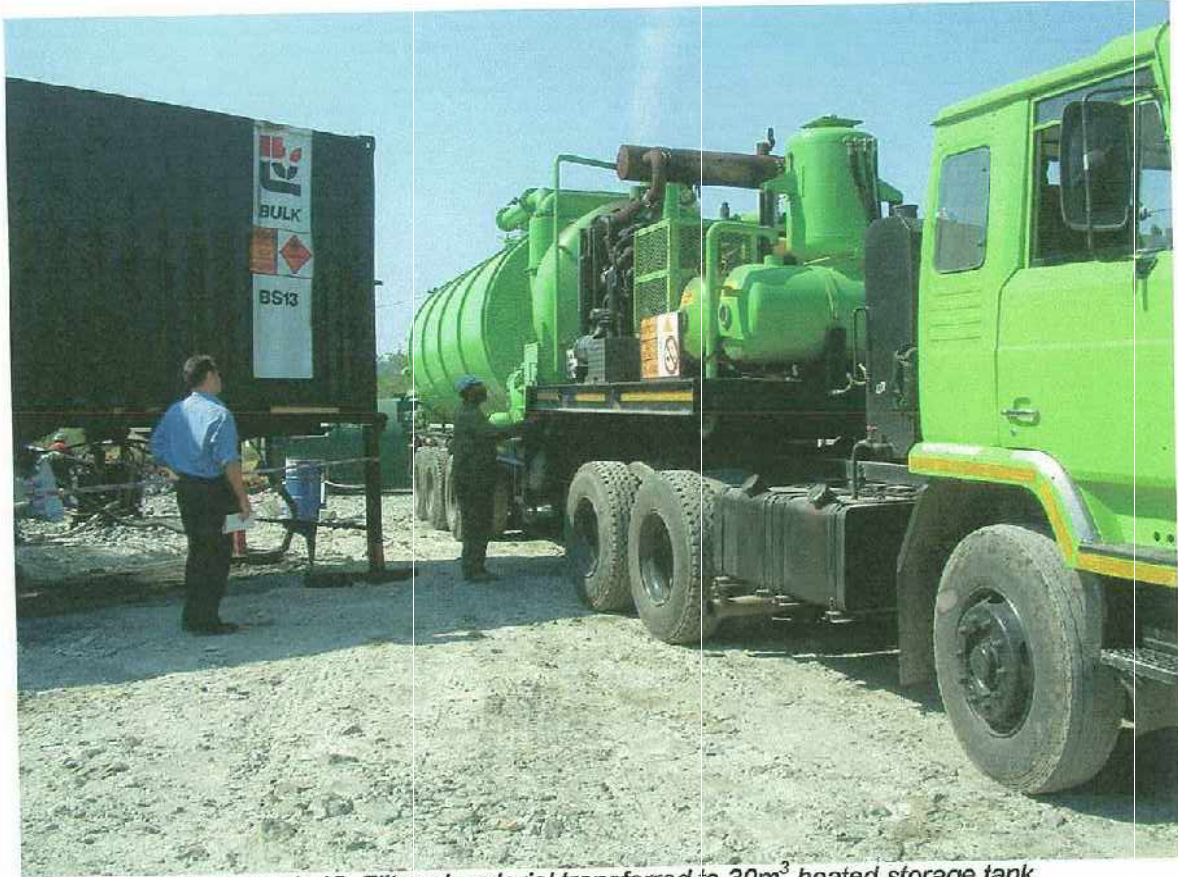
*Photograph 15: Filtered material transferred to 30m<sup>3</sup> heated storage tank*

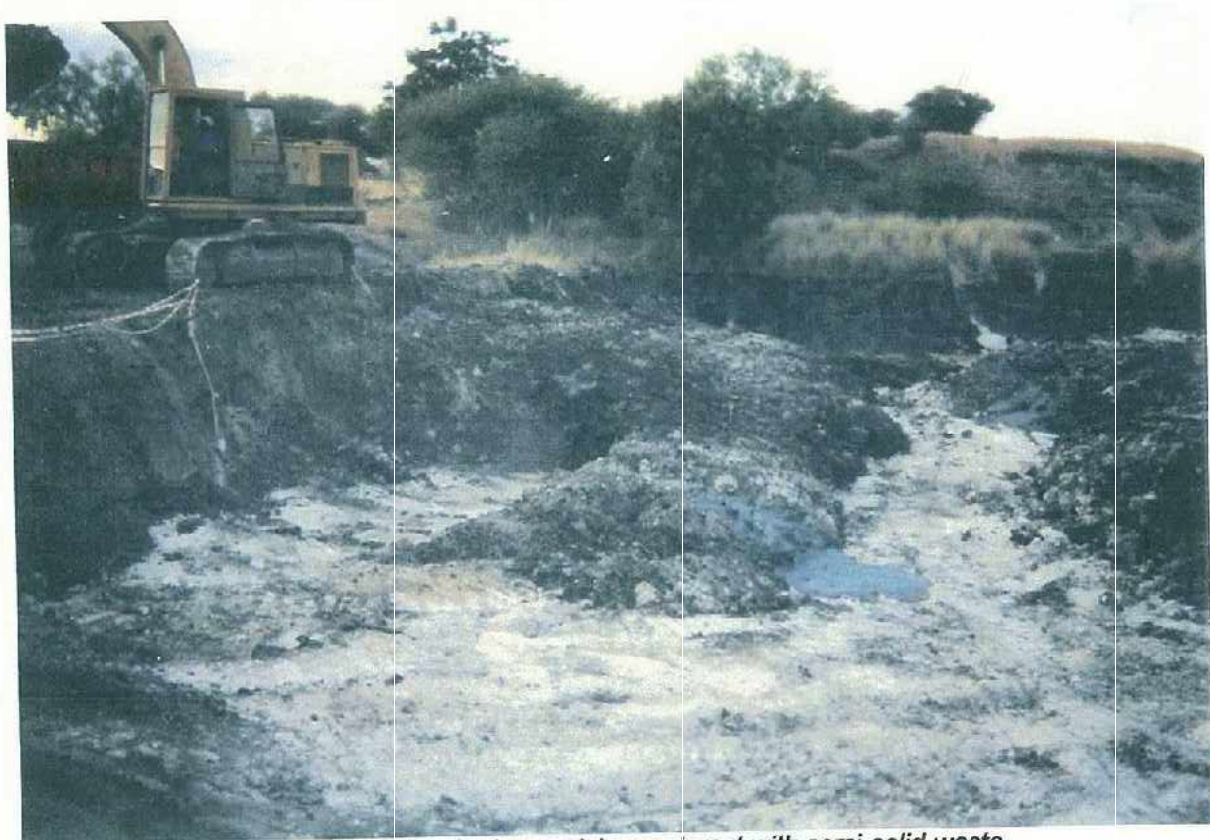
Photograph 21: Grader busy mixing undercut with semi-solid waste

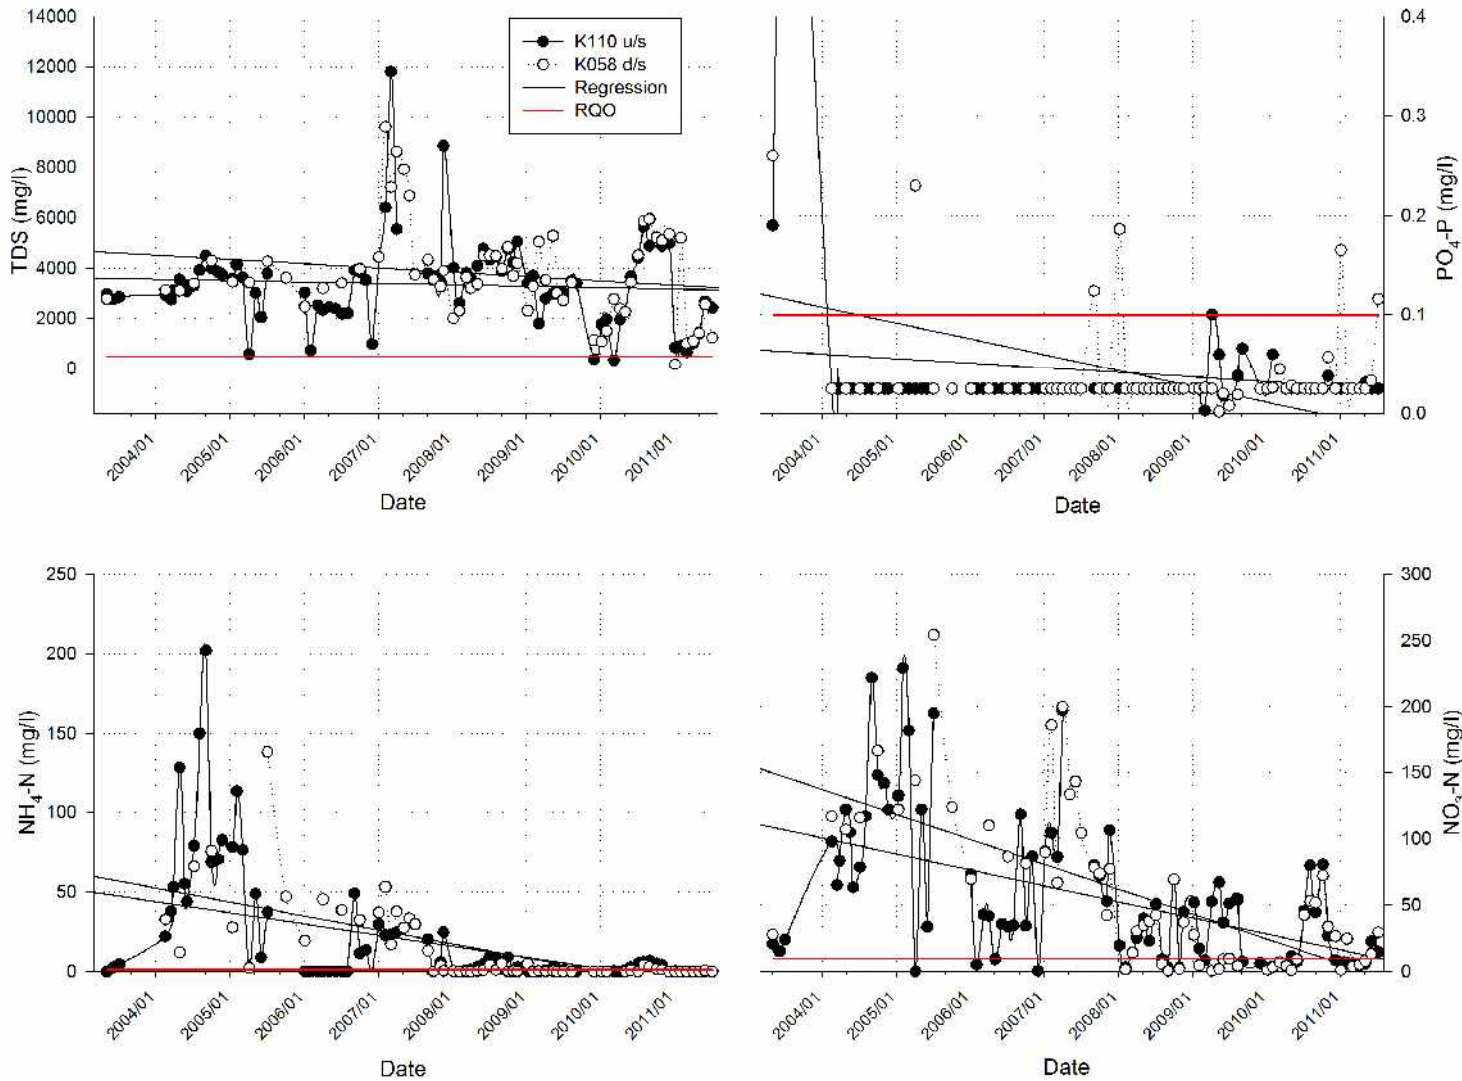
**Figure 5.6.1-1: Trend analyses for the Klipfontein Spruit localities situated upstream and downstream relative to the tar dam.**

Increasing trends are noted for downstream groundwater (NB12) relative to the tar dam indicating an impact. ***Increasing (deterioration) trends in terms of TDS, PO<sub>4</sub>-P and NH<sub>4</sub>-N are noted for NB12 with quality deteriorating from beginning of 2010 onwards (Figure 5.6.2-1).*** Of significance is that ***no similar distributions exist for the upstream tar dam borehole NB12A or additional upstream boreholes in the vicinity (Figure 5.6.2-2).*** It is uncertain whether any RPM-RS related activities coincide with the timeframe but a possible scenario could be that due to the slow movement of groundwater, soluble contaminants emanating from the tar dam moving with groundwater have reached the downstream NB12 only at this time. However, this is dependent on aquifer hydraulic characteristics such as groundwater velocity and hydraulic conductivity and should be verified by a specialist geohydrologist.

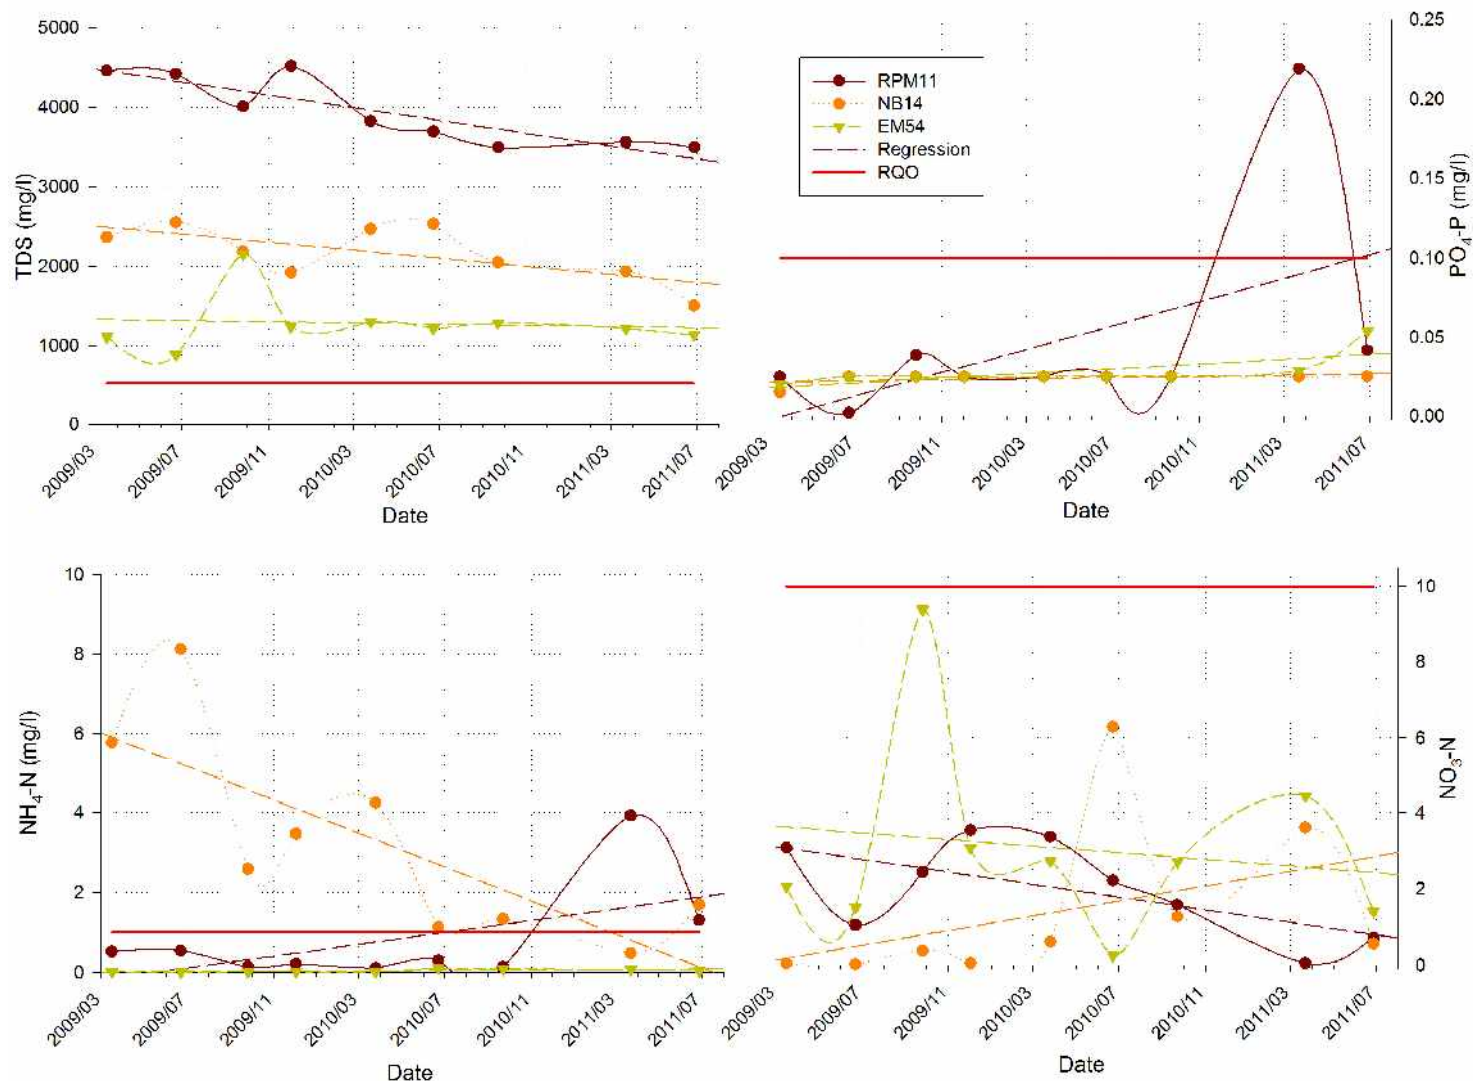
Figure 5.6.2-2: Trend analyses for upstream boreholes relative to the tar dam.

Although the RQO for TDS is significantly exceeded at the additional upstream boreholes, trend analyses indicate improving conditions. All these additional localities remain well within RQO in terms  $\text{PO}_4\text{-P}$  and  $\text{NO}_3\text{-N}$ . Only NB14 show historic high  $\text{NH}_4\text{-N}$  but trend analysis indicate improving conditions.

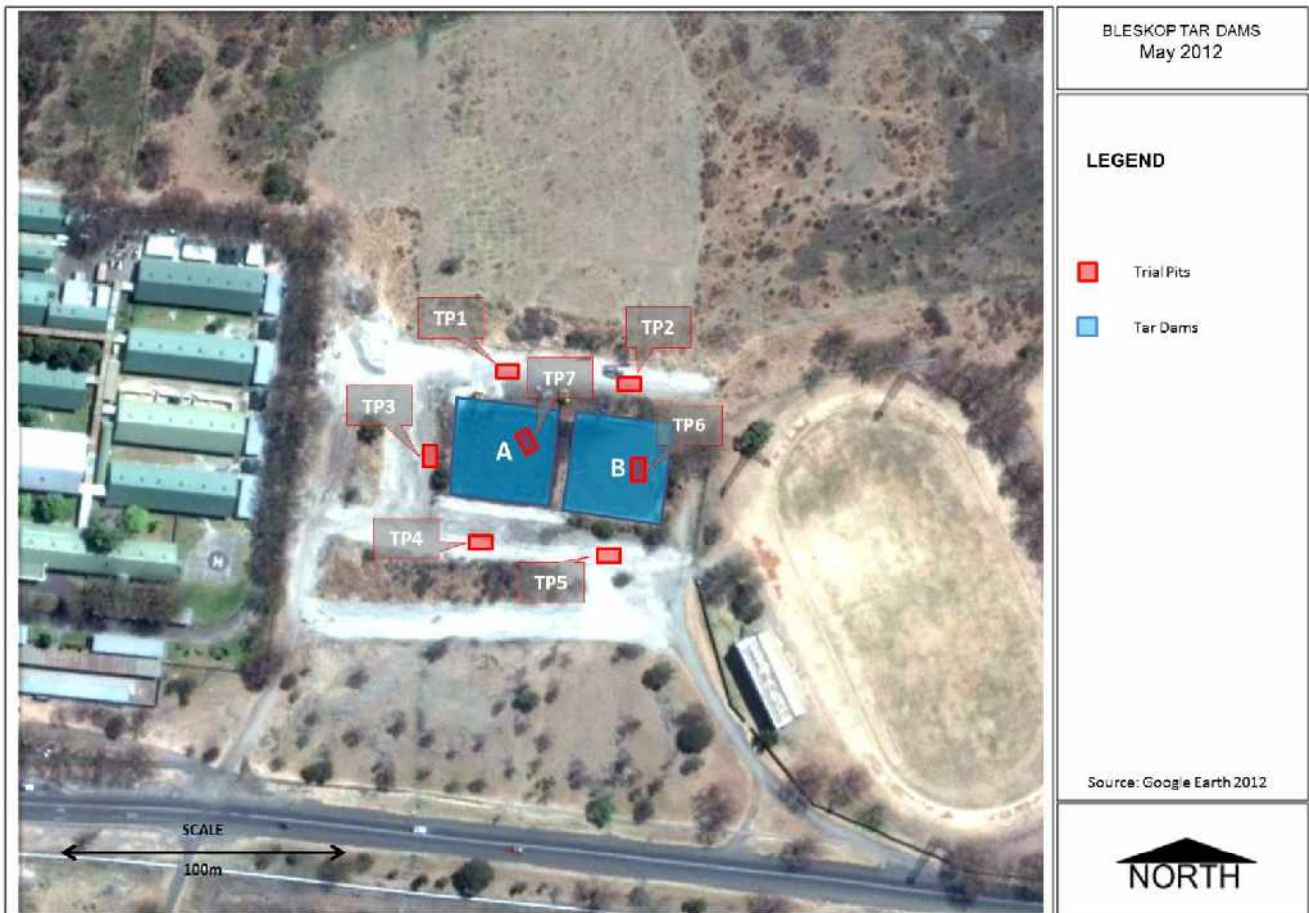
**Figure 5: Bleskop Trial Pit Locations**

Seven trial pits were excavated around the Bleskop Tar Dams. Two trial pits to the north and south; one to the west and one each within Tar Dam A and Tar Dam B. A trial pit could not be located to the east of the tar dams due to the proximity of the Bleskop Stadium and storm water service line located on the eastern boundary of the site.

Soils sampling was undertaken using a tractor loaded backhoe (TLB) on the 27<sup>th</sup> March 2012. Trial pits were excavated at various points adjacent to and inside the tar dams. The Bleskop trial pit locations are indicated in **Figure 5** and TESMO trial pit locations in **Figure 6**.

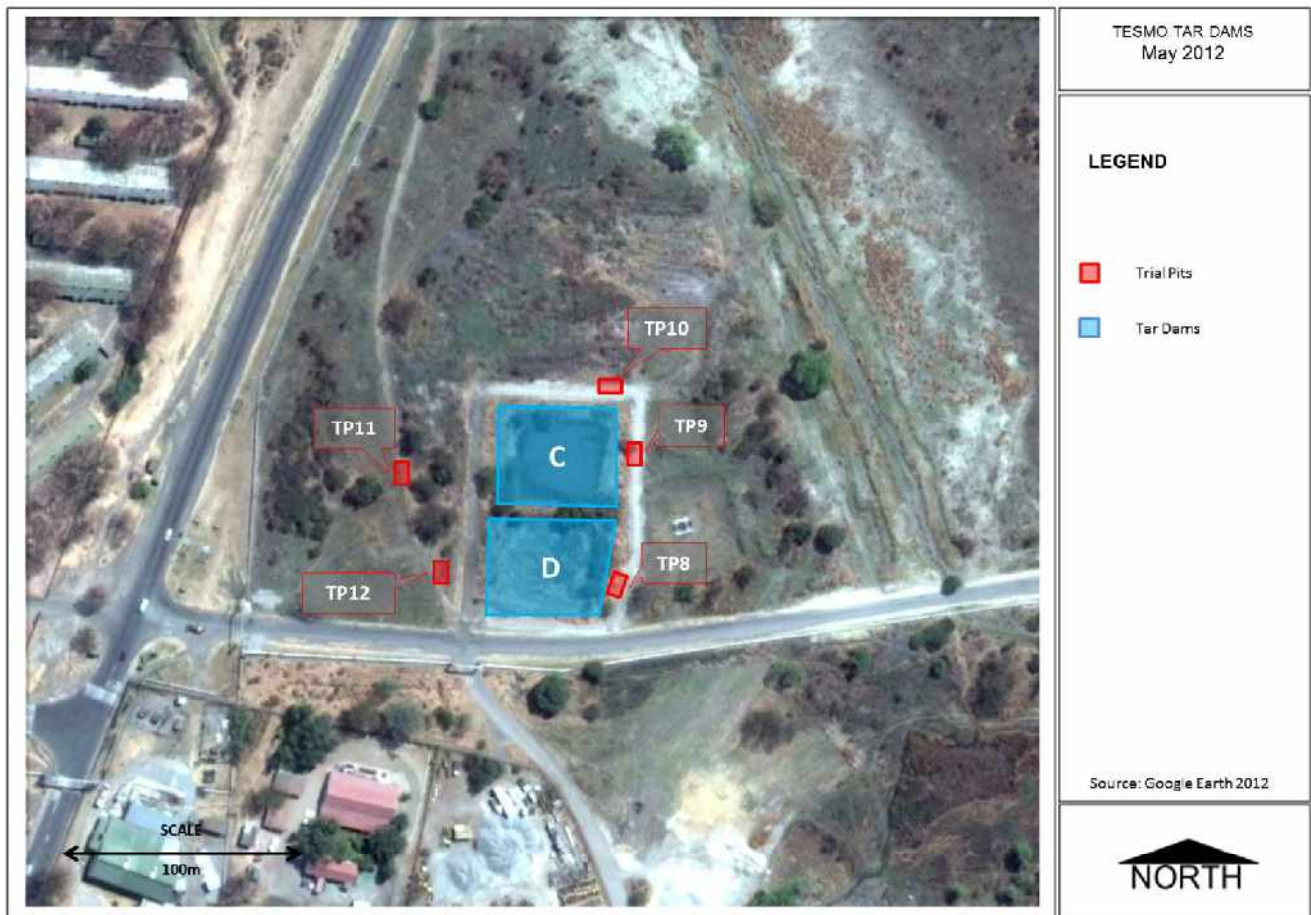
**Figure 6: TESMO Trial Pit Locations**

Five trial pits were excavated around the TESMO Tar Dams. Two trial pits to the east and west; with one to the north. A trial pit could not be located to the south due to the proximity of the road and underground services running parallel with the road; nor could trial pits be located within Tar Dam C and Tar Dam D due to the steep sides of the excavated tar pits and as no access ramp was present.

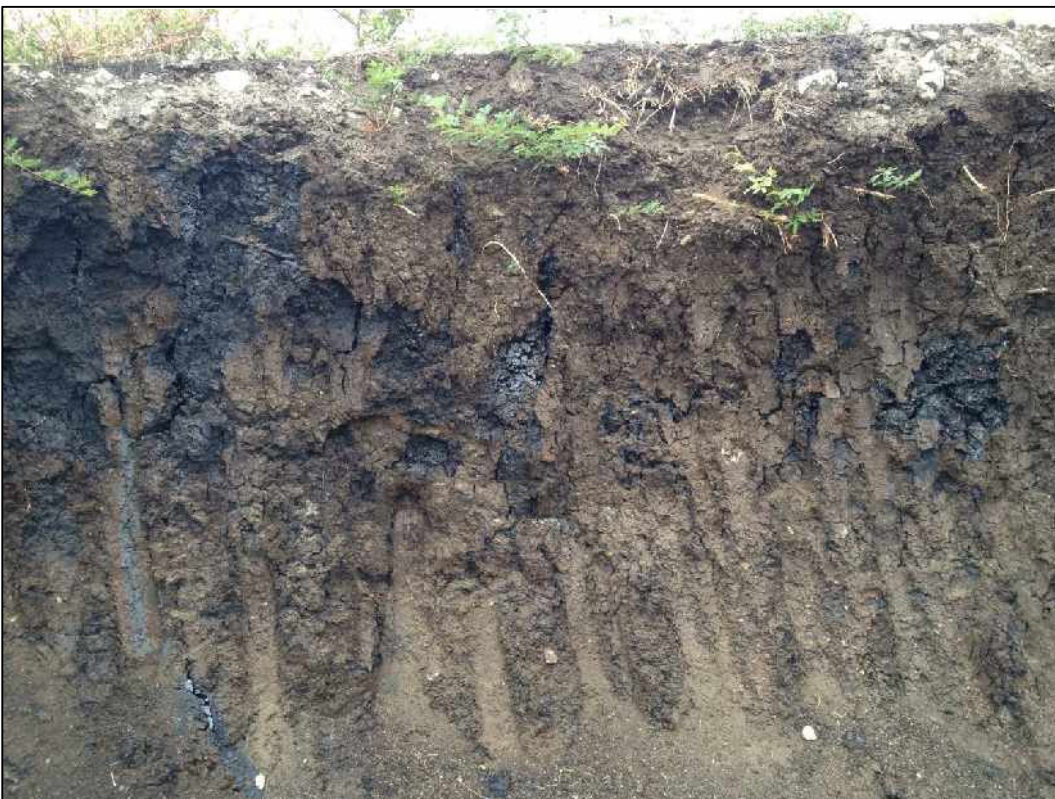
**Plate 9. View of tar residue seeping out of pit wall on Tar Dam B (South)**

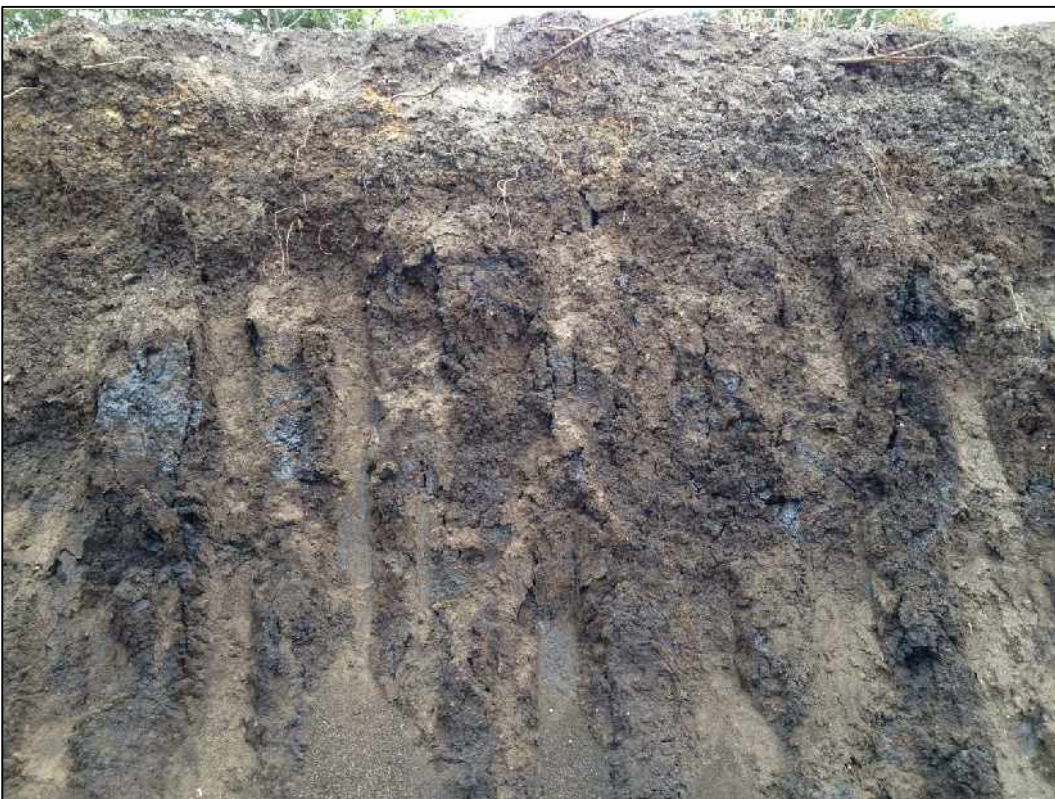
Plate 11. View of tar residue seeping out of pit wall on Tar Dam A (West)

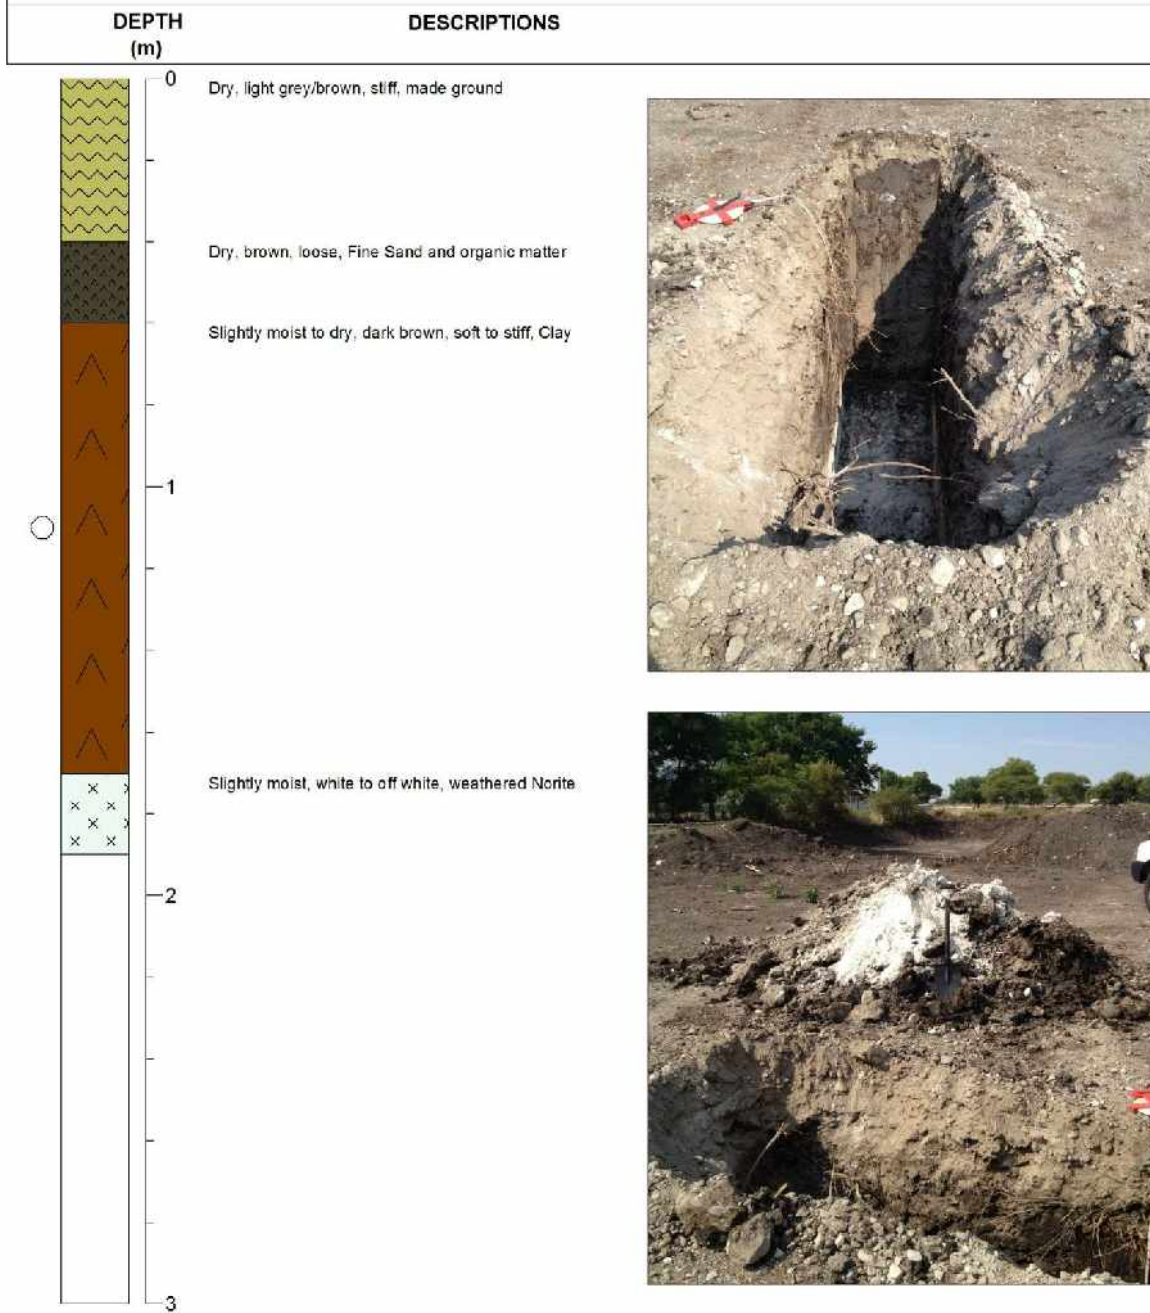
DATE: 27 March 2012  
 HOLE NO: TP2  
 HOLE COORDINATES (Lat., Long): (-25.697200°, 27.358945°)  
 Coordinates based on visual positioning only
