Appendix C – Photographs

Vulani Coronation Mining Prospecting Works Program for Difusi Land Trust

Vulani Coronation Mining Prospecting Works Program – Paterson Silica Sand

A PHASE 1 ARCHAEOLOGICAL IMPACT ASSESSMENT (AIA) FOR THE PROPOSED SAND MINING ON THE ELVA HEIGHTS FARM 102 AND ON THE DIFUSI LAND TRUST PROPERTY INCORPORATING THE FARMS DE BRUYNS KRAAL, DOORN KLOOF AND LANG VLEY, PATERSON, SUNDAY'S RIVER VALLEY MUNICIPALITY, CACADU DISTRICT MUNICIPALITY, EASTERN CAPE PROVINCE

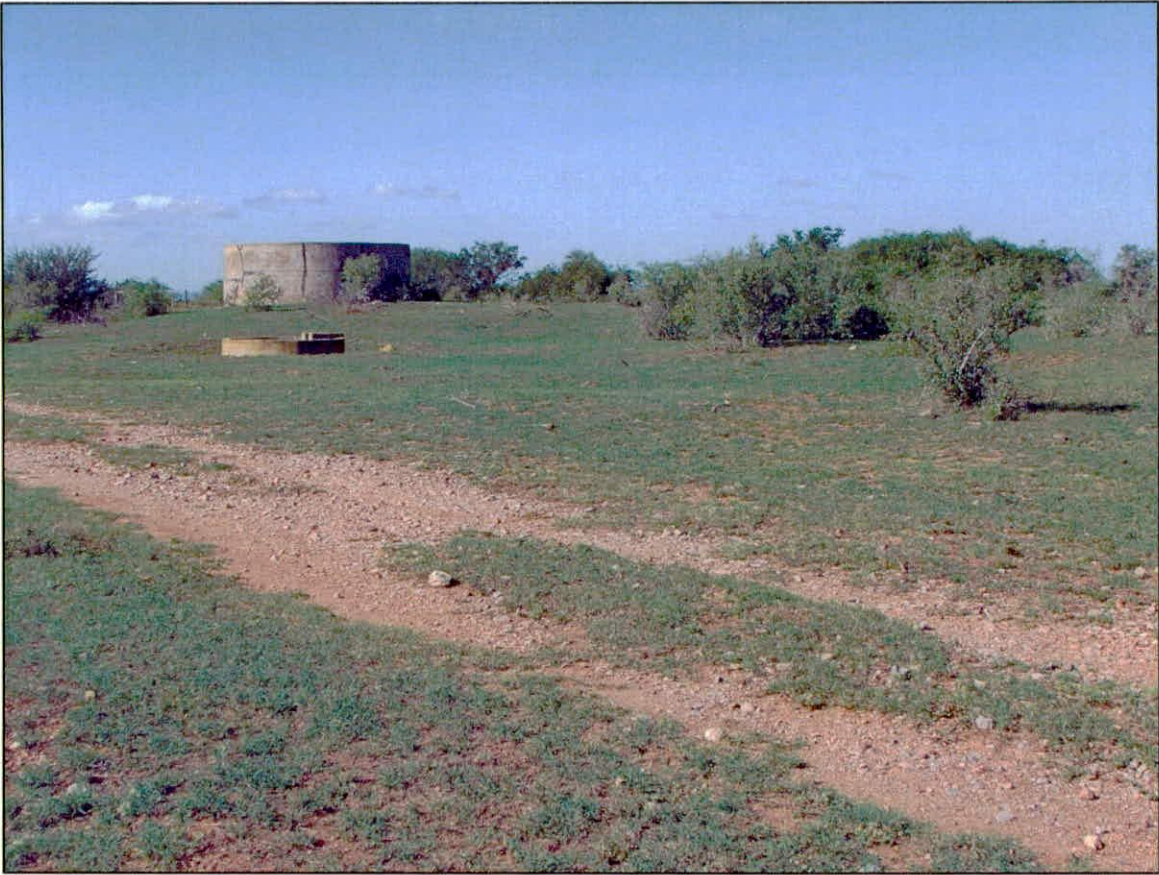
Figure C-5: Reservoir on the south-western part of the proposed site

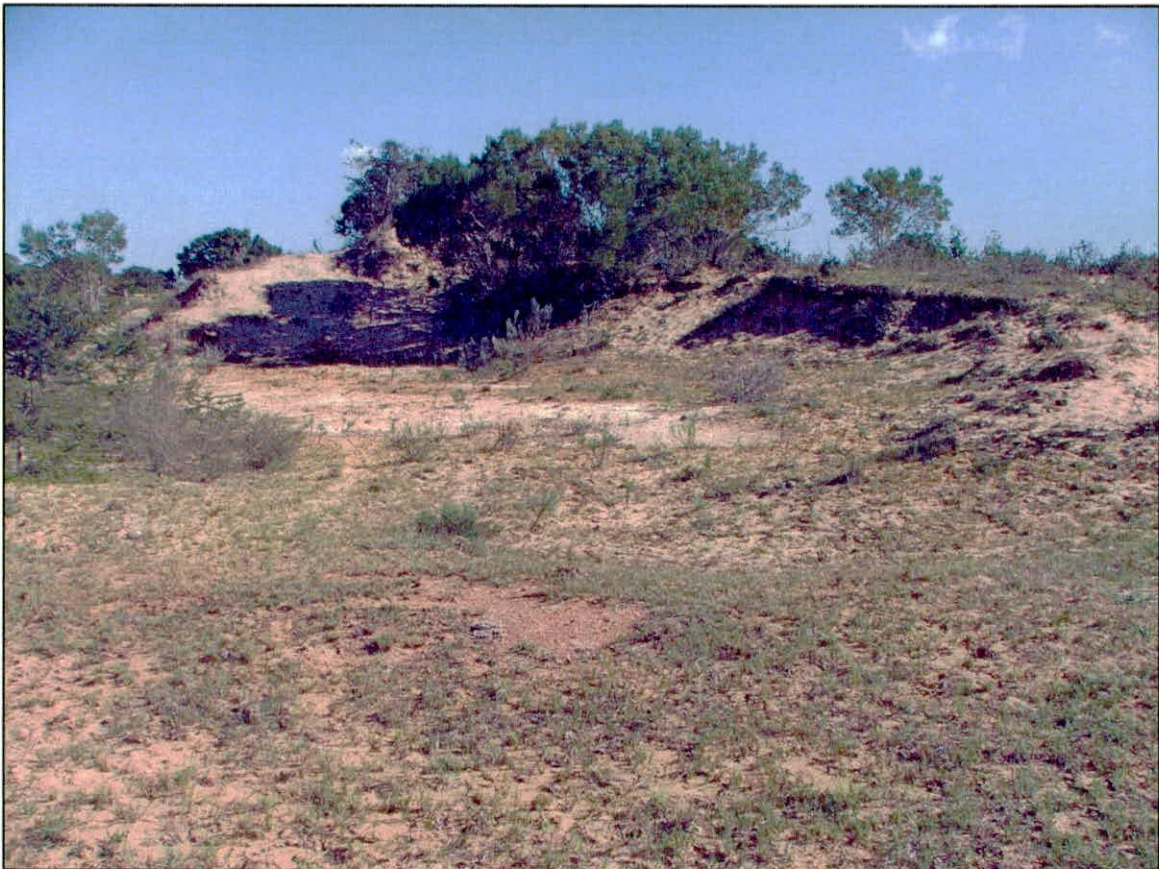
Figure C-6: Previously mined sand dune

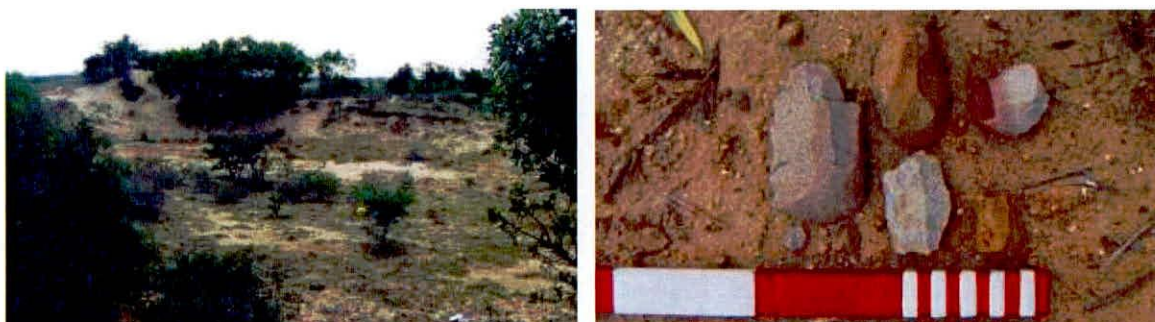
Figs 15-16. Disturbed area where MSA stone artefact scatter (right) was documented.

The smaller sandy area situated in the south-west corner of the property comprises of vegetated and semi-vegetated Holocene river sand dunes. Previous disturbance has been caused by the boundary fence that runs between these sand dunes (Figs 13-14). One Middle Stone Age (MSA) stone artefact surface scatter is situated at the area marked GPS14 (33°25'42.90"S; 25°58'28.02"E). The stone artefact scatter was observed on an open calcrete patch that underlies the overlying Holocene river sand dunes that may have been disturbed during previous prospecting activities. They were identified by the characteristic faceted platform 'prepared core technique' and include flakes and blades made on fine-grained quartzite and silcrete (Figs 15-16).

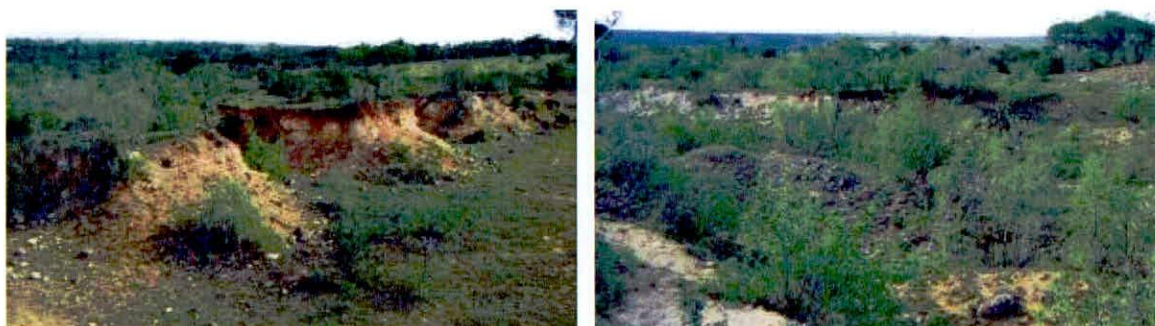
Figs 17-18. Disturbed calcrete digging area.

Calcrete mining has previously occurred within the area marked GPS4 (33°25'47.52"S; 25°58'49.02"E). No archaeological remains were identified within this area (Figs 17-18).

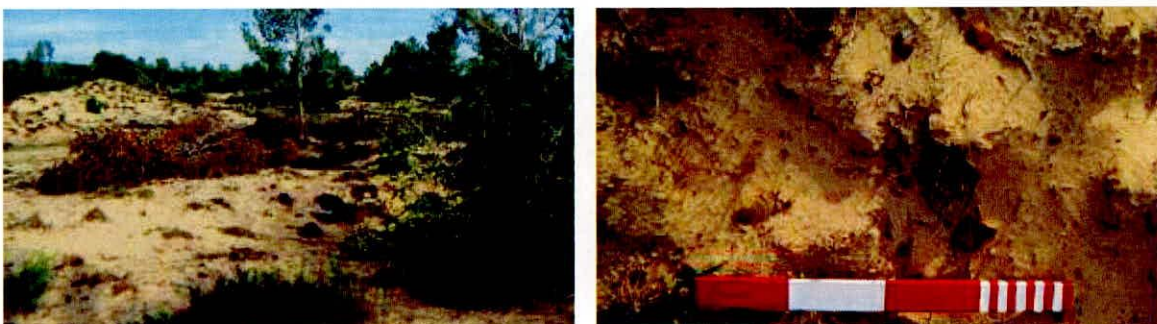
Figs 21-22. The area where the LSA stone artefact scatter (right) was documented.

The larger sandy area situated within the south-east corner of the property similarly comprises of vegetated and semi-vegetated Holocene river sand dunes (Figs 19-20). One Later Stone Age (LSA) stone artefact scatter was observed within a deflation bay at the area marked GPS17 ($33^{\circ}25'42.72''S$; $25^{\circ}59'10.63''E$). The stone artefact scatter included flakes and one scraper made on fine-grained quartzite, quartz chalcedony and silcrete (Figs 21-22). The sandy areas situated at the areas marked GPS25 ($33^{\circ}25'26.20''S$; $25^{\circ}59'24.13''E$) and GPS26 ($33^{\circ}25'16.07''S$; $25^{\circ}59'24.22''E$) were also investigated for archaeological materials and remains, however, no stone tool artefacts or other archaeological materials and remains were observed within the areas.

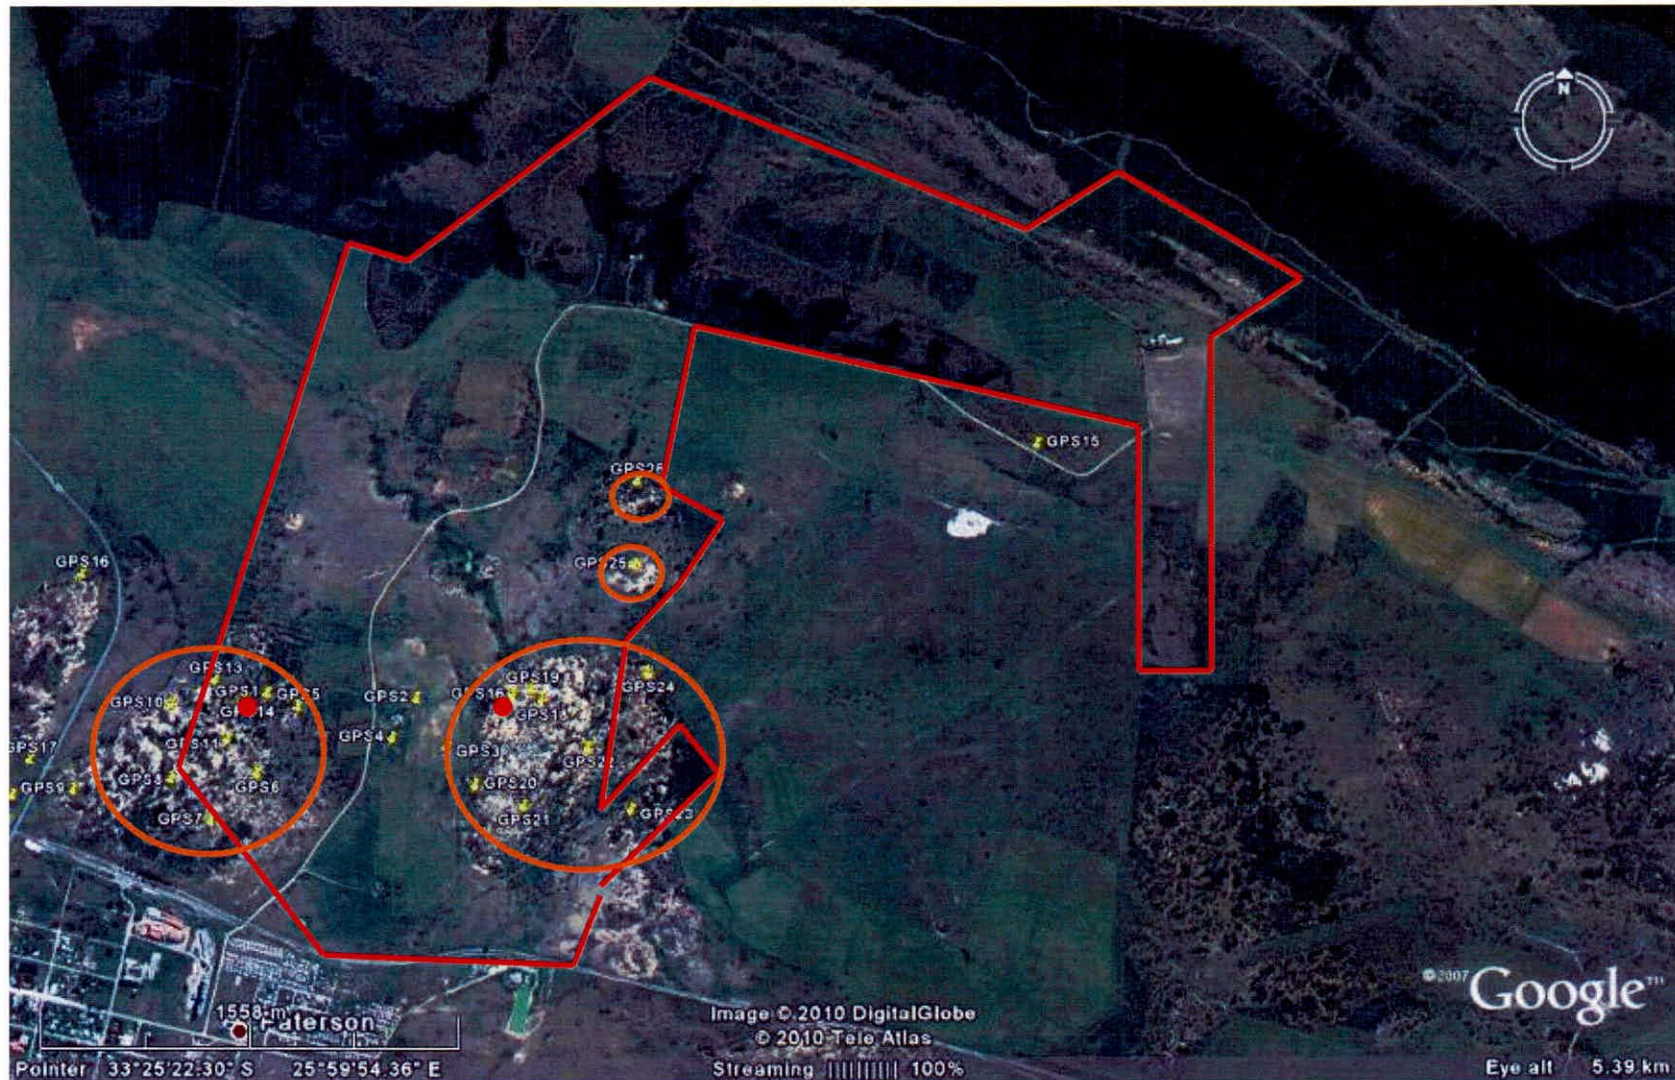
Map 4. GPS plots and an aerial view of the Difusi Land Trust Property proposed for the mining of sand (the orange circles highlight the prominent sandy areas; the red dots show the positions of the stone artefact scatters).

DIFUSI LAND TRUST PROPERTY (Map 4):
