**CONSULTATION IN TERMS OF SECTION 40 OF THE MPRDA OF 2002:
ENVIRONMENTAL MANAGEMENT PLAN, NONYEZA-KANASE BORROWPIT NKANYA
ADMINISTRATIVE AREA, ELLIOTDALE, EASTERN CAPE**

NONYEZA-KANASE BORROWPIT ENVIRONMENTAL MANAGEMENT PLAN

NONYEZA-KANASE ACCESS ROAD

ENVIRONMENTAL MANAGEMENT PLAN (EMP): BORROWPIT

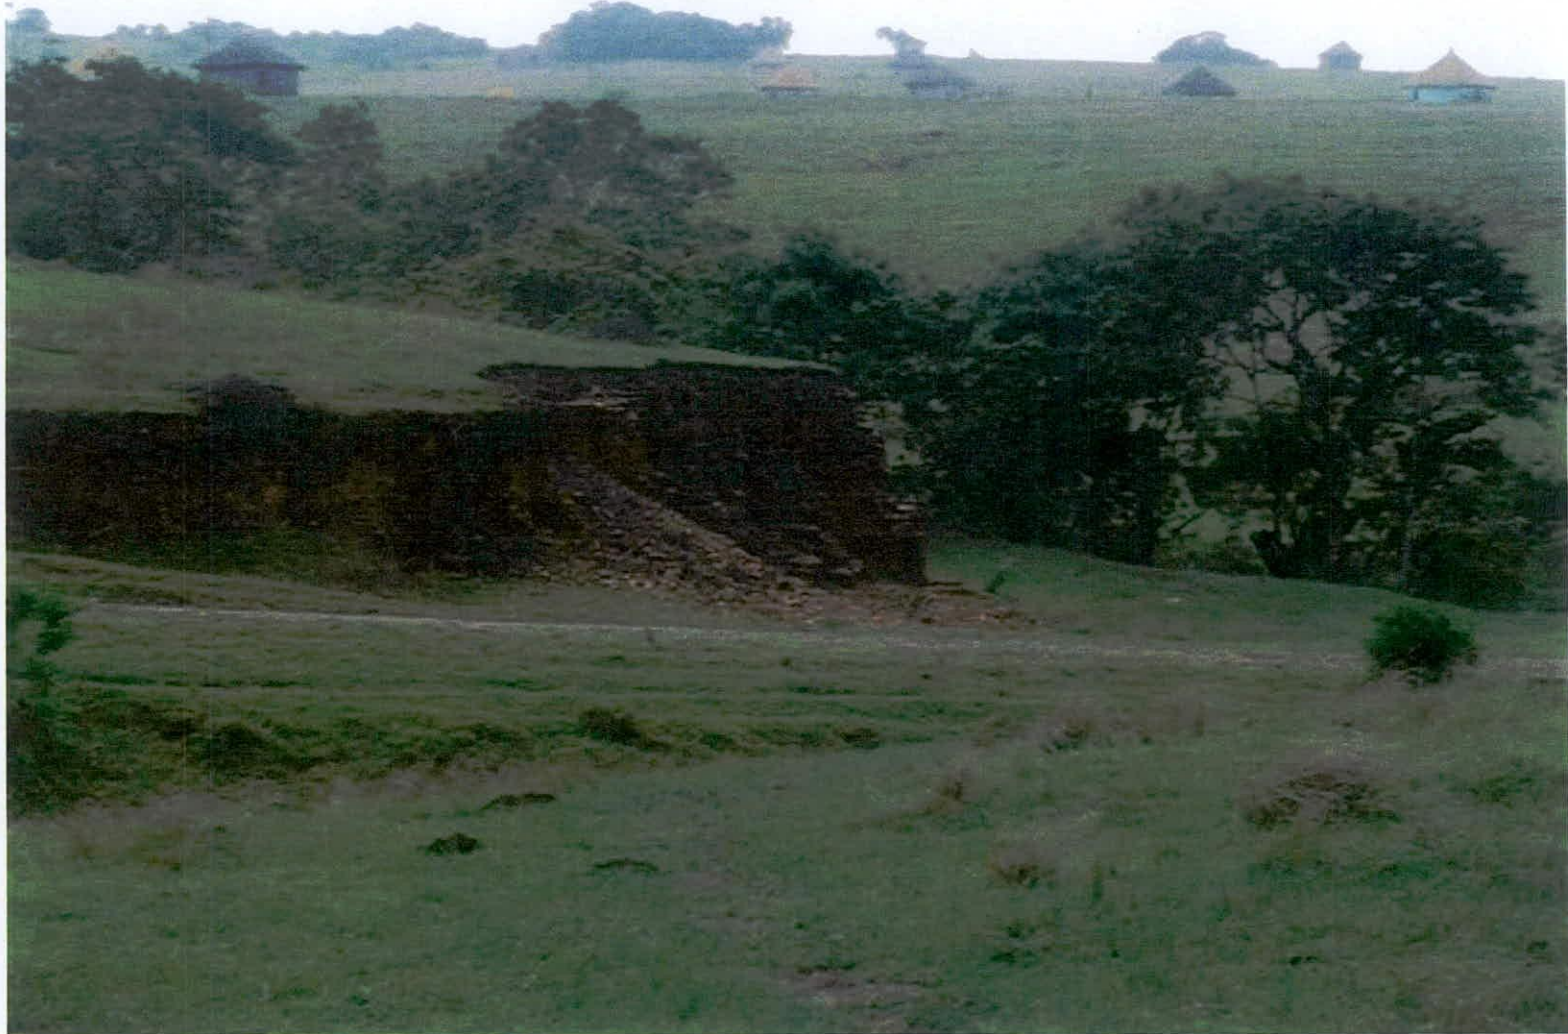
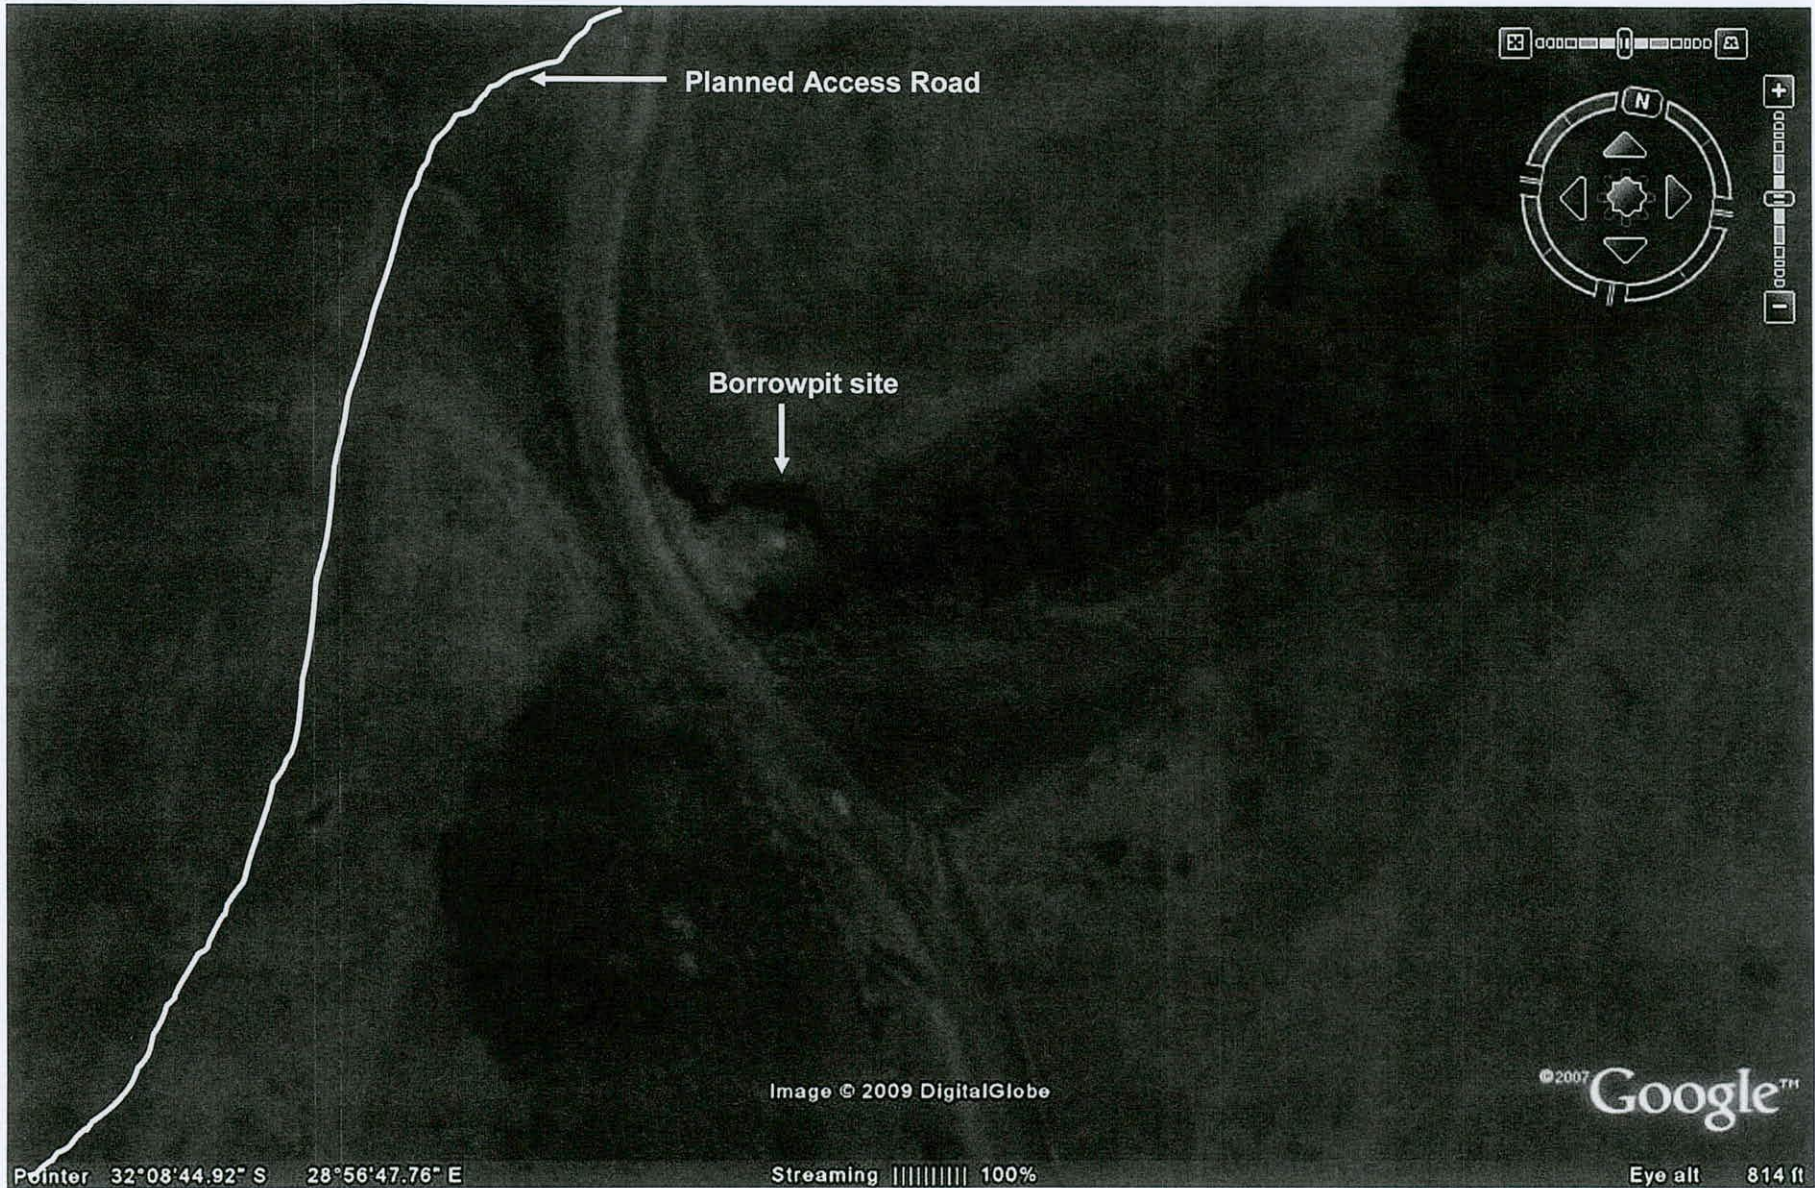
Site photographs

Planned Access Road

Borrowpit site

A geotechnologist was appointed to identify and test the borrowpit situated near the start of the road to be constructed for gravel wearing course material (see locality plan in **Appendix A**). The borrowpit site is currently open and looks like it was not properly rehabilitated after it was used. The site is located near agricultural land (North of borrowpit site), which at the time of the site visit was not cultivated. A mixture of indigenous and alien tree species could be identified along a non-perennial stream (which was dry during the time of the site visit) on the Eastern side of the borrowpit site (see site photographs in **Appendix C**).

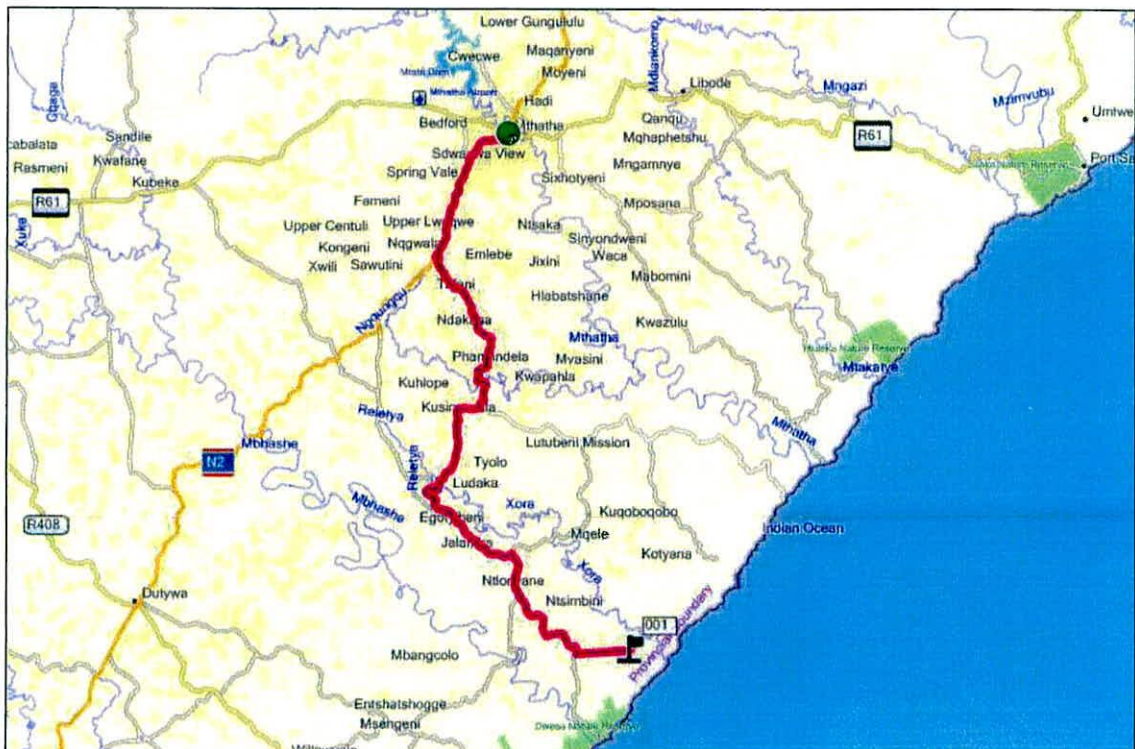
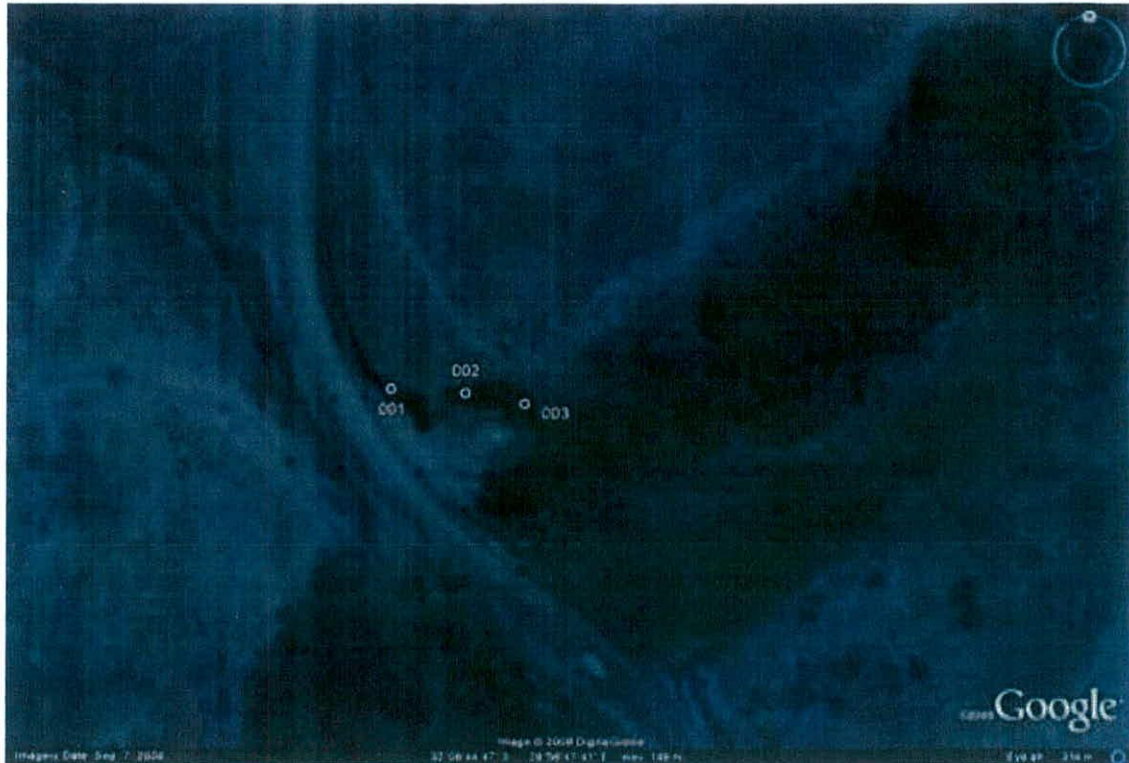
ControlLab was requested to do a road indicator tests on samples collected from this project. One (1) existing borrow pit in the area as well as samples from the existing gravel road were investigated to determine the quality (TRH14 and TRH20 classification) of the material. Samples were taken from the face of the borrow pit at three positions and the GPS coordinates of the positions were:

- A - S 32°08.739 E 28°56.796
- B - S 32°08.741 E 28°56.800
- C - S 32°08.742 E 28°56.802

Three (3) disturbed soil samples were taken for Road Indicators, California Bearing Ratio (CBR) and Atterberg Limits tests. All the test results are attached to this document.
