**CONSULTATION IN TERMS OF SECTION 40 OF THE MPRDA OF 2002:
ENVIRONMENTAL MANAGEMENT PLAN (EMP); EXPANSION OF TSOJANA
QUARRY, DIVISION OF COFIMVABA**

PROJECT NUMBER WP9024: FULL DESIGN SERVICES AND CONSTRUCTION SUPERVISION FOR THE REHABILITATION OF DAMS TO COMPLY WITH DAM SAFETY STANDARDS

TSOJANA DAM: FINAL ENVIRONMENTAL MANAGEMENT PROGRAMME FOR THE EXPANSION OF TSOJANA QUARRY: TWO SIGNED COPIES

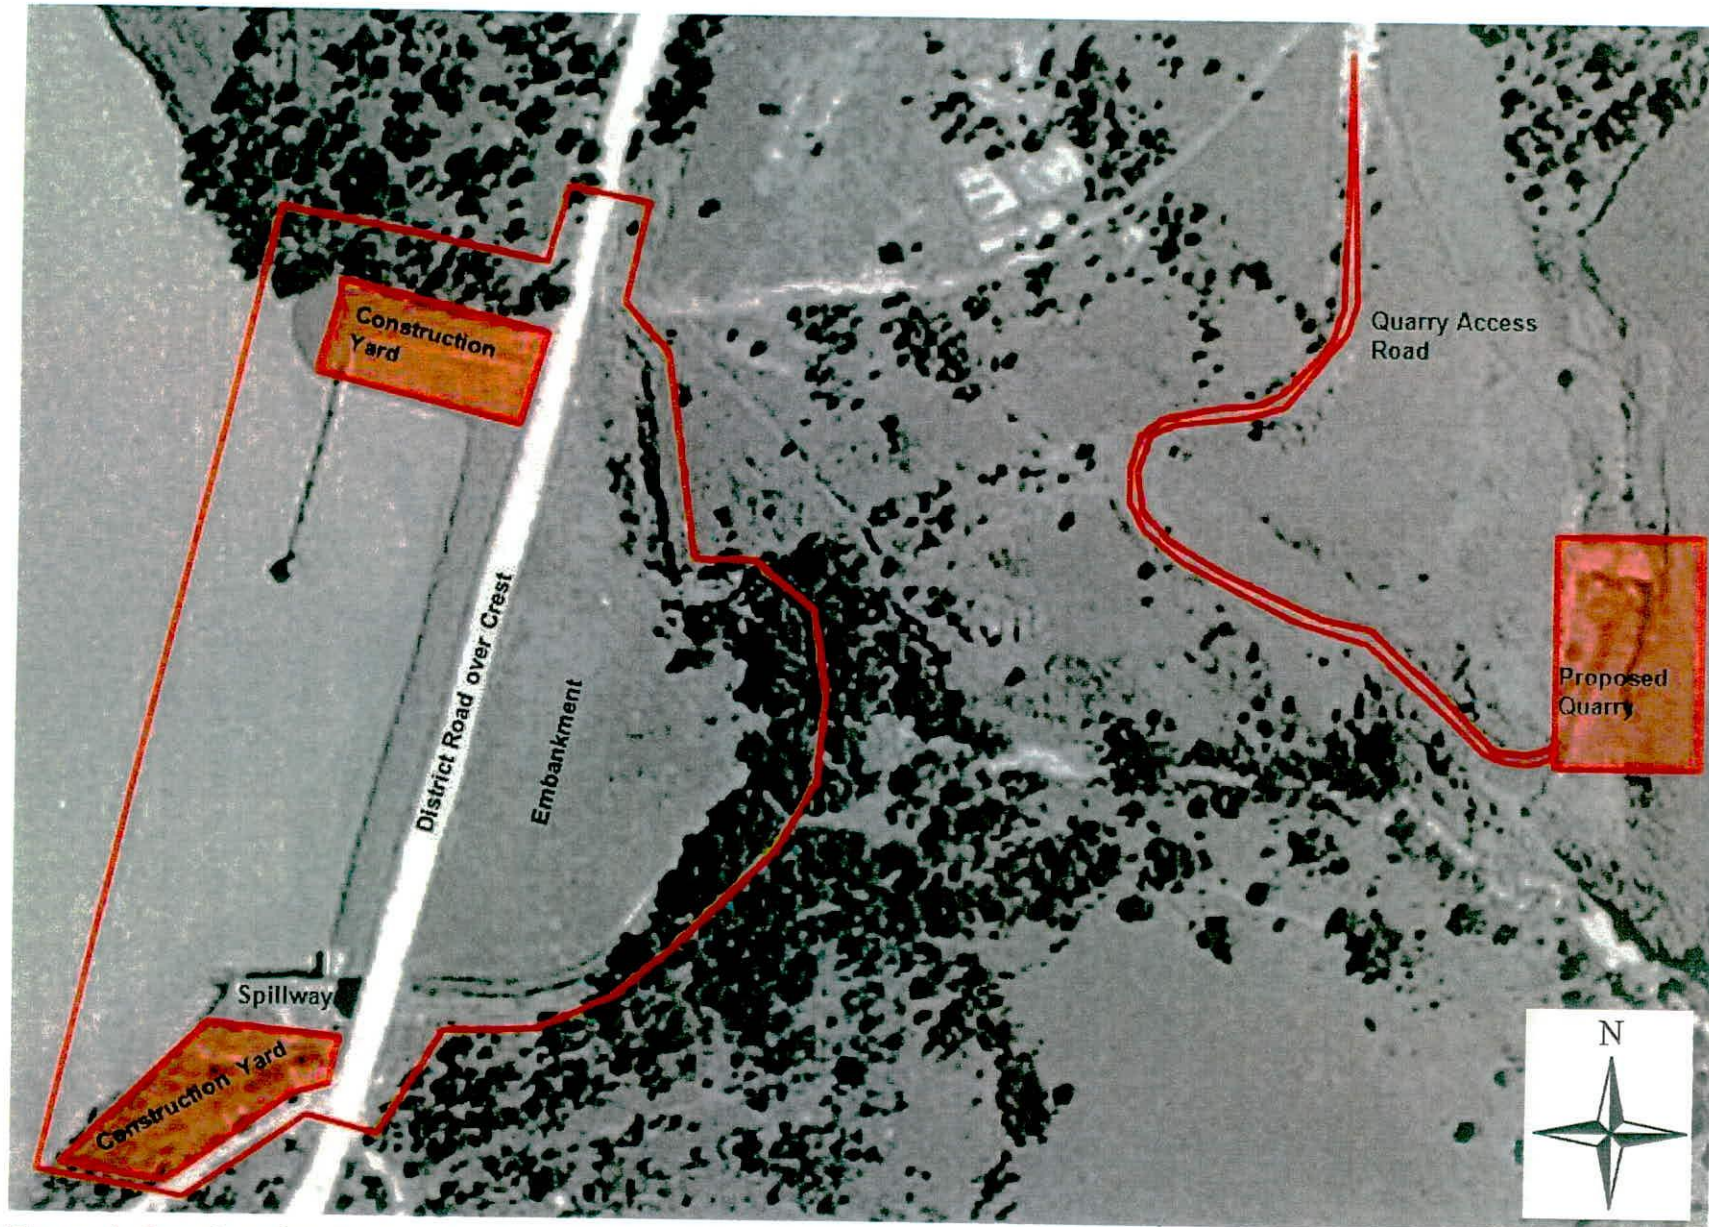
Figure 4: Construction Domain for Tsojana Dam and quarry site (Knight Piésold, 2007)

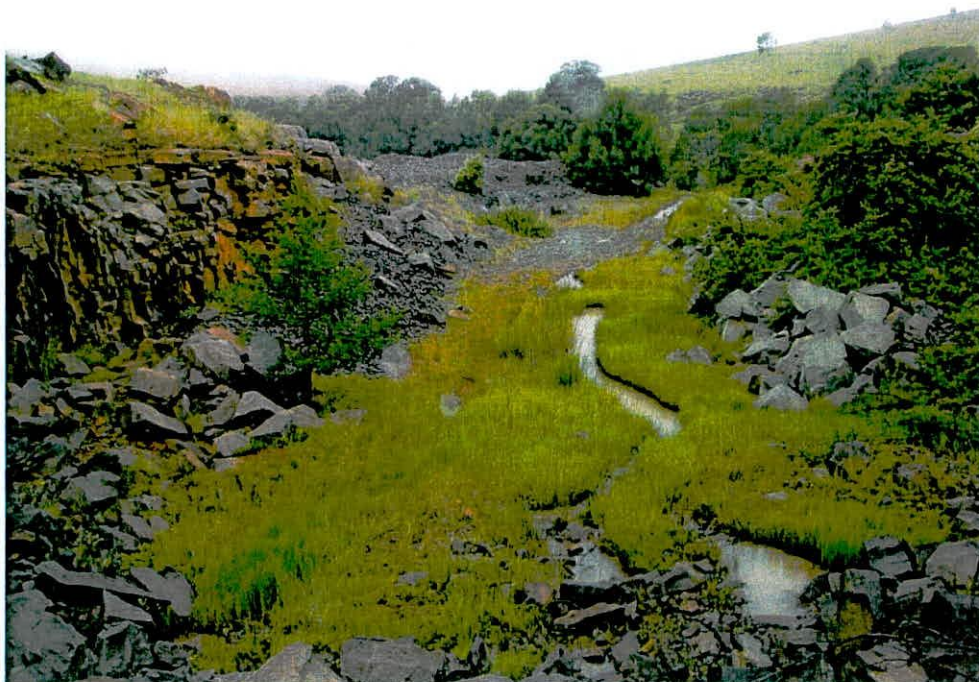
Figure 6: View from the quarry, downstream from atop the waterfall (RMS, 2008)

Note: The green graminoid species in the foreground is *Fimbristylis dichotoma*. The shrubs (which are visible in the front right) are *Leucosidea sericea*. The trees (visible on the left and centre) are the invasive tree species, *Acacia mearnsii*.
