**Heritage impact assessment report for the
TSOJANA DAM REHABILITATION PROJECT, COFIMVABA
MAGISTERIAL DISTRICT, EASTERN CAPE PROVINCE**

Rehabilitation of Tsojana dam

TSOJANA DAM CONSTRUCTION DOMAIN

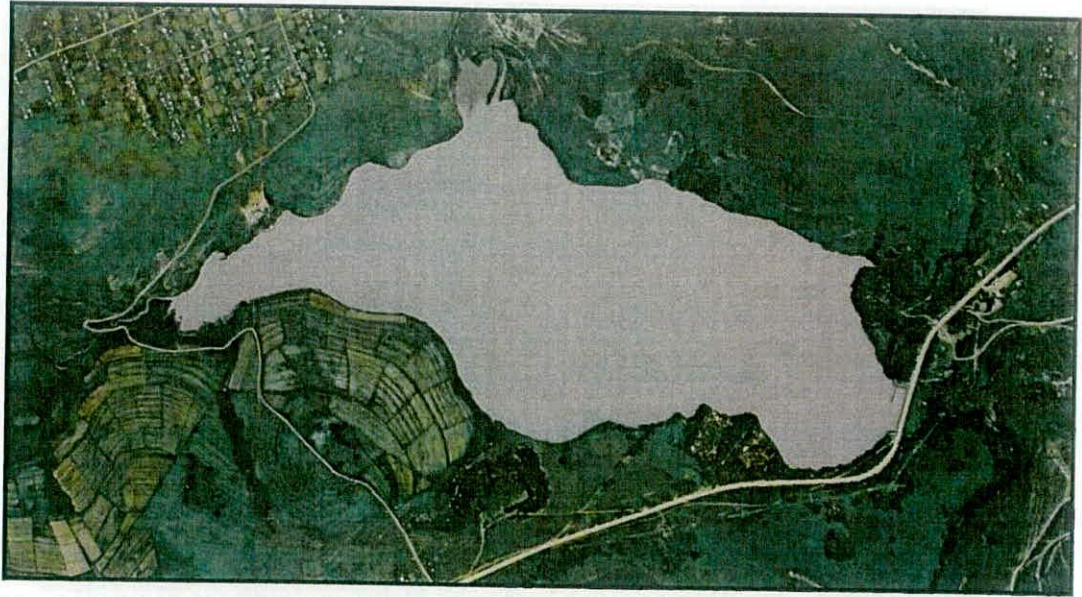
Fig. 4. Aerial photograph of the dam.
(Photo: Google Earth)

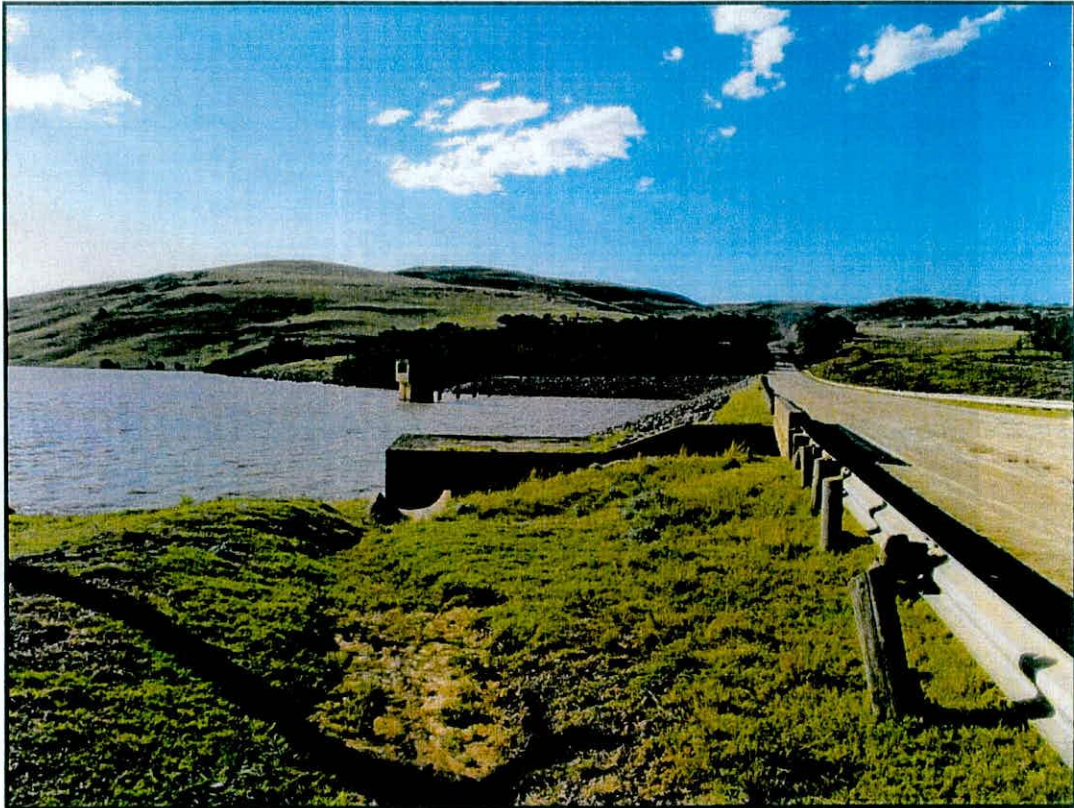
Fig. 5. Looking north along the dam wall.

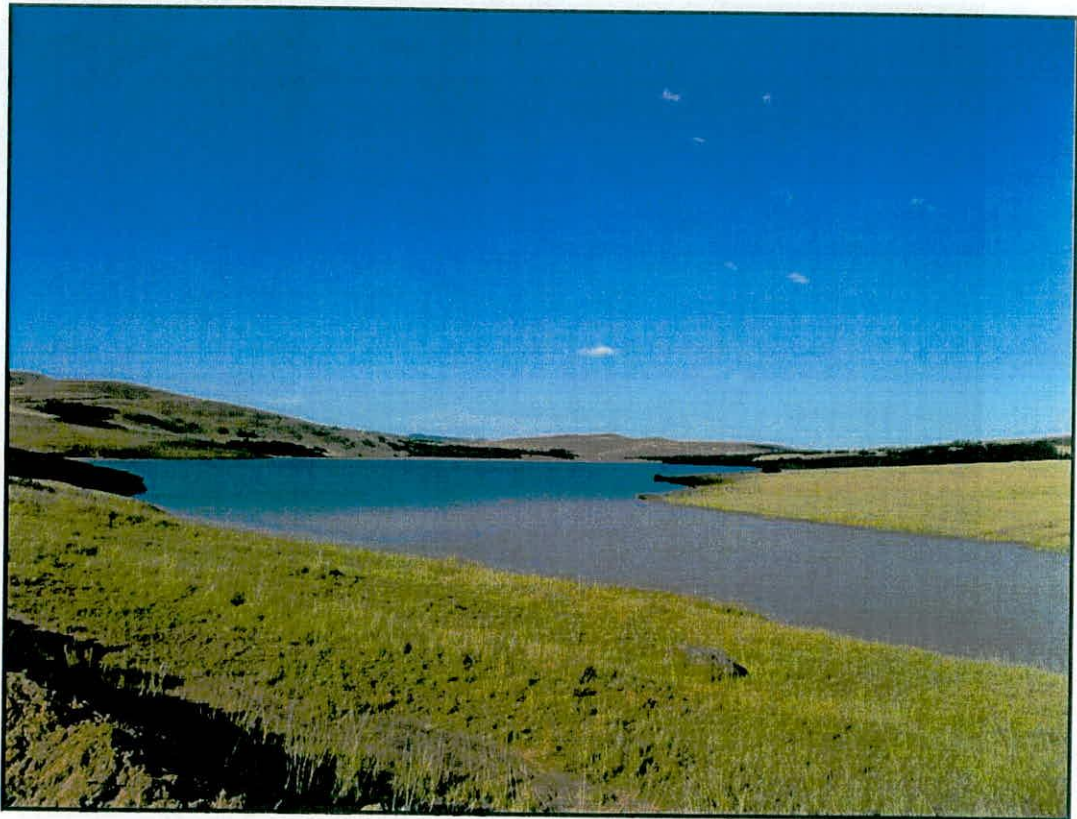
Fig. 6. Looking west, upstream of the dam wall.

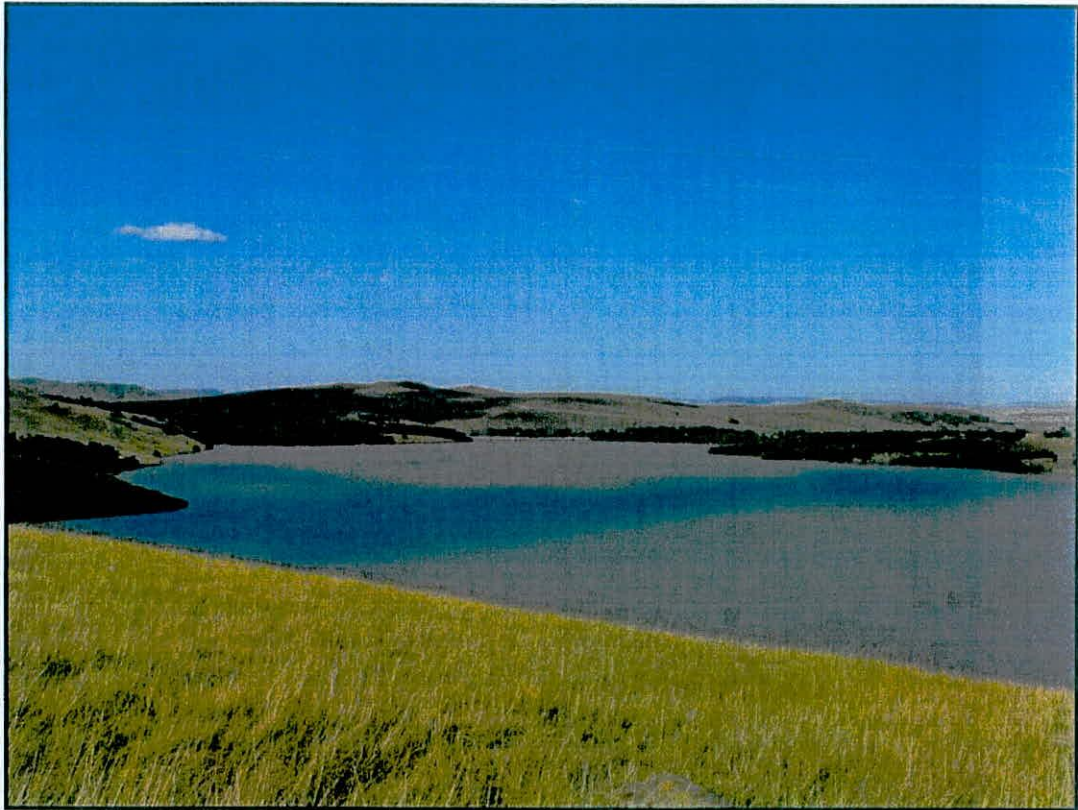
Fig. 7. Looking east towards the dam wall.

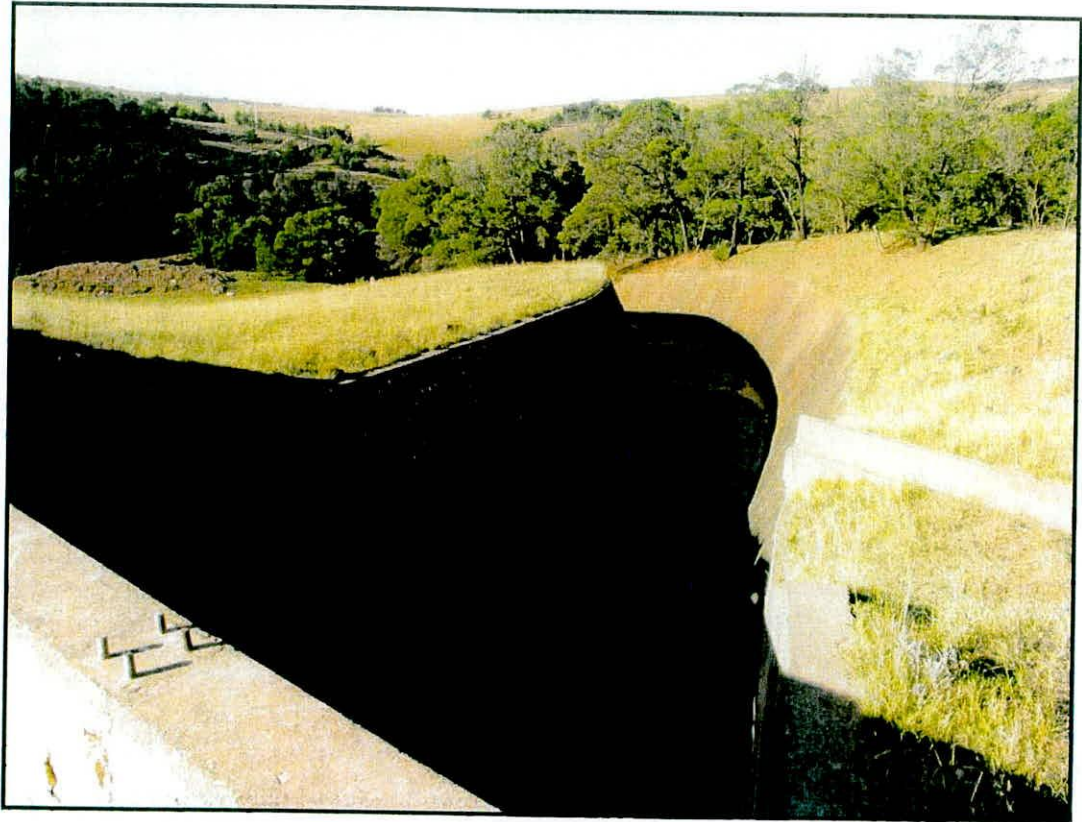
Fig. 8. The spillway at the dam wall.

- The construction of a temporary bridge during construction
- Stabilizing the embankment with rockfill material
- Increasing the length of the spillway and widening the chute
- Concrete repairs carried out on the spillway and chute
- Surfacing of the district road running over crest
- Existing quarry to be excavated 400m downstream to obtain rock material for dam construction
