ROBBEN ISLAND BLUESTONE QUARRY WALL RESTORATION PROJECT

REPORT ON OUTCOMES OF EXPERIMENTAL RECONSTRUCTION OF THE BLUESTONE QUARRY WALL

(AHSA) Archaeological and Heritage Services Africa (Pty) Ltd
Reg. No. 2016/281687/07

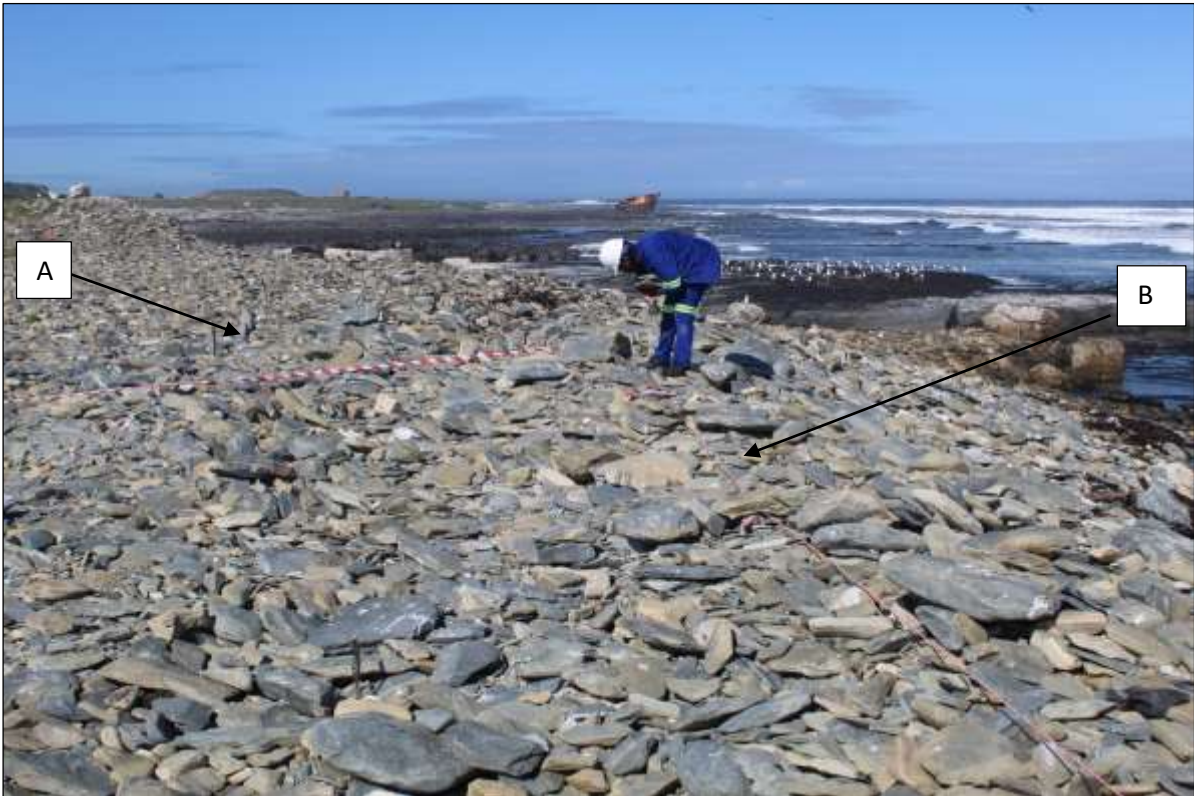
Figure 1: Two tie ropes, A & B, were laid parallel to each other along the collapsed section of the BSQW. They were used to guide the search for the foundation of the wall. Foundation courses were found 30cm to right of cord A.

Pre-construction archaeological screening proved essential as it led to the discovery of foundation courses of the wall. In order to plot the approximate position and course of the wall under the rubble two 10mm gauge tie ropes were laid out to approximate the curve of the wall between the two standing sections of the broken wall (Figure 1). The team worked through the debris with meticulous observation to pick out stone arrangements that were likely to be *in situ* and those that had been washed out of position by the waves. In the process, foundation courses of the wall, at least 2 courses 25 cm high, were exposed (Figures 2- 4). As debris and sand were cleared, brick laying and coursing techniques employed by the prisoners could be studied.

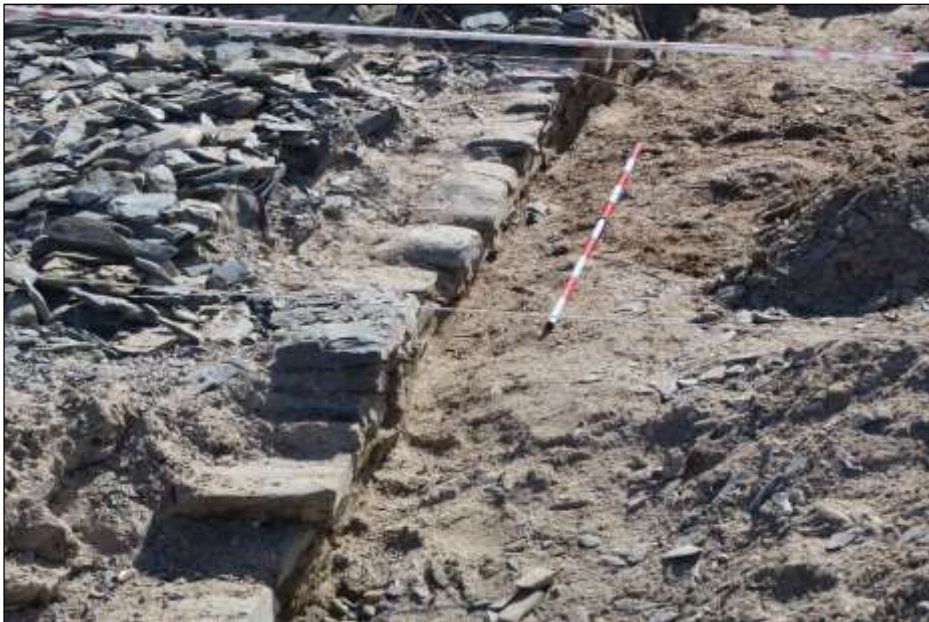
Figure 2: Foundation courses were exposed during pre-construction archaeological screening of the site (view from the south).

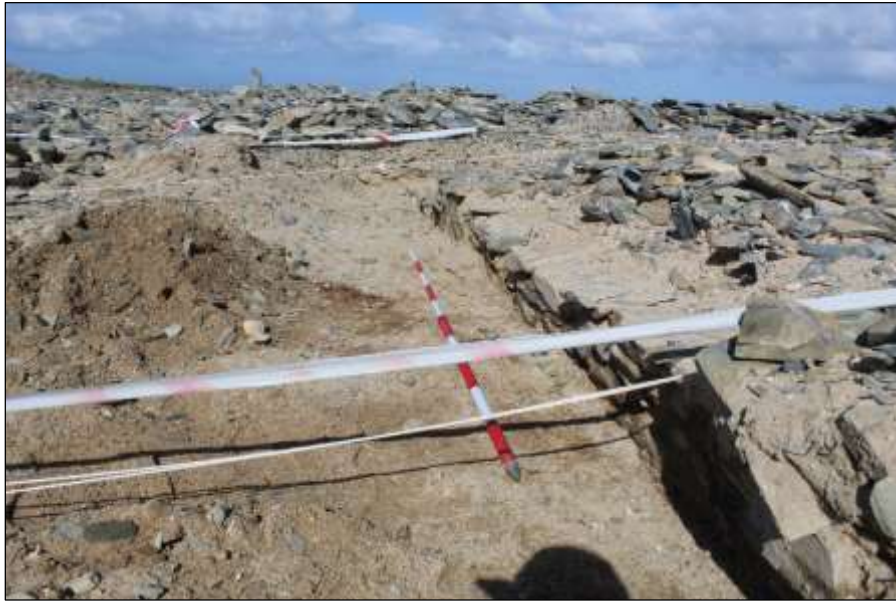
Figure 3. Foundation courses, view from the north.

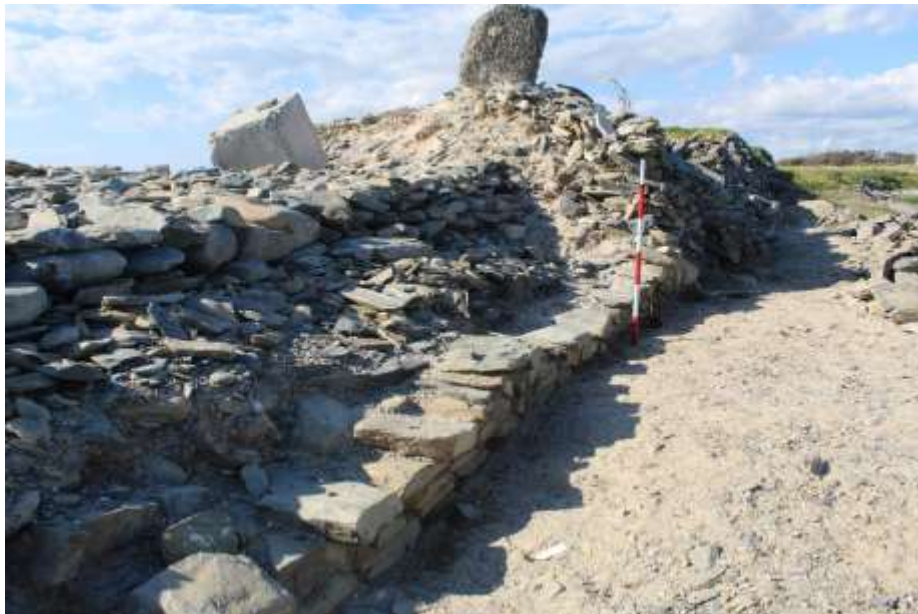
Figure 4: Foundation courses of the wall. View north shows a standing section of the wall with a sand deposit in the core of wall below a concrete cube.

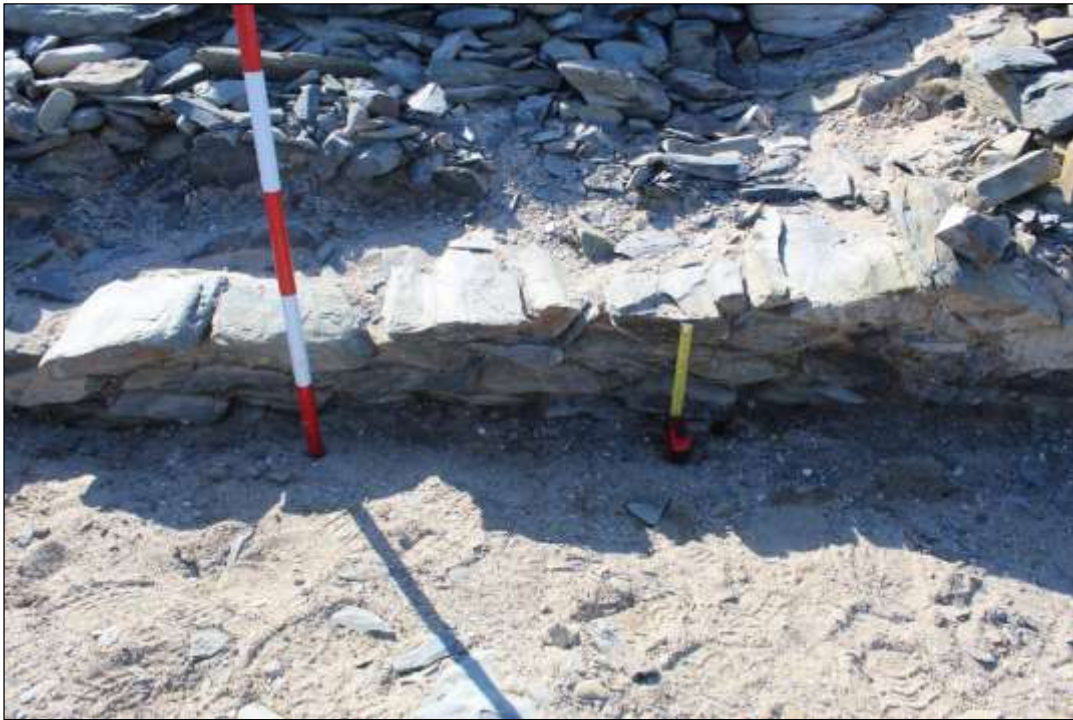
- (i) In the foundation courses exposed, most stones are laid with the long side laid transverse to the course of the wall. That was sound engineering; the

foundation stones must imbed well into the core to increase the bonding between the façade stones and the rest of the structure (Figure 5).

Figure 5: Foundation courses in the collapsed section of the BSQW exposed before the construction of the experimental wall. The longer side of the foundation stones are laid transverse to the course of the wall.

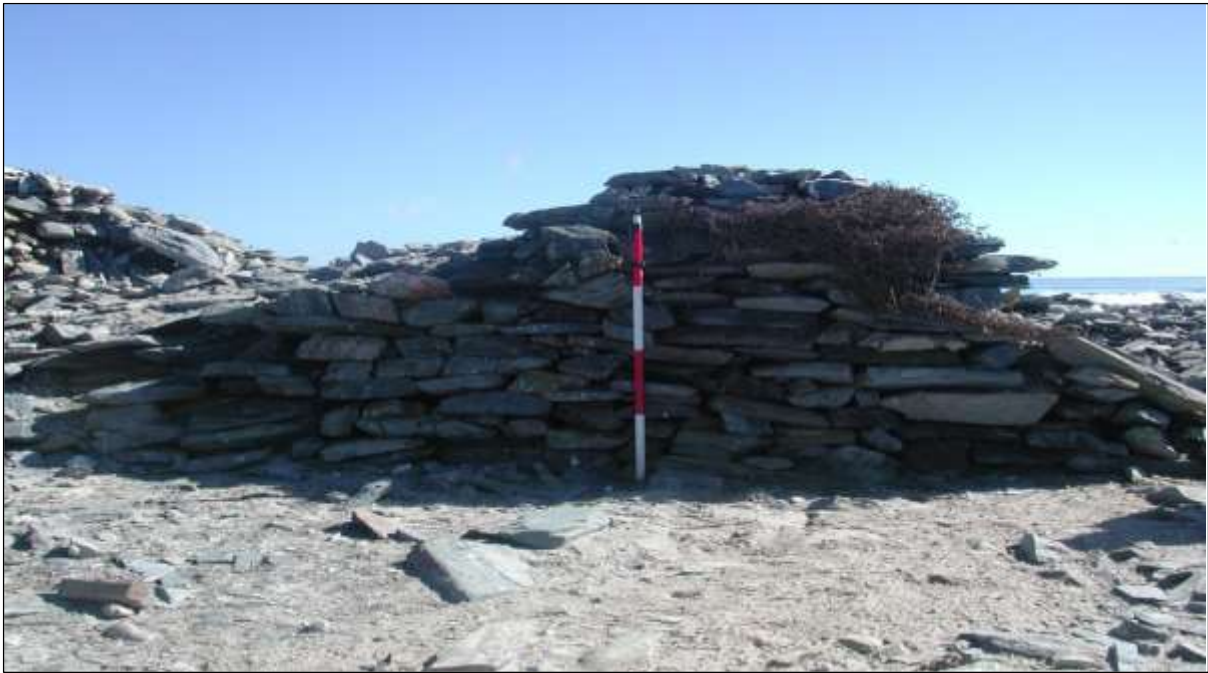
- (ii) On the basis of photographs taken in 2004 this technique was varied as they continued to stack the stones. The builders laid many façade stones with the longer dimension aligned with the course of the wall. This in turn tended to create a weak bond between the face stones and the core. But preference to this technique possibly suggests that there was a general shortage of face stones, and the decision to change the orientation of the longer faces would have been an attempt to compensate for shortage (Figure 6).

Figure 6: This wall was standing in 2004 in the section that was washed away in 2011. It shows the frequent use of façade stones with long faces. There is poor structural coherence, i.e. bonding between the façade and the core (Matenga 2004, page ix).

The preferred building technique is one that lends a good structural bond between the façade stones and the core. This entails mixing short and long face stones in ratios in which there are more short faces than long faces. Our assessment informed by the experimentation is that there is a shortage of face stones, and these have to be supplied from an external source.

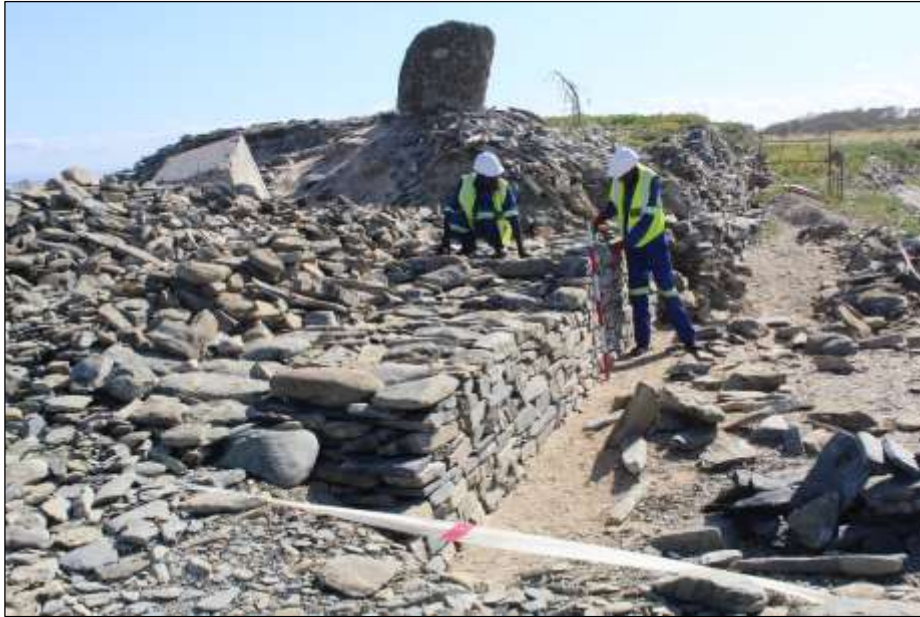
From the available documentary evidence the core of the wall consisted of heterogeneous material of different sizes including sand, gravel waste from the dressing of the mined bluestone, other stones and seashells. This shows the limitations the prisoners experienced with regard to material procurement and selection. The material of sharply varying sizes deviated far from the optimal graph required to achieve reasonable structural stability.

Figure 7: Sand load placed in the core of the wall can be seen below the concrete cube in the background. The recommended packing of the core excluding the sand can between two concrete cubes in the foreground.

All stones from the debris other than those selected for the construction of the façade, or are very large, will be packed in the core of the wall, making sure that the core stones interlock well with the façade. Long stones will be laid in the core in transverse orientation to provide additional bonding.

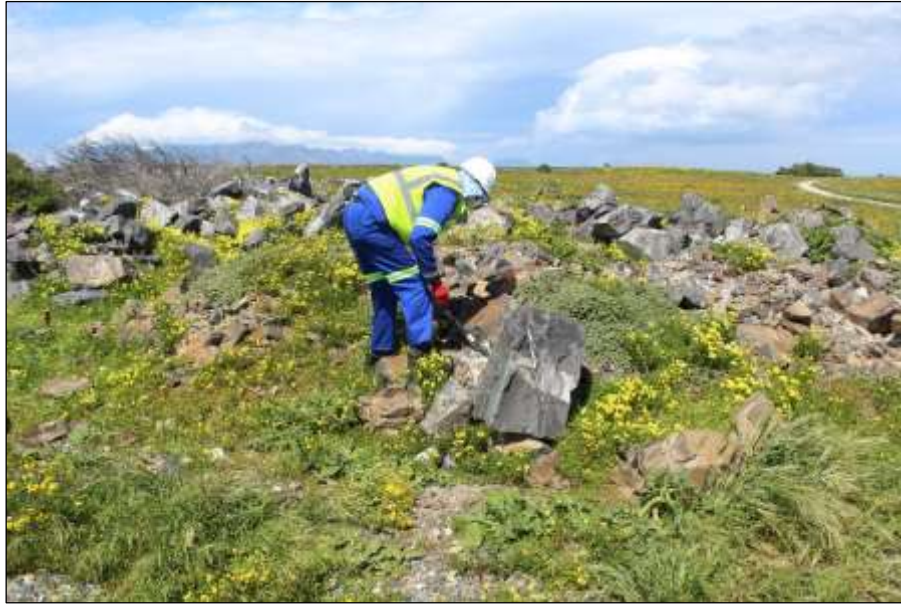
The plan entails introducing large stones with incremental size from the centre of the breadth of the wall towards the sea. In other words the size of the stones to be packed increases in size with increasing distance towards the sea from the centre of the core. There are very few large stones in the debris (Figure 9).

Figure 9: Stockpile of raw stone to be broken and used for the construction of the BSQW.

- (i) Mechanical power to break the stones: the team has attempted without satisfactory results to break the raw material stones brought to the site using a 14 pounds hammer. A machine with more compressive power is required.
- (ii) Machinery will be required to lift the stones from the temporary stockpile and stack them on the seaside of the wall. Stonemasons will be trained to direct the machine operator to place the stones in the right positions.
