**PROPOSED KHAUTA SOLAR PHOTOVOLTAIC (PV) CLUSTER
AND ASSOCIATED GRID CONNECTIONS DEVELOPMENT,
RIEBEECKSTAD NEAR WELKOM, FREE STATE PROVINCE**

SITE SENSITIVITY VERIFICATION REPORT

MAY 2022

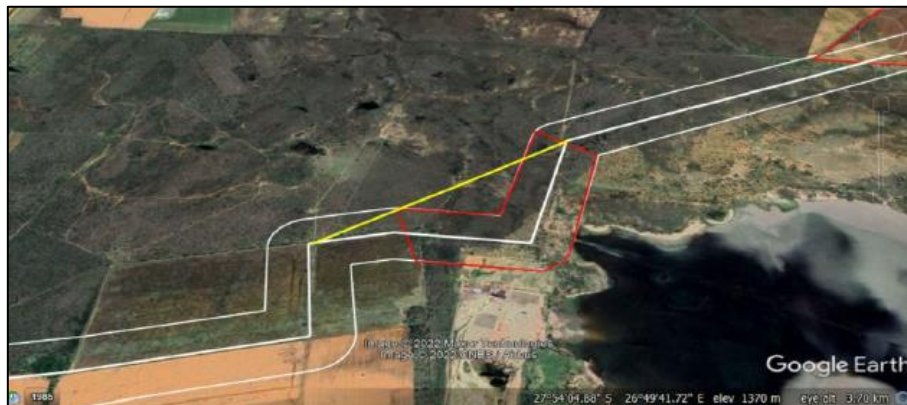
Figure 2 The yellow line depicts the proposed deviation in the 44 kV route to avoid an area of high collision risk (polygon depicted in red along the 300 m corridor)

A deviation of the 44 kV line is proposed, to avoid the pan and area of high collision risk (Figure 2). The deviation will reduce the collision risk for birds flying to or away from the pan.

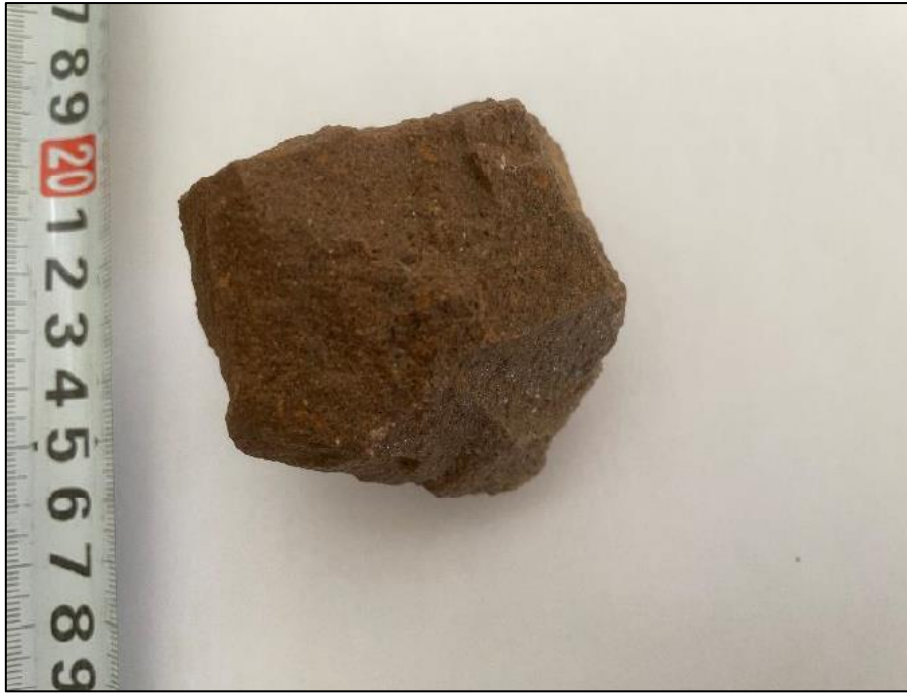
- A Middle Stone Age¹ (MSA) quartzite core (Point 0016) was recorded alongside the proposed 44 kV powerline corridor, on the Farm Kopje Alleen 81 (Figure 5).
- There is barely any surface stone covering the proposed solar PV site.
- There are no significant landscape features such as rocky outcrops or kopjes, on the site.
- The isolated context in which it was found, means that remains have been graded as having *low* (3IV) archaeological significance.

Figure 5 MSA core (Point 0016). Scale is in cm

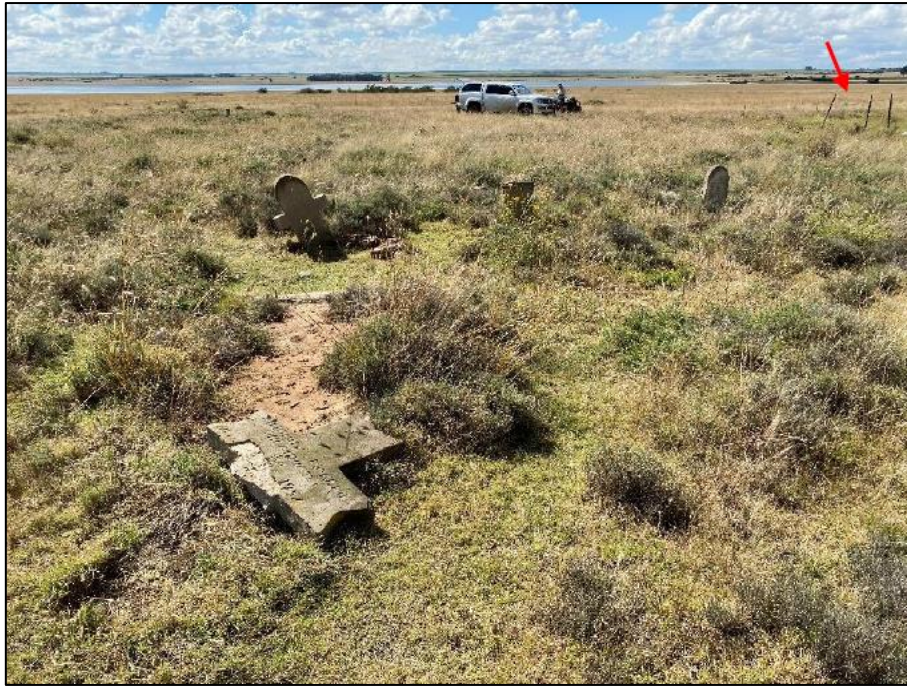
- A graveyard (Point 0026) was recorded on the Farm Commandants Pan 382/9, \pm 500 m east of the edge of the pan (Figure 6).
- Approximately 40-50 barely visible graves were counted in an area measuring about 30 x 40 m in extent.
- The majority of graves comprise of low mounds of clay and stones without headstones or footstones. Several graves with headstones were also identified, including a grave that has been fenced off and slightly apart from the others (Figure 6).

Figure 6 Graveyard (Point 0026) on the Farm Commandants Pan 382/9. View facing south east. Arrow indicates fenced off grave

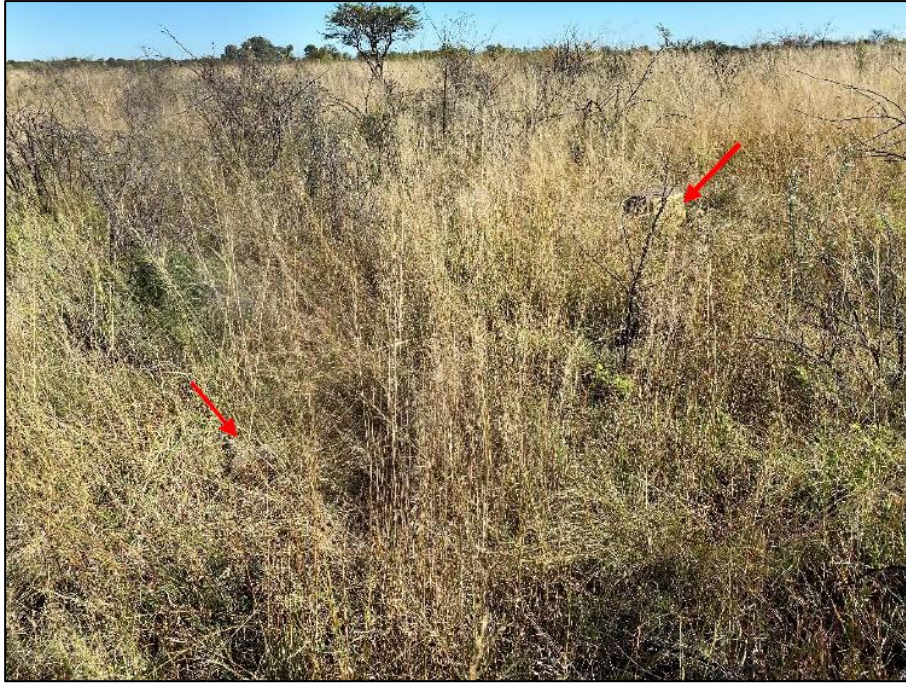
- Two graves (Point 0096) were recorded in the proposed 44 kV route option on the farm Klein Koppie Aleen 182/1 (Figure 7).
- Both graves contain headstones but are barely visible in the long grass.
- According to the farm owner, Mr Chris Gouws (pers. comm. April 2022), there were previously three graves identified, but the remains of one of the deceased was removed more than 10 years ago and buried elsewhere in Riebeeckstad or Welkom.
- Graves and graveyards are rated as having high (3B) significance because of their social value.

Figure 7 Graves (Point 0096). Arrows indicates the 2 headstones on the Farm Klein Koppie Aleen 182/1

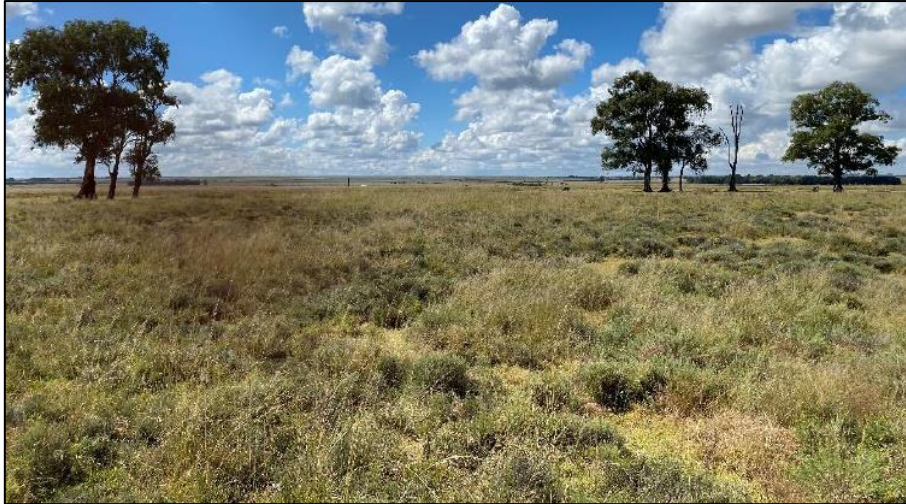
- An Outspan was identified on the Farm Commandants Pan 382/9, about 200 m east of the graveyard (Point 0036) (Figure 8).
- The Outspan was pointed out to the heritage specialist by Mr Johan van Merwe who currently leases the farm from the landowner. Three large trees on the flat hilltop 'mark' the site.

- The area surrounding the Outspan was searched where the base of a rusted potjie pot was noted. No other remains were found.

Figure 8 Outspan (Point 0036) on the Farm Commandants Pan 382/9. View facing north east.
