DPR

Report on the ecological and biodiversity assessment for the proposed bulk water pipeline for the Greenfields residential development in Postmasburg, Northern Cape Province.

May 2021

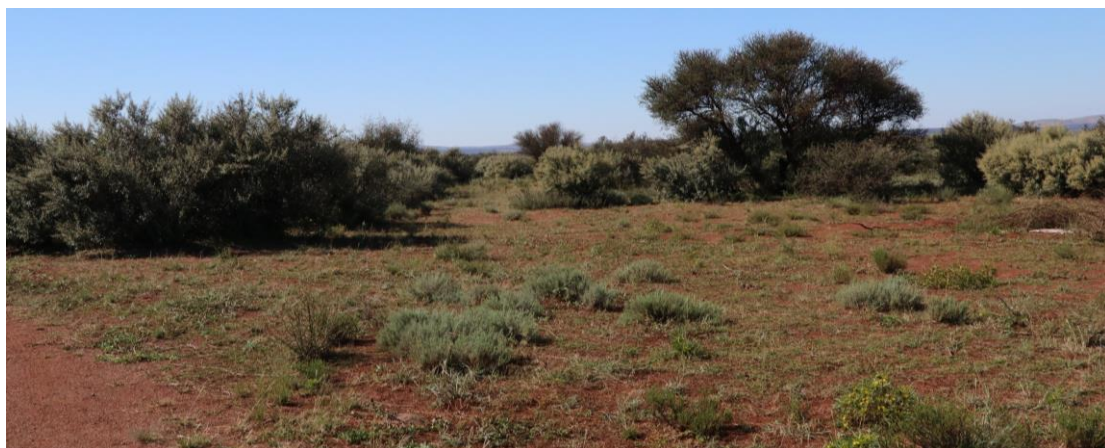
Figure 2: View of the vegetation along the pipeline route which is clearly still natural though note the decrease in the grass layer due to overgrazing by livestock.

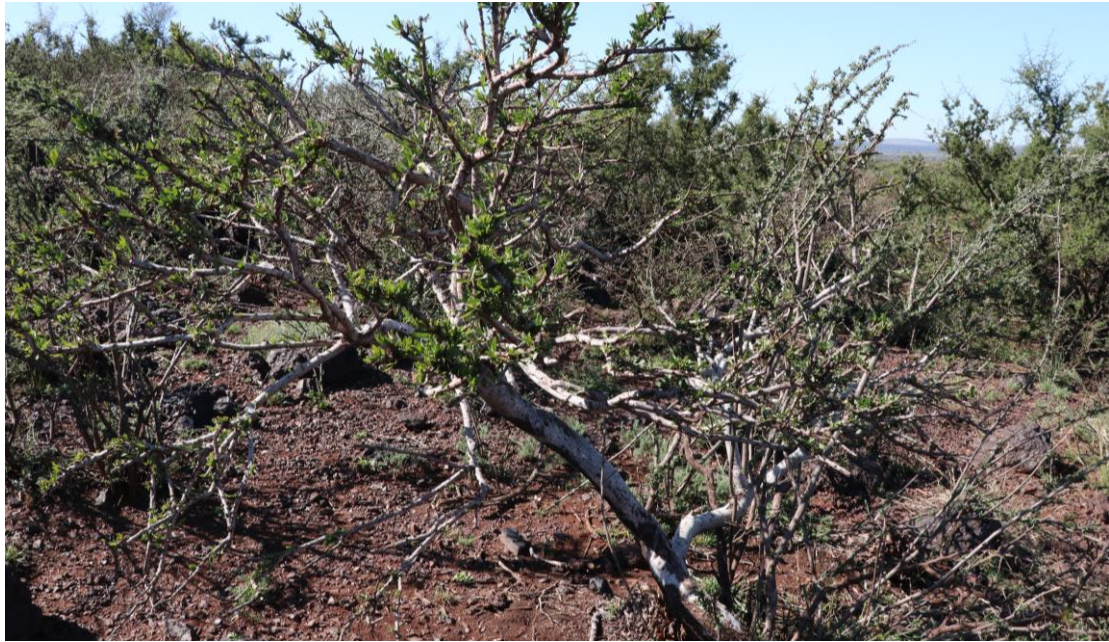
Figure 3: Signs of overbrowsing among the smaller shrubs are common with most leaves being stripped and lower branches being devoid of any new growth.

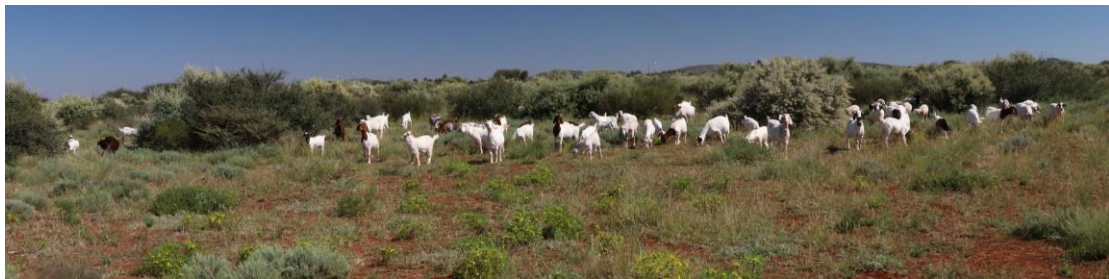
Figure 4: Overgrazing and -browsing, especially by domestic goats, are well known to cause degradation of the natural vegetation.

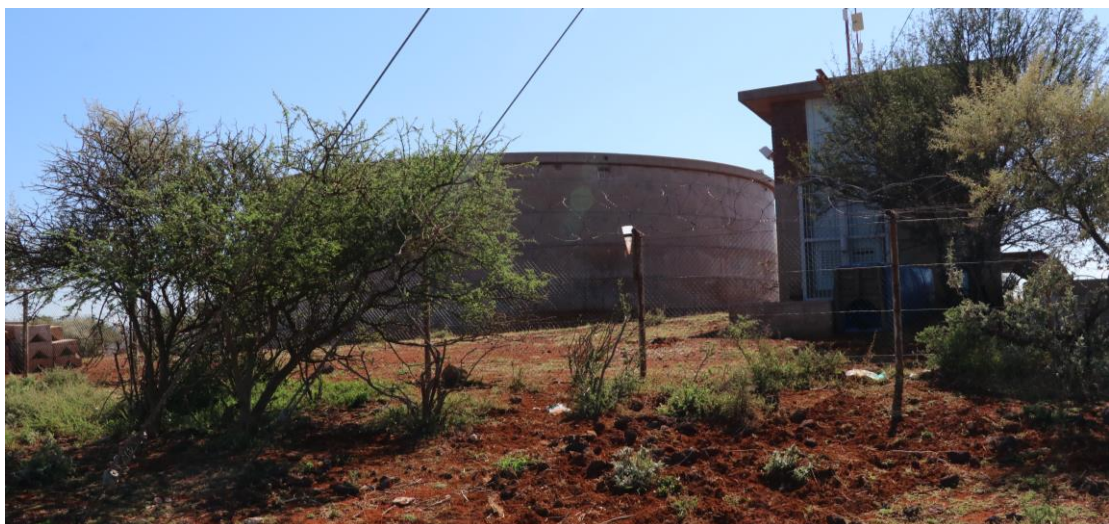
Figure 5: View of the existing reservoir complex on top of the low hill at the eastern end of the pipeline route.

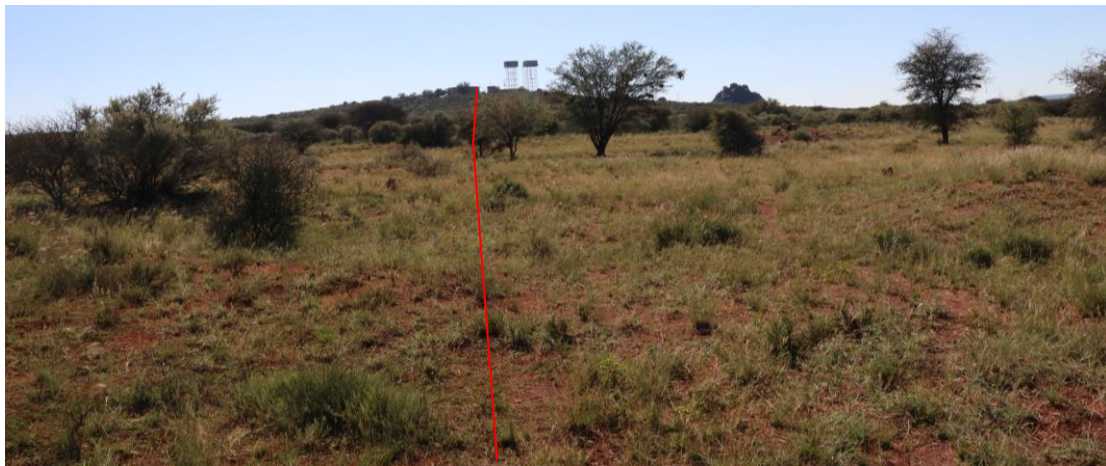
Figure 6: The majority of the pipeline route is situated along the lower lying plain with a low hill clearly visible along the eastern portion of the pipeline route.

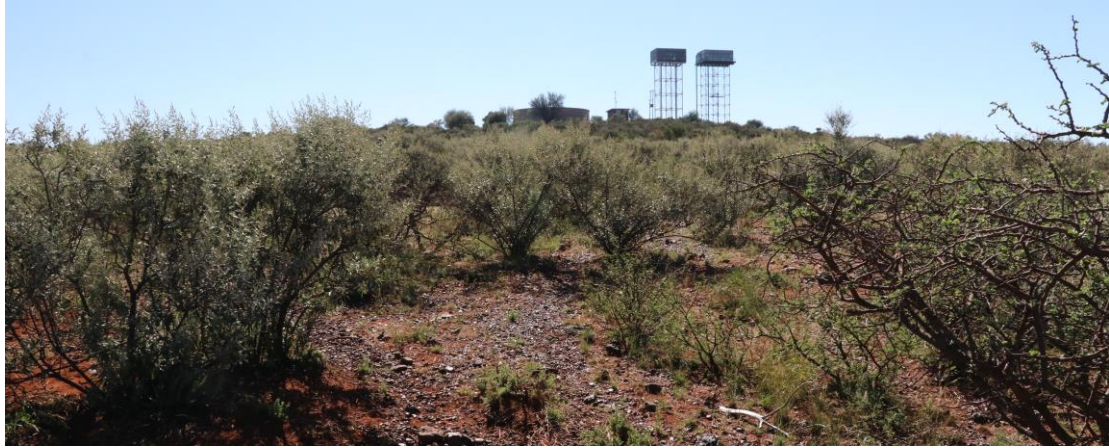
Figure 7: The vegetation on top of the low hill contains a much denser shrub layer. Note also a high percentage surface stones.

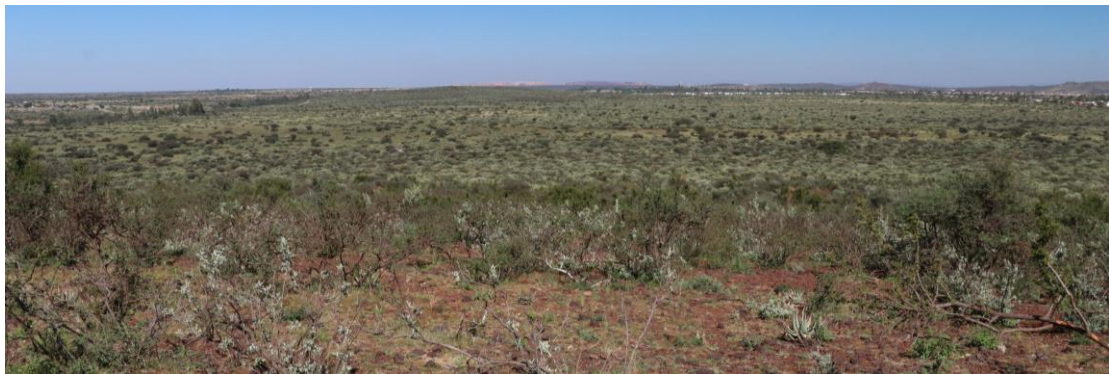
Figure 8: View from the low hill toward the western portion of the pipeline route. Note a quite dense shrub layer dominates the vegetation structure.

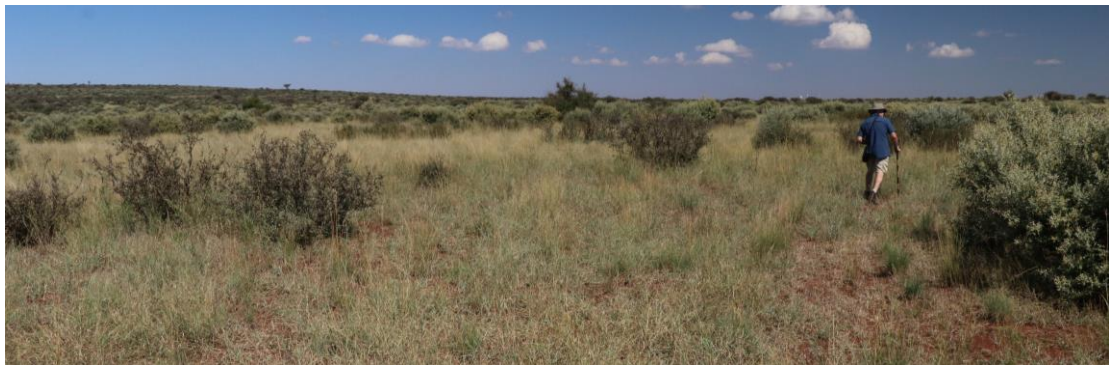
Figure 9: Within the lower lying plains portion of the pipeline route a well-developed grass layer is also evident.

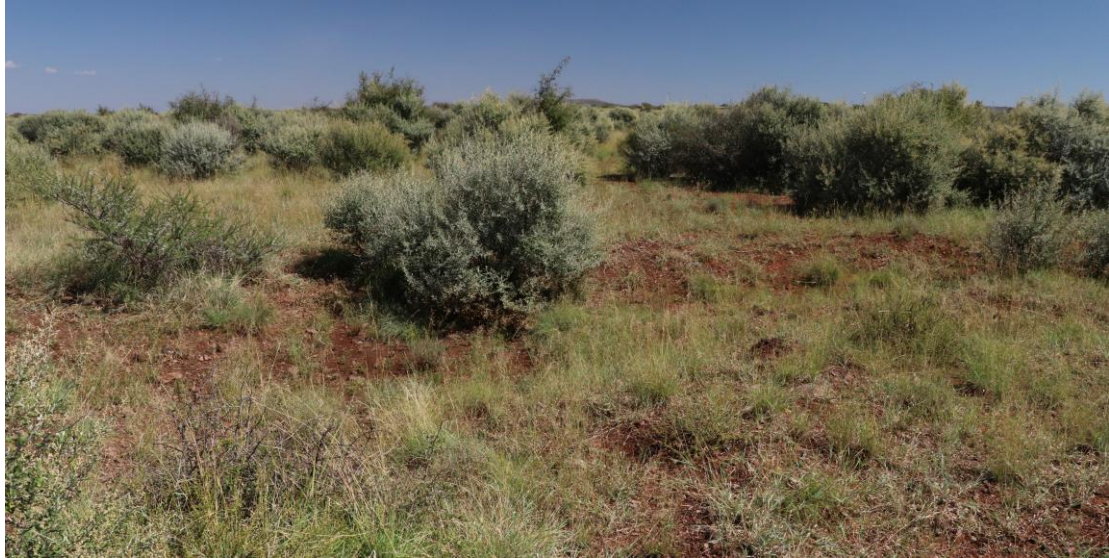
Figure 10: The lower lying plain is dominated by a dense shrub layer with well-developed grass layer also being prominent.

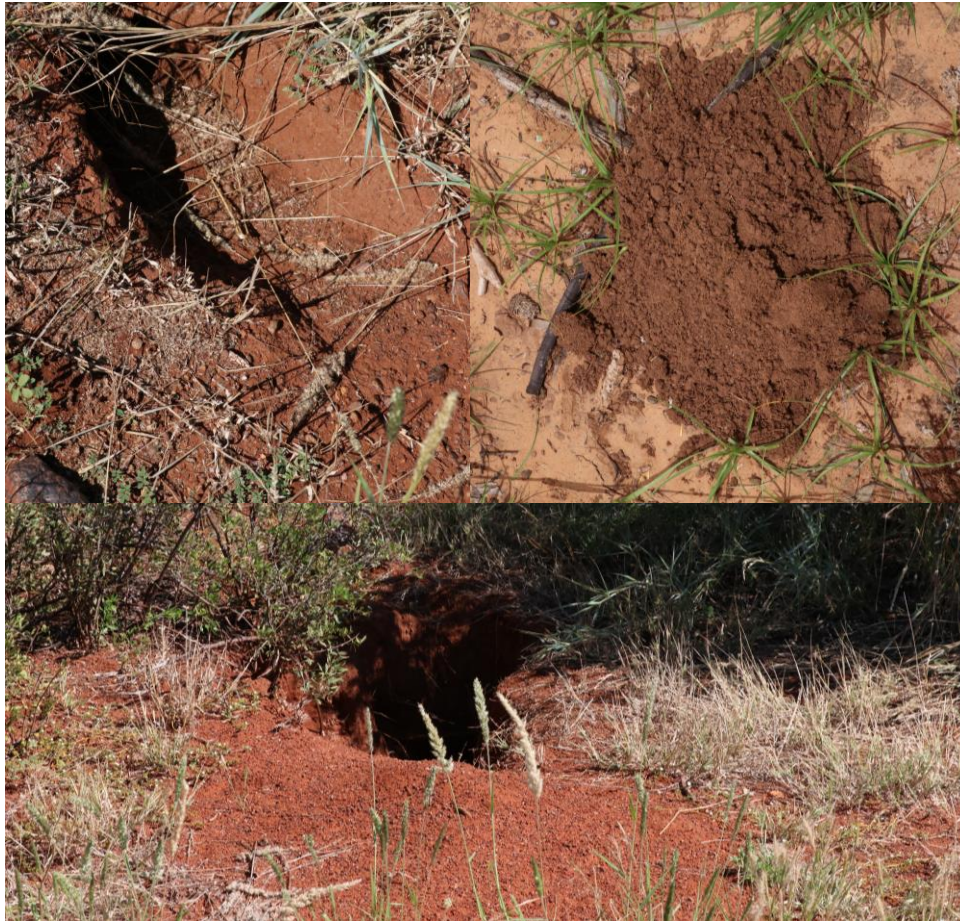
- Soil mounds of the Common Molerat (*Cryptomys hottentotus*) were observed in the sandy plains portion. This is a widespread species which has even become adapted to urban areas. It is a generalist species anticipated to occur in this area.

- Foraging excavations which can most likely be associated with Porcupines (*Hystrix africaeaustralis*) were noted on the study area. This is also a generalist species, widespread and common in peri-urban areas. It is also able to inhabit disturbed habitats as occurs on the site.

- A burrow of an Antbear (*Orycteropus afer*) was noted along the pipeline route. This is also a widespread species, not uncommon but very shy and very seldom observed. It is also a listed protected species and therefore of significant conservation value. They are however also abundant in the surrounding area and given the small extent of the pipeline footprint should not be affected by the development.

Figure 11: Tracks and signs of mammals on the site include clockwise from top left; Foraging excavations, most likely of a Porcupine (*Hystrix africaeaustralis*), soil mounds of the Common mole rat (*Cryptomys hottentotus*) and burrow of an Antbear (*Orycteropus afer*).

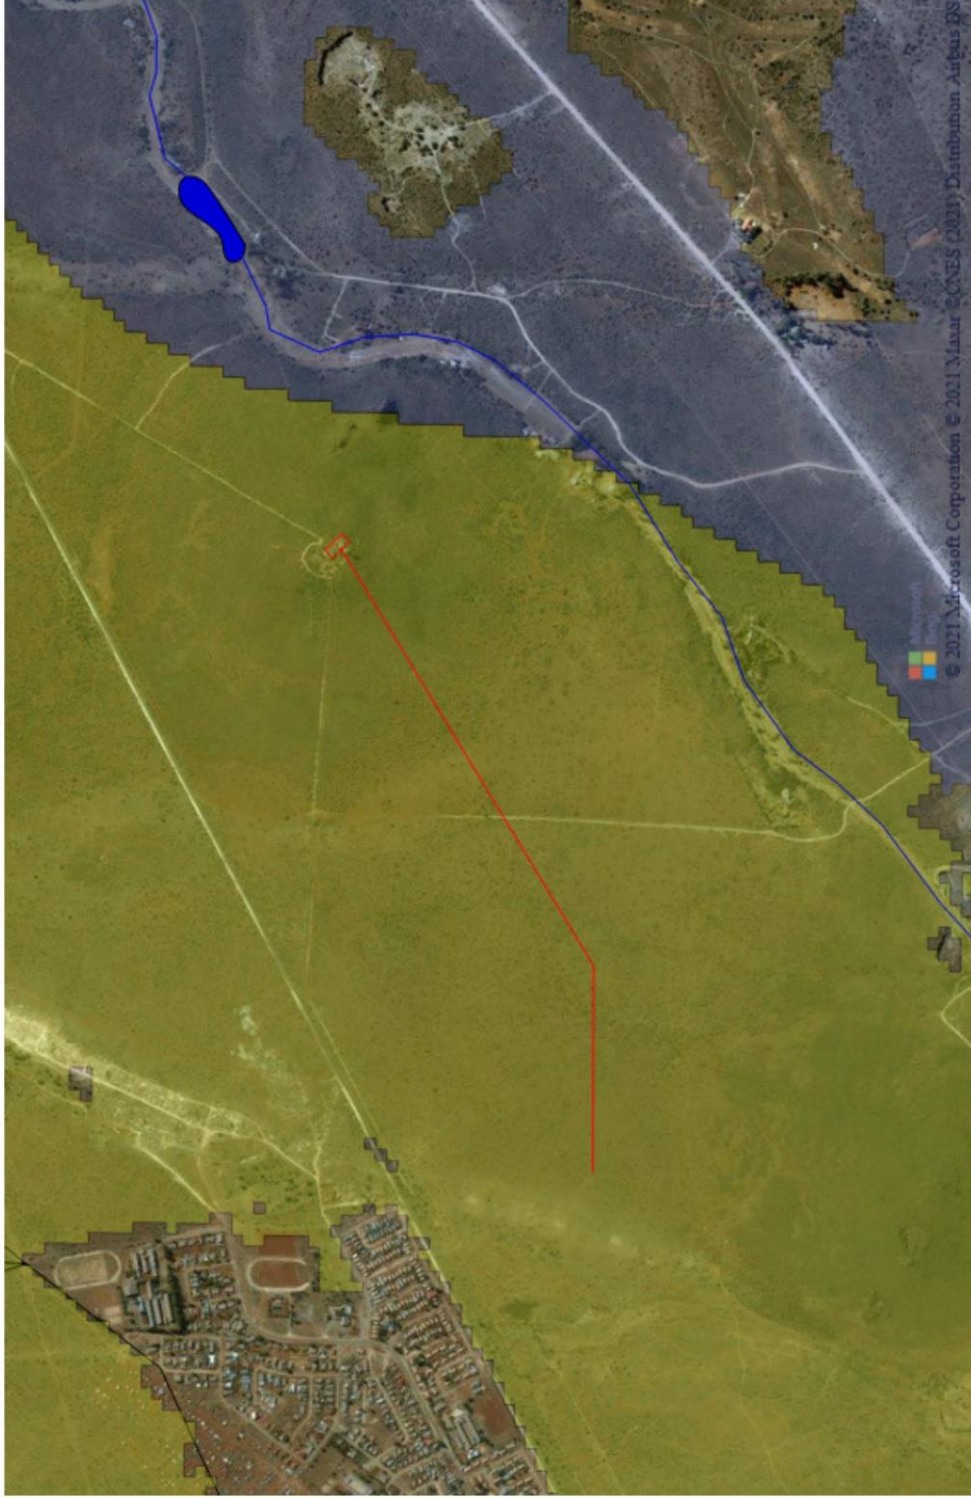
Map 1: Locality map of the proposed bulk water pipeline in Postmasburg. The area clearly still consists of natural vegetation and falls within the Kuruman Thornveld vegetation type. Note the residential areas to the north west and the Groenwaterspruit located 700 meters to the south.

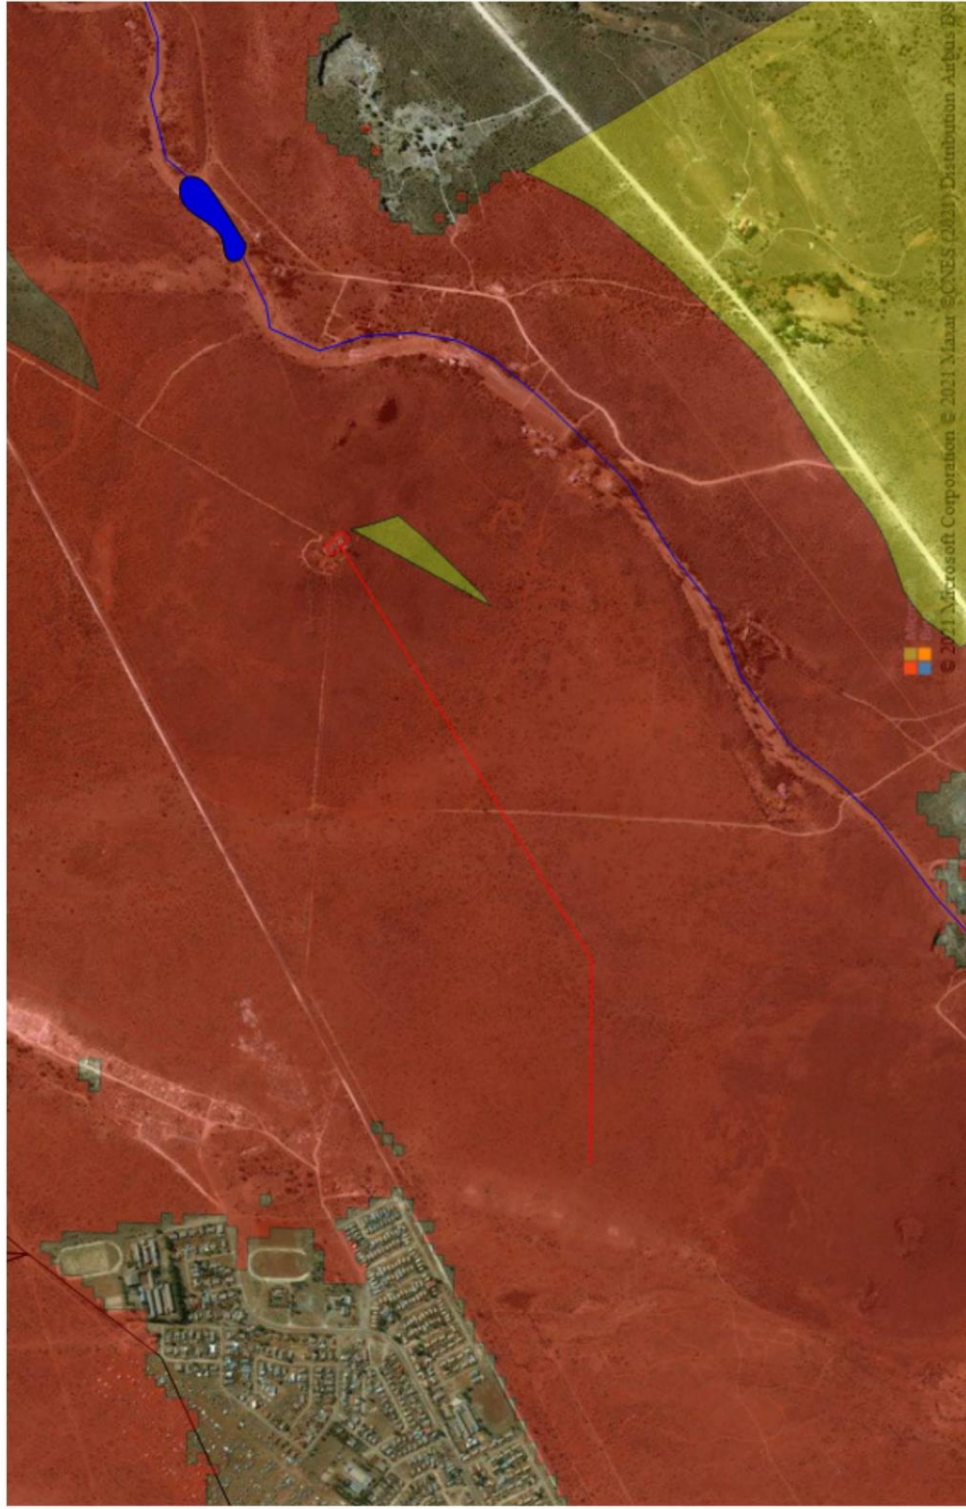
Map 2: General ecology map of the proposed bulk water pipeline in Postmasburg. The pipeline route is situated within a Critical Biodiversity Area 1 though it does not form part of a Threatened Ecosystem or NPAES Focus Area. The Groenwaterspruit located approximately 700 meters to the south is also visible. The area also falls within the Southern Ghaap Plateau Strategic Water Source Area (SWSA) though this is not indicated on the map.

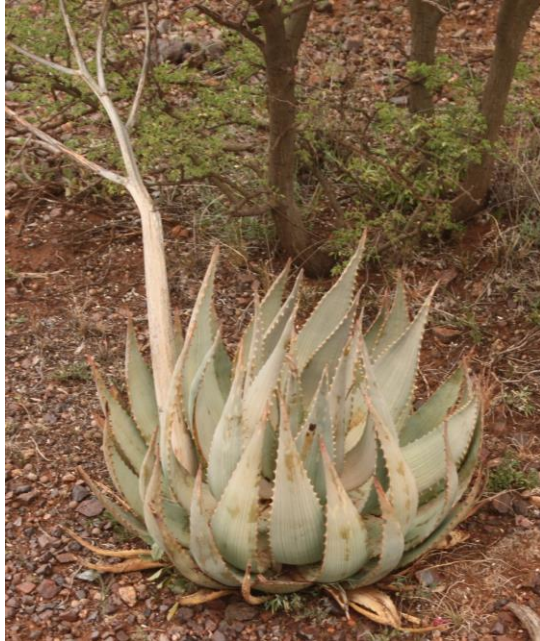
Aloe hereroensis
Herero Aloe/Sandaalwyn

Protected in the Northern Cape Province

National Red List Status: **Least Concern (LC)**

Method: The species is abundant on the site especially the low hill. Where they are affected by construction they should be removed and transplanted to an adjacent area where they will not be affected.

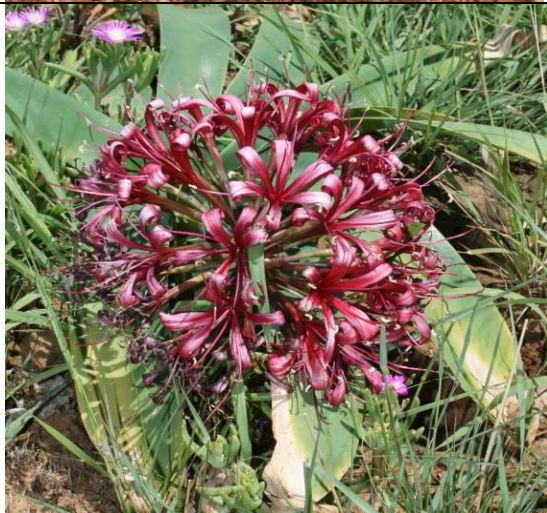
Ammocharis coranica
Seeroogblom/Ground Lily

Protected in the Northern Cape Province

National Red List Status: **Least Concern (LC)**

Scattered specimens occur in the sandy plains on the site. Where they are affected by construction they should be removed and transplanted to an adjacent area where they will not be affected. They have a large underground bulb which will have to be taken into account with the transplanting.

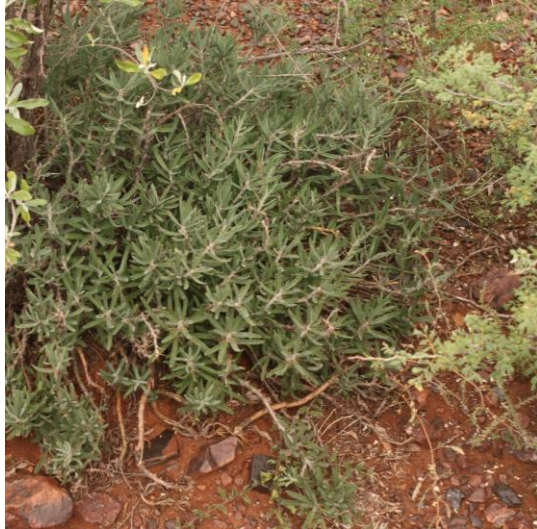
Pachypodium succulentum
Bobbejaankambroo/Dikvoet

Protected in the Northern Cape Province

National Red List Status: **Least Concern (LC)**

Method: **The species is abundant on the site especially the low hill. Where they are affected by construction they should be removed and transplanted to an adjacent area where they will not be affected. Large underground tubers need to be taken into account for this species.**

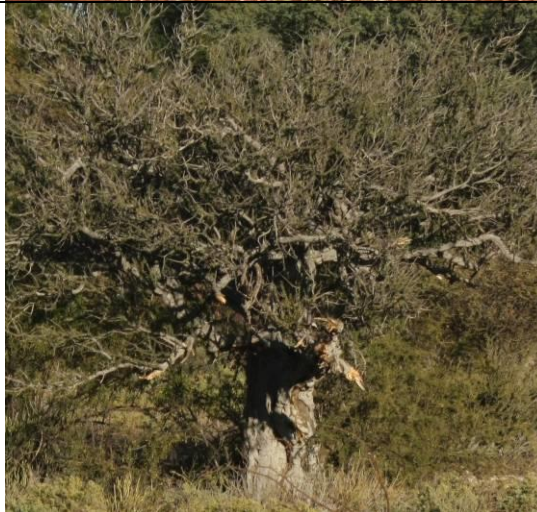
Boscia albitrunca
Shepherds Tree/Witgat Boom

Protected in the Northern Cape Province

National Red List Status: **Least Concern (LC)**

Method: **The species is abundant on the site especially the low hill. Where they are affected by construction permits must be obtained to removed them.**

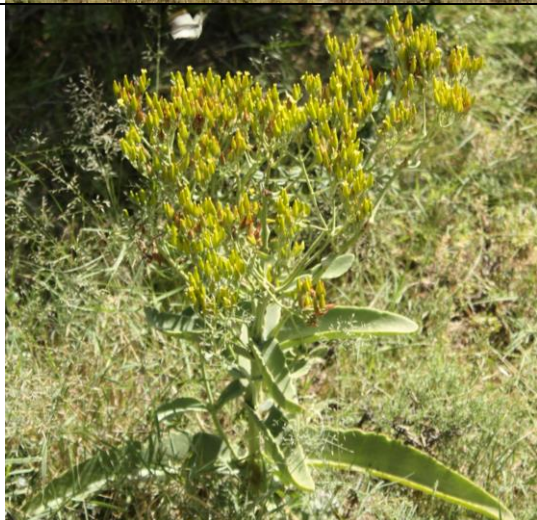
Kalanchoe paniculata
Hasieoor/Krimpsiektebos

Protected in the Northern Cape Province

National Red List Status: **Least Concern (LC)**

Method: **Scattered on the on the site especially the low hill. Where they are affected by construction permits must be obtained to removed them.**

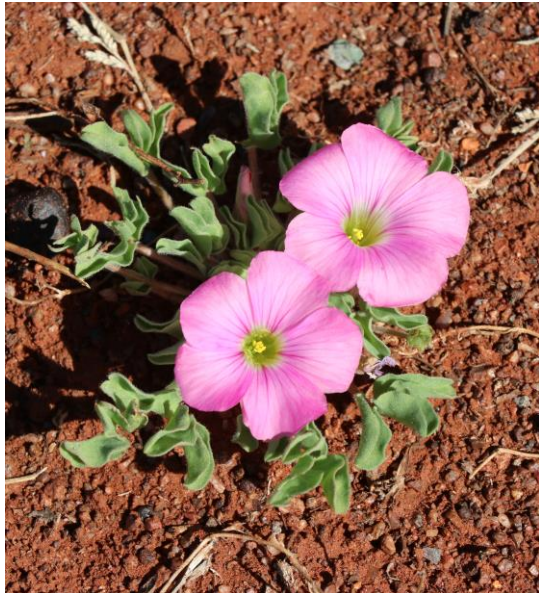
Oxalis lawsonii
Vlaktesuring

Protected in the Northern Cape Province

National Red List Status: **Least Concern (LC)**

Scattered specimens occur in the sandy plains on the site. Where they are affected by construction they should be removed and transplanted to an adjacent area where they will not be affected.

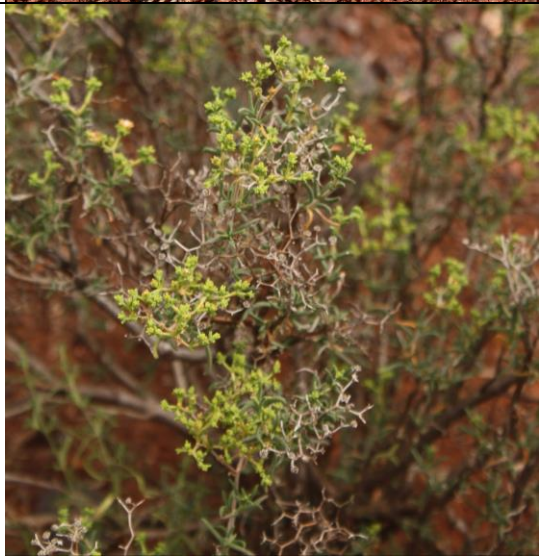
Mestoklema tuberosum
Donkievybossie

Protected in the Northern Cape Province

National Red List Status: **Least Concern (LC)**

Method: The species is abundant on the site especially the low hill. Where they are affected by construction they should be removed and transplanted to an adjacent area where they will not be affected.

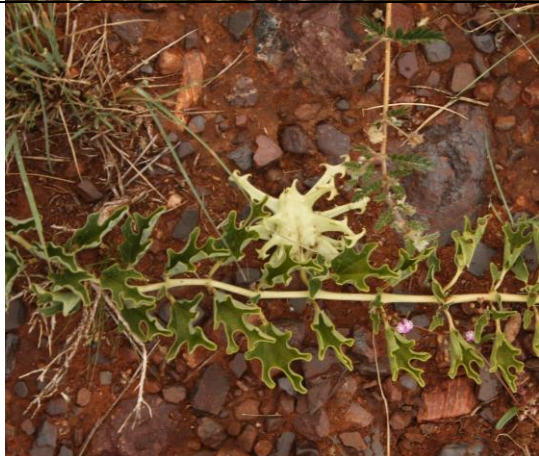
Harpagophytum procumbens
Devil's Claw/Duiwelsklou

Protected in the Northern Cape Province/also listed as National TOPS: Protected Medicinal Species.

National Red List Status: **Least Concern (LC)**

Method: Numerous specimens occur in the sandy plains on the site. Where they are affected by construction they should be removed and transplanted to an adjacent area where they will not be affected. They have an exceedingly large taproot which will have to be taken into account with the transplanting.

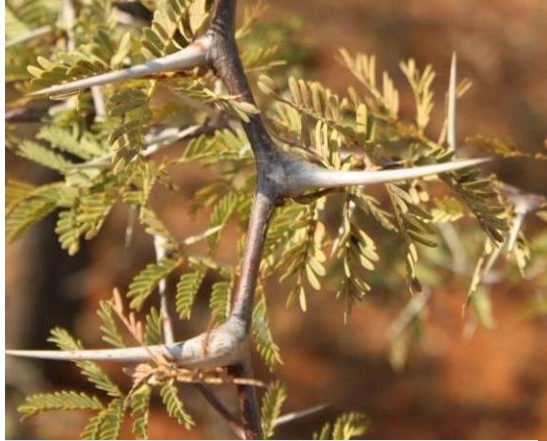
Acacia erioloba
Camel Thorn/Kameeldoring

Listed as a protected tree species.

The species is subjected to a continuing decline and is therefore listed as a **Declining** species.

Method: **Several specimens noted in the central sandy plains portion. Other trees may also occur. Where they are affected by construction permits must be obtained to removed them.**
