Report on the floristic and ecological assessment of the proposed establishment of the Lennertsville Graveyard, Northern Cape Province.

July 2014

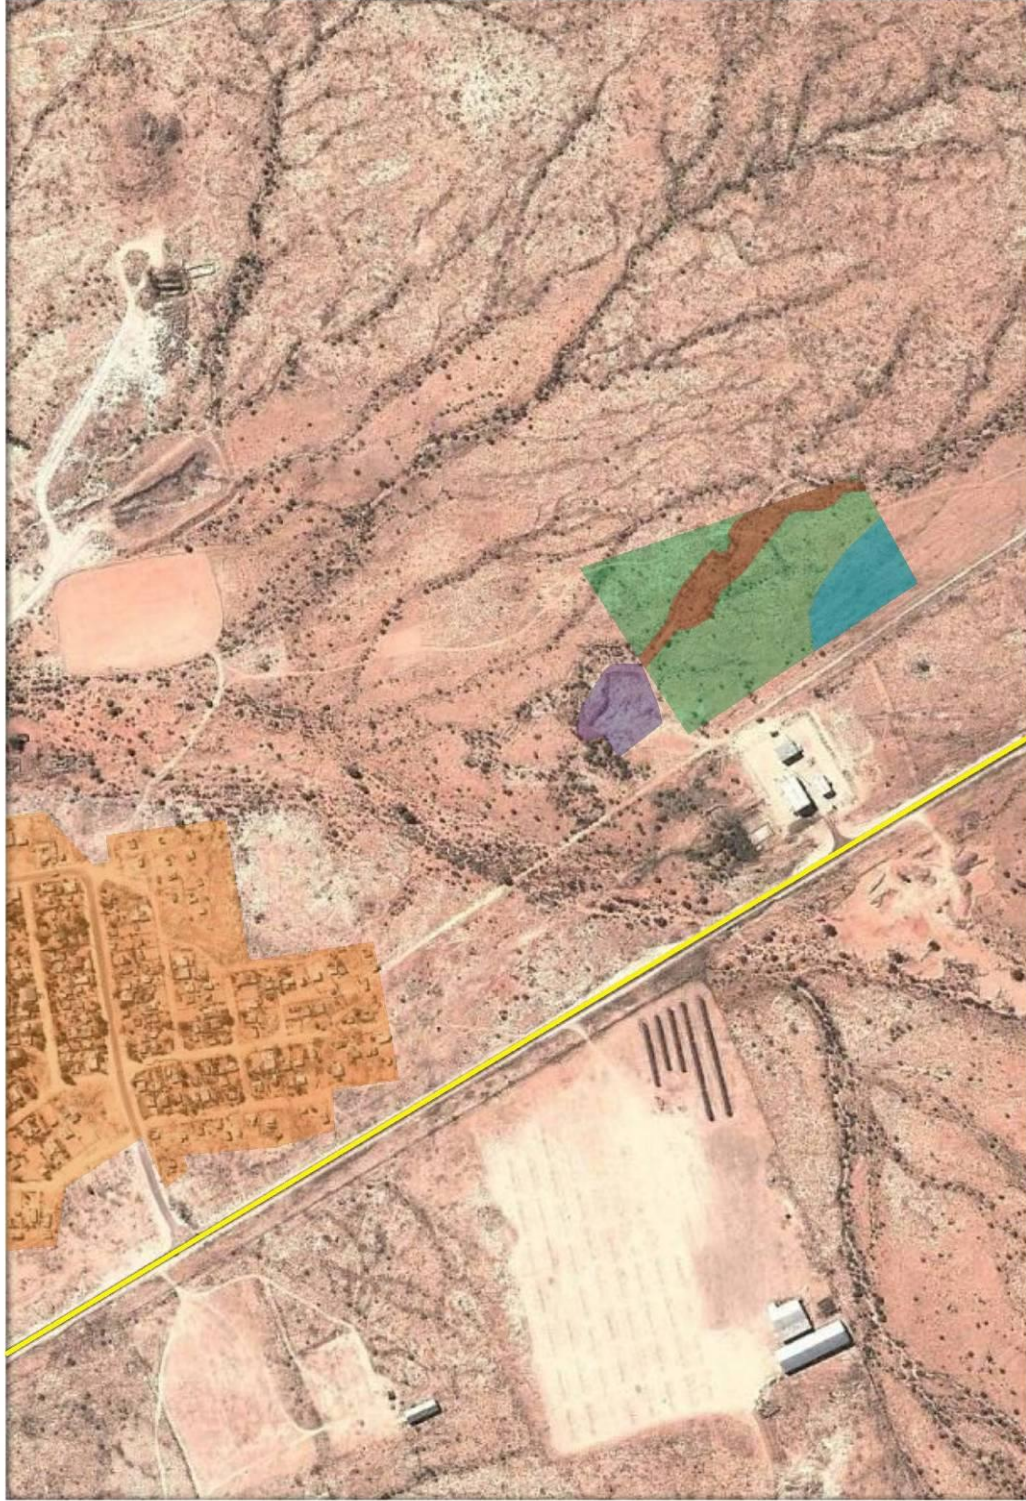
Layout map for the proposed establishment of the Lennertsville Graveyard, Northern Cape Province.

Map 1: Layout for the proposed establishment of the Lennertsville Graveyard, Northern Cape Province. The drainage line is indicated as well as the area that has previously been ploughed. The old borrow pit and Lennirtsville settlement is also indicated. Note buildings to the west of the site as well as surrounding areas cleared for cultivation.

An ephemeral drainage line crosses the site (Map 1). The drainage line enters the at the south of the site and flows north where it exits the site. The drainage line is degraded downstream of the site by the borrow pit and extensive vineyards. Although in a degraded condition the drainage line remains a vital water transporting body and therefore is regarded as sensitive. It should be excluded from the graveyard and a buffer zone of 10 meters should be afforded to the drainage line.

The drainage line on the site, although degraded, still has a significant conservation value and must be excluded from the graveyard (Map 1).

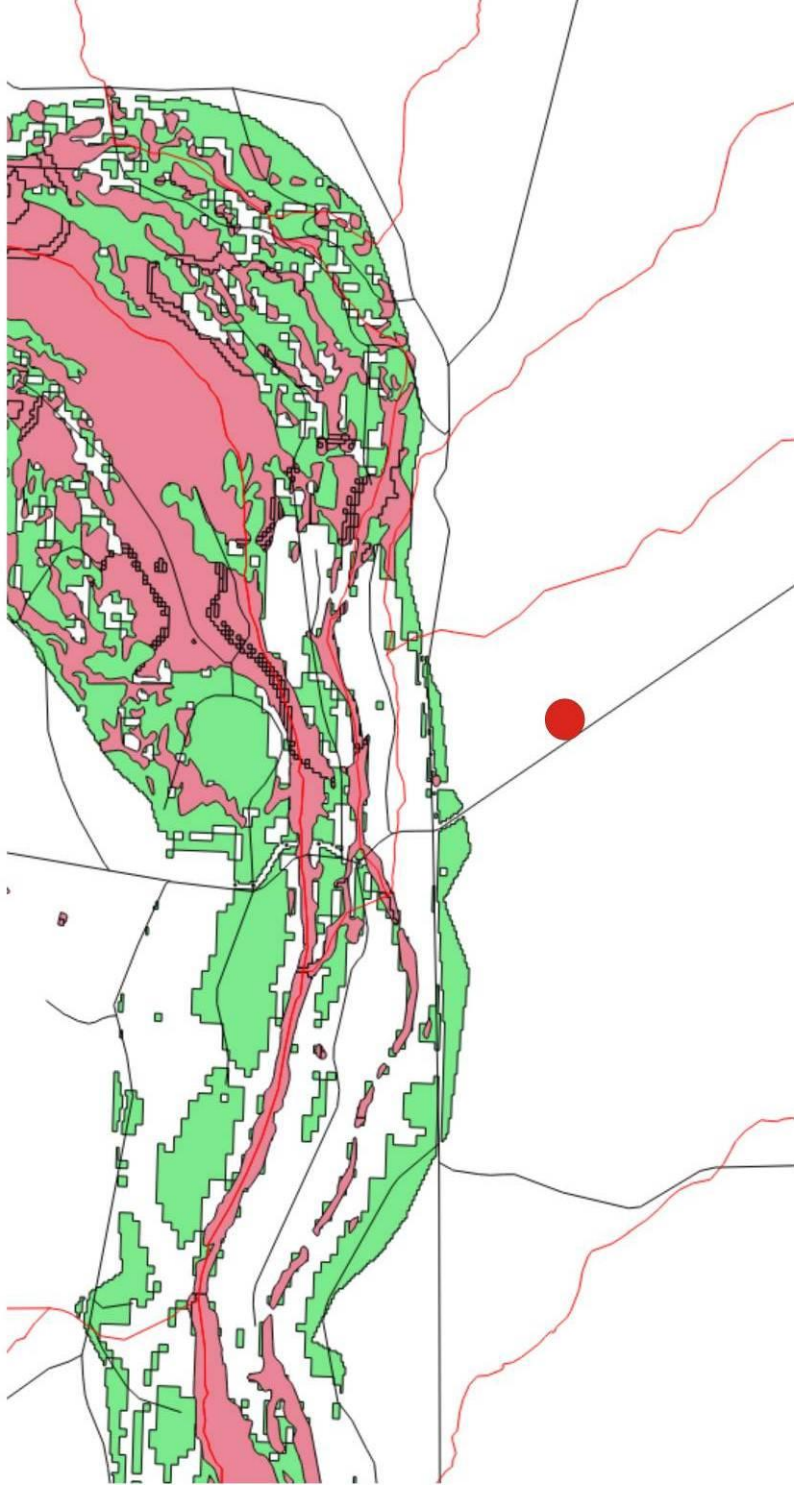
Sensitivity map for the proposed establishment of the Lennertsville Graveyard, Northern Cape Province.

Map 2: Sensitivity map of the proposed establishment of the Lennertsville Graveyard, Northern Cape Province. Areas consisting of Threatened Ecosystems, National Freshwater Ecosystems Priority Areas (NFEPA) rivers and wetlands are indicated. Note that the site does not fall within any of these areas. The region also does not contain any Strategic Water Source Areas (SWSA), National Protected Areas Expansion Strategy (NPAES) Focus Areas or Important Bird Areas (IBA).

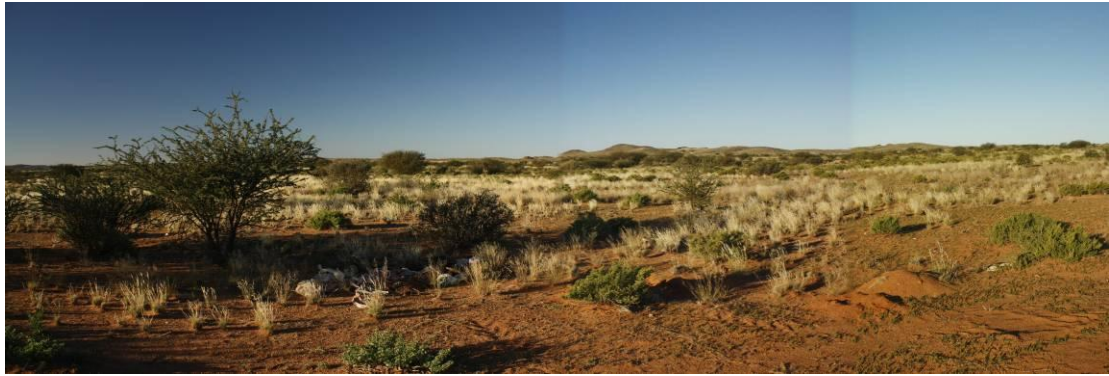
Figure 1: Panorama of the site. The percentage ground cover is relatively low due to the aridity of the area. Note scattered small trees and shrubs. The vegetation is dominated by white grasses including *Stipagrostis spp.*

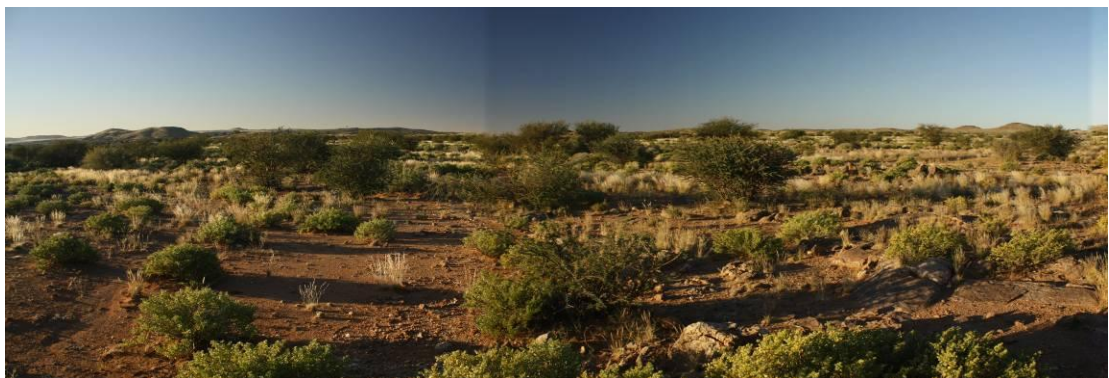
Figure 2: Panorama of the site. The percentage ground cover is relatively low due to the aridity of the area. Note scattered small trees and shrubs.

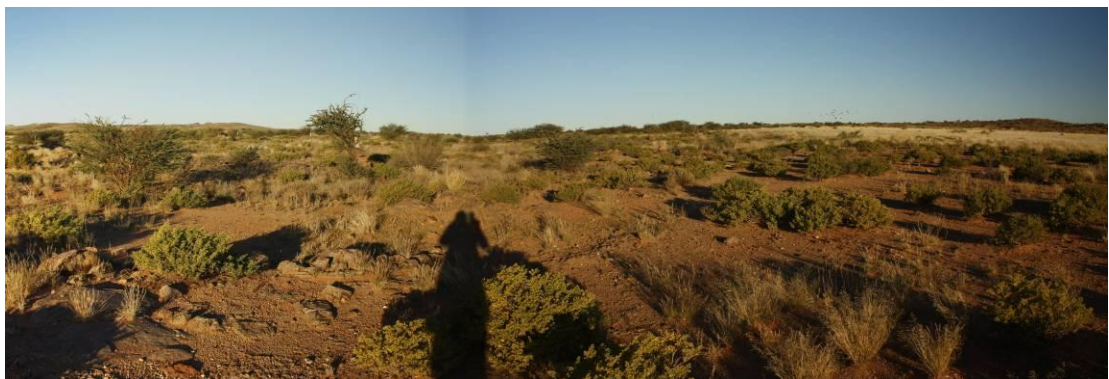
Figure 3: Panorama of the site. The percentage ground cover is relatively low due to the aridity of the area. Note scattered small trees and shrubs.

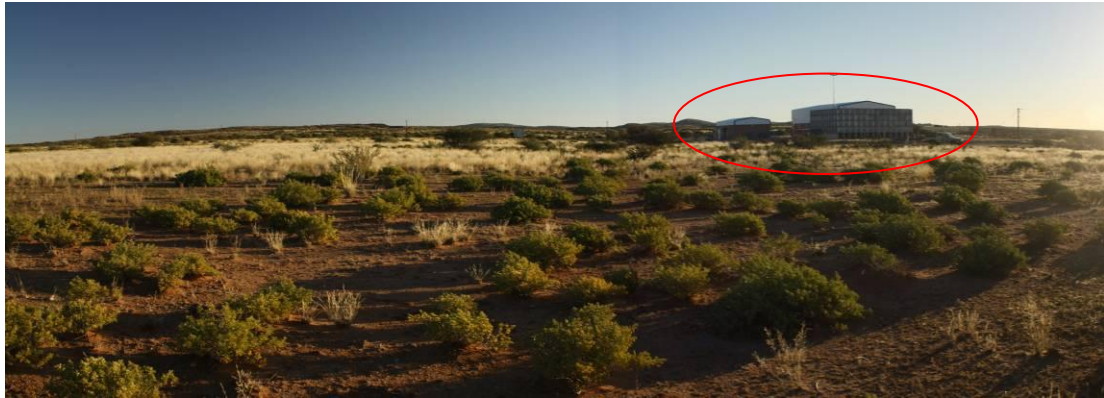
Figure 4: Panorama of the site. The percentage ground cover is relatively low due to the aridity of the area. Note scattered small trees and shrubs. Note adjacent buildings (red).

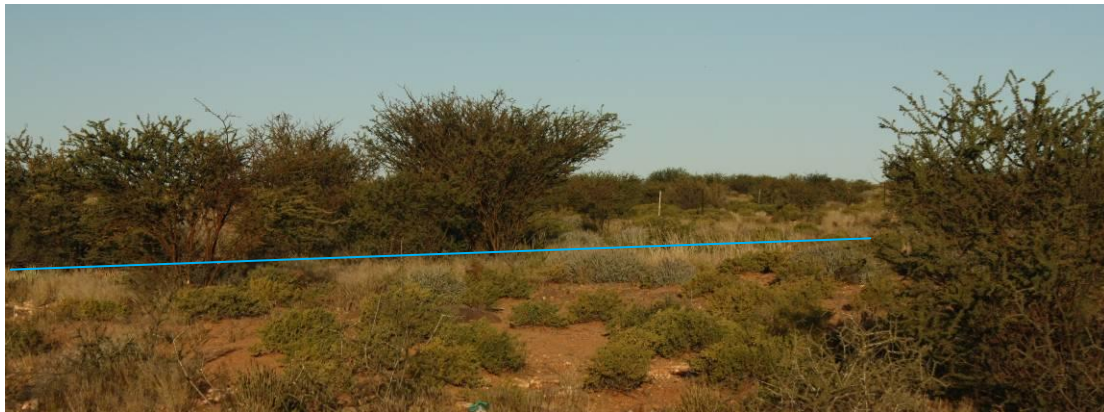
Figure 5: View of the drainage line on the site (blue).

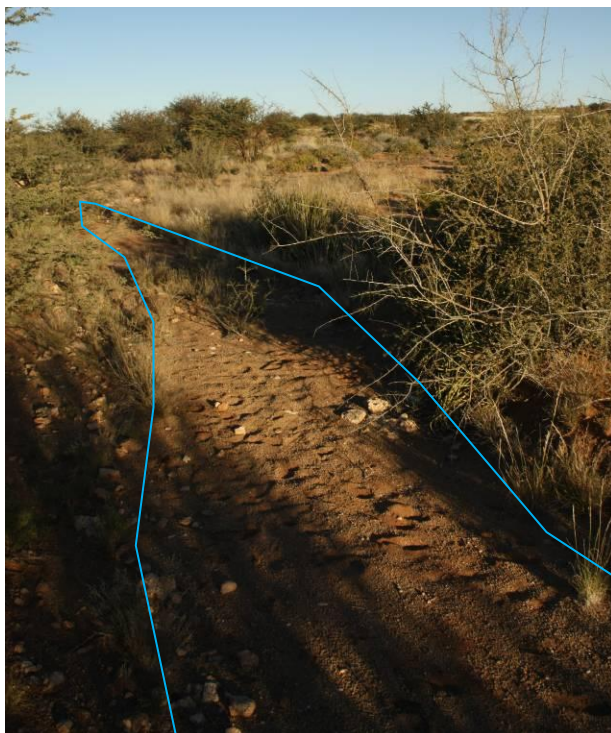
Figure 6: View of the drainage line on the site (blue). This illustrates the main channel of the drainage line.
