3. DESCRIPTION OF THE PRE-MINING ENVIRONMENT

Belfast Silica Mine is located on the Remaining Extent of Portion 1 of the farm Klipfontein 385 JS and is situated approximately 8 km north west of Belfast and Siyathuthuka (Figure 2.1). The mine has an approved mining right area of 19.19 ha as indicated in Figure 2.2a.

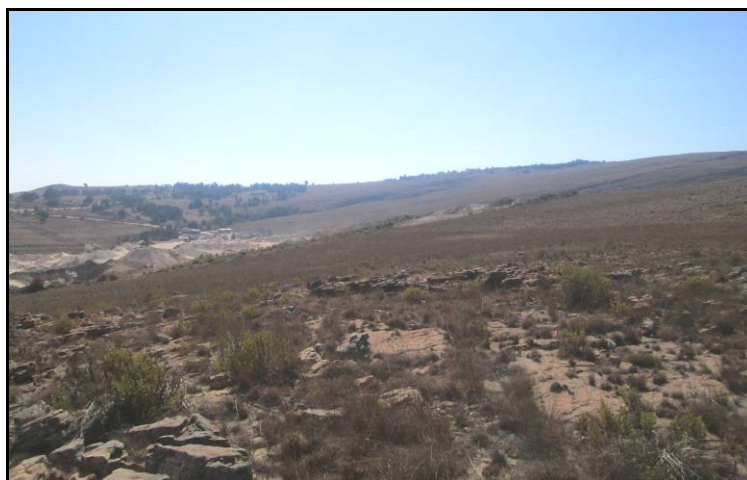
Photo 3.1: Westerly/northwesterly slope towards the existing quarries

This area slopes steeply in a westerly/northwesterly direction towards the existing quarries (Photo 3.1) and the unnamed tributary (Photo 3.2) extending through the centre of the Belfast Silica Mine area.

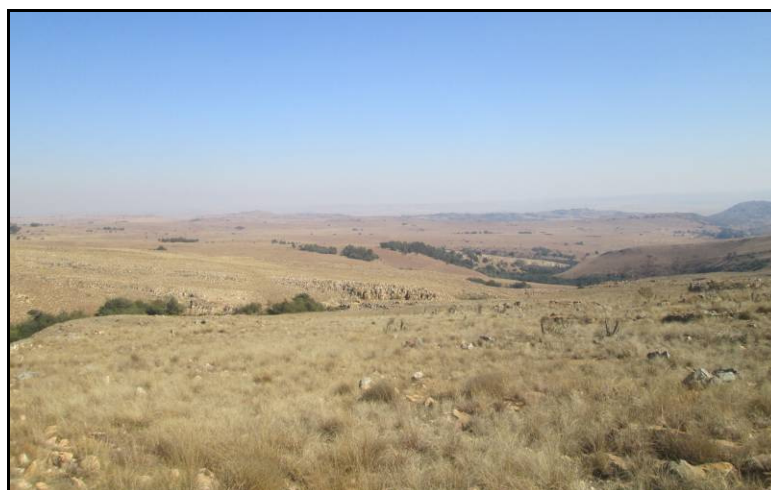
Photo 3.3: Southwesterly slope towards the Langspruit

A portion of the site also slopes steeply in a southwesterly direction towards the Langspruit (Photo 3.3). Relatively flat areas are also present near the boundary of the site (Photo 3.4).

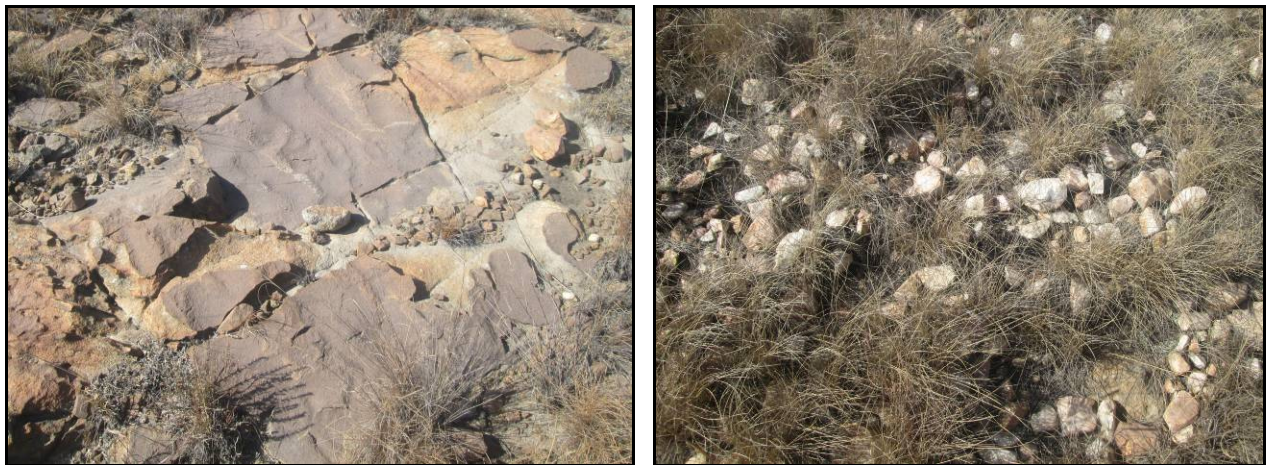
Photo 3.5: Rocky nature of the site

Topsoil or overburden is virtually non-existent at the Belfast Silica Mine since the said site is very rocky (Photo 3.5). This is also the case for the proposed extension area.

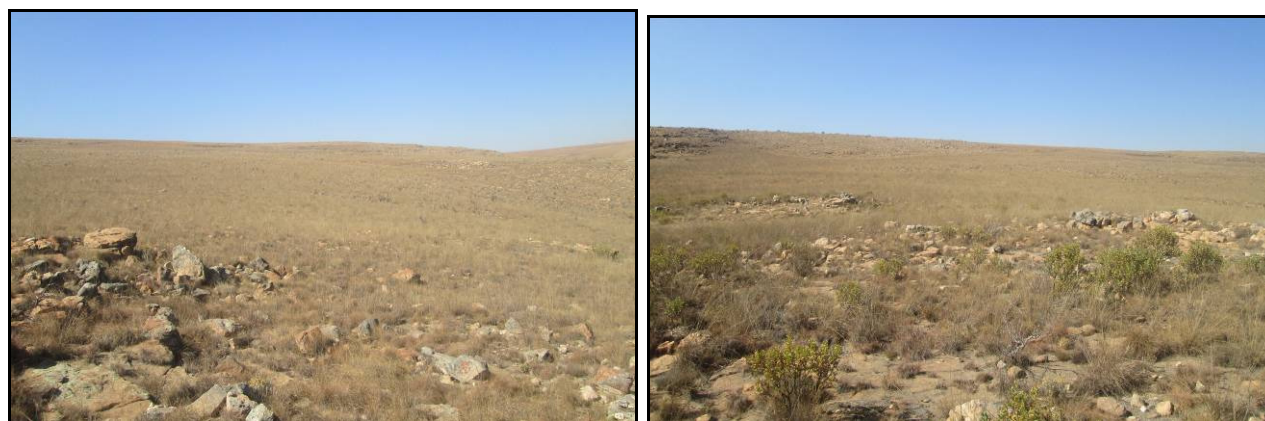
Photo 3.6: View of the vegetation on site

The proposed extension area is also characterised by the presence of Lydenburg Montane Grassland, which is of low height (approximately 30 - 50cm in height) and rich in forb species. This vegetation has not been impacted by the existing mining operation and can be seen as almost pristine (Photo 3.6). No alien plant species (which indicate disturbance) were noted within the proposed extension area.

Boat grass (*Monocymbium ceresiiforme*) was noted to be dominant while in areas, the Monkeys tail (*Xerophyta retinervis*) was dominant. A lone protea shrub (*Protea* sp.) and the shrub, *Lopholaena coriifolia*, were noted near the boundary of the site.

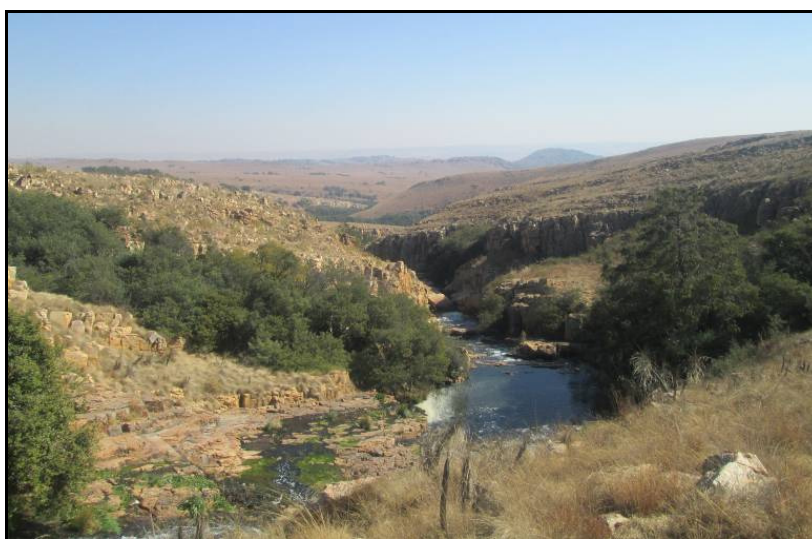
Photo 3.8: View of the Langspruit

The Langspruit is located to the west of the Belfast Silica Mine site as indicated in Figure 3.14 and Photo 3.8. This river is characterised by a rocky base resulting in the presence of rapids, waterfalls and rock pools. From the site visit, it was evident that this river is polluted with sewage (Photo 3.9) and is heavily invaded by alien plant species (e.g. *Acacia* sp.) (Photo 3.10). Wetlands would also be associated with this system.

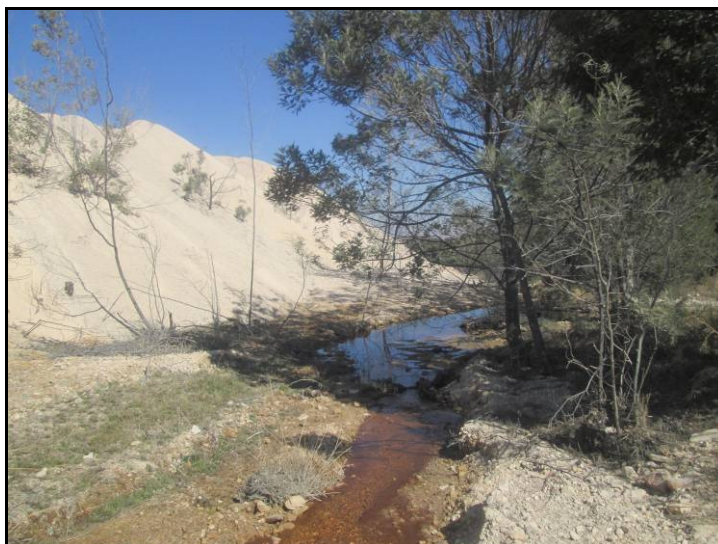
Photo 3.11: The unnamed tributary of the Langspruit

A non-perennial, unnamed tributary of the Langspruit flows through approximately the centre of the site (Figure 3.14 and Photo 3.11). This tributary/stream is fed by a number of drainage areas and a fountain as indicated in Figure 3.14. Wetlands would be associated with this system.

- ♣ Construction of two roads (with drainage pipes) across the stream and drainage area/wetland.
- ♣ Excavation of a small dam (12m x 3m x 1m deep) within the drainage/wetland area (east of the site; Figure 3.14).
- ♣ Placement of product stockpiles on the banks of the stream resulting in sand and gravel being washed into the stream during heavy downpours (Photo 3.11).
- ♣ Presence of black wattle and silver wattle trees (Photo 3.11).

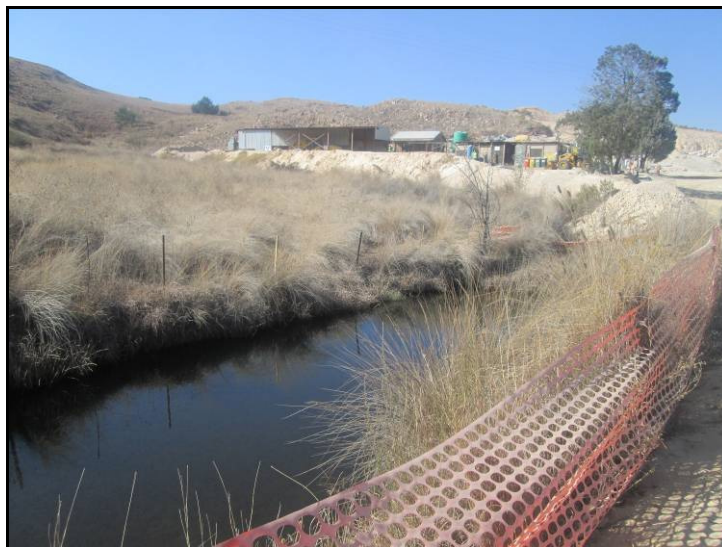
Photo 3.12: Small dam in drainage area

According to the mine, the surface water quality of the unnamed tributary is of good quality. Water for domestic purposes is obtained from the fountain located on the adjacent property (Figure 3.14). Water is also abstracted from the small dam located in the drainage area for dust suppression purposes (Photo 3.12).

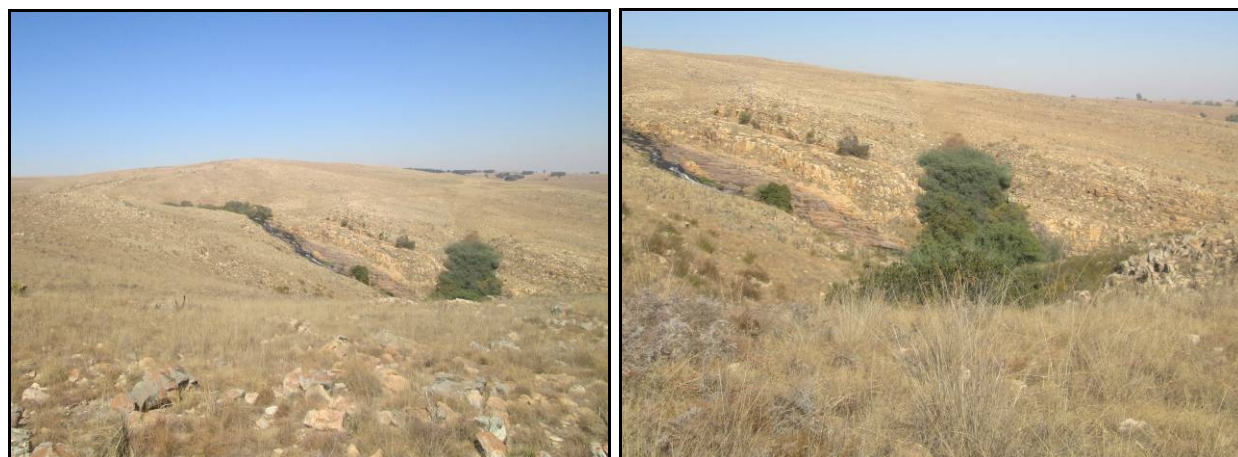
Photo 3.13: Seepage area (associated with geological fault) flowing into the Langspruit

No surface water environments (rivers/streams) are present within the proposed extension area. A seepage area that flows into the Langspruit (Figure 3.14 and Photo 3.13) was however noted to the west of the proposed extension area. This seepage area appears to correspond with a geological fault that extends within the proposed extension area (Photo 3.13). The seepage area is well vegetated and has not been impacted by mining activities to date.
