# ECOLOGICAL IMPACT ASSESSMENT

CONSTRUCTION OF A
RESIDENTIAL DWELLING AT
PORTION 358 OF LOT 61,
SHEFFIELD BEACH, KWADUKUZA

# ECOLOGICAL IMPACT ASSESSMENT FOR THE PROPOSED RESIDENTIAL DEVELOPMENT AT PORTION 358 OF LOT 61, SHEFFIELD BEACH, KWADUKUZA

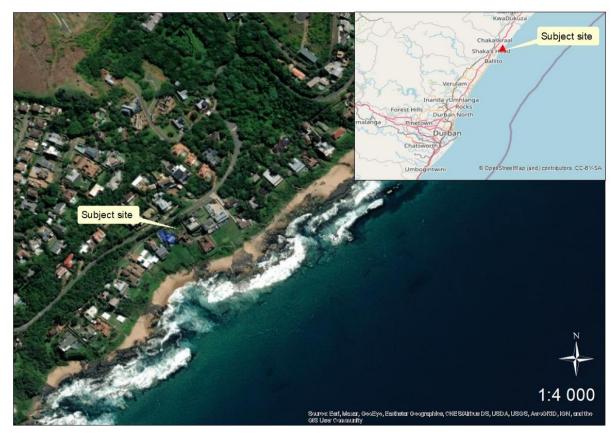
**Figure 1.** A map showing the study area from a regional and local perspective.

The subject site lies within Sheffield Beach, a residential suburb within the KwaDukuza Municipality (see Figure 1 above). Sheffield Beach is a relatively recently developed, urban settlement with its first formal structures being established during the early 1900s. Much of the natural terrestrial components of the sand sharing system have become stabilised or highly transformed, altering the dynamism within the sand sharing system.

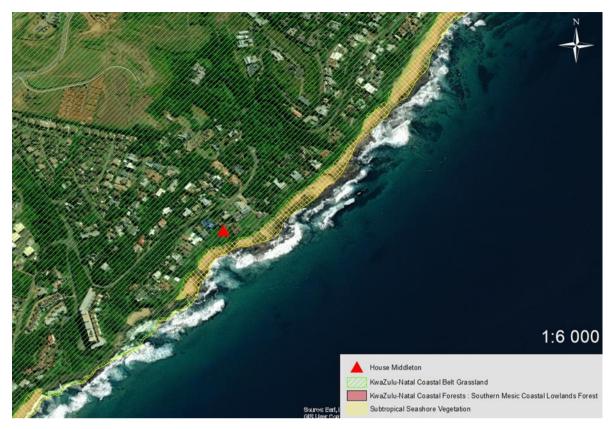
Figure 6. Map showing site in relation to prevailing vegetation forms (source: SANBI 2018).

From a terrestrial perspective, the study site falls within two biomes: KwaZulu-Natal Coastal Belt Grassland and Subtropical Seashore vegetation (Mucina and Rutherford 2006) (Figure 6). These vegetation types are considered "Critically Endangered" and "Least Threatened", respectively (SANBI 2018). KwaZulu-Natal Coastal Belt is described as a highly dissected undulating coastal plain environment, which was historically covered by subtropical coastal forest (Mucina and Rutherford 2006). As much as 50% of this vegetation type has been transformed for cultivation, urbanisation, and infrastructure. The study area also falls on Subtropical Seashore vegetation which is characterised by recent/young coastal sandy sediments which form beaches and dunes that support herbaceous and dwarf-shrubby vegetation (Mucina and Rutherford 2006). Dominant species common to this vegetation type typically include *Scaevola plumieri*, *Phylohydrax carnosa*, *Gazania rigens* and *Canavalia rosea*.

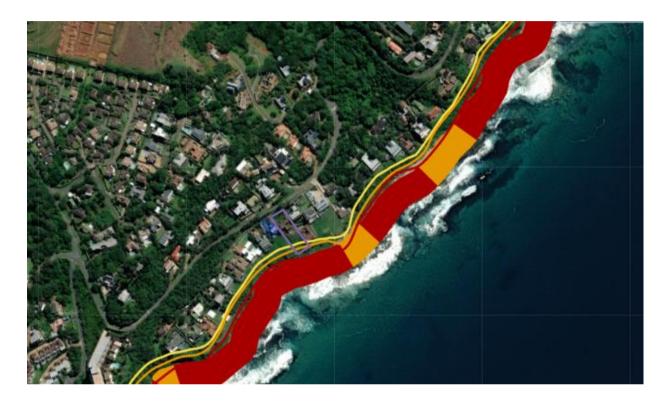
**Figure 8** Results from the Coast KZN database (<a href="http://www.coastkzn.co.za/">http://www.coastkzn.co.za/</a>) showing the risk lines and coastal vulnerability index associated with the study area.

According to the Coast KZN database, the study site falls within a long-term (100 year) risk category and is under "High Risk" in terms of the Coastal Vulnerability Index (<a href="http://www.coastkzn.co.za/">http://www.coastkzn.co.za/</a>) (Figure 8). Vulnerability is measured according to a number of parameters relating to the width, function and integrity of the coastline. Notably, few sites are considered to be of "low" vulnerability in KwaZulu Natal. Sites considered "high" risk are those that have an increased probability in terms of erosion, sea level rise and susceptibility to extreme events (Palmer et al. 2011).

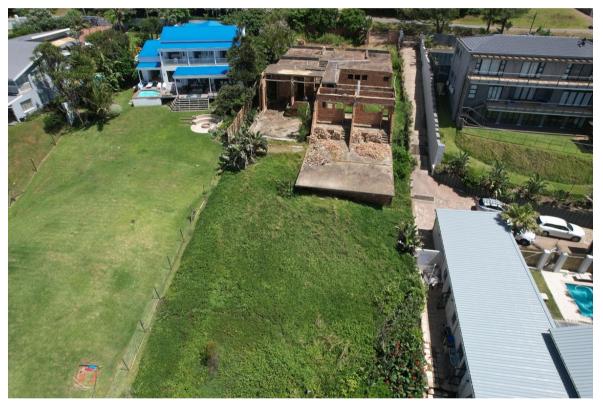
Figure 9. An aerial image showing the general nature of Portion 358 of Lot 61, Sheffield Beach.

The coastal properties along Sheffield Beach are fringed by rocky promontories and inshore reefs extending throughout this stretch of coastline. The study site at Portion 358 of Lot 61 Sheffield Beach lies upon an elevated paleo dune complex underlain by a fractured sandstone geology with dolerite intrusions, which are associated with the numerous small embayment's along this stretch of coastline. The nature of the subject site can be divided into two areas, namely a more landward portion of dune form comprising of deep, consolidated clayey sands and a more seaward landform comprising of unconsolidated sands of marine origin. Much of the existing structures lies on the upper, stable dune form (Figures 9).

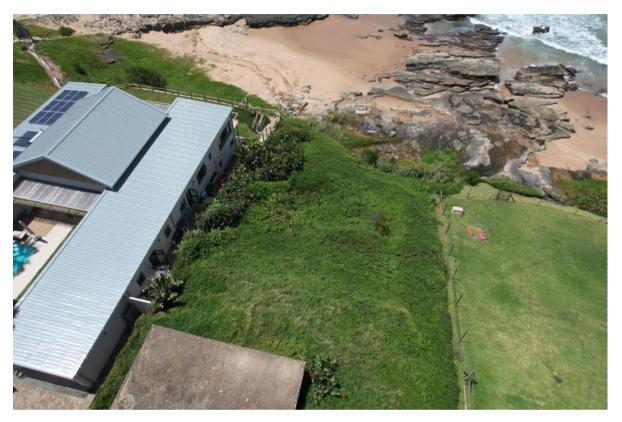
**Figure 10.** Aerial image of site showing established platform and frontage as well as beach environment. Note the homestead on northern property (left hand side) which lies in a former wetland environment, with diversion of flows being undertaken.

As such, this situation places the built structures at approximately 40m from the high-water mark of the sea, which in turn lies on a sandstone scarp overlain by generally consolidated sandy clays of the Berea Red Formation. Notably, the structures are also elevated at nearly 20m amsl. The shoreward extent of the property lies at approximately 2.5m above the beach with a distinct rocky scarp being present (Figure 10). Under high storm conditions, waves reach to the toe of the scarp. Above this sandstone scarp lies a perched wetland environment, a feature common to this area, where shale and sandstone fractures direct flows into the lower strata, near the beach. This portion of land immediately above the scarp can be described as a 'perched wetland seep' environment. This wetland environment has

however, been subject to significant transformation on account of urban development in the area and on the subject property, where it has been drained and levelled. In addition, a structure has been established on the neighbouring property in close proximity to the shore, which in itself, serves to transform the nature of the shoreline and scarp, while during its construction, has required the draining of wetland and diversion of seep.

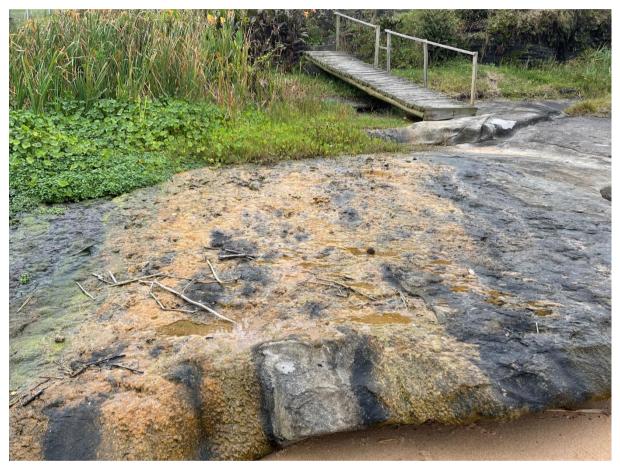
**Figure 11.** Image showing algal response on beach due to high nutrient discharge from freshwater systems.

Notable, however, is the evident brown algal growth within the intertidal and supra tidal rock forms associated with the shoreline. Such algal growth is likely to be attributable to eutrophication of the discharge waters arising from the terrestrial wetland environments fringing the beach. While no microbial analysis was undertaken to confirm such, it is believed that discharge from the numerous

septic tanks along this portion of coastline is responsible for this state and not only serves to alter the supra tidal ecology but is likely to pose a threat to the recreational use of the beach. In addition, it is also clear that while some pathogens may be addressed through the percolation system of septic tanks, nitrates and other nutrients are not. Such nutrients are thus driving the eutrophication of this environment and according to recent research, are responsible for impacts in marine invertebrates (Klein 2021).

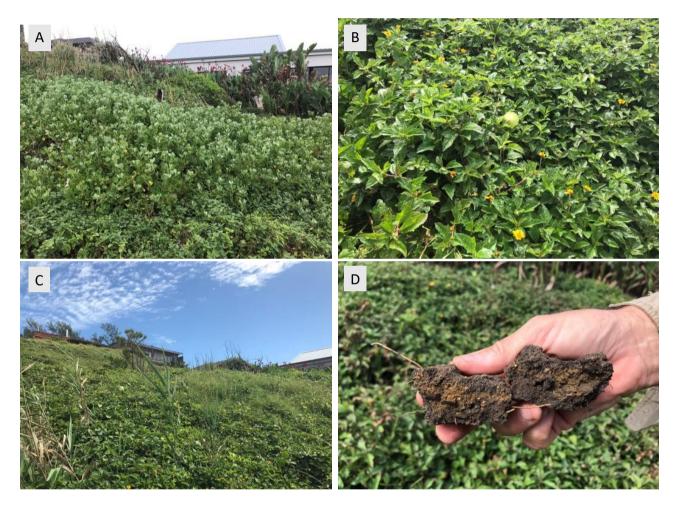
**Figure 12.** A) Chrysanthemoides monilifera along the rear of the dune; B) Category 1b invasive, Sphagneticola trilobata, present throughout much of the site; C) Typha capenis and Pennisetum purpureum indicating flow within the dysfunctionalized wetland; D) "Mottling" of desiccated soils on site, indicative of a wetland environment.

Immediately above the beach and atop the scarp the prevailing landform presents a thin veneer of aeolian sands which interface with a desiccated wetland seep. This environment is dominated by the dune pioneering species *Chrysanthemoides monilifera* and more landward, *Tephrosia purpurea* with the exotic *Sphagneticola trilobata*, being dominant in and above the dysfunctional wetland. *S trilobata* is a category 1b invasive species (Figure 12). Common dune species, namely *Strelitiza nicolai* and *Brachylaena discolor* are also encountered along the western extent of the property. Notably, the exotic *Canna indica* dominates within drains and seeps to the northeast of the property.

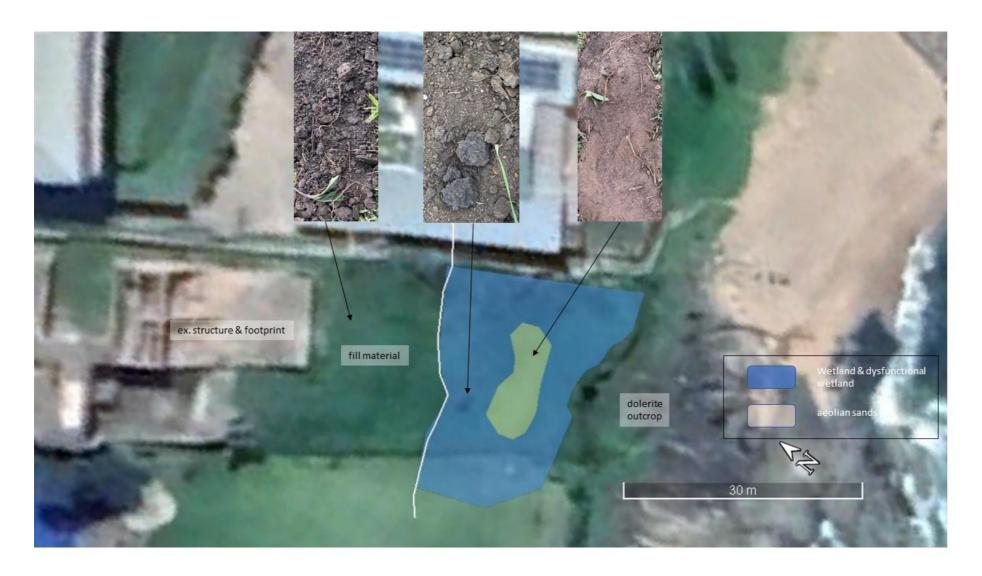
Annexure C -Wetland and other soil indicators found on site together with selected ecological features.

Annexure C indicates the broader landscape context of the site, with the relic wetland and seep environments, areas of aeolian sands and areas of infill. This image indicates that the development footprint of the proposed "new" structure lies to the lee of the identified wetland environment, however both sewer and stormwater will have to be accommodated within the seaward extent of the property.
