**PROPOSED NEW DOUBLE STOREY HOUSE
WITH LOFT APARTMENTS & SWIMMING POOL**

PORTION 292 OF FARM LOT 61 No 1521, SHEFFIELD BEACH

Geotechnical Report

July 2021

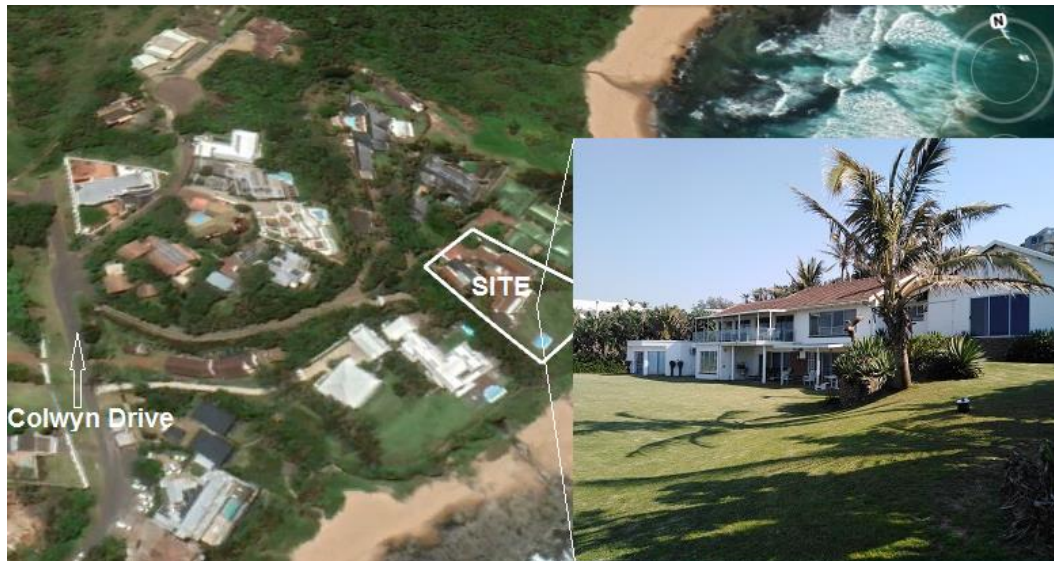
Figure 1: View of the location of the project area at number 99 Colwyn Drive, Sheffield Beach

The property is pie shaped and elongated along northwest – southeast axis. The site is surrounded to the east and south by the beach, to the northwestern by Colwyn Drive and to the north by existing properties (Figure 1).

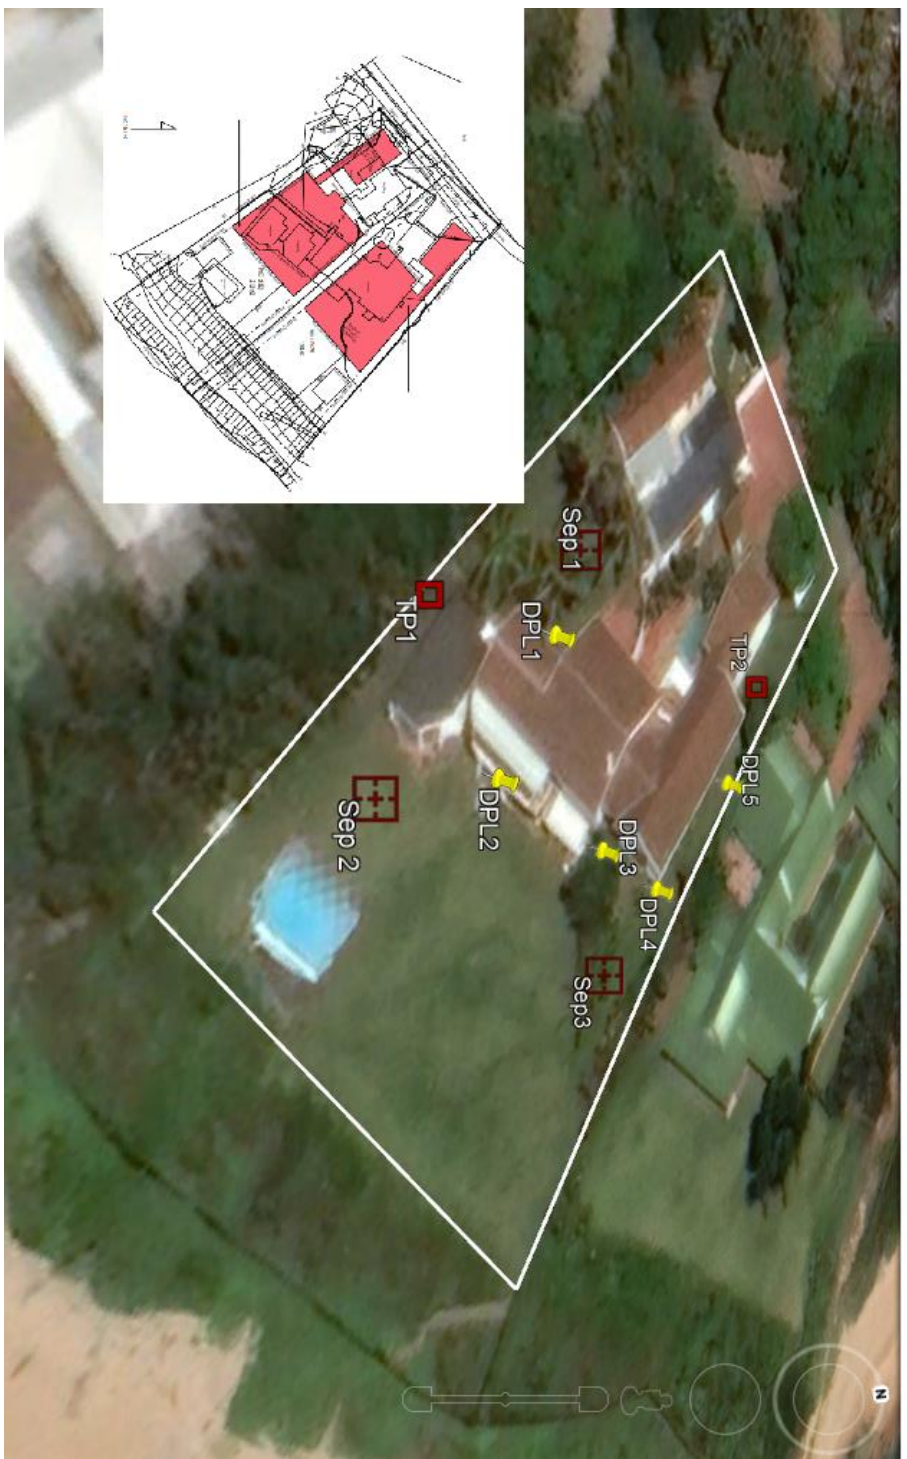
FIGURE 2: VIEW OF THE PROJECT AREA – 99 COLWYN DRIVE, SHEFFIELD BEACH

During the fieldwork, we have been told by the gardener that 3 septic tanks are possibly located in the areas presented in Figure 2.

The DPL tests were performed to determine the consistency of the subsurface soil materials and for the derivation of the soil bearing capacities across the site. The DPL tests were carried out at the approximate positions shown in Figure 2 of Appendix A.

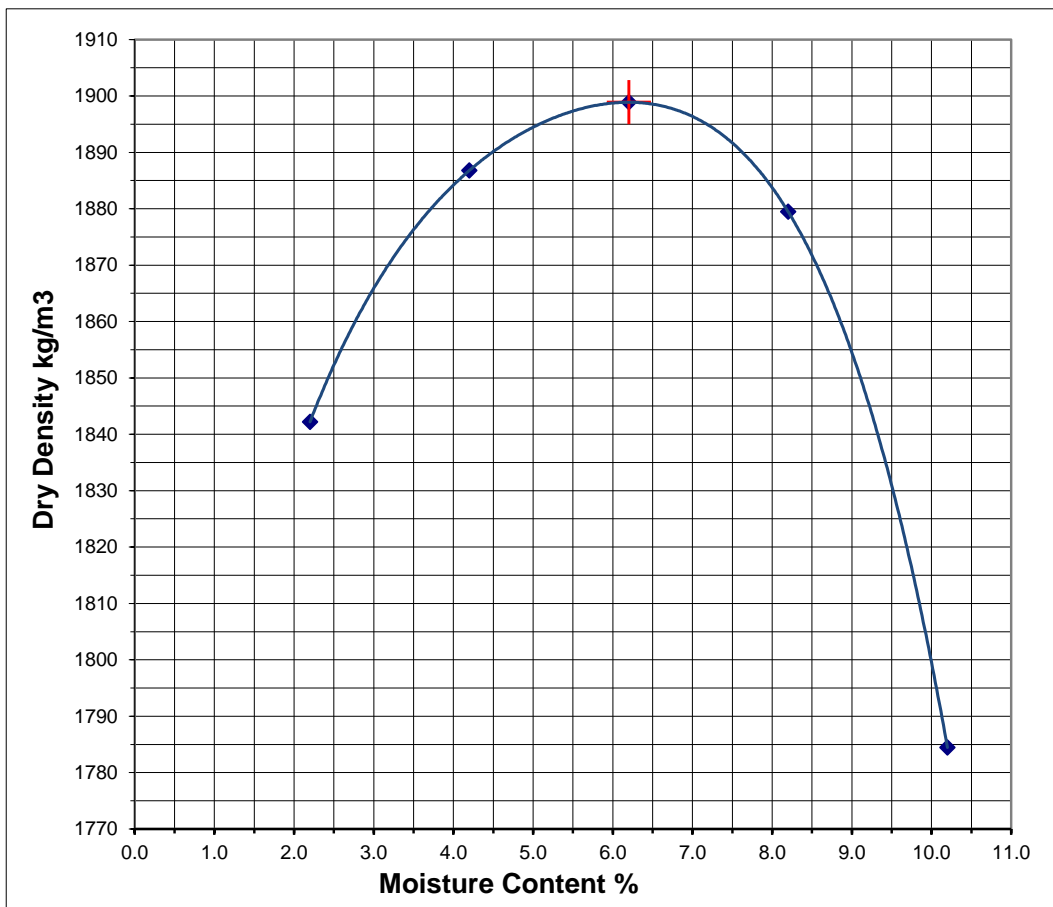
Sample Position (SV)		TP2
Depth (mm)		1000 - 1400
Sample No		1748
Materials Description	Source	In-situ
	Colour	Dark Brownish Grey
	Soil Type	Poorly Graded Silty SAND
	Classification	-

Maximum Dry Density (kg/m ³)	1899
Optimum Moisture Content (%)	6.2

- The laboratory results show that the poorly silty sand has moderate maximum dry density and moderate optimum moisture content. The soil sample yielded adequate CBR values at densities typically specified in the field (90% to 93%).
- The in-situ moisture content of 4.9% indicates that the soils were dry than the optimum moisture content at the time of sampling and will require additional water to achieve an Optimum Moisture Content of 6.2%.

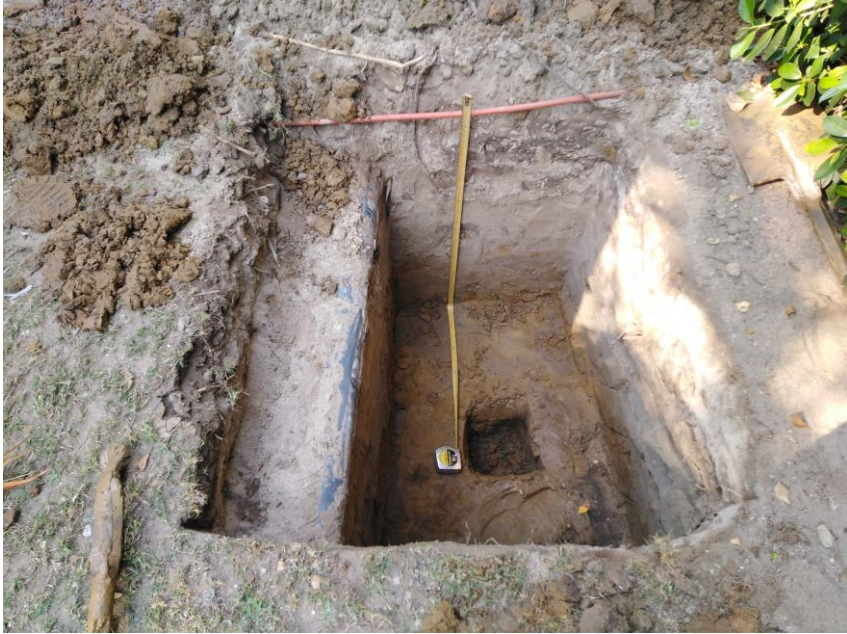
Description : TP1 Illustration of the side walls and depth of the trial pit TP1. Depth: 0.00 – 1.00m.			
Client Name : Mr. Rob Emmanuel		Project: Proposed New Double Storey House	
Project : MB 3627			
Photo No :2	Date : 20/05/2021

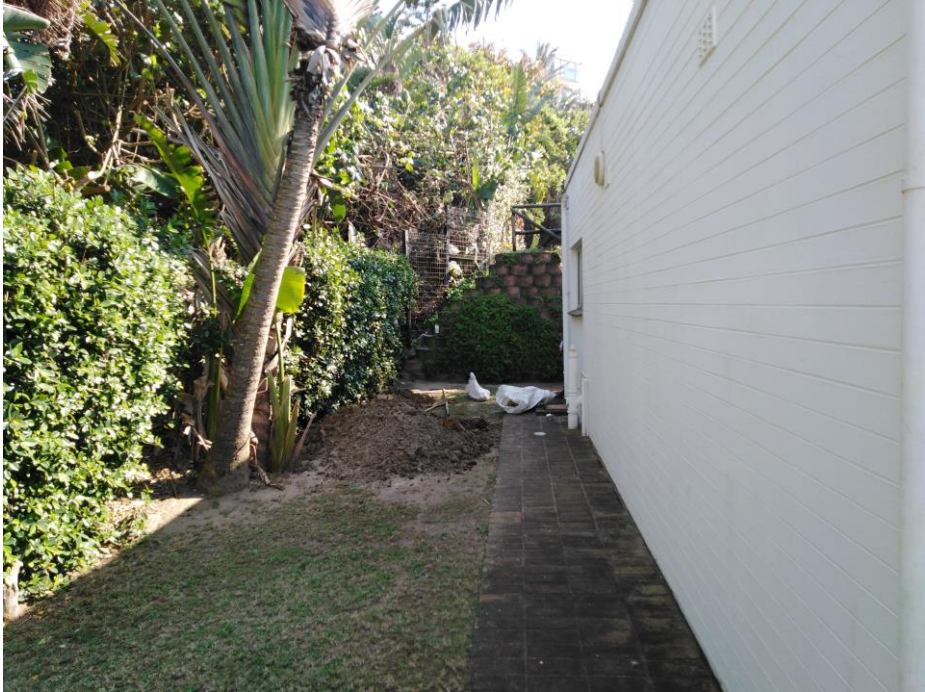
Description : TP1 Illustration of the area where TP1 was dug.

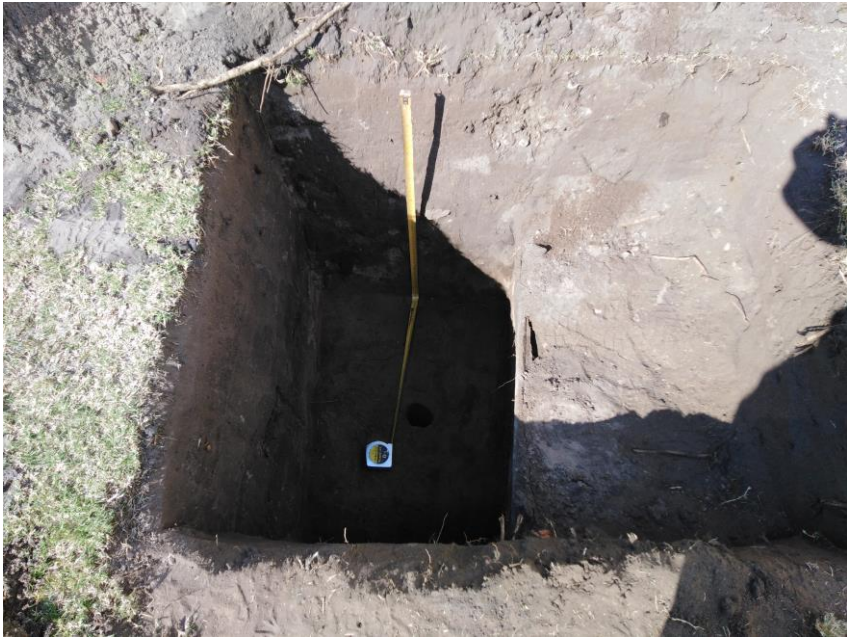
Description : TP2			
Illustration of the side walls and depth of the trial pit TP1. Depth: 0.00 – 1.00m.			
Client Name : Mr. Rob Emmanuel		Project: Proposed New Double Storey House	
Project : MB 3627			
Photo No :4	Date : 20/05/2021

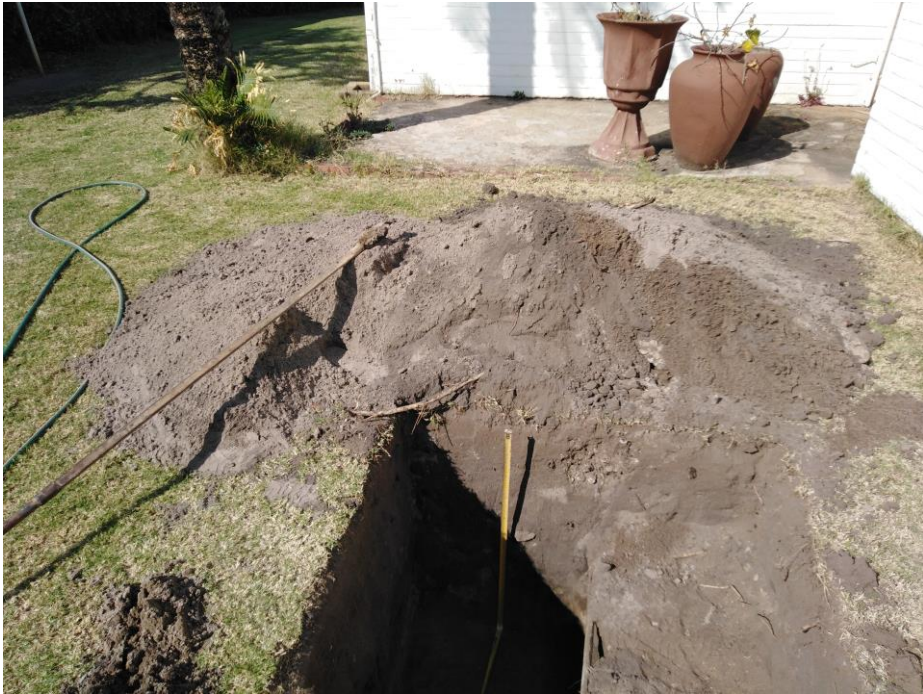
Description : TP2			
Illustration of the stockpile dug in TP2.

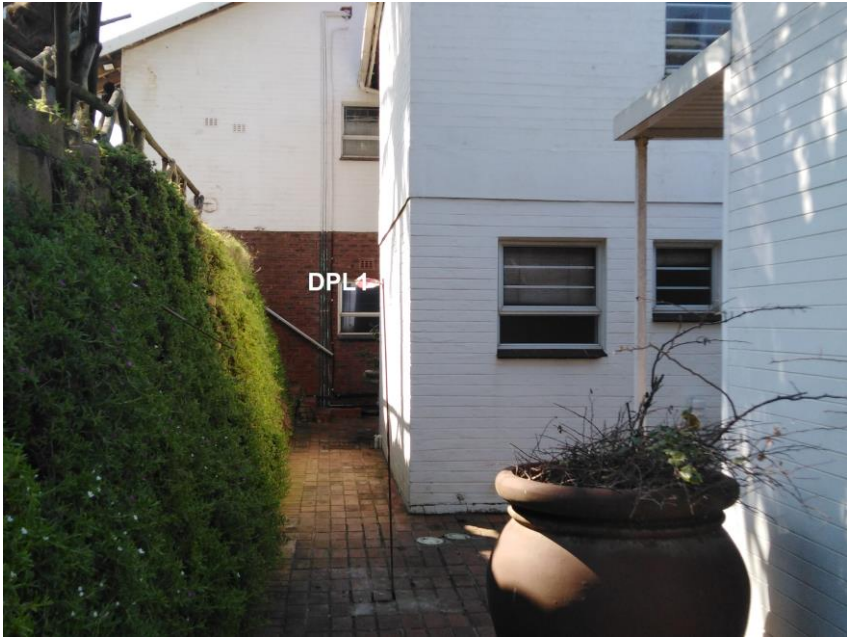
Description : Illustration of the location of the DPL test DPL1			
Client Name : Mr. Rob Emmanuel		Project: Proposed New Double Storey House	
Project : MB 3627			
Photo No :6	Date : 20/05/2021

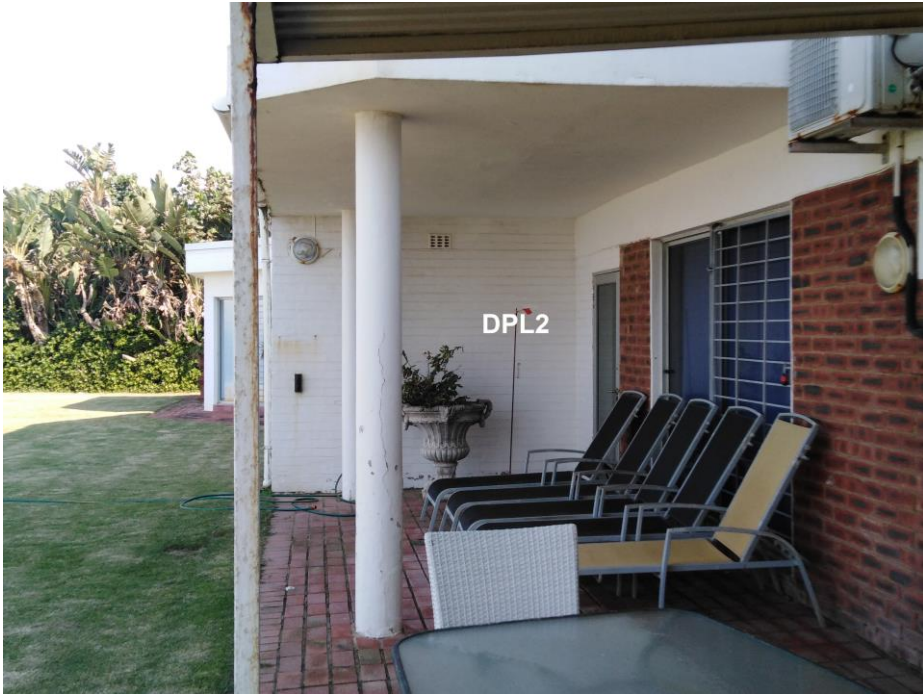
Description : Illustration of the location of the DPL test DPL2

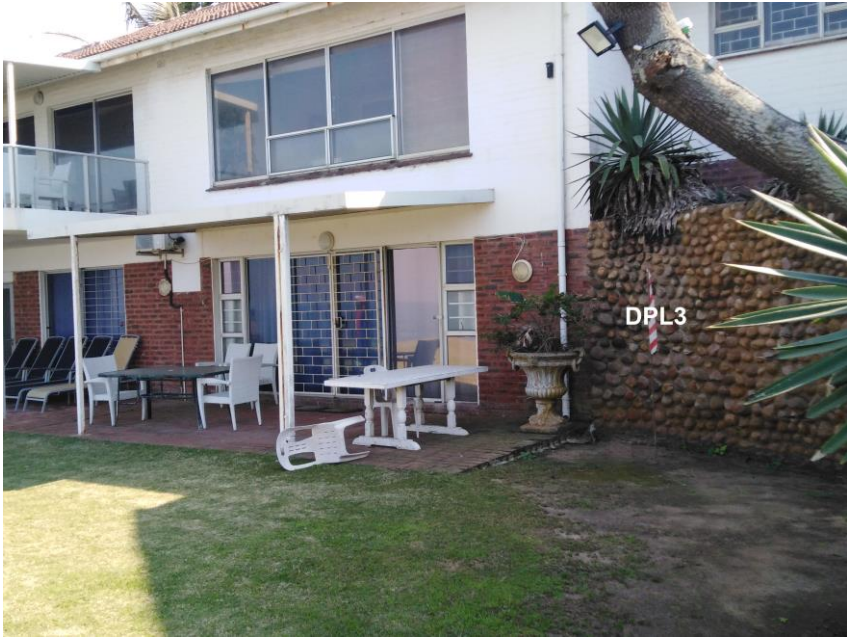
Description : Illustration of the location of the DPL test DPL3			
Client Name : Mr. Rob Emmanuel		Project: Proposed New Double Storey House	
Project : MB 3627			
Photo No :8	Date : 20/05/2021

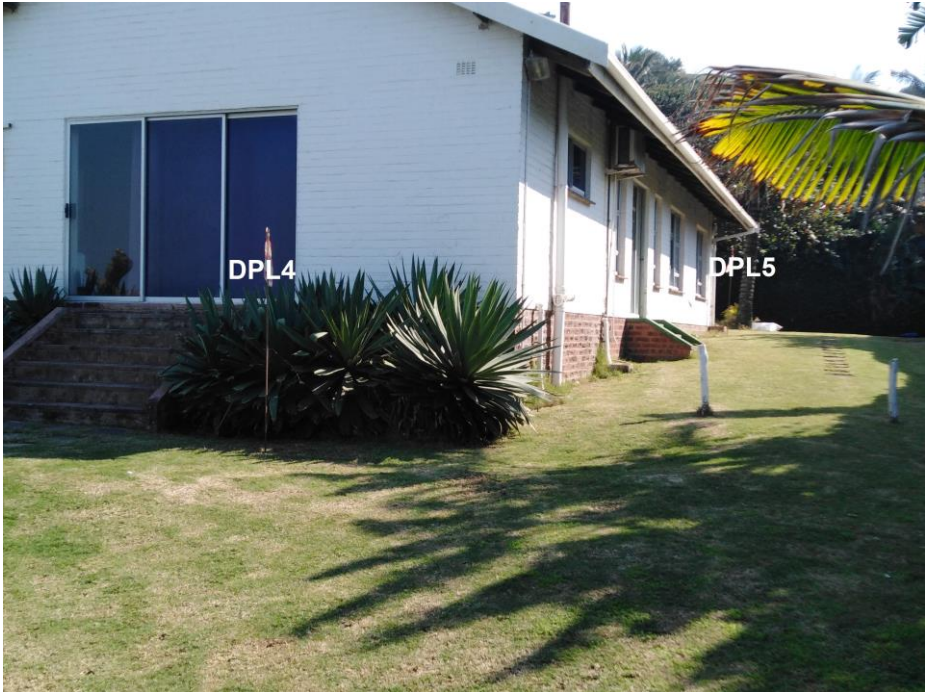
Description : Illustration of the location of the DPL test DPL4 & DPL5
