**DOLOMITIC STABILITY &
GEOTECHNICAL INVESTIGATION**

**FOR THE PROPOSED EXTENSIONS TO
SPRINGS FRESH PRODUCE MARKET**

Report No. 3546

October 2017

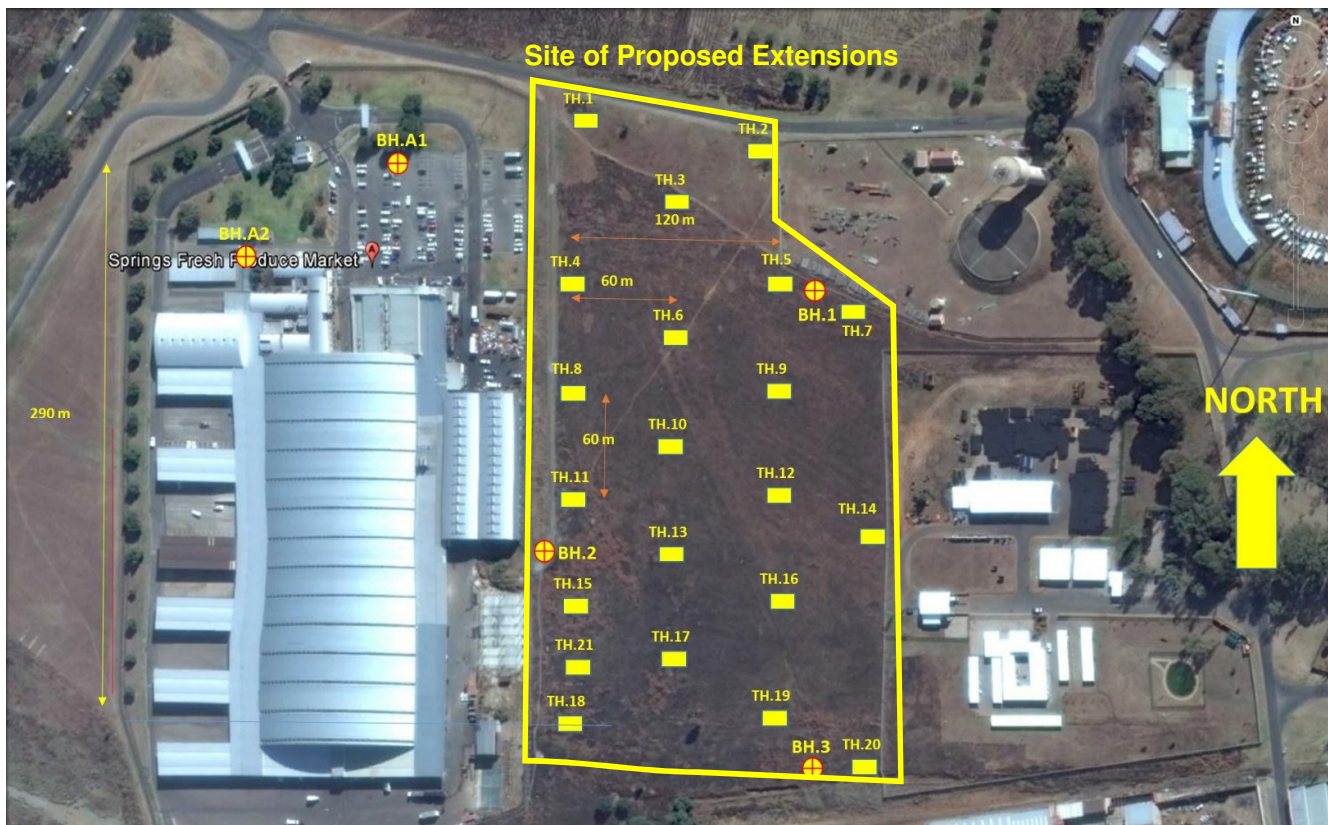
Figure. (i): Satellite Image Showing Positions of Boreholes and Trial Holes

6.2.1 In order to establish the deep subsoil conditions and dolomitic stability of the site to be occupied by the proposed market extensions, 3 boreholes, referenced BH.1 - BH.3, were drilled to cover the site. Their position is shown on the attached satellite image, Figure (i) and 3(a) and the Site Plan, Figure 3 (b). The chip samples recovered were subsequently logged in detail and the results are shown in the borehole logs, Figures 4 - 6.

- 7.1.1 The near-surface field exploratory work was carried out during the period from 1-2 June 2017, and comprised the excavation, detailed examination and sampling of 21 exploratory trial holes at the positions referenced TH.1 – TH.21 and on the attached site plan Figure 3. A powerful Sumitomo excavator was used for this purpose.
- 7.1.2 It should be noted that the trial holes were excavated in accordance with the original project layout, which has since changed.
- 7.1.3 Each of the holes was examined in detail immediately after excavation and the resulting trial hole logs are shown in Figures 7 - 27 of this report.

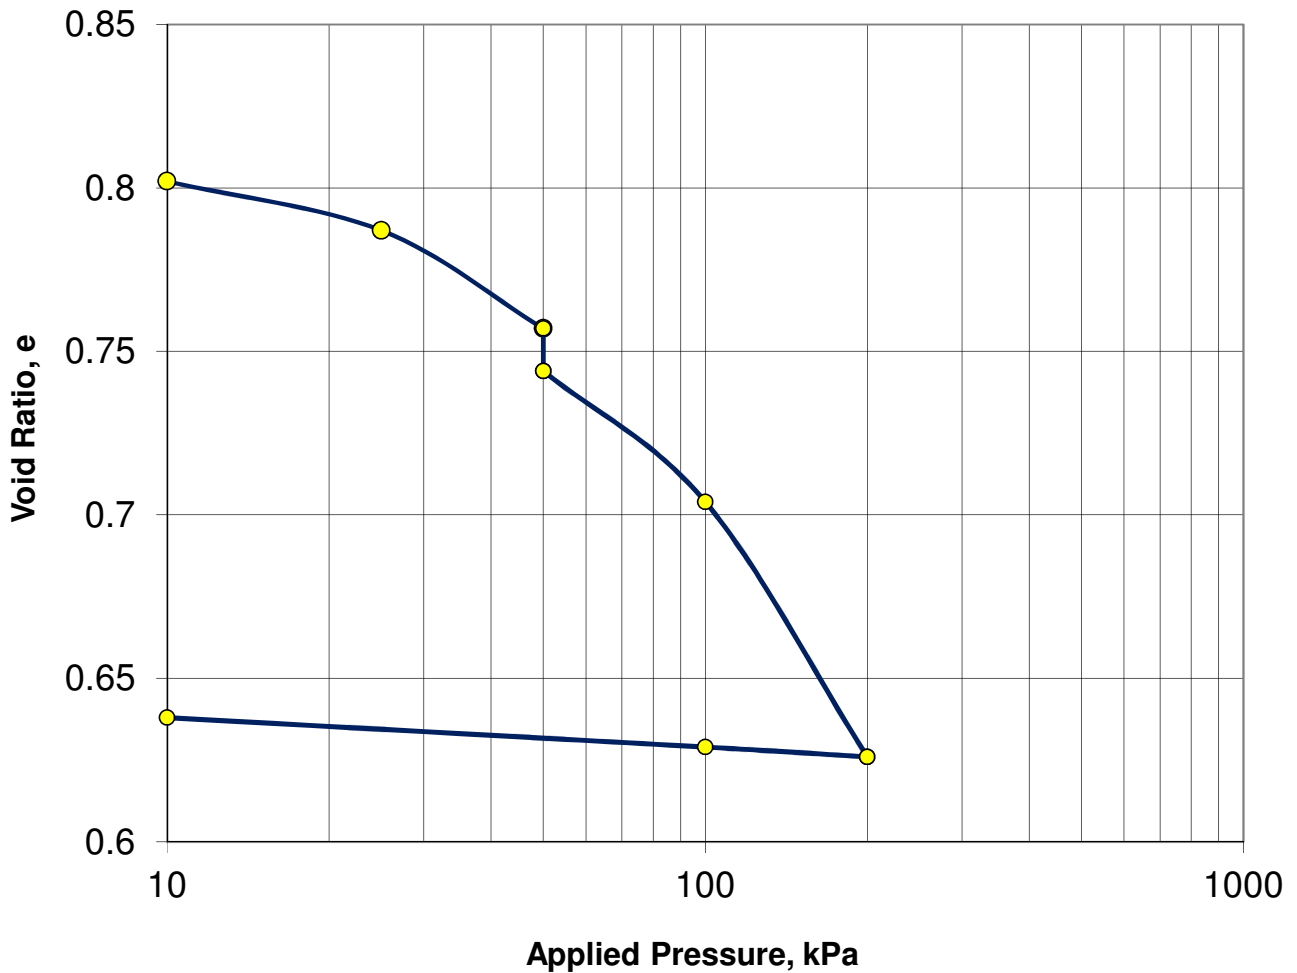
Depth 0.80-1.10 m

APPLIED PRESSURE, kPa	VOID RATIO	APPLIED PRESSURE, kPa	VOID RATIO
10	0.802	100	0.629
25	0.787	10	0.638
50	0.757		
50	0.744		
100	0.704		
200	0.626

- 9.2.7 Oedometer tests carried out on compacted specimens of the near surface hillwash soils at degrees of compaction of 93 - 95% Mod AASHTO dry density at optimum moisture content indicated that their compressibility at the compacted state is improved with the Constraint Modulus varying mostly within the 8 - 9 MPa range. Further analyses of the results, however, suggested that the Constrained Modulus is improved to an average of 10 and 15 MPa corresponding to degrees of compaction of 93% and 95%, respectively, or greater values.
