AMAFA APPLICATION

ERF 8679 DURBAN

38 BAINES ROAD, UMBILO

APPLICATION IN TERMS OF SECTION 37(1)(a) OF THE KWAZULU-NATAL AMAFA AND RESEARCH INSTITUTE ACT (5/2018,) FOR A PERMIT TO ALTER OR ADD TO A STRUCTURE WHICH IS, OR WHICH MAY REASONABLY BE EXPECTED TO BE OLDER THAN 60 YEARS

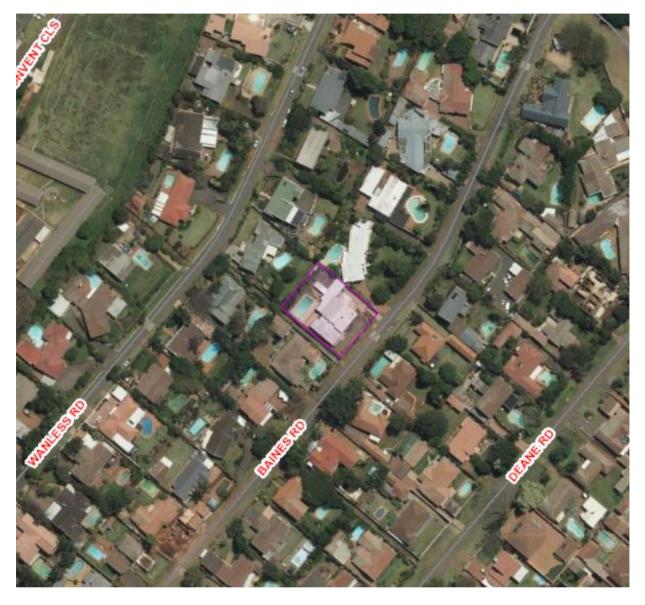
Figure 2 Aerial map indicating view of site and the neighbouring buildings within the vicinity

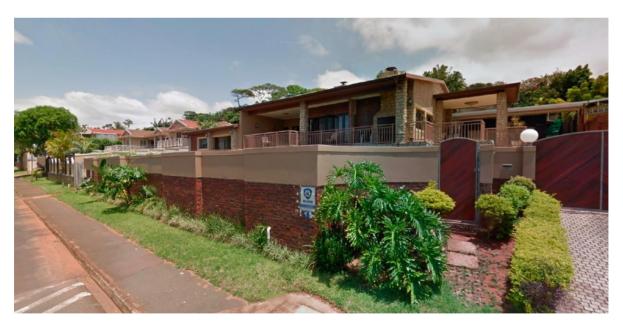
Figure 3 Image of street elevation on Baines Road which depicts exposed face brick and plaster brick boundary wall

The boundary wall on the Baines Road frontage bears similarity with the neighbouring boundary walls as it makes use of exposed face brick and plastered brick. This allows for the wall to be expressive while also maintaining the modest aesthetic that the rest of the street bears.

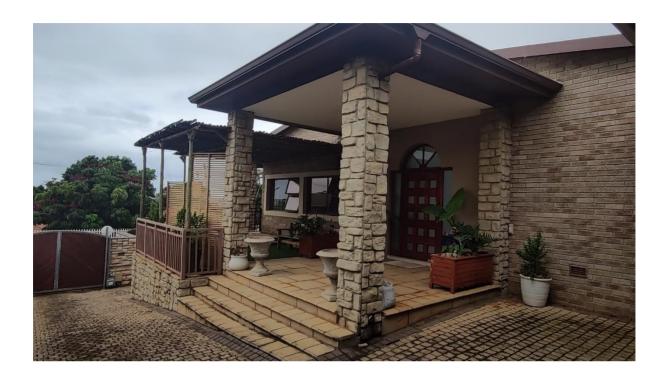
Figure 4 Image of the South Eastern Elevation of the property. Façade and columns of face brick with the existing pergola .

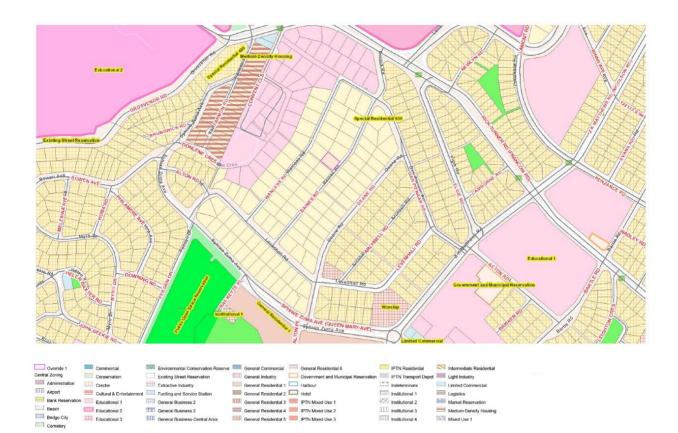
Figure 5 (page 6) Image illustrating the various properties in a 700-metre radius from the property which is located centrally on the map. The zoning is also indicated on the map with Residential Zoning in yellow and Educational Zoning in Pink.

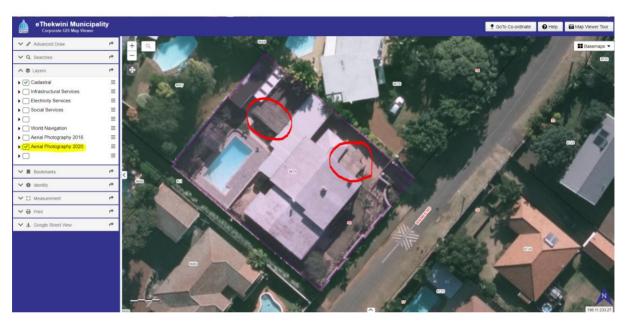
Figure 6 (page 7). Image substantiates that the items were constructed prior to 2022, and therefore would not have been applicable to the general 60-year protection as they are existing.

It must firstly be noted that the awnings and pergolas were built prior to the main dwelling unit triggering the general 60-year protection period. Such is reflected on the latest approved plan. The pergola, awning over pool deck and awning at the servants' quarters were previously not reflected on the latest approved plans.

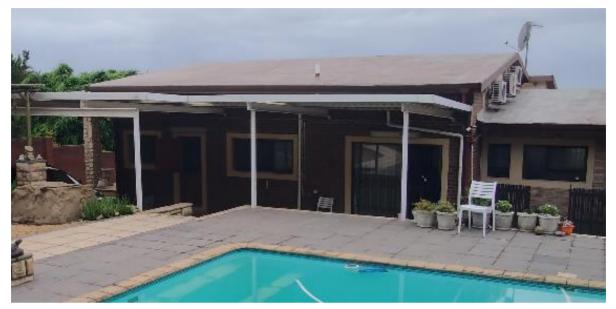
Figure 7 (page 7). Image illustrates the current poor condition of the roof sheeting which is to be replaced in accordance to the attached plans.

The existing roofing is to be replaced due to the current poor condition of the roof sheeting. The new proposed sheeting is to be Saflock 700 Roof sheeting which is to be placed on the existing roof members with new aluminium gutters installed.

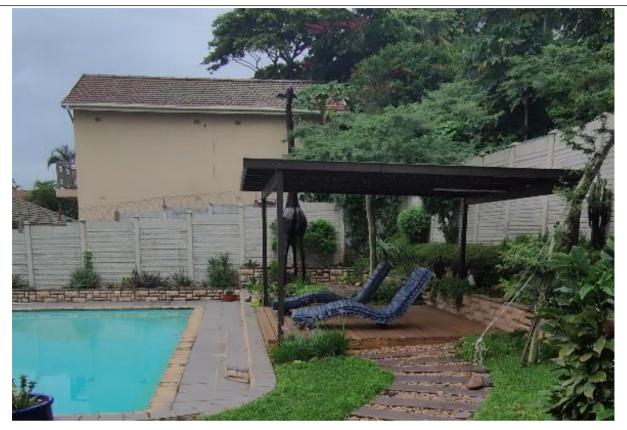
Figure 8. Image illustrates the existing pool deck and awning.

Lastly a new timber pool deck has been installed with an awning. The construction of this will provide a new shaded recreational space for the residents of the dwelling. The construction of this deck and awning will also extend beyond the rear building line hence the inclusion of this item in a relaxation application.

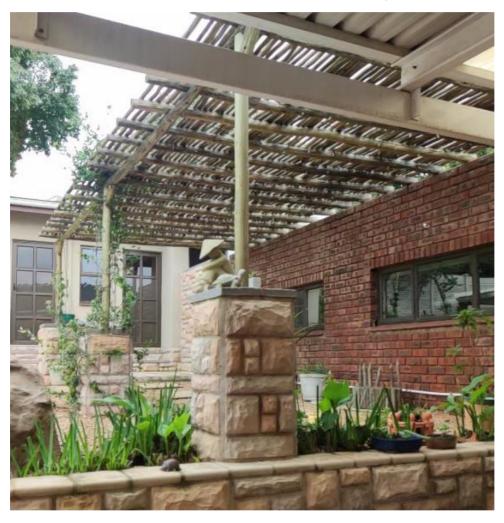
Figure 9. Image illustrates the existing pergola over the gravel landscaping.

Additionally, the inclusion of a well-designed pergola will improve the overall experience of the outdoor space without having to make use of any major construction methods. Another pergola is also to be located over the gravel landscaping that lies between the garage and the existing pool. These Items are minor in nature and do not alter the facades materially.

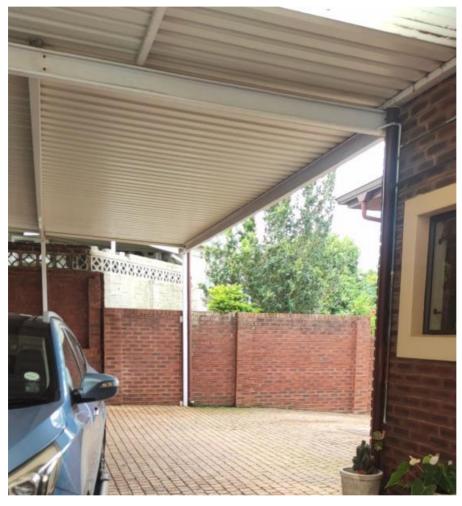
Figure 10. Image illustrates the existing awning over the garage entrance extending to the kitchen that is to be altered according to the attached plans

A new awning that extends from the garage to the kitchen will also be installed. This awning is to serve the purpose of covering the walkway from the kitchen to the garage as this is currently exposed to the elements. Additionally, the new awning will provide shading to the kitchen which currently undergoes major heat gain. To construct this awning, new brick columns will have to be constructed to support the

steel columns and beams for the awnings. Beams will also be connected into the existing structures. This awning will have to extend over the current building line as anywhere else would impede access to the garage. A relaxation application has been placed to address this.

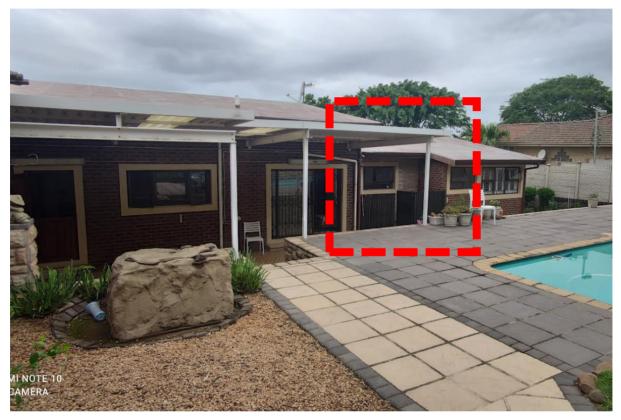
Figure 11. Image illustrates the portion of the bathrooms that will be extended.

Internally, the client wishes to extend and combine his current two bathrooms into a single bath. The extension merely entails a partial demolition of the wall and constructing a new, to be in-line with the existing datum of the main façade. It does not affect the façade as the extension will not surpass the main datum of same. Furthermore, this alteration is made to a façade that is not street facing and has been previously altered in the past.

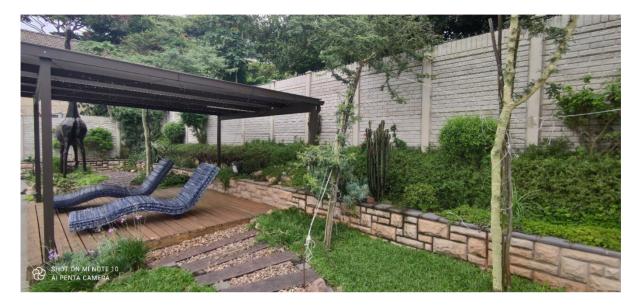
A1. Image illustrates the rear boundary wall with the existing planter. Existing pool deck and awning to be altered according to plans also visible

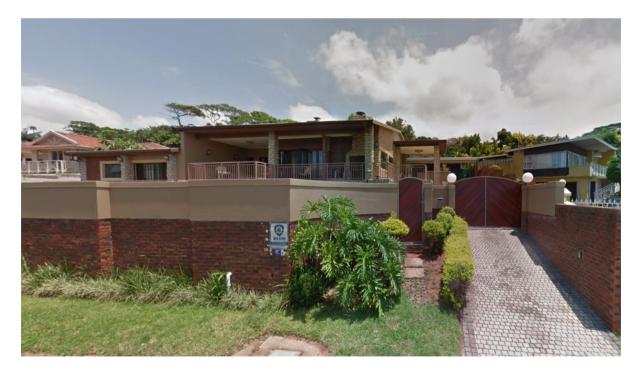
A2. Image illustrates the Baines Road facing boundary wall

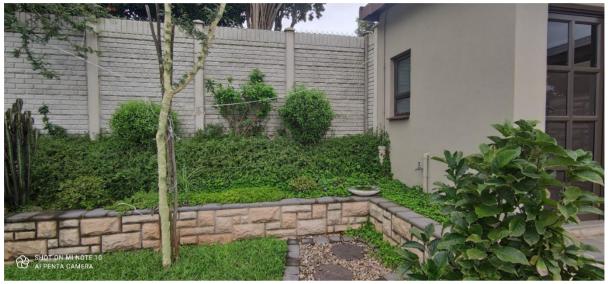
A3. Image illustrates the existing planter adjacent to ancillary unit at the rear of the site

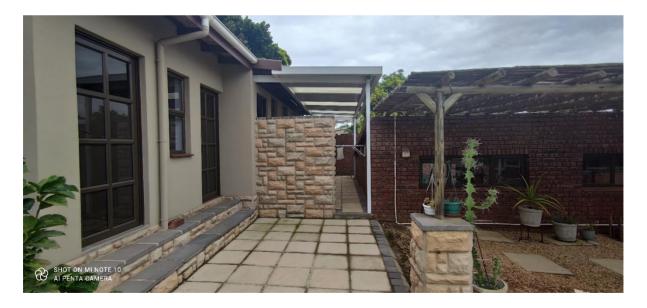
A4. Image illustrates ancilliary units as well as the awning existing over the gravel landscaping that is to be altered according to the plans attached

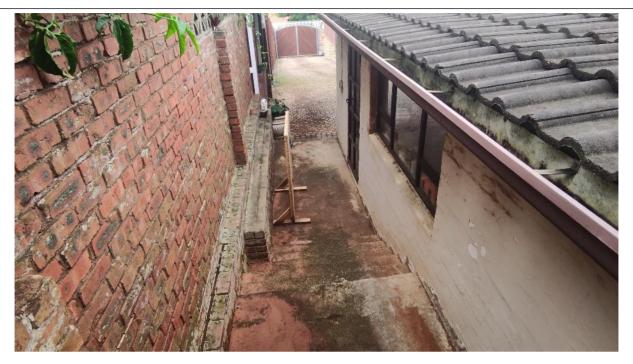
A5. Image illustrates the service passage between the garage and boundary wall

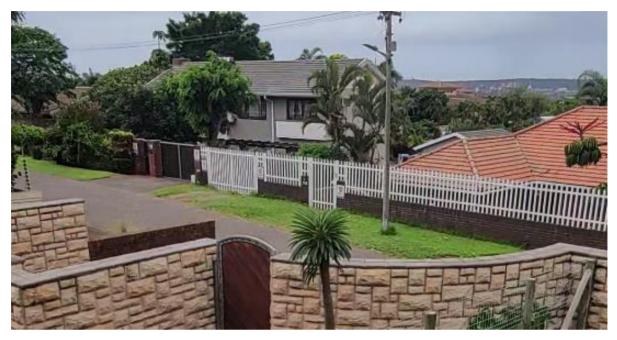
B1. Image illustrates the a neighbouring dwelling opposite the main house. The house boundary walls bears little to no architectural similarity

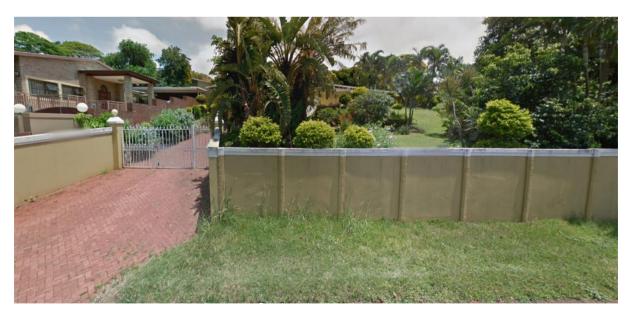
B2. Image illustrates the a neighbouring dwelling to the right of the main house. The house boundary walls bears little to no architectural similarity

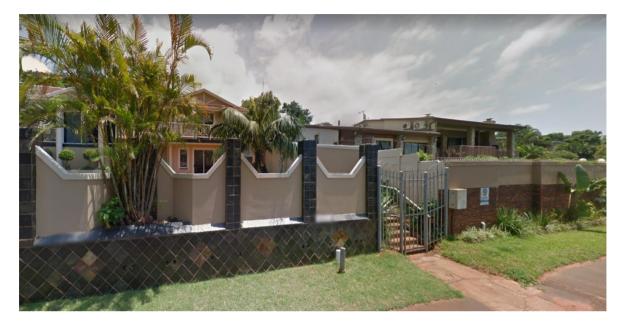
B3. Image illustrates the a neighbouring dwelling to the right of the main house. The house boundary walls bears little to no architectural similarity

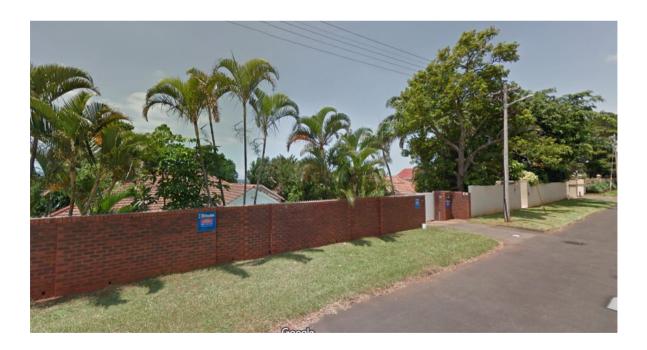
B4. Image illustrates the a neighbouring dwelling opposite the main house. The house boundary walls bears little to no architectural similarity
