Report on the floristic and ecological assessment of the proposed construction of a bulk water transfer pipeline from the Maselspoort Dam and purification plant to the New Northern Waste Water Treatment Works (WWTW) and Bloemfontein WWTW, Bloemfontein, Free State Province.

January 2015

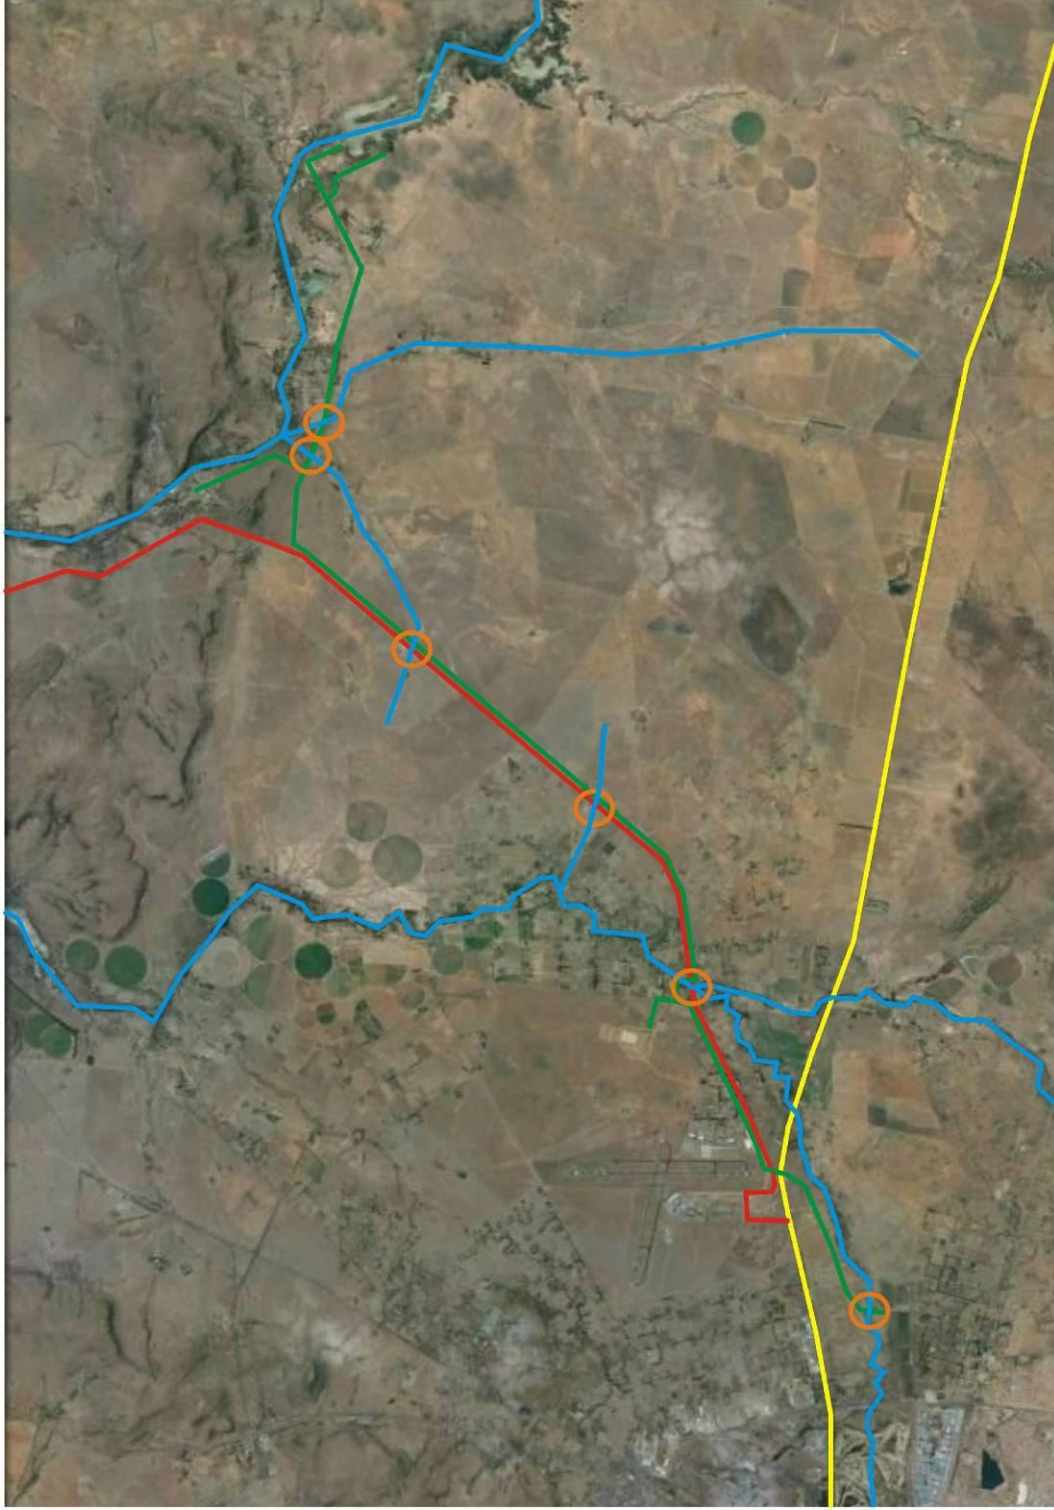
Map 1: Location of the proposed construction of a bulk water transfer pipeline from the Maselspoort dam and purification plant to the New Northern WWTW and Bloemfontein WWTW, Bloemfontein, Free State Province.

The majority of the pipeline route will follow the tarred road (Map 1). The areas adjacent to this road has also been degraded by the impact of the road, firebreaks along the fence and dirt tracks. However, the pipeline still crosses several sensitive areas consisting of natural streams (Map 1 & 2).

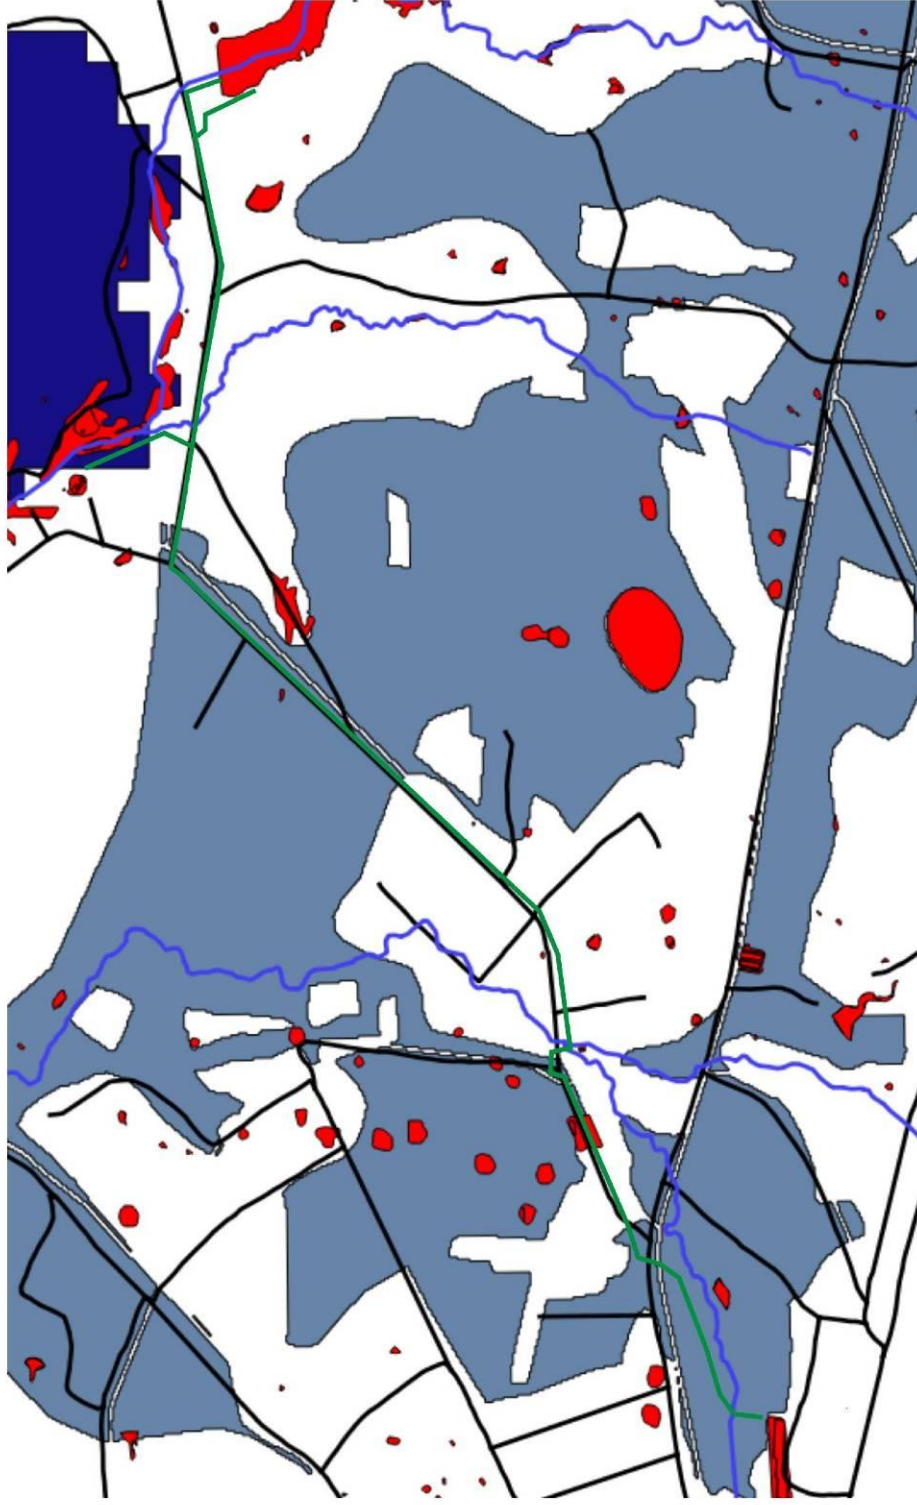
The vegetation along the majority of the pipeline route consists of Bloemfontein Dry Grassland which is considered a Threatened Ecosystem and listed as being Vulnerable (VU) (Map 2). A large portion of the pipeline route from the Roodewal Small Holdings to the crossing of the N8 National Road is in varying degrees of degradation and transformation and is consequently no longer considered to be representative of this vegetation type. The footprint of the pipeline will be small and not a large portion of the vegetation will be transformed. The pipeline will follow the Maselspoort road and will be installed adjacent to the road just outside of the road reserve inside the farm fence. The survey has indicated that this area has been degraded to varying degrees. The area has been utilised as a firebreak and dirt tracks and the vegetation has therefore been degraded to varying degrees. The installation of the pipeline should be confined to this disturbed portion outside the road reserve. The footprint of the construction and installation of the pipeline should be kept to a minimum. Strict mitigation should be implemented especially regarding the handling of topsoil including removal and replacement thereof to ensure that as natural as possible vegetation re-establishes on the site.

The vegetation along the majority of the pipeline route consists of Bloemfontein Dry Grassland which is considered a Threatened Ecosystem and listed as being Vulnerable (VU) (Map 2). The footprint of the pipeline will be small and not a large portion of the vegetation will be transformed. The survey has indicated that the area adjacent the road reserve where the pipeline will be installed has been degraded to varying degrees. The conservation value is therefore only considered to be moderate.

The vegetation along the majority of the pipeline route consists of Bloemfontein Dry Grassland which is considered a Threatened Ecosystem and listed as being Vulnerable (VU) (Map 2). A large portion of the pipeline route from the Roodewal Small Holdings to the crossing of the N8 National Road is in varying degrees of degradation and transformation and is consequently no longer considered to be representative of this vegetation type. The footprint of the pipeline will be small and not a large portion of the vegetation will be transformed. The pipeline will follow the Maselspoort road and will be installed adjacent to the road just outside of the road reserve inside the farm fence. The survey has indicated that this area has been degraded to varying degrees. The area has been utilised as a firebreak and dirt tracks and the vegetation has therefore been degraded to varying degrees. The installation of the pipeline should be confined to this disturbed portion outside the road reserve. The footprint of the construction and installation of the pipeline should be kept to a minimum. Strict mitigation should be implemented especially regarding the handling of topsoil including removal and replacement thereof to ensure that as natural as possible vegetation re-establishes on the site.

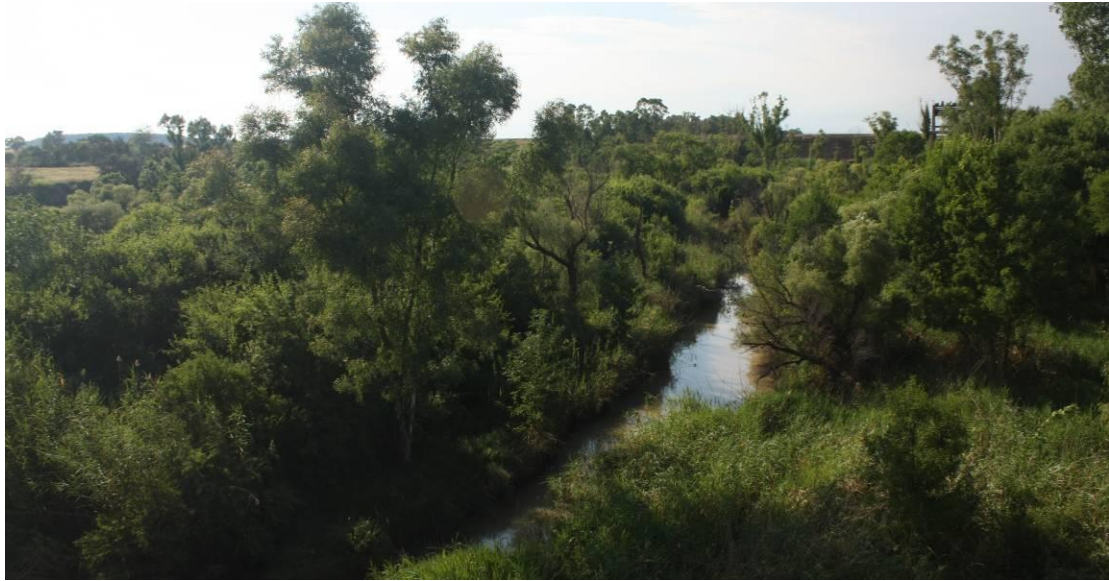
Figure 1: View of the Modder River the pipeline will be installed to the west of the river and will not cross it.

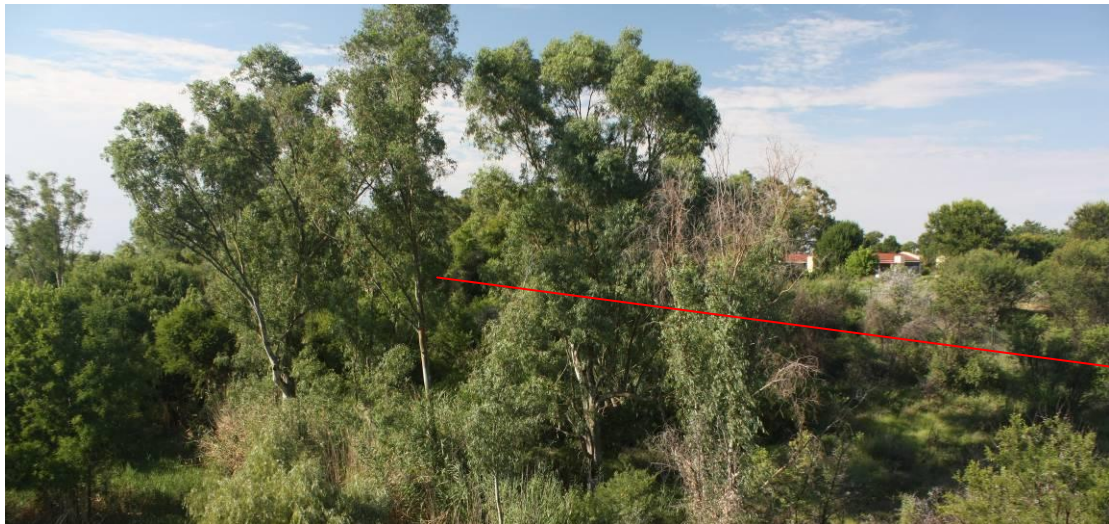
Figure 2: View west of the Modder River indicating the approximate location of the proposed pipeline (red line).

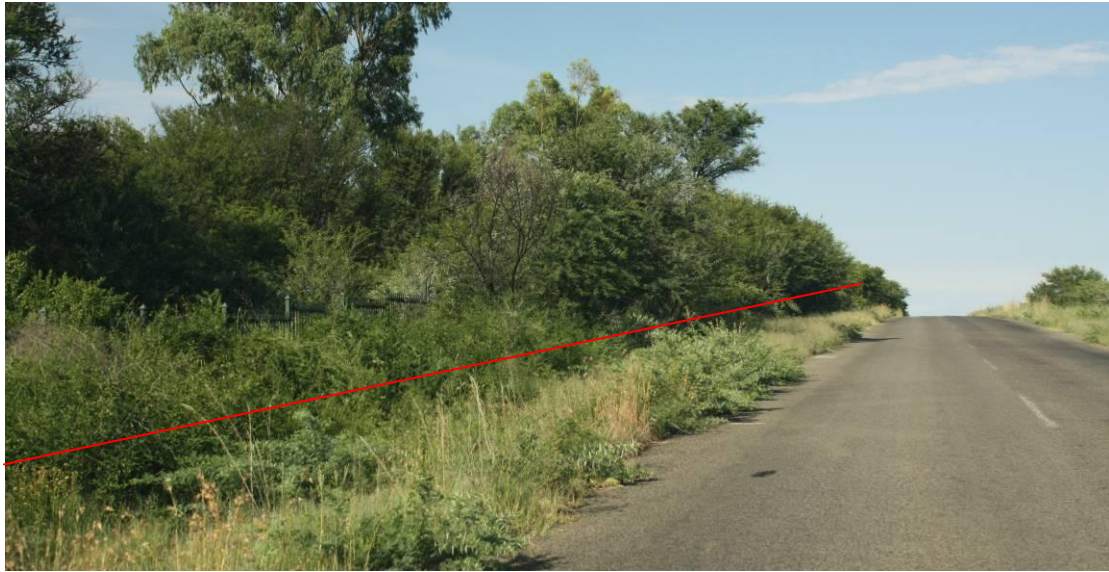
The vegetation structure along the pipeline route is dominated by a uniform grass layer. However, near the Maselspoort Dam and consisting of a large area consists of thicket associated with the Modder River. The Modder River near the Maselspoort Dam also contains a dense riparian thicket with sedge and reed beds. The seasonal streams along the route consist of sedge and reed layers. The Bloemspruit and Renosterspruit also contain dense thicket and reed beds.

Figure 3: Position of the pipeline along the northern portion leading to the Maselspoort Dam (red line). Note the dense thicket occurring in this area.

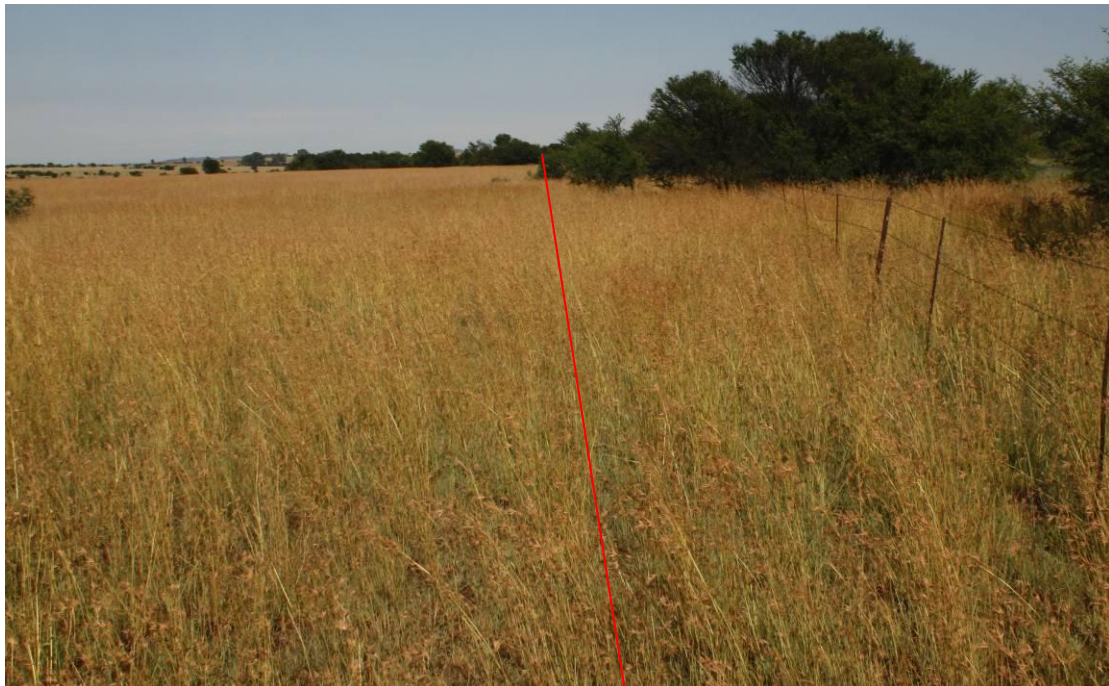
Figure 4: View of the northern portion of the proposed pipeline (red line). Note grassland in relatively good condition but uniform species composition.

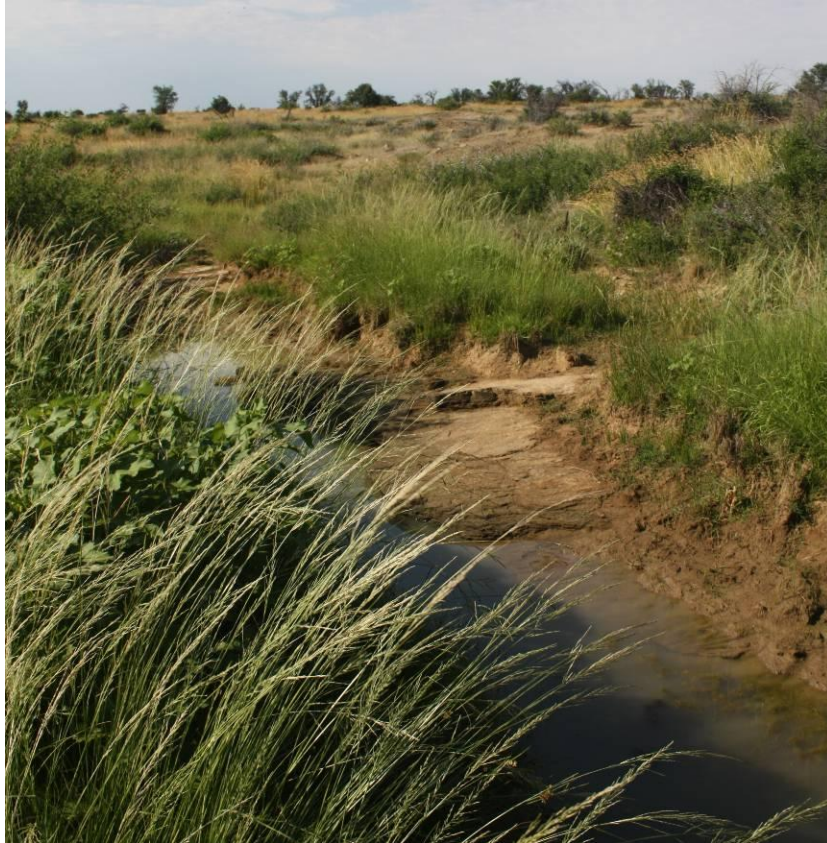
From the Maselspoort Dam turnoff to the dam itself the pipeline crosses two seasonal streams which are 300 meters from each other. Both of these have their origins to the south of the road and within the natural surrounding grassland. Small weirs have been constructed in their flow channels but few other impacts are evident on these streams. As a result they are relatively unchanged, natural and in a good condition. Numerous specimens of the Red Listed and Declining *Crinum bulbispermum* (Orange River Lily) occur along the banks of these streams. This also increases the sensitivity of these streams. They must be considered as sensitive and utmost care must be taken when construction occurs near these streams. Mitigation measures should include keeping the footprint to a minimum, taking utmost care with topsoil, monitoring of weed establishment, transplanting of affected Red Listed species and no manholes within 32 meters of the stream.

Figure 5: View of the seasonal stream 4 in the northern portion of the pipeline route. The stream will be crossed by the pipeline and is in a good condition, utmost care must be taken to keep the impact on the stream to a minimum.

- The construction footprint along the streams should be kept to a minimum.
- Topsoil should be carefully removed to a depth of 30 cm and stored. Once the pipeline is installed the topsoil should be replaced to virgin soil level and not elevated as this will act as a water barrier. Excess soil should be removed from the site.

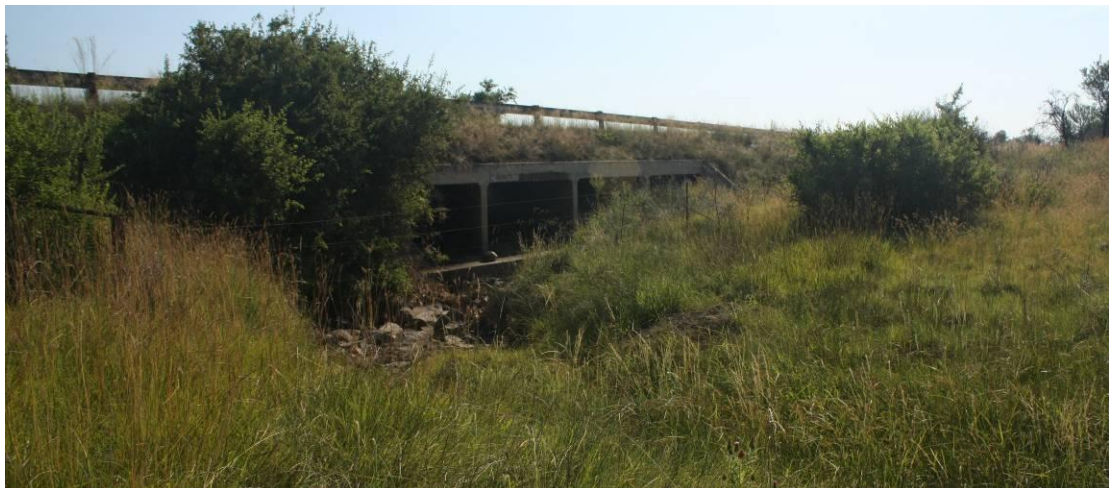
Figure 6: View of the seasonal stream 3 in the northern portion of the pipeline route. The stream will be crossed by the pipeline and is in a good condition, utmost care must be taken to keep the impact on the stream to a minimum.

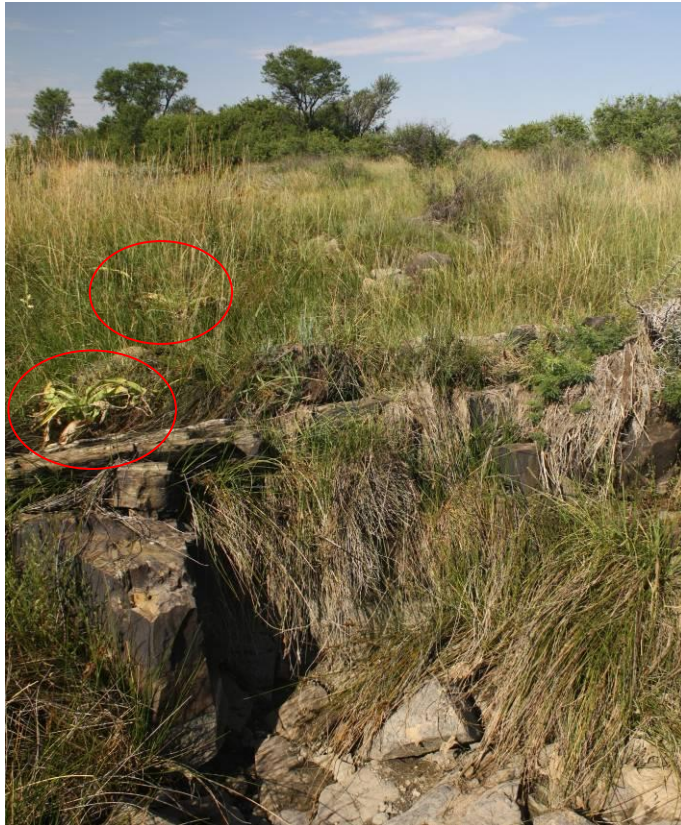
No rare or endangered species could be identified along the pipeline route except for one species (Appendix B). This species, *Crinum bulbispermum* (Orange River Lily) occurs along the Modder River and the two seasonal streams being crossed by the pipeline near Maselspoort. This species is currently listed in the National Red List as being a Declining species. The species is widespread but can be considered as somewhat rare and rapidly declining. It must be regarded as having a significant conservation value. Due to the small footprint of the pipeline only a small portion of the population will be affected. It is recommended that all specimens which will be affected by the pipeline construction should be removed and transplanting adjacent to the pipeline in an area of suitable and similar habitat. Permits must be obtained for those specimens to be transplanted.

Figure 7: View of seasonal stream 3. Note also the Red Listed and Declining *Crinum bulbispermum* which will be affected by the pipeline construction (red circles). These are only a few of the specimens which are present at this stream.

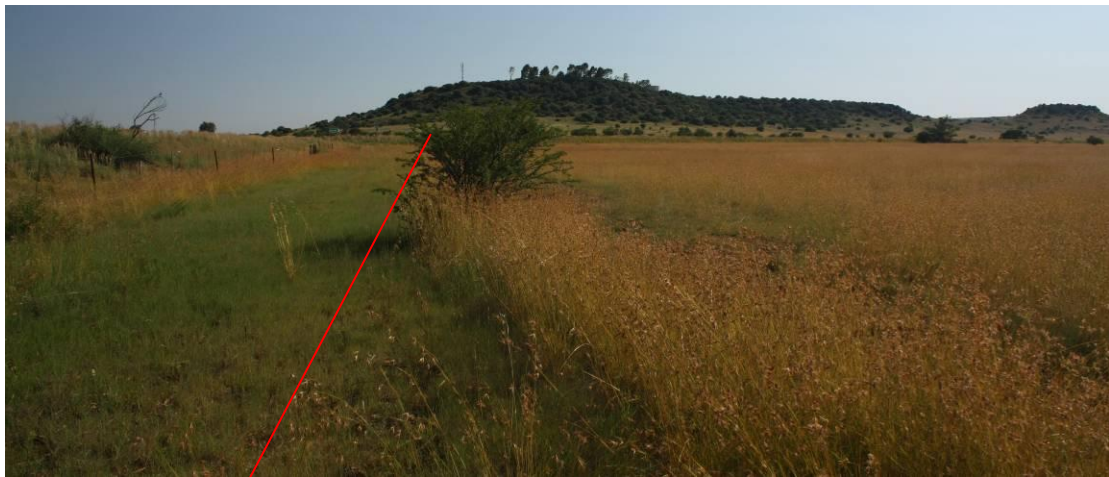
Figure 8: A portion of the pipeline route within the northern natural area. Note that the area outside the road reserve is degraded due to being cleared as a firebreak.

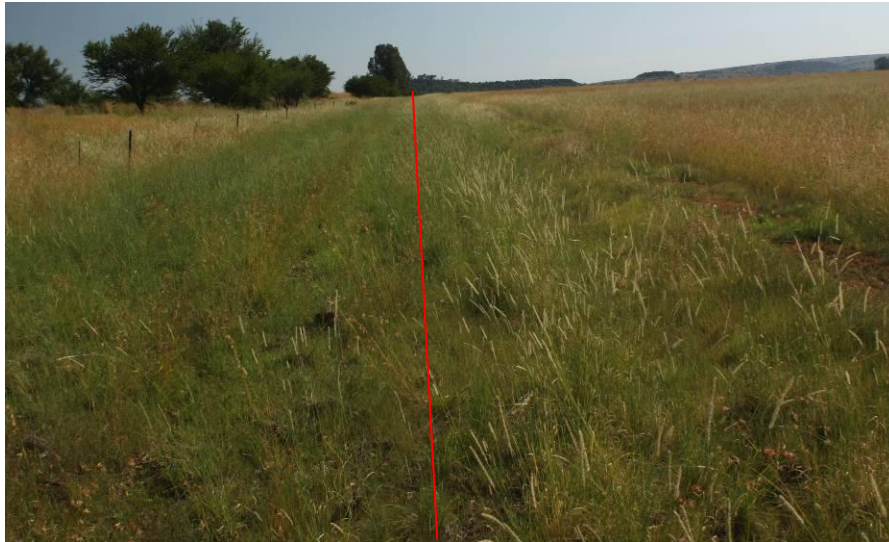
Figure 9: A portion of the pipeline route within the northern natural area. Note that the area outside the road reserve is degraded due to being cleared as a firebreak.

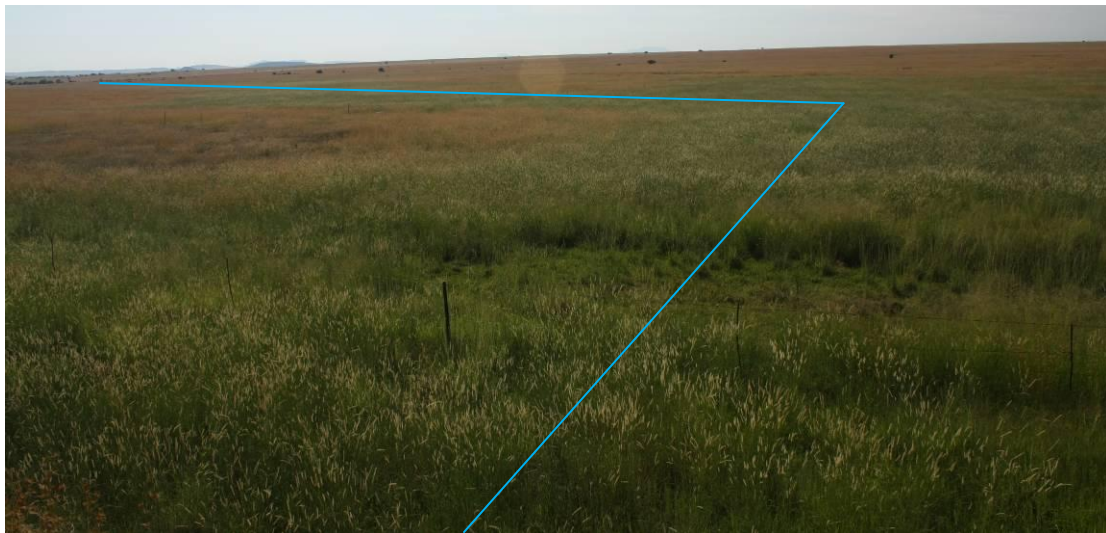
Approximately 2.3 km before the Maselspoort Dam turnoff the pipeline will cross a small seasonal stream. The stream has its origins within the surrounding natural grassland. A small weir has been constructed in the stream damming runoff and the stream is also crossed by the tarred road. These impacts have an influence on the stream but it is considered largely natural and in a good condition. The main channel of the stream is not well defined and it may be difficult to discern this stream. This stream must be regarded as being sensitive and utmost care must be taken when crossing this stream. Mitigation measures should include keeping the

Figure 10: View of the seasonal stream 2 (blue line). The main channel of the stream is indistinct but it is clear that the stream transports a high volume of water. It is in a good condition and utmost care must be taken to keep the impact on the stream to a minimum.

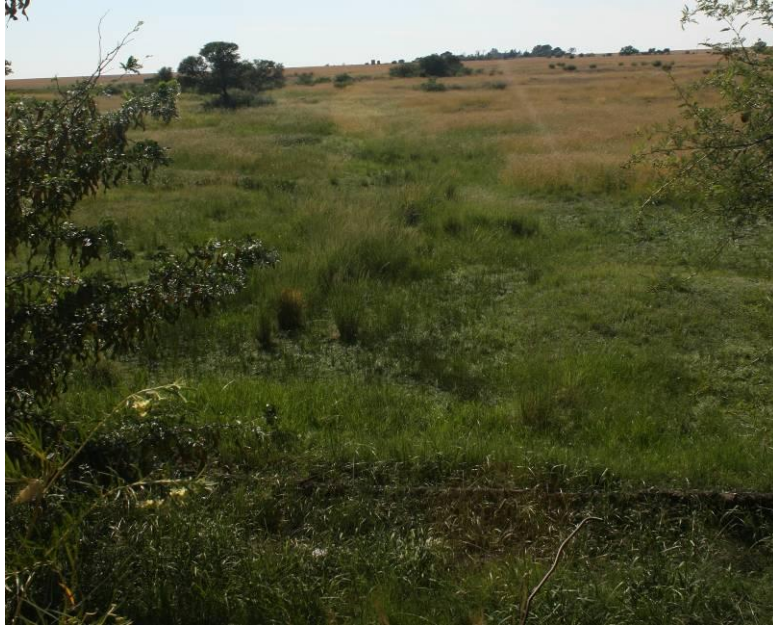
North of the Renosterspruit crossing and within the Roodewal Small Holdings a small seasonal stream is crossed. This stream flows through the small holdings which are disturbed and transformed. As a consequence the stream is also degraded and disturbed. Despite this it must be regarded as sensitive and care must be taken when crossing this stream.

Figure 11: View of the seasonal stream 1. The stream flows through small holdings and consequently is degraded.

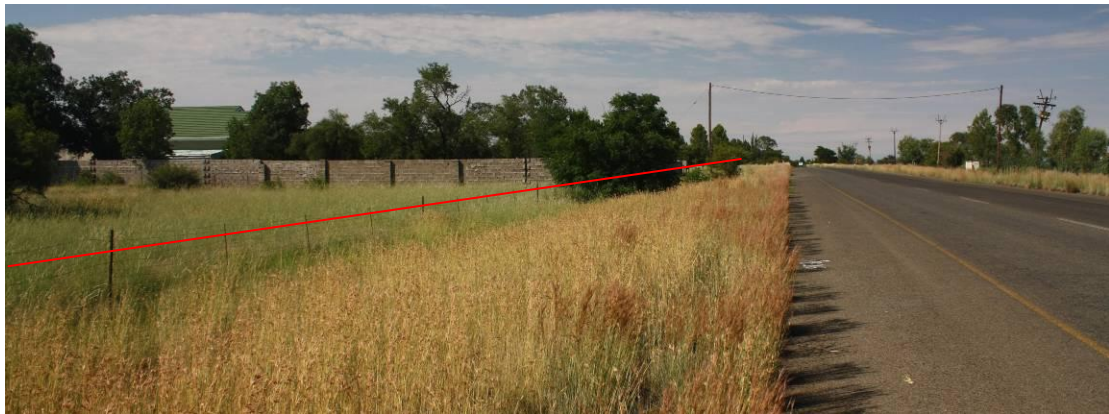
Figure 12: View of the Roodewal Small Holdings through which the pipeline will be installed (red line). This area is transformed.
