# PRELIMINARY GEOTECHNICAL REPORT

PROPOSED 165MW KHAUTA NORTH PHOTOVOLTAIC  
SOLAR FARM ON PORTION 0 OF THE FARM KOPJE  
ALLEEN NO. 81 AND PORTION 1 OF THE FARM KOPJE  
ALLEEN NO. 81, RIEBEECKSTAD NEAR WELKOM,  
MATJHABENG LOCAL MUNICIPALITY, FREE STATE  
PROVINCE

3 February 2023 (Rev 0)

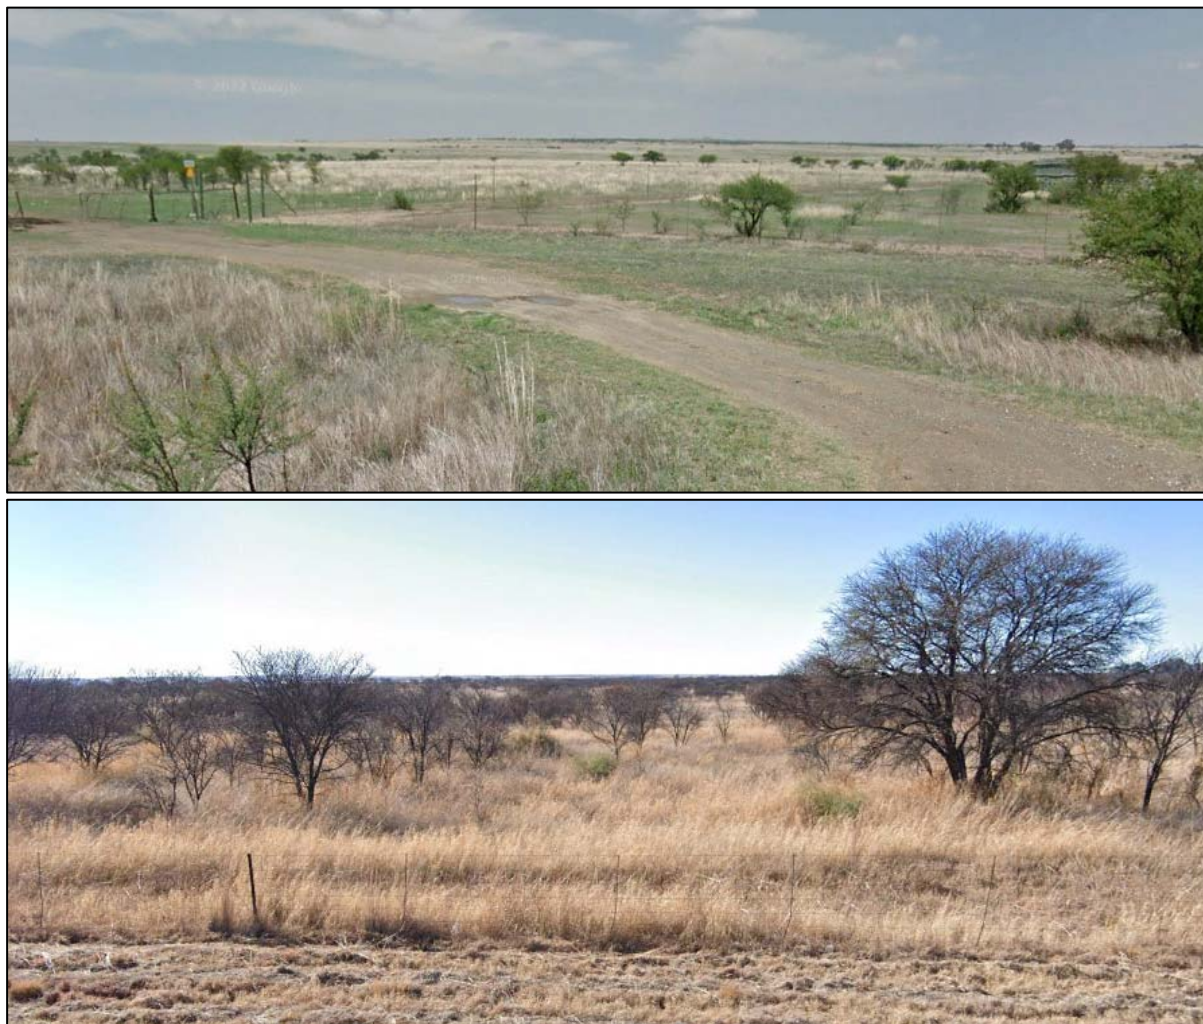
tributaries of the Sandspruit, which flowed west. The vegetation types were dominated by thorn trees and long dry grass (See **Figure 4**).

**Figure 4: Typical topography and vegetation cover in the vicinity of the site (source: Google Earth)**

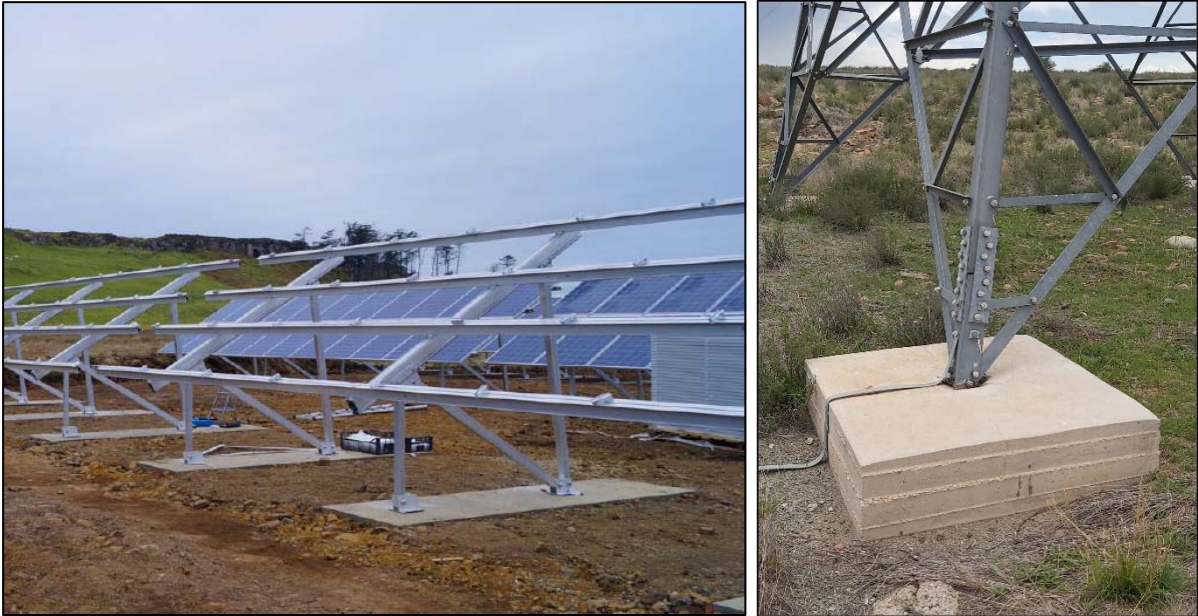
**Figure 11: Typical spread (gravity) foundation systems for PV panels (left) and overhead powerlines (right)**

PV array frames and overhead powerline structures would typically be founded on shallow spread (gravity) foundations, frictional driven piles or pre-manufactured steel piles cast into pre-bored holes (see **Figures 11 & 12**). The method would largely be dictated by the ground profile to be determined in detailed geotechnical investigations. Short frictional piles cast into a pre-bored hole would be more

suitable in shallow very dense/stiff soils or rock, whereas driven piles would be more suitable in thicker granular soil profiles. The dominant forces in consideration in the design of foundations for PV arrays are horizontal forces and moments due to wind acting on the panels, which are then transferred into the frame and down into the ground. The foundations should be deep enough or heavy enough to resist uplift forces and overturning moments. The founding conditions on the site would have to be investigated with subsurface testing to determine soil/rock profile and geotechnical properties.

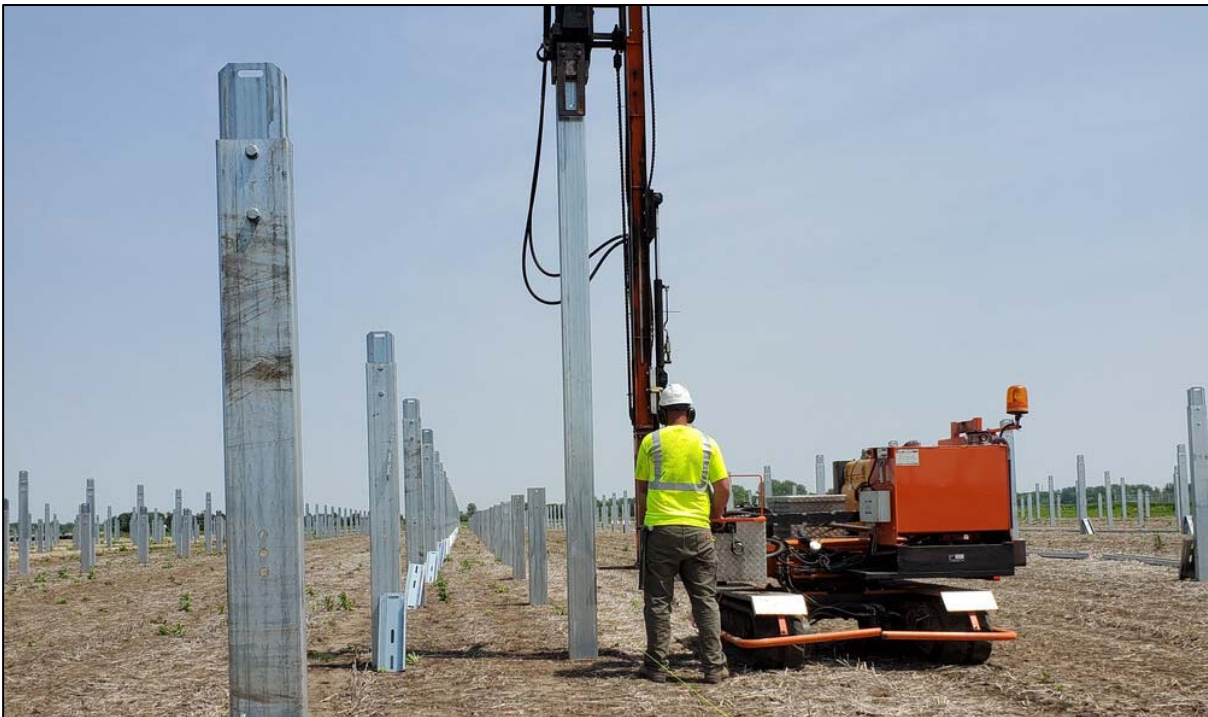
**Figure 12: Driven piles for PV array frames**
