PRELIMINARY GEOTECHNICAL REPORT

PROPOSED 80MW KHAUTA WEST PHOTOVOLTAIC
SOLAR FARM ON PORTION 3 OF THE FARM KOPJE
ALLEEN NO. 81, RIEBEECKSTAD NEAR WELKOM,
MATJHABENG LOCAL MUNICIPALITY, FREE STATE
PROVINCE

3 February 2023 (Rev 0)

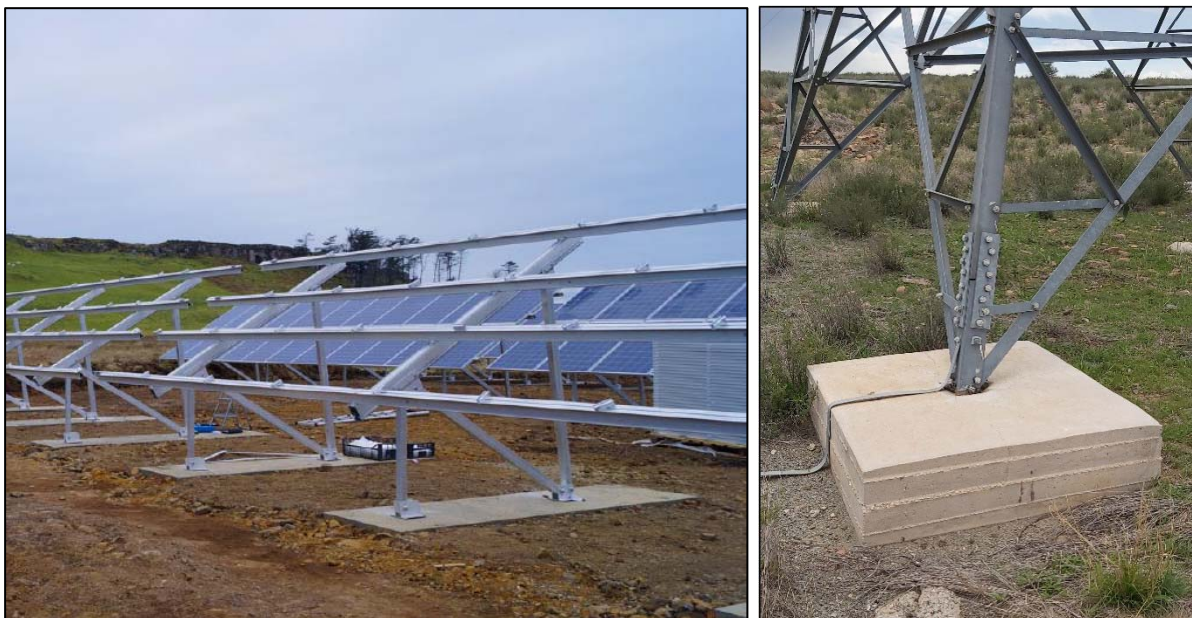
Figure 11: Typical spread (gravity) foundation systems for PV panels (left) and overhead powerlines (right)

PV array frames and overhead powerline structures would typically be founded on shallow spread (gravity) foundations, frictional driven piles or pre-manufactured steel piles cast into pre-bored holes (see **Figures 11 & 12**). The method would largely be dictated by the ground profile to be determined in detailed geotechnical investigations. Short frictional piles cast into a pre-bored hole would be more

suitable in shallow very dense/stiff soils or rock, whereas driven piles would be more suitable in thicker granular soil profiles. The dominant forces in consideration in the design of foundations for PV arrays are horizontal forces and moments due to wind acting on the panels, which are then transferred into the frame and down into the ground. The foundations should be deep enough or heavy enough to resist uplift forces and overturning moments. The founding conditions on the site would have to be investigated with subsurface testing to determine soil/rock profile and geotechnical properties.
