SHELL AND BP REFINERIES PTY. LTD.

SAPREF SINGLE BUOY MOORING (SBM) PIPELINE ENVIRONMENTAL MAINTENANCE MANAGEMENT PLAN

06 APRIL 2020

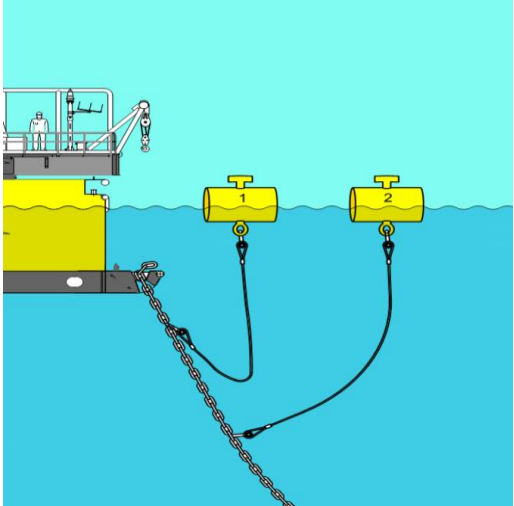
Phase	Illustration	Additional description
<p>Connecting Can Buoys</p>

<p>The Buoy ops team connect two Can buoys to the anchor leg to aid the Anchor Handling Tug (AHT) in gathering the chain and for the buoy winch to transfer the load from the buoy to the AHT.</p>
<p>Buoy Winch Connect to Chain</p>

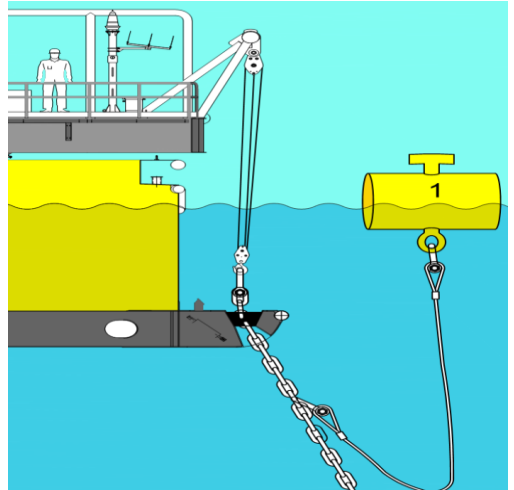
<p>The buoy winch block is connected to the anchor chain bitter end. The buoy winch block is the smaller unit that will pass through the chain hawse pipe.</p>

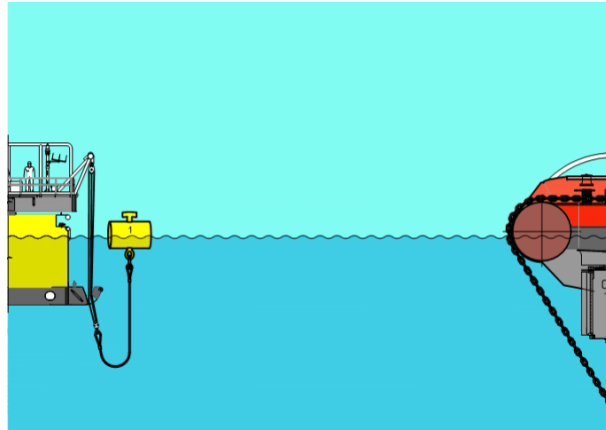
Anchor Leg Retrieval

The AHT starts the anchor leg retrieval operations

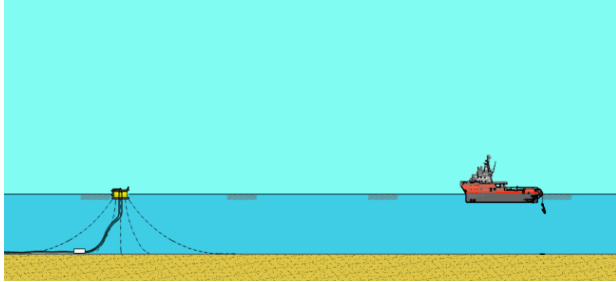
<p>ROV deployed to ensure the correct orientation of the anchor, and the AHT will then lay away the new chain towards the SBM. Chain will be laid on the original anchor leg route.</p>
<p>Lowering Anchor to Seabed</p>

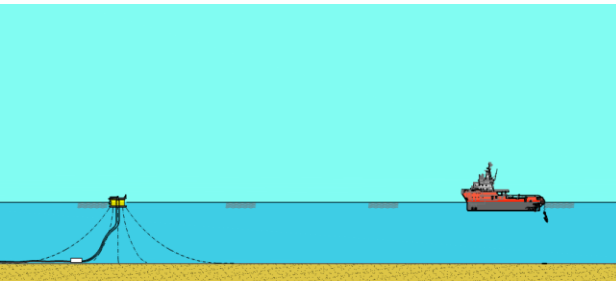
<p>Deck personnel shall overboard the new anchor and chain to the seabed.</p>
<p>ROV Observation to Confirm Orientation of Anchor</p>

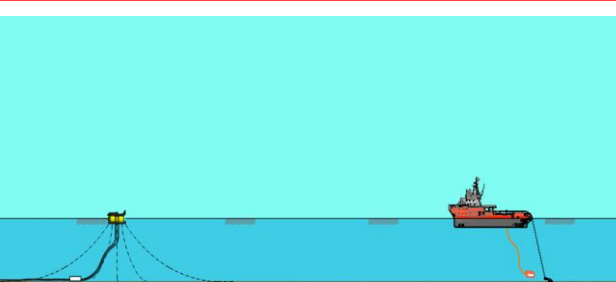
<p>ROV to capture the catenary path of the new anchor legs until its burial location.</p>

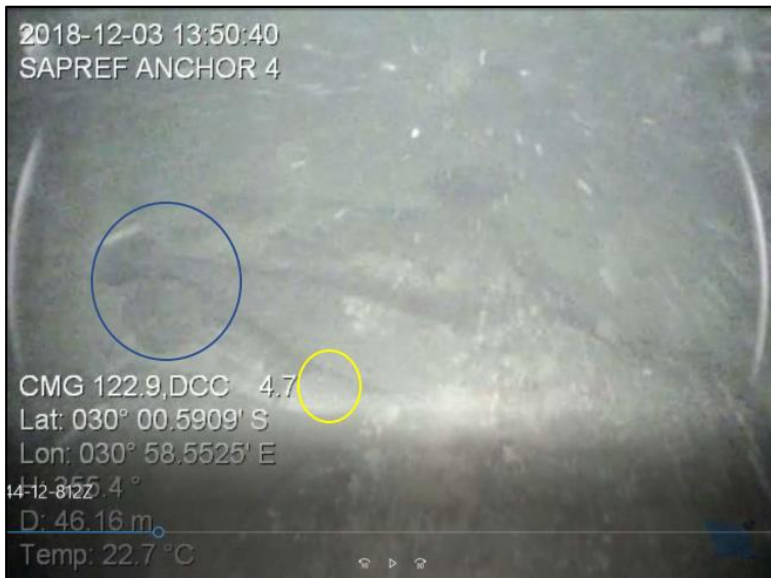
Figure 2: Metal plating is visible, with thickened edges (yellow) as well as standing rigging (blue)

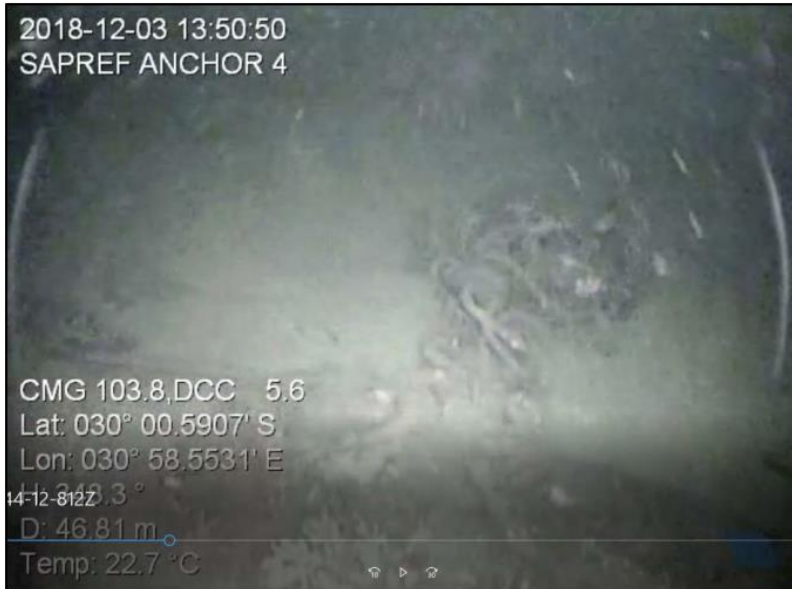
Figure 3: Cluster of light chain

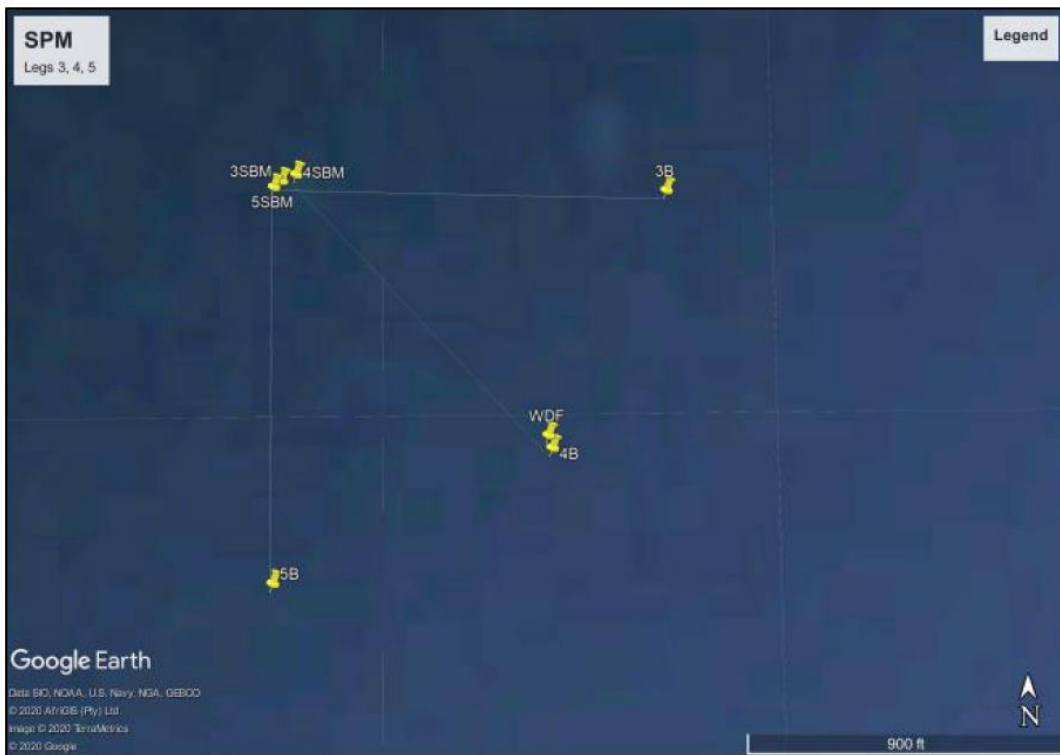
Figure 4: PLEM anchor chain arrangement (SAPREF)

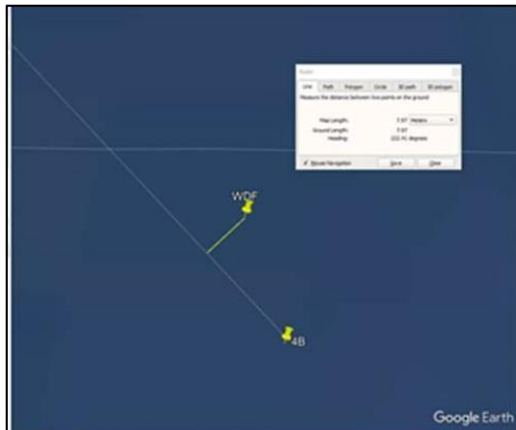
Figure 5: Close-up of anchor chain 4 and plotted MUCH resource (SAPREF)

Using the SHP file from the geophysical report (SBM_Nov18_Anchor_Chains.shp) and the GPS co-ordinates from the ROV footage (above) I notice that there is only a 12 m distance between the anchor chain and the wreck. However, it is beyond the anchor point for the chain.
