Mining Environmental Management Plan for the Proposed Rehabilitation of the N10 Section 4 between Cradock and Knutsford

South African National Roads Agency SOC Limited

Report Number 443824

July 2012

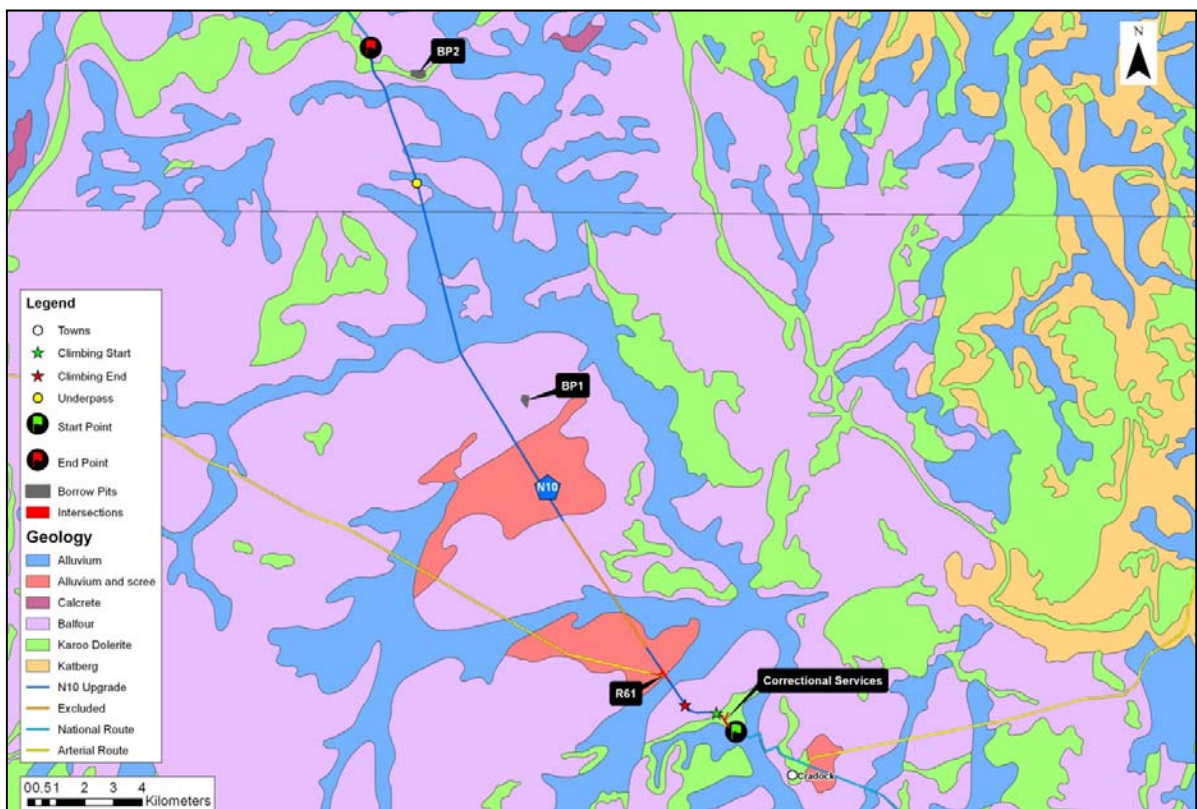
Figure 3-1: Geology at each borrow pit site

Borrow Pit 1 is entirely covered by alluvium. In places small steps in the surface are marked by weathered sandstone fragments, indicating the presence of thin sandstone interbeds within mudstone. A nearby borrow pit exhibited a coarse greenish mudstone which was not found to be fossiliferous. Paleontological Evaluation of this site will not be possible until after works have proceeded (Rob Gess, 2012).

Borrow Pit 2 exhibits a thick bed of fine greenish mudstone which contains shallow water ripple planes. This is in part overlain by a coarser layer within which a horizon containing well-preserved sphenophyte stems. These Balfour Formation sediments underlie the dolerite sill. The intention is to extend the borrowpit backwards to exploit aggregate contained in a small spur. This spur is topped by a loose pavement of weathered sandstone and alluvium, except in the north-west corner of the proposed site where dolerite caps the strata. Although no fossils of high significance were located during the survey, this site has the potential to contain important fossils (Rob Gess, 2012).

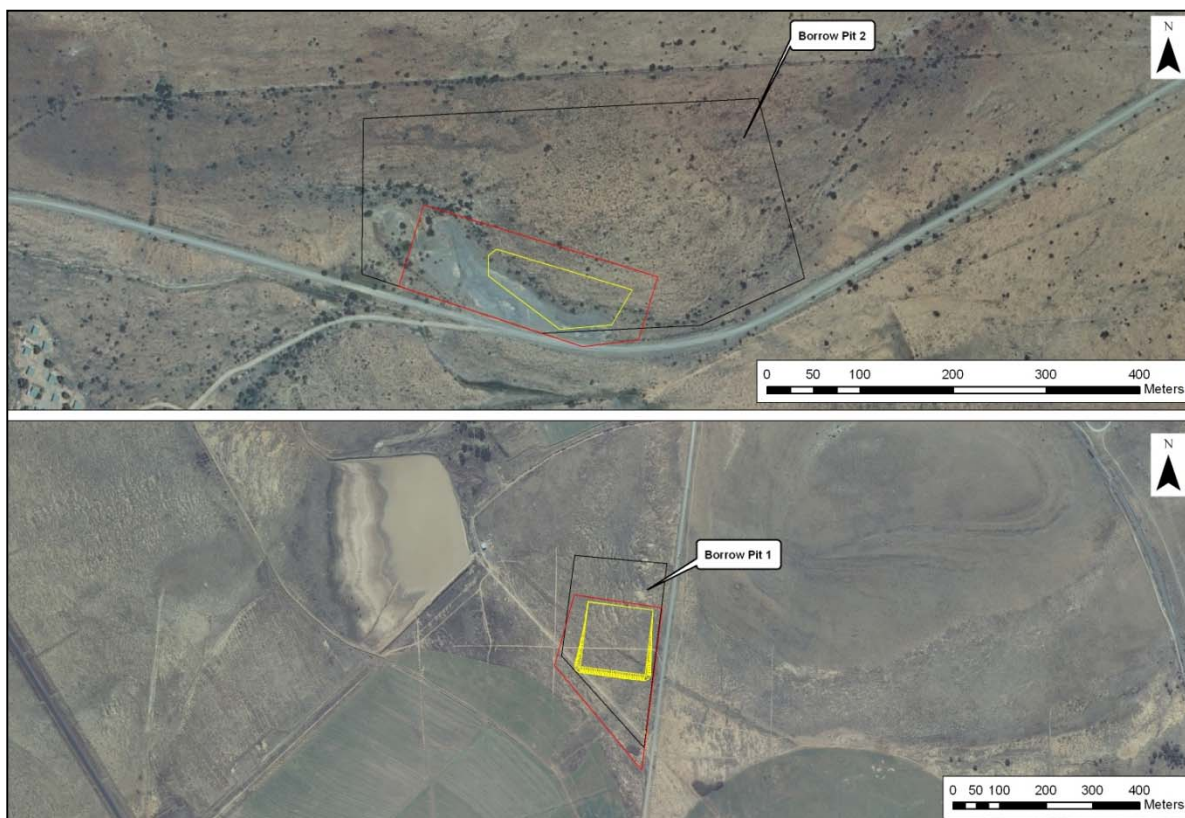
Figure 3-3: Aerial photograph illustrating the hydrology within 500 m of each Borrow Pit site

Yellow line – proposed borrow pit excavation

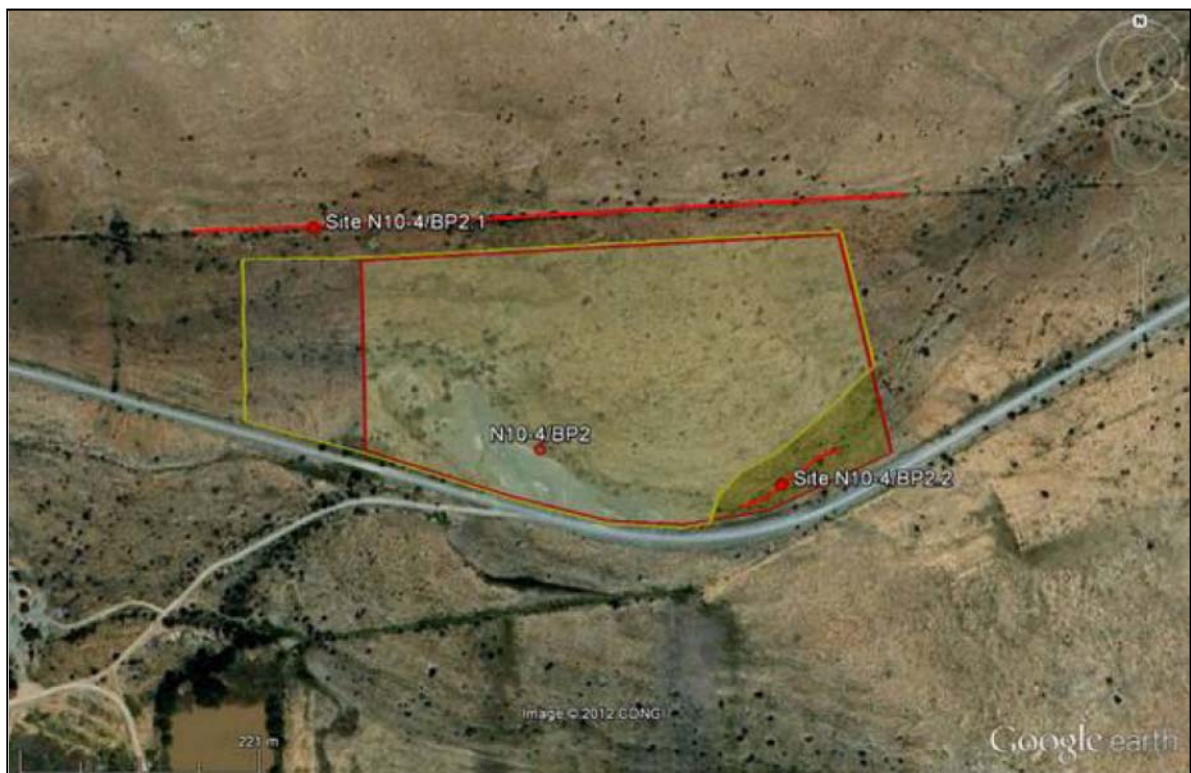
Figure 3-8: Sites identified by the archaeologist based on original BP 2 layout (Karen van Ryneveld, June 2012)

Proposed development of BP2 has clearly taken the presence of the Colonial Period wall into account and the northern boundary of the proposed borrow pit site is situated more than 30 m south of the Site N10-4/BP2.1 stone wall. The wall will not be impacted on and formalization (formal fence) of the borrow pit study site will ensure the continued conservation of the wall. However, due to close proximity it is recommended that additional conservation measures be put in place to ensure the conservation of the Site N10-4/BP2.1 stone wall.

Site N10-4/BP2.2 (S31 57'29.6"; E25 29'21.2) demarcates the locality of a 2nd Colonial Period stone wall, situated just east of the existing borrow pit area of impact and running for approximately 100 m towards the north-east following the ridge contour, where decay has taken its obvious toll on the site remains but remains again continue further to the north-east along the aerially visible vegetation alignment and cross cutting the Site N10-4/BP2.1 wall remains. Again it is inferred that the origin of the wall may well have been for farming purposes (due to its extensive extension towards the north-east), but reinforcement thereof during times of political turmoil may well have proven very useful specifically relating to the view over the valley to the south from the site. The current development proposal will directly impact on the Site N10-4/BP2.2 Colonial Period stone wall. It is recommended that the developer considers revision of the study site in order to ensure at least a 30 m conservation barrier between the borrow pit and Site N10-4/BP2.2. Slight extension of the study site towards the west will not impact on any cultural heritage remains. Should a change to the study site not prove a viable development option, the developer should ensure that Phase 2 archaeological mitigation (archaeological excavation, documentation and analysis) precede development in order to record necessary data relating to the stone wall prior to destruction.

The proposed N10-4/BP2 site layout plan has been altered to conserve the Site N10-4/BP2.2 Colonial Period stone wall feature, in accordance with SAHRA's recommendations (preferred heritage management option).

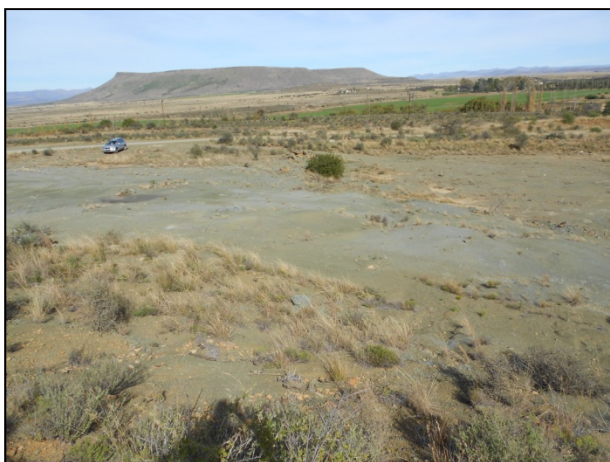
Photo C5: Poorly rehabilitated existing borrow pit 2

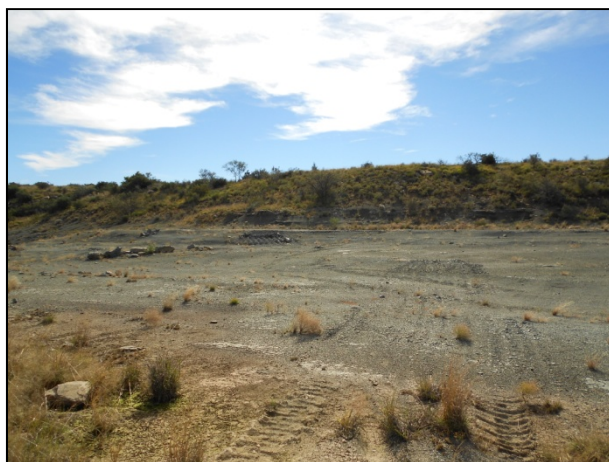
Photo C6: Hillside of borrow pit 2 which will be cut back in order to extend the borrow pit

The existing Borrow Pit will be extended into the northern hillside Mining will take place by advancing the face away from the existing face towards the proposed limit of mining, in order to mix the materials from the upper portion with those from the lower portion of the face.
