# **Environmental Impact Assessment Report:**

## **Draft Environmental Management Programme (Second Revision)**

**South Coast Stone Crushers (Pty) Ltd.**

Report Number 483383-IAR

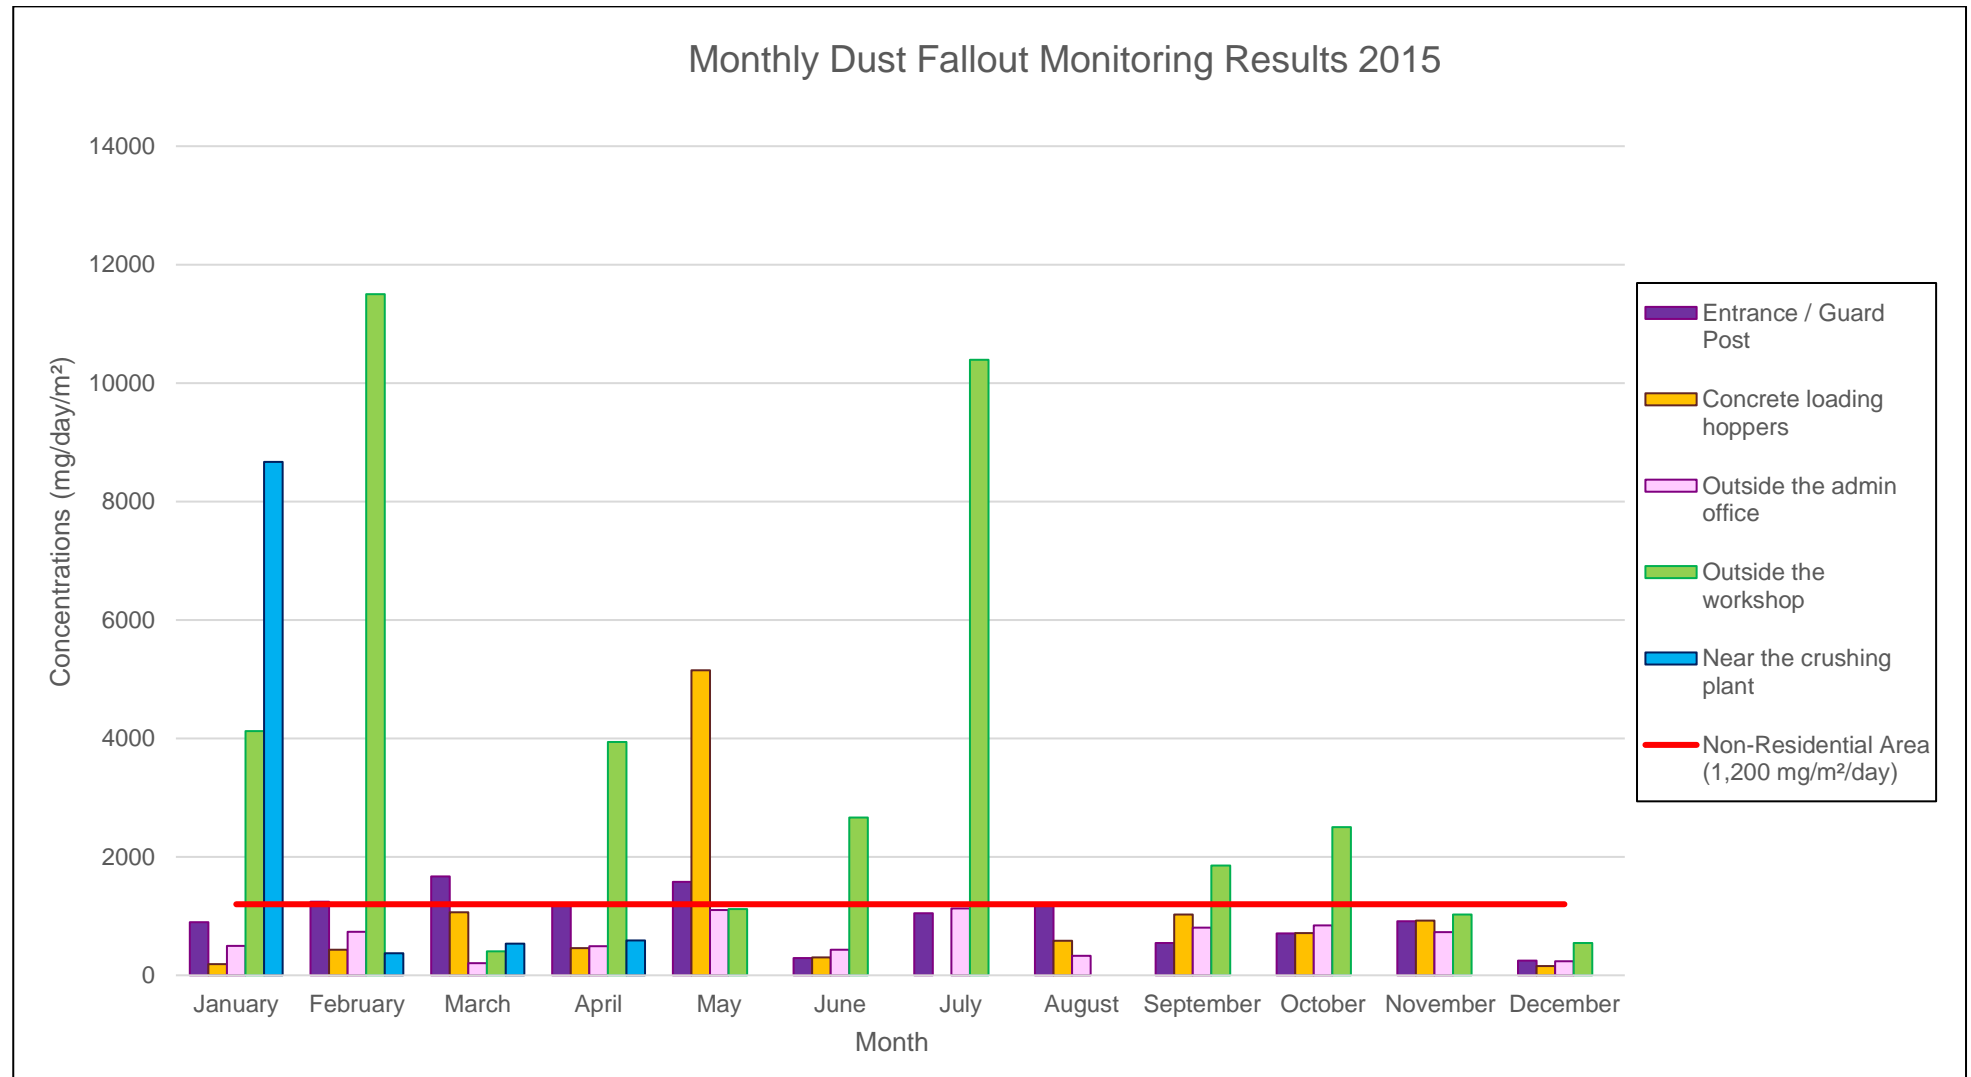
**Figure 4-2** Dust fallout concentrations for the period January 2015 to December 2015

The Non-Residential Area standard of 1,200 mg/m<sup>2</sup>/day was exceeded 14 times during the period from January to December 2015, with 7 of the exceedances being noted at the sampling point outside the workshop. The Non-Residential area standard of 1,200 mg/m<sup>2</sup>/day was exceeded 3 times from January to April 2016, all of which were outside the workshop.

Exceedance with the Non-Residential Area Standard of 1,200 mg/m <sup>2</sup> /day
Monitoring Data below the Non-Residential Area Standard of 1,200 mg/m <sup>2</sup> /day
No Data recorded

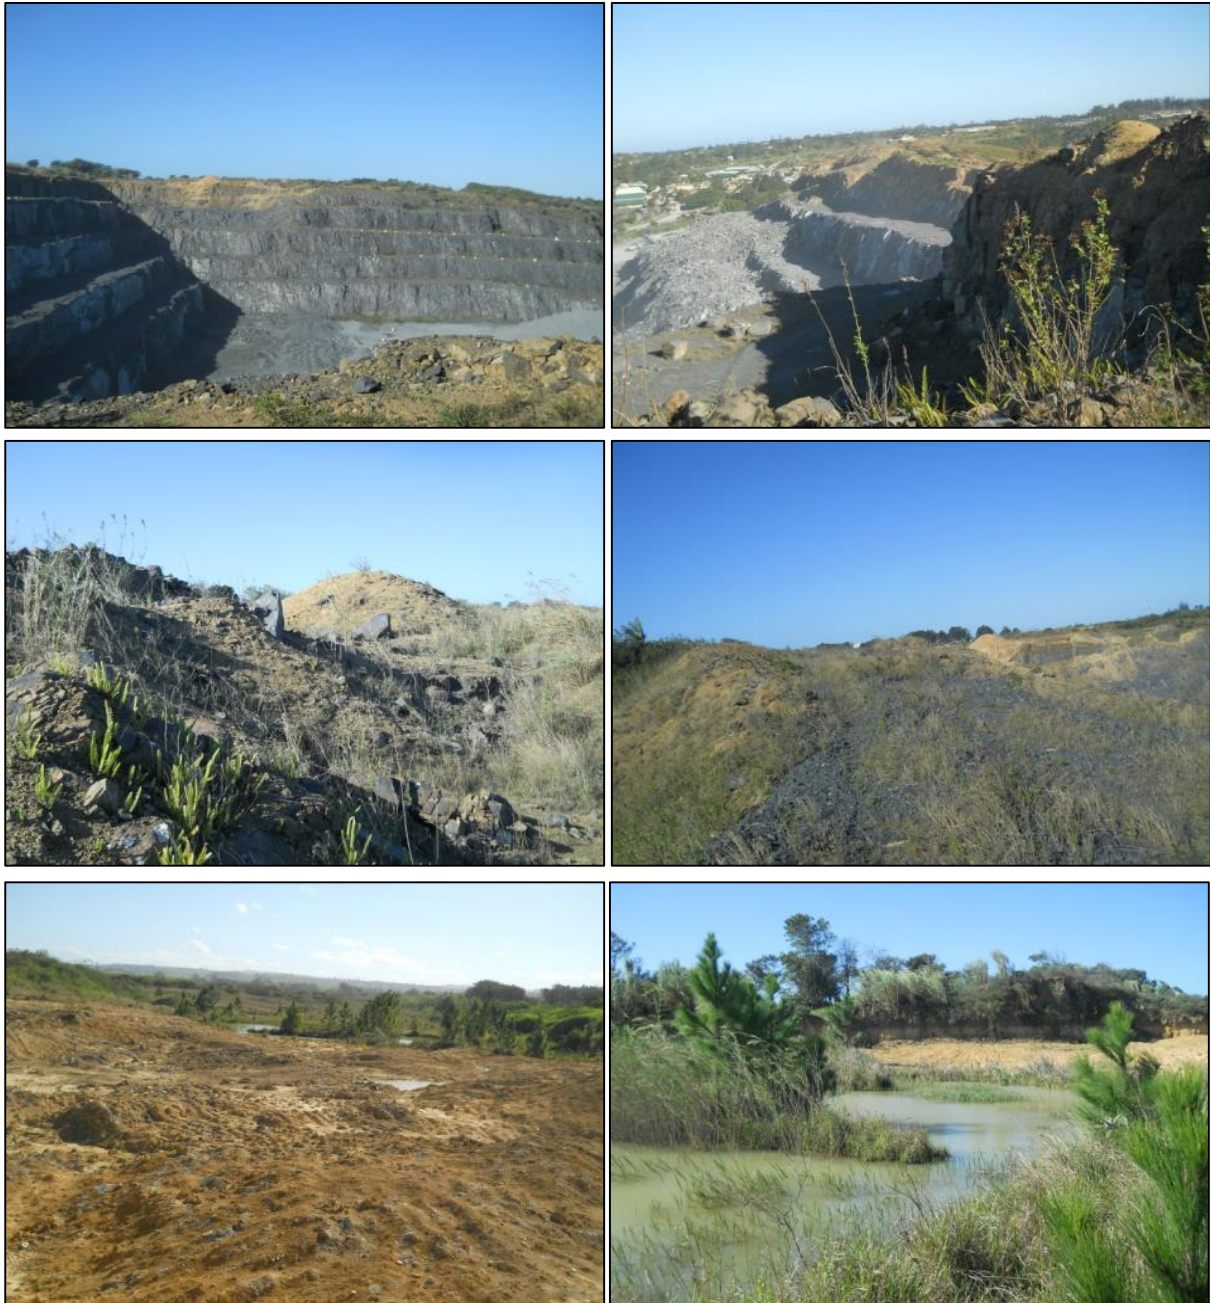
**Figure 12:** The photographs illustrate the Transformed Habitat Unit impacted by mining operations (top), the disturbed area to the north of the existing open pit (centre), earmarked for rehabilitation and the portion of the study area to the northeast where topsoil has been stripped as a result of clay mining activities which occurred in the past (bottom)

The Transformed Habitat Unit (Figures 12 & 13) is representative of the majority of the vegetation within the study area and comprises of mining areas and associated disturbed areas as well as offices and related infrastructure within the centre and south of the study area, areas in the north where topsoil has been cleared and agricultural land in the west.

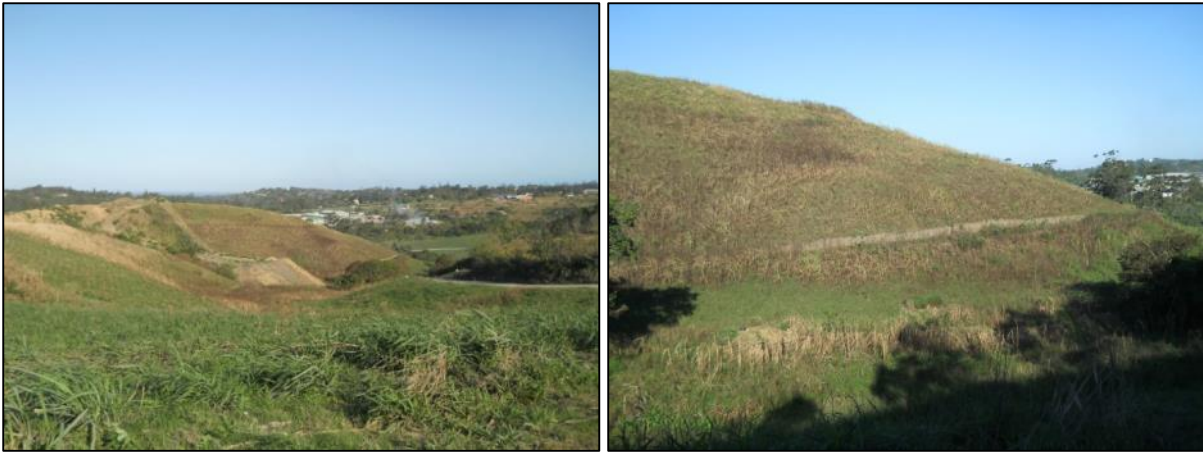
**Figure 13: The Transformed Habitat Unit associated with agricultural (sugarcane) fields within the west of the study area.**

The Transformed Habitat Unit is dominated by bare soils and alien vegetation, including species such as *Casuarina equisetifolia*, *Eucalyptus* sp., *Melia azedarach* and *Morus alba* as a result of very high levels of disturbance, with limited indigenous species present. Although these areas, including areas in the vicinity of the agricultural fields and the area where topsoil has been stripped, provide habitat for some indigenous species, this habitat is not a natural condition and has undergone significant transformation. Dominant floral species encountered within the Transformed Habitat Unit during the field assessment are listed in the table below.

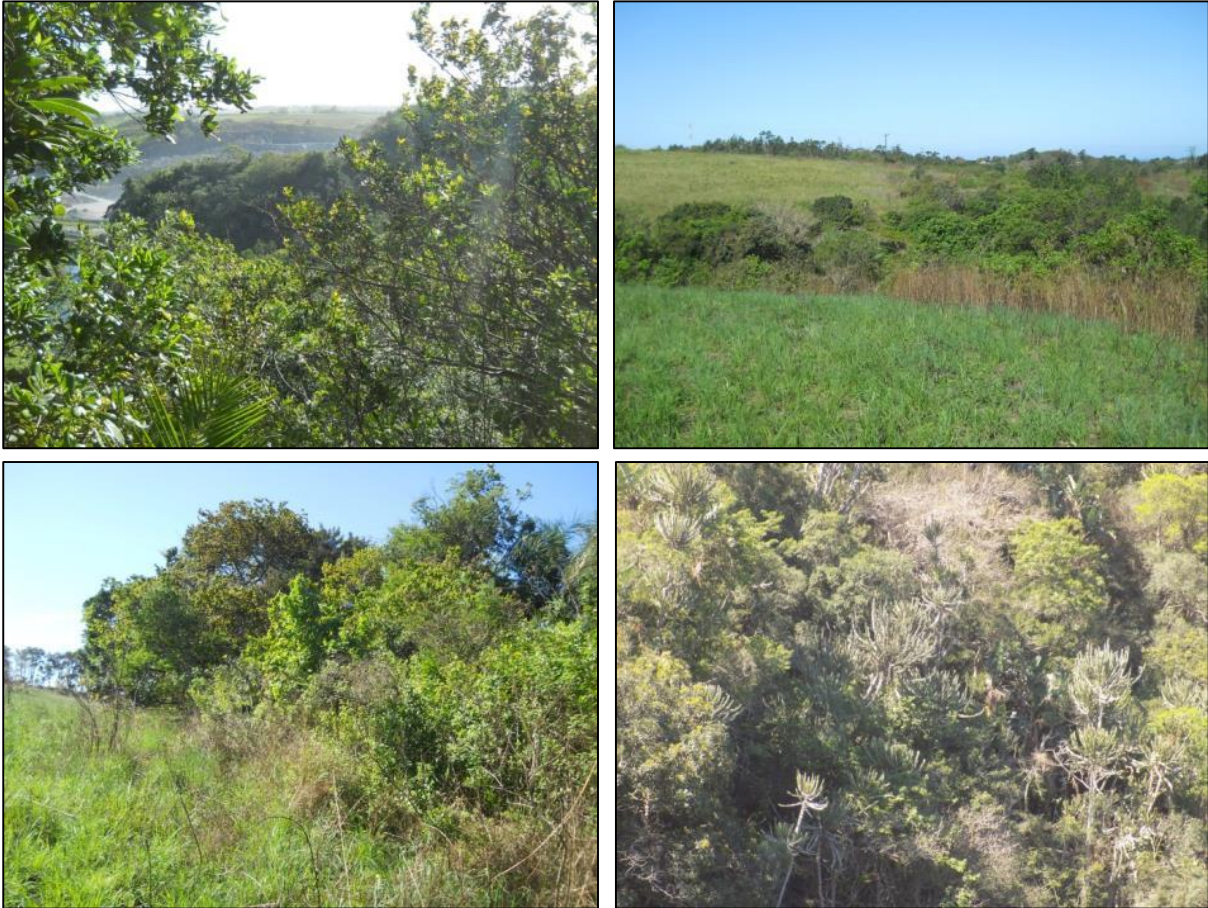
**Figure 15: The Coastal Forest Habitat Unit to the north of the study area.**

The Coastal Forest Habitat Unit (Figure 15) is located within the eastern portion of the study area within the area earmarked for mining expansion activities during the 2020 to 2036 period.

This habitat unit is associated with two unnamed tributaries of the Uvongo River and related habitat and originates within steep kloofs above the river. Vegetation associated with this habitat unit is dominated by woody species, including *Syzygium cordatum*, *Phoenix reclinata*, *Bridelia micrantha* – all species indicated to be dominant within the KwaZulu-Natal Coastal Belt vegetation type, with other woody species including *Halleria lucida*, *Ficus natalensis* and *F. sur*.

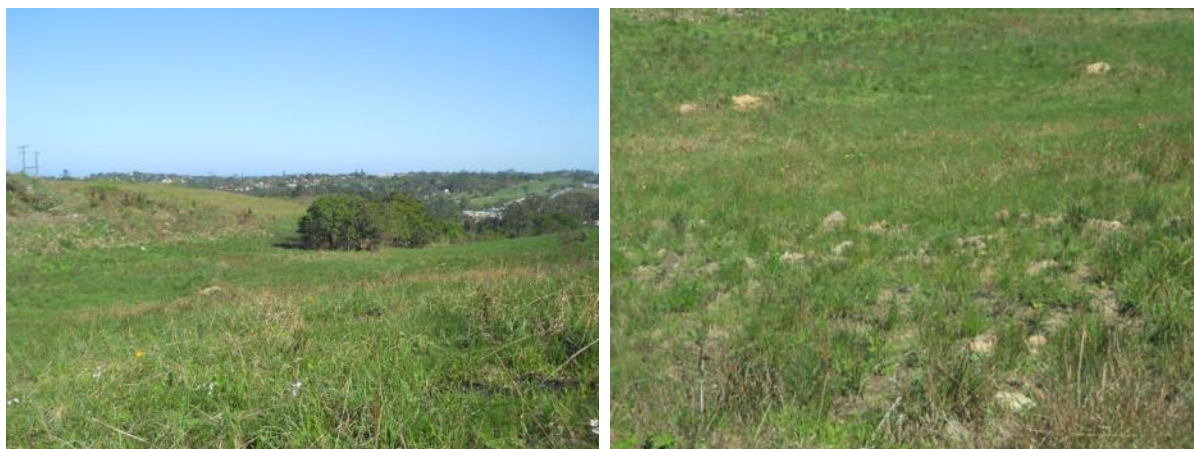
**Figure 16: The Grassland Habitat Unit within the northeast of the study area.**

The Grassland Habitat Unit (Figure 16) is located within the northeast of the study area and comprises a portion somewhat impacted grassland of limited extent.

This habitat unit shows some sign of recent disturbance and is relatively isolated from any similar habitat in the region due to surrounding earthworks, disturbances from the roadway to the north, topsoil stripping and the construction of berms in its immediate vicinity. This portion of grassland, does however provide habitat for a relatively high diversity of indigenous grass species and forb species such as *Hypoxis hemerocallidea*, a floral SCC species listed by SANBI as 'Declining', *H. colchifolia*, *Helichrysum nudifolium*, *Cynium tubulosum* and *Watsonia* sp. Alien species are present along the boundaries of this habitat unit.

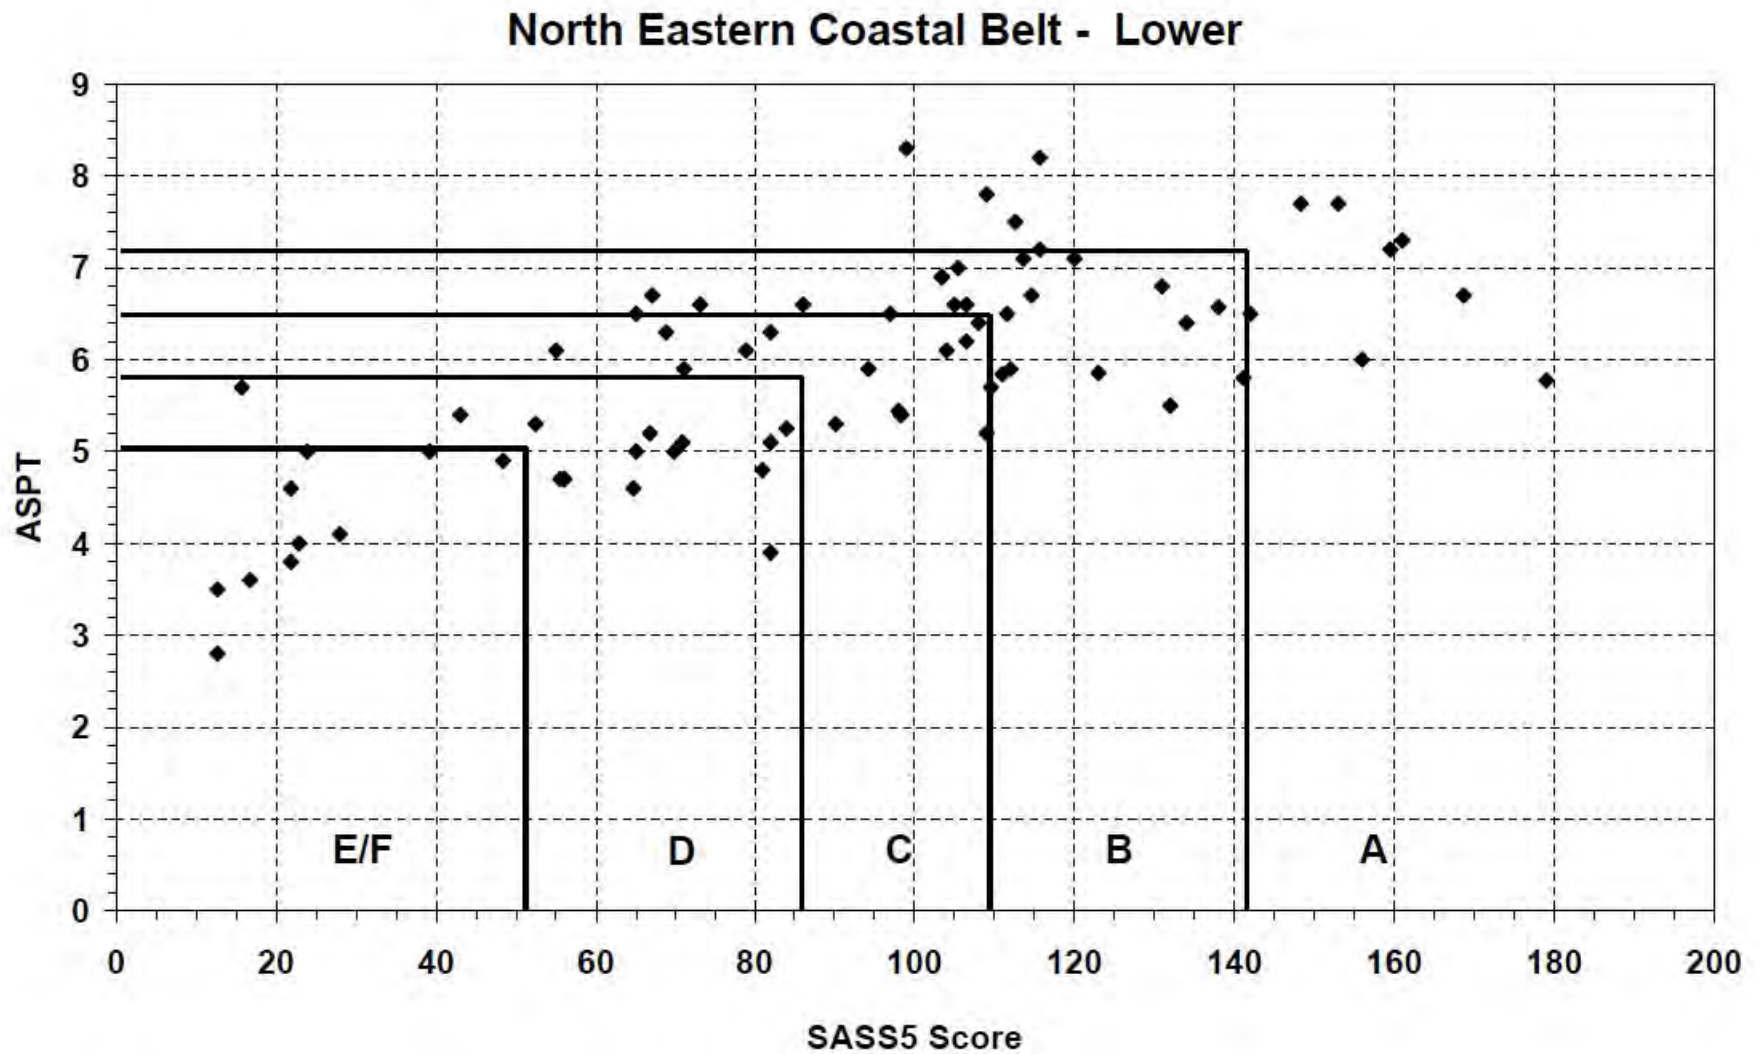
**Figure 3: Biological bands for the North Eastern Coastal Belt – Lower zone, calculated using percentiles**

SASS Data Interpretation Guidelines (Dallas, 2007) were used to interpret the SASS 5 information collected during the survey. The guidelines method utilises natural variation in SASS 5 scores and ASPT to determine preliminary biological bands. The study area falls within the Level 1 Ecoregion for the North Eastern Coastal Belt and the SASS5 score and ASPT values were evaluated according to these bands. Figure 3 below indicates the Northern Eastern Coastal Belt - Lower biological band.

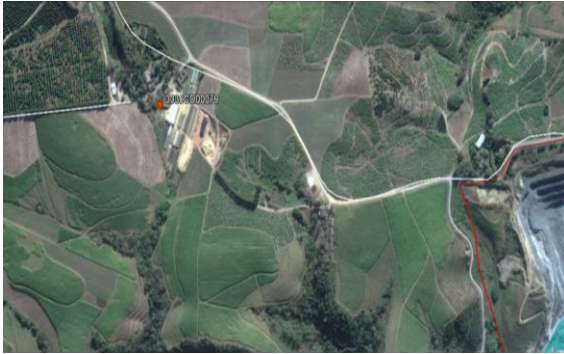
**Plate 1:** Background well located in private property.

Groundwater sampling should be conducted on a bi-annual basis during October (i.e. end of dry season) and April (i.e. end of wet season). The monitoring well locations are summarised in **Table 2** and illustrated in **Figure 3**.

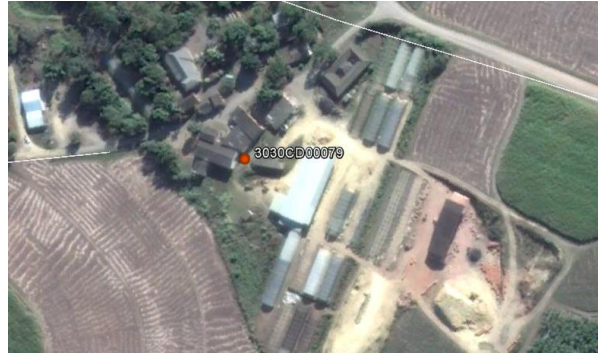
**Plate 2:** Close up image of the Background well located in Sea View Farm property.

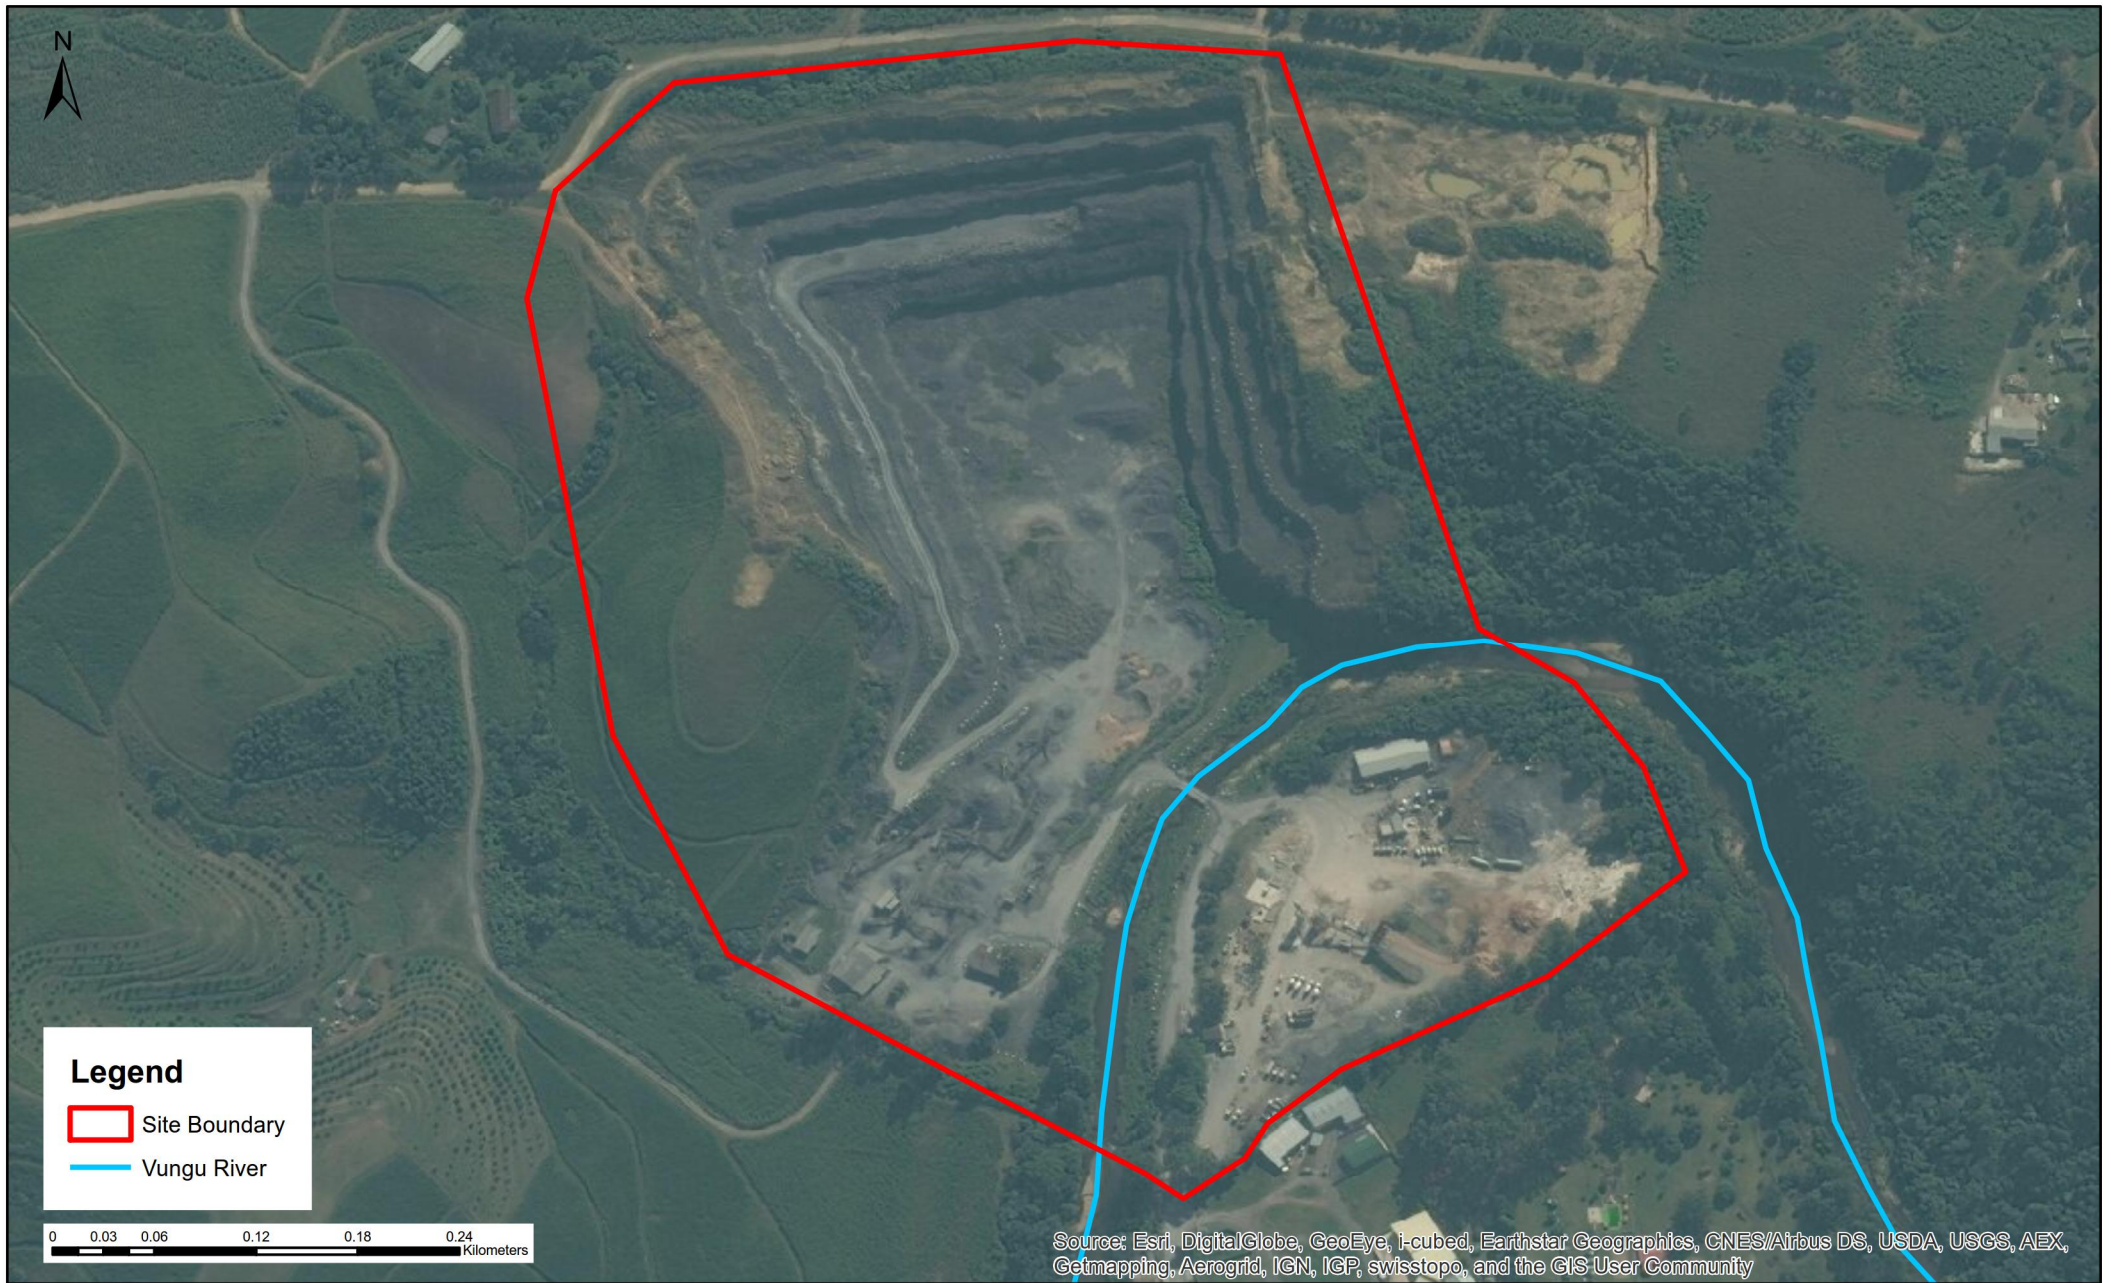
Site Map

SCSC occupies a total area of 27ha, centred at global co-ordinates 30°49'23.25" south and 30°22'33.27" east. The quarry is located approximately 1.3km north east of Uvongo (**Figure 1**). SCSC is bisected by the Vungu River, with the Aggregate Plant located on the northern bank and Concrete Plant located on the southern bank of the Vungu River (**Figure 2**).
