CONFINEMENT OF MONTANASPRUIT

REVIEW **AQUATIC ASSESSMENT**

**Review of Existing Aquatic Assessment Reports for the Proposed
Confinement of the 1:100 Year Floodplain of the Montanaspruit on
Portions 28 to 42, 137 & 138 of Doornpoort 295 JR, City of Tshwane,
Gauteng Province**

JULY 2019

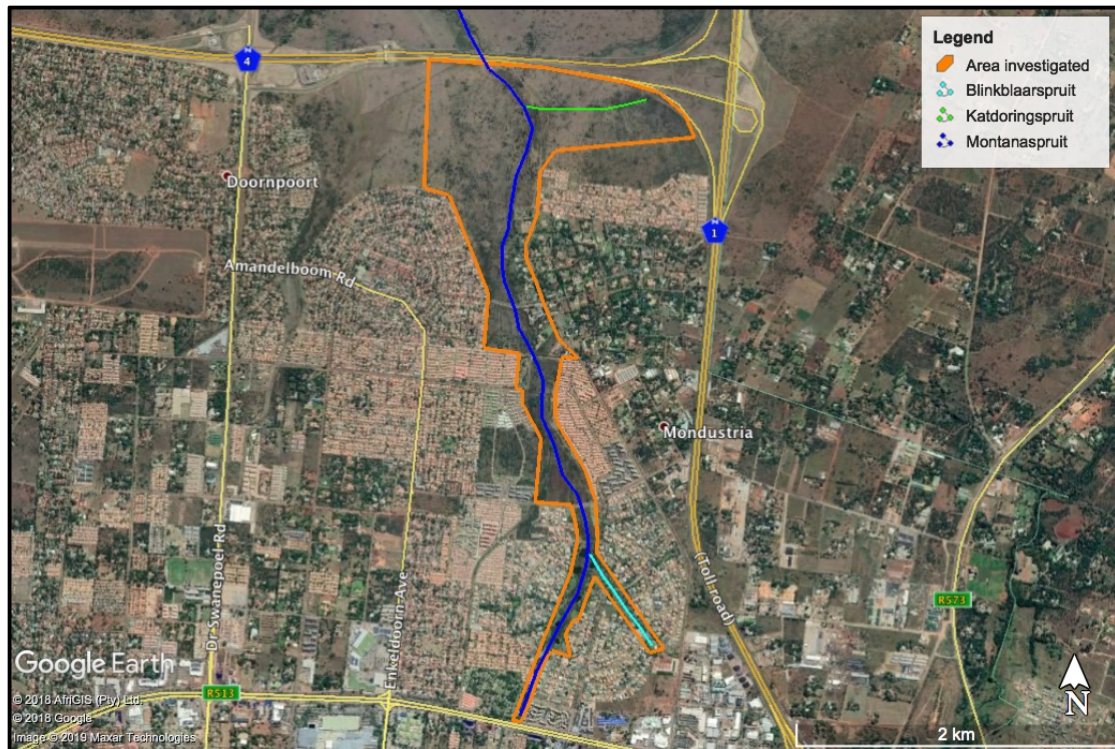
Figure 3: Main watercourses in the study site and greater area

Figure 3, below, shows the Montanaspruit (Stream), which is the main watercourse in the area and the only one that flows through the study site. The Blinkblaarspruit (to the south) and the Katdoringspruit (to the north / northeast) are tributaries of the Montanaspruit and also part of the larger aquatic ecosystem of the area.

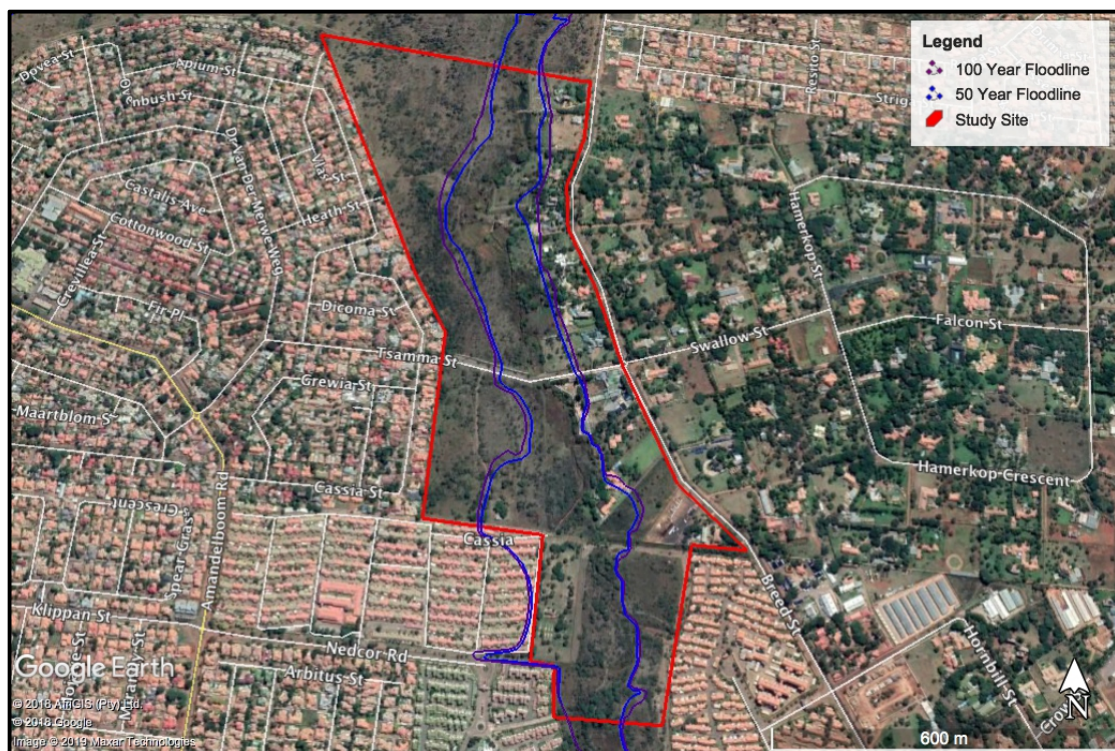
Figure 4: 50-year and 10-year floodlines of the Montanaspruit in the study site

The existing 50-year and 100-year floodlines have also been delineated, as shown in below in Figure 4

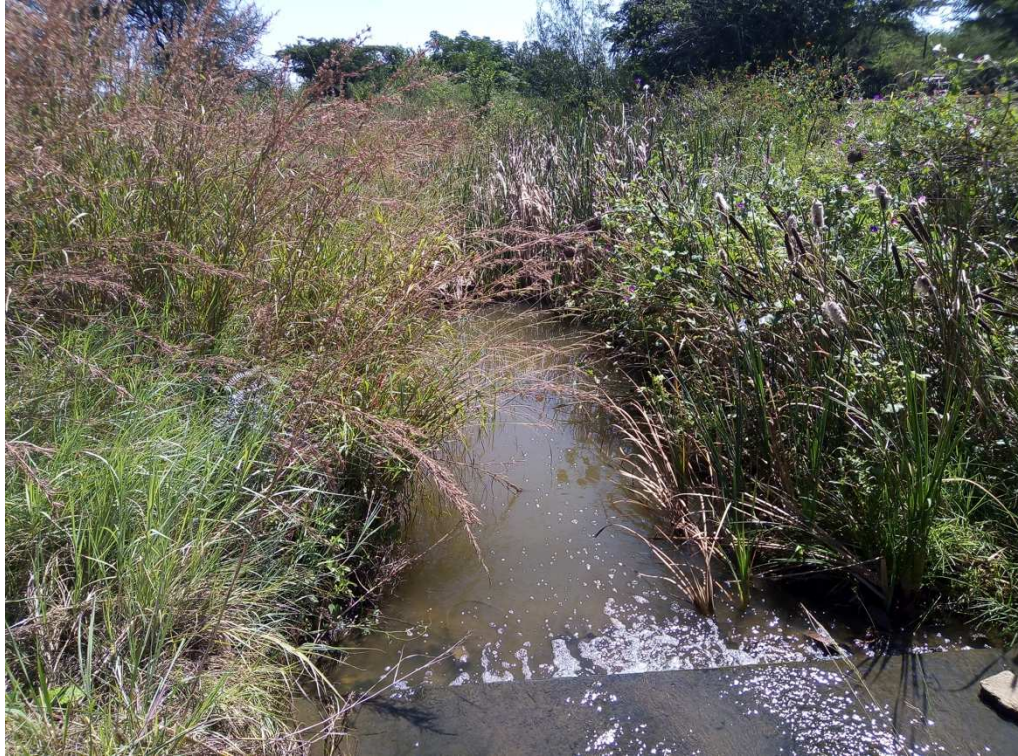
Photo 3: Stream showing dense grasses and rushes along the banks and in the riparian zone

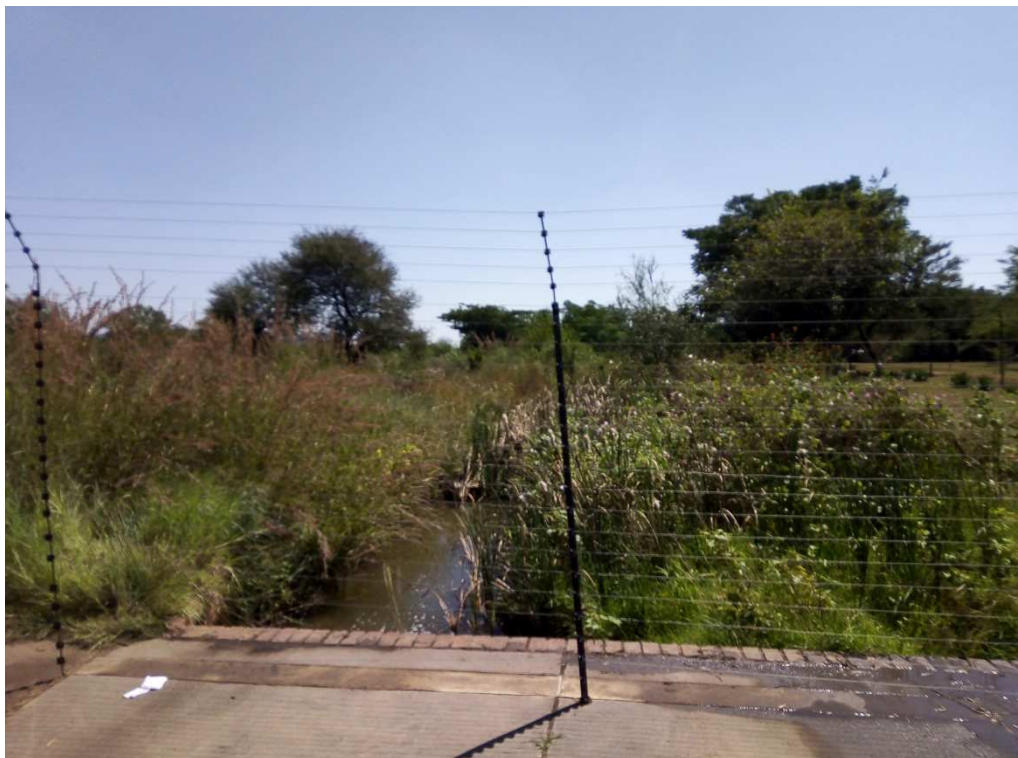
Photo 4: Low-level bridge and road crossing over stream (Tsamma St)

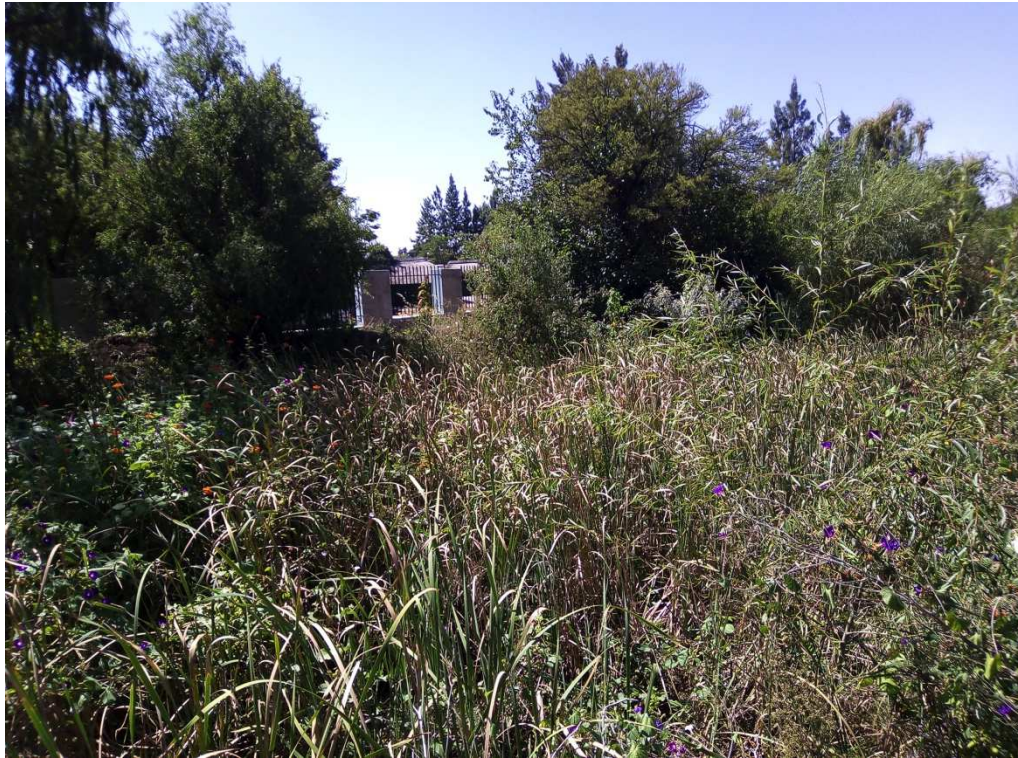
Photo 5: Dense rushes in stream and floodplain. Also notice alien invasive weeds (morning glory and zinnia)

- It is strongly recommended that aquatic monitoring of the Montanaspruit be implemented during the construction phase of the project. Monitoring must take place upstream, in the study area itself and upstream. The greatest potential negative impacts arising from the project are during the construction phase and these are mostly in terms of siltation; loss of riparian vegetation and zone; alteration of the main channel; and introduction of invasive weed species.
